LONG RANGE ACOUSTIC PROPAGATION PROJECT.  
BLAKE TEST SYNOPSIS REPORT

**Long Range Acoustic Propagation Project**

**BLAKE TEST Synopsis Report**

**TECHNICAL REPORT**

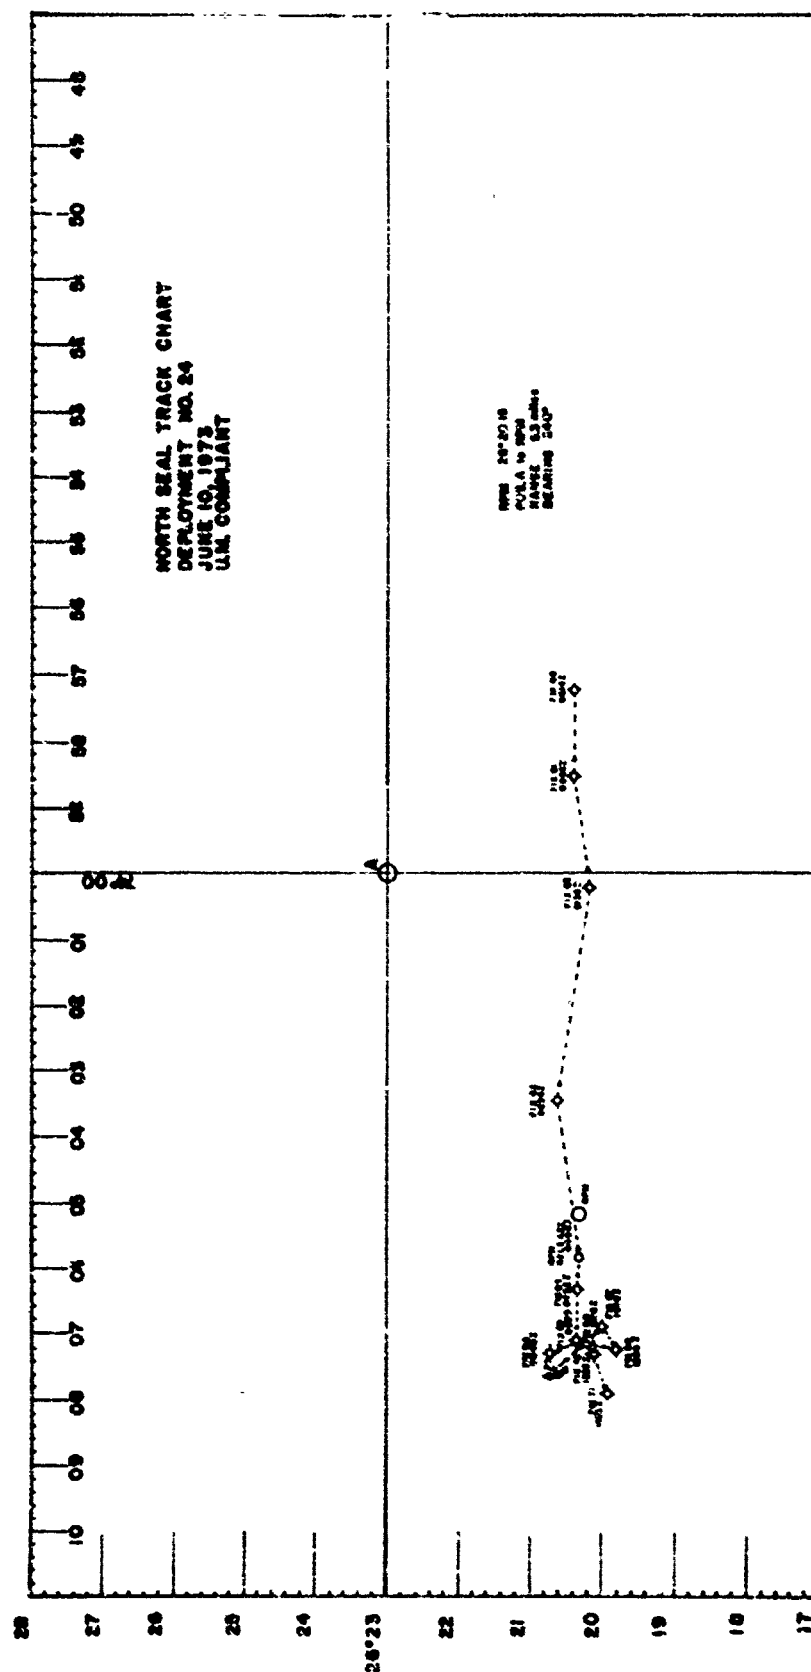
Figure 4. BLAKE TEST Deployment Chart. U.M. Compliant Mooring

The compliant mooring failed due to slippage of seizings which attach pigtails to the electro-mechanical cable. The slippage was caused by the reduction in cross section of both the pigtail and the electromechanical cable under the dynamic launching loads. The maximum load would be felt at the lower end of the cable which is where the failure occurred. It is necessary to find an attachment which rather than slipping under load, tightens under load. Two possibilities are to knot the pigtail onto the cable by means of a rolling hitch or to join by a braided attachment commonly known as a "Chinese finger". An important consideration in the attachment to the relatively soft compliant cable is to avoid damage in the insulation on the internal conductors. Both of these approaches will be tested and a proved remedy will be provided prior to the next deployment.

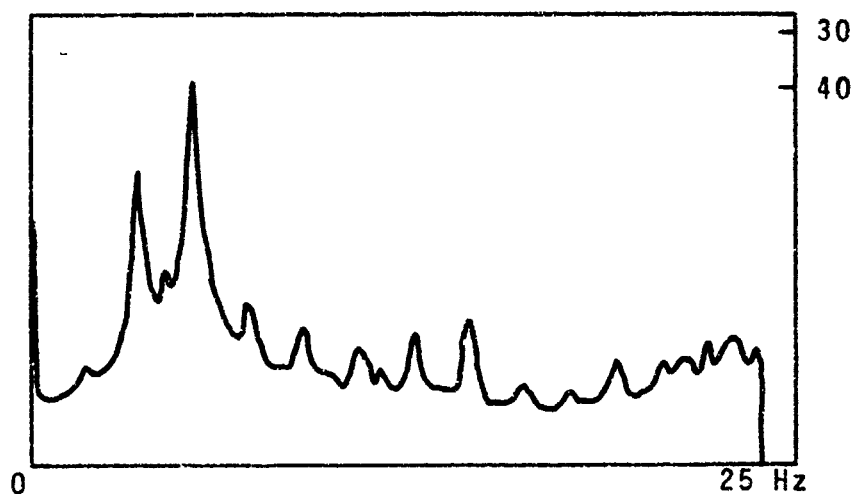
Figure 12. Narrow Band Power Spectrum 0-25 Hz BLAKE TEST  
WHOI/TI Array Hydrophone No. 6 22202 12 June

Data were reduced by three organizations, the Woods Hole Oceanographic Institution, the Applied Research Laboratory of the University of Texas and Texas Instruments, Inc; See G. E. Ellis et al, "ARL Preliminary Data Analysis from ACODAC System" ARL-TM-73-11 of 14 June 1973 and "Blake Test Quick Look Report" July 1973, Texas Instrument, Inc. Woods Hole data were reduced and presented in the ACODAC 1/3 octave format. Each one minute average in selected 1/3 octave bands was plotted. The resultant time series were displayed with distribution histograms on the left ordinate. These are shown in Figures 10 and 11. Another form of data was the narrowband power spectrum, produced by FFT. Power spectra of approximately 1/4 Hz and 1/10 Hz resolution were calculated which permitted diagnosis of the sources of certain strumming lines. See Figures 12 and 13. Sequential narrowband spectra constituted the most useful data from ARL/UT and LOFARgrams produced by TI were useful in identifying strumming occurrences and frequencies. See Figures 14 and 15.
