INVESTIGATION OF THE HOOD EFFECT
OF THE 6" COMM. MK. 27-7 PROJECTILE
AT VARIOUS OBLIQUITIES

EXPERIMENTAL DEPARTMENT MEMORANDUM

No. 1238-47

21 April 1947.

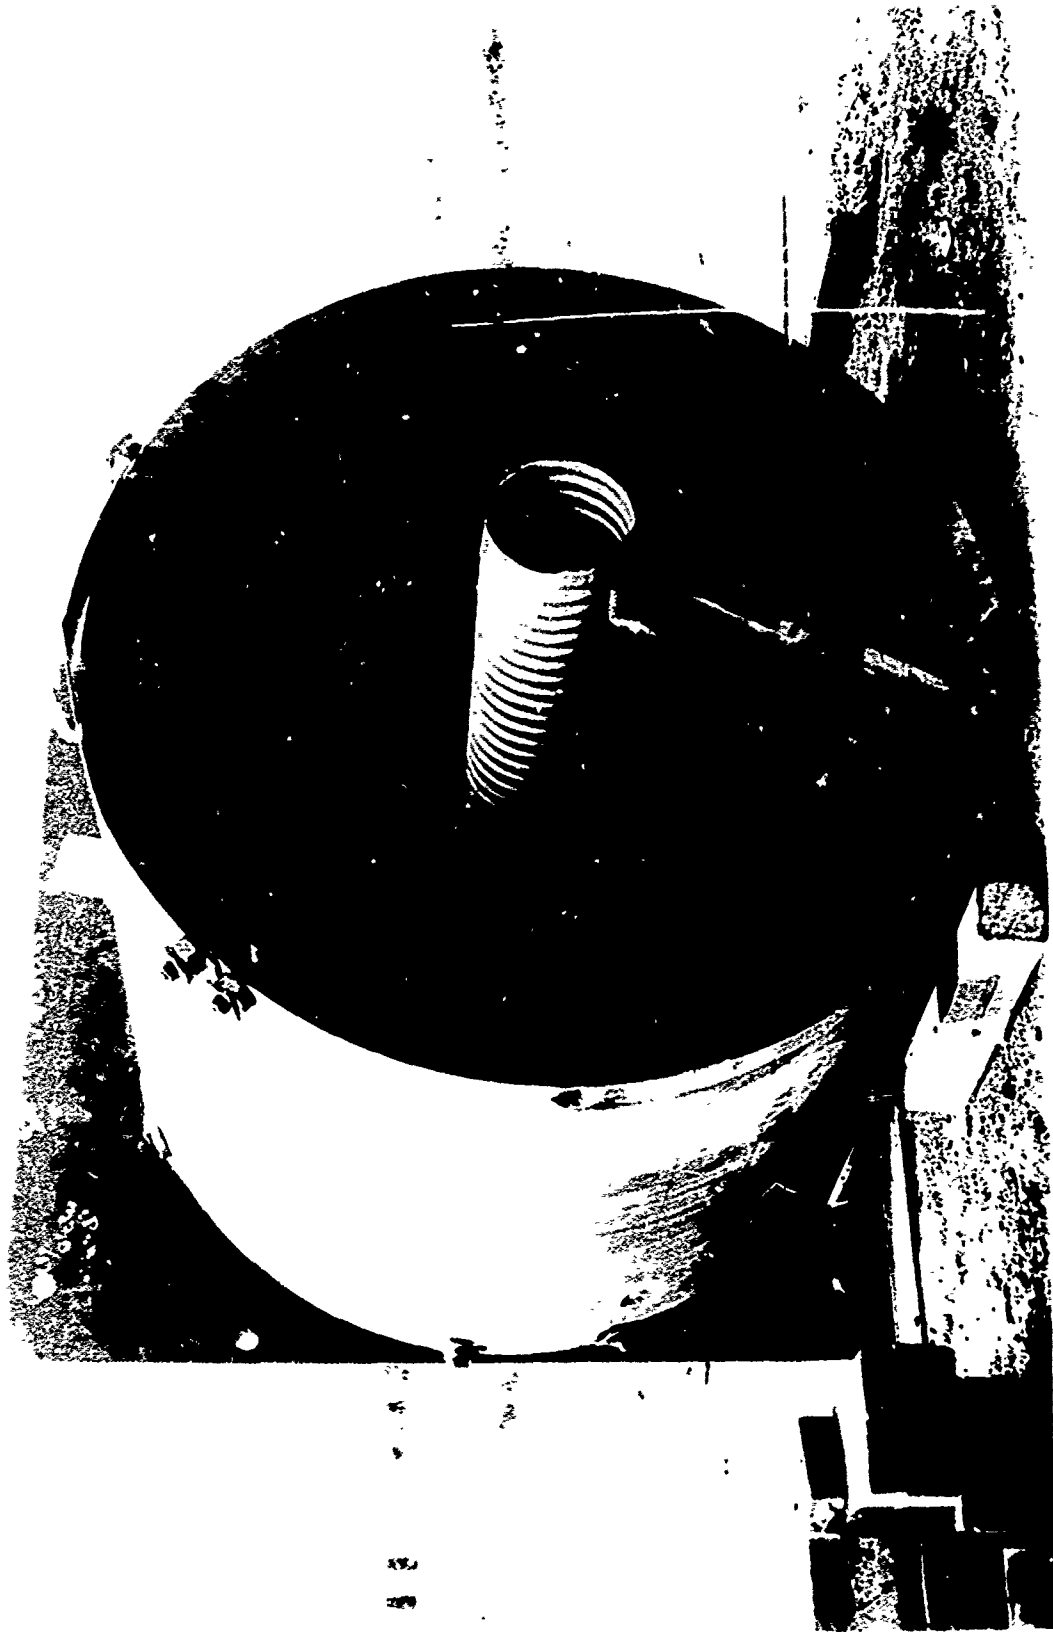
29 35052 - Bal. Exp. Test of 18908 3T3 Plate No. 98503 l'fd. by Carnegie
Illinois Steel Corp. vs. 6" Corron Wk. 27-7 Proj. IL&P fired for recovery
of fragments of the windshield and hood. View: Front of fragment recovery
tube with cover plate removed to show concentric arrangement of culvert
pipe and armor tube.
