**COMPARATIVE PERFORMANCE OF STRUCTURAL LAYERS IN
PAVEMENT SYSTEMS**

**VOLUME I. DESIGN, CONSTRUCTION, AND BEHAVIOR
UNDER TRAFFIC OF PAVEMENT TEST SECTIONS**

ARMY ENGINEER WATERWAYS EXPERIMENT STATION

JUNE 1974

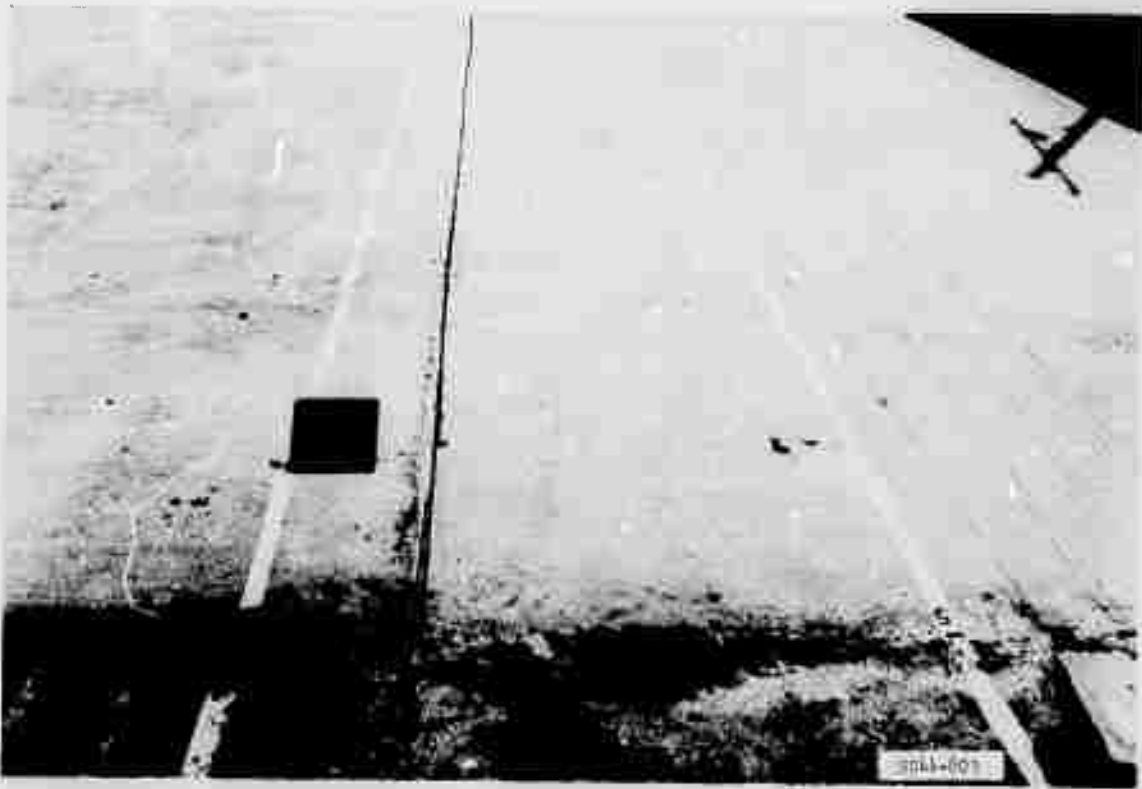
Figure A1. Item 1, lane 1, rigid pavement test section, prior to traffic

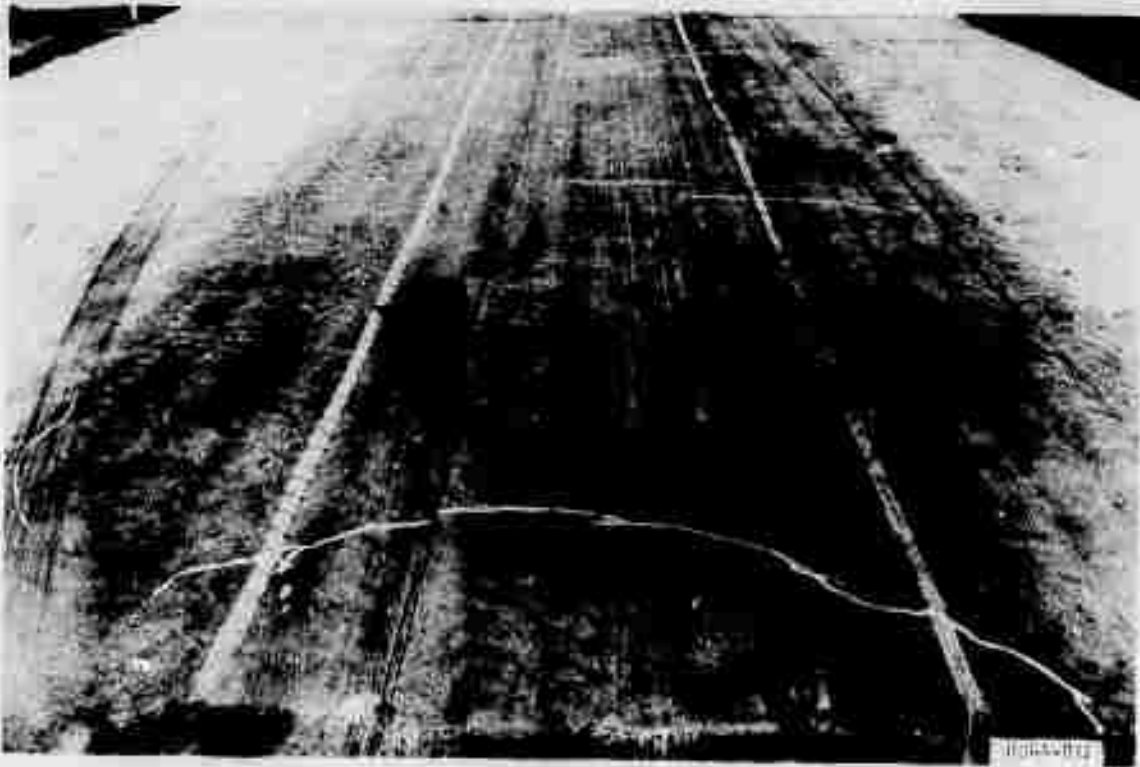
Figure A2. Item 1, lane 1, rigid pavement test section, after 200 coverages by 200-kip twin-tandem assembly

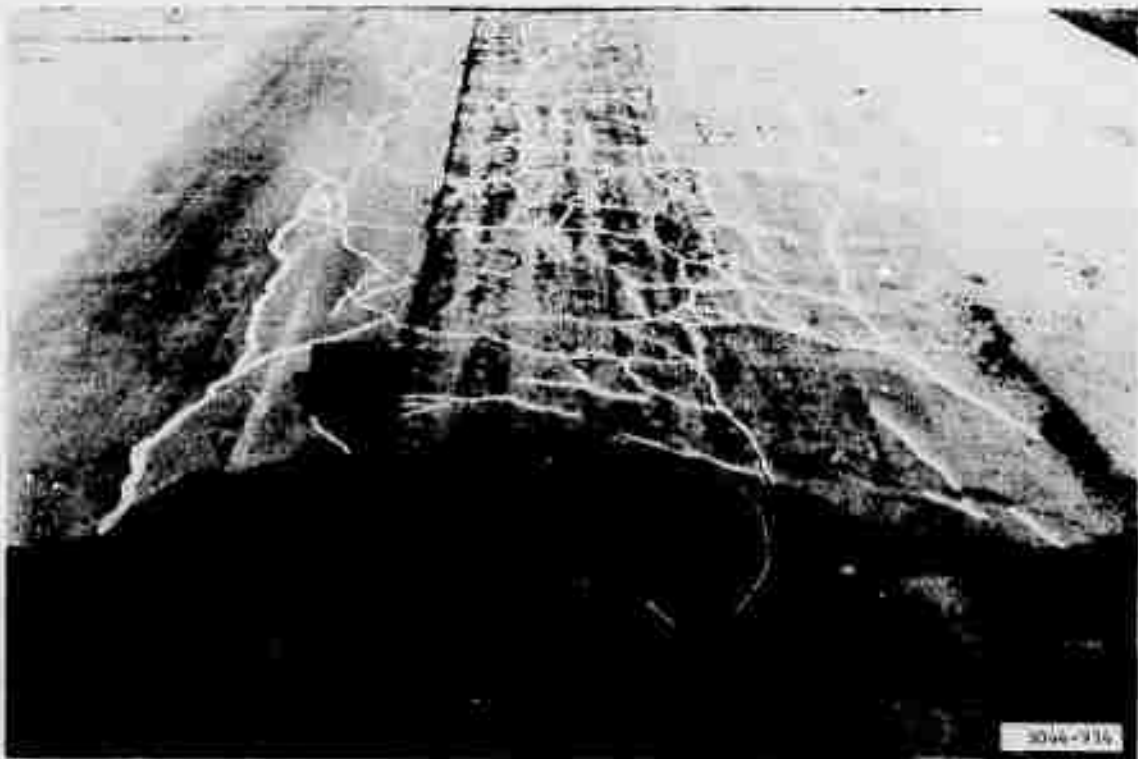
Figure A4. Item 1, lane 1, rigid pavement test section, after 3000 coverages by 200-kip twin-tandem assembly

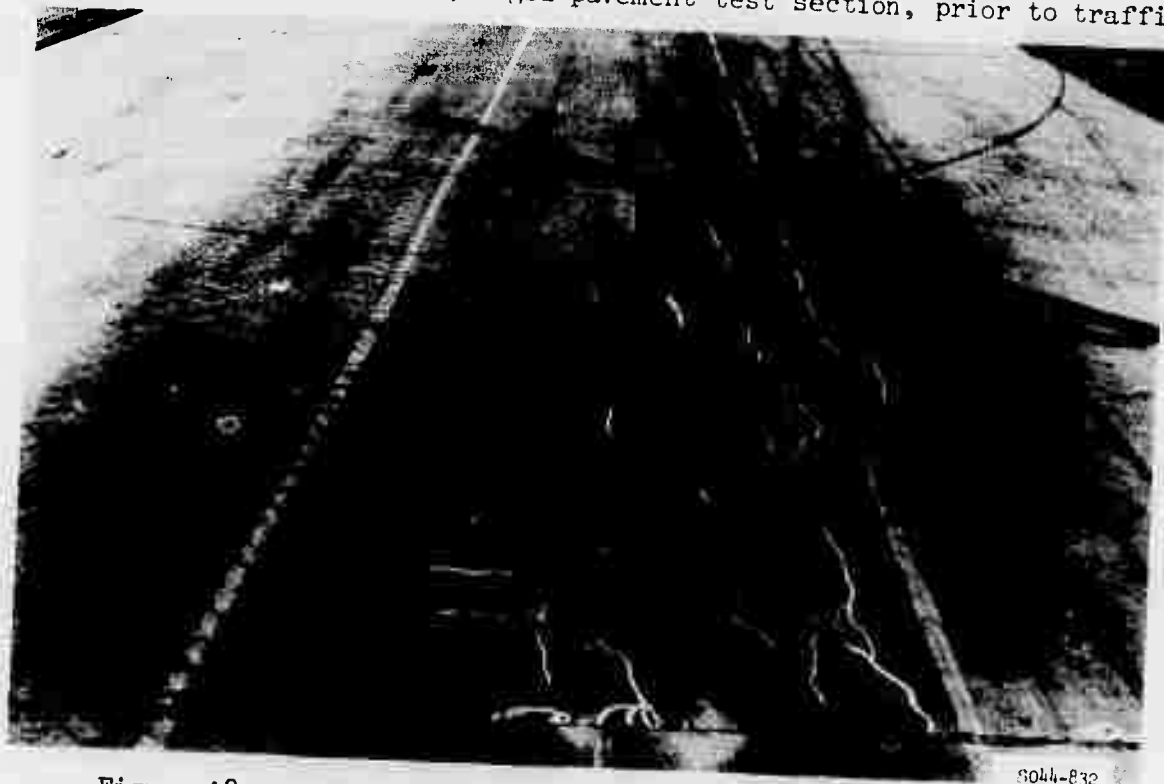
Figure A8. Item 2, lane 1, rigid pavement test section, after 200 coverages by 200-kip twin-tandem assembly .

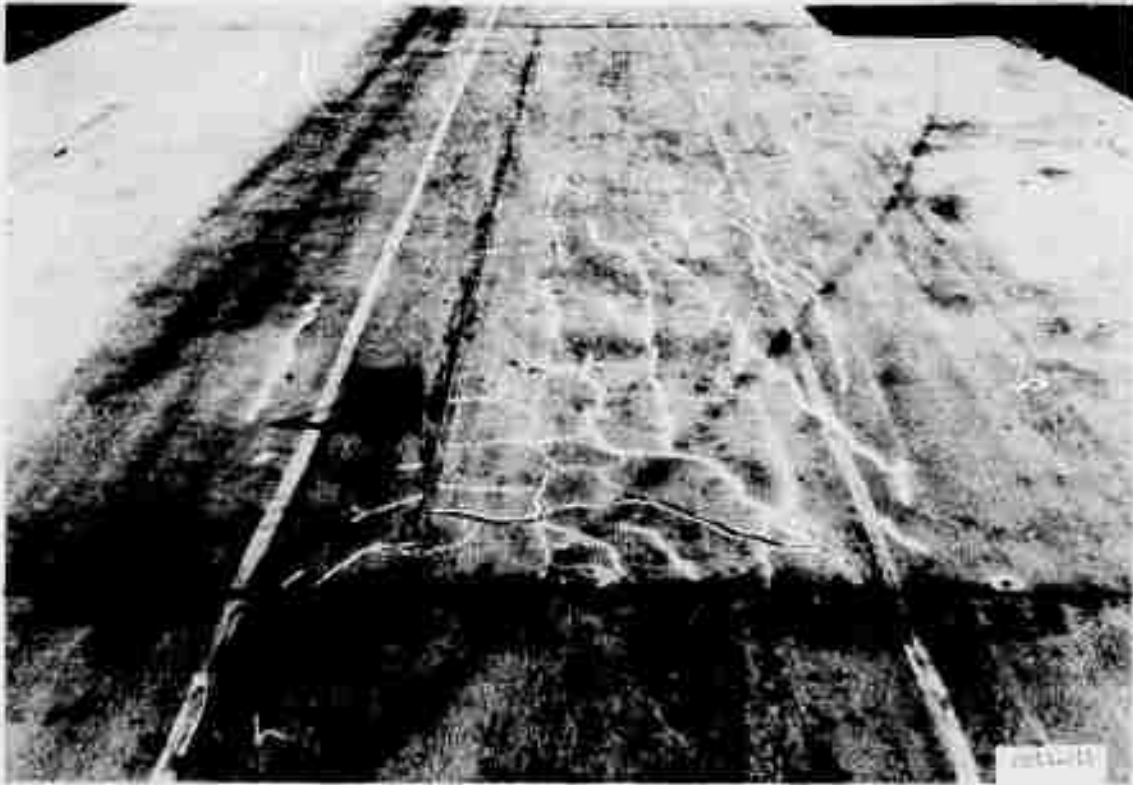
Figure A9. Item 2, lane 1, rigid pavement test section, after 1000 coverages by 200-kip twin-tandem assembly

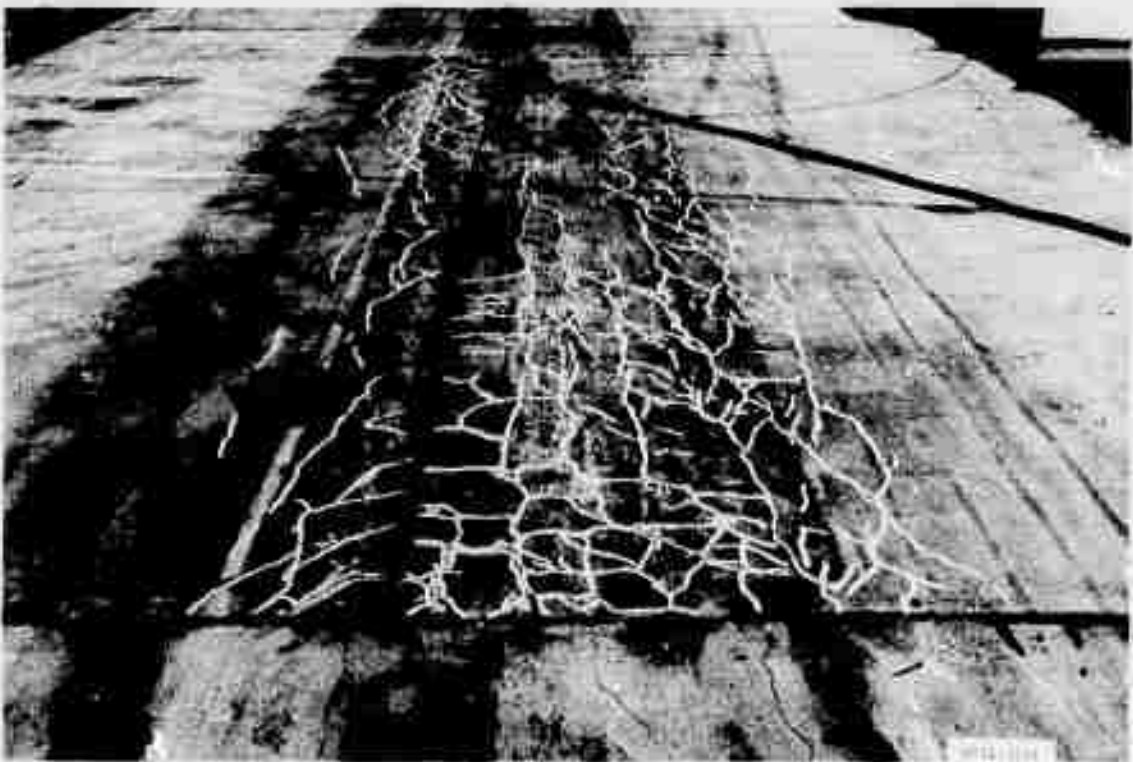
Figure A10. Item 2, lane 1, rigid pavement test section, after 1770 coverages by 200-kip twin-tandem assembly

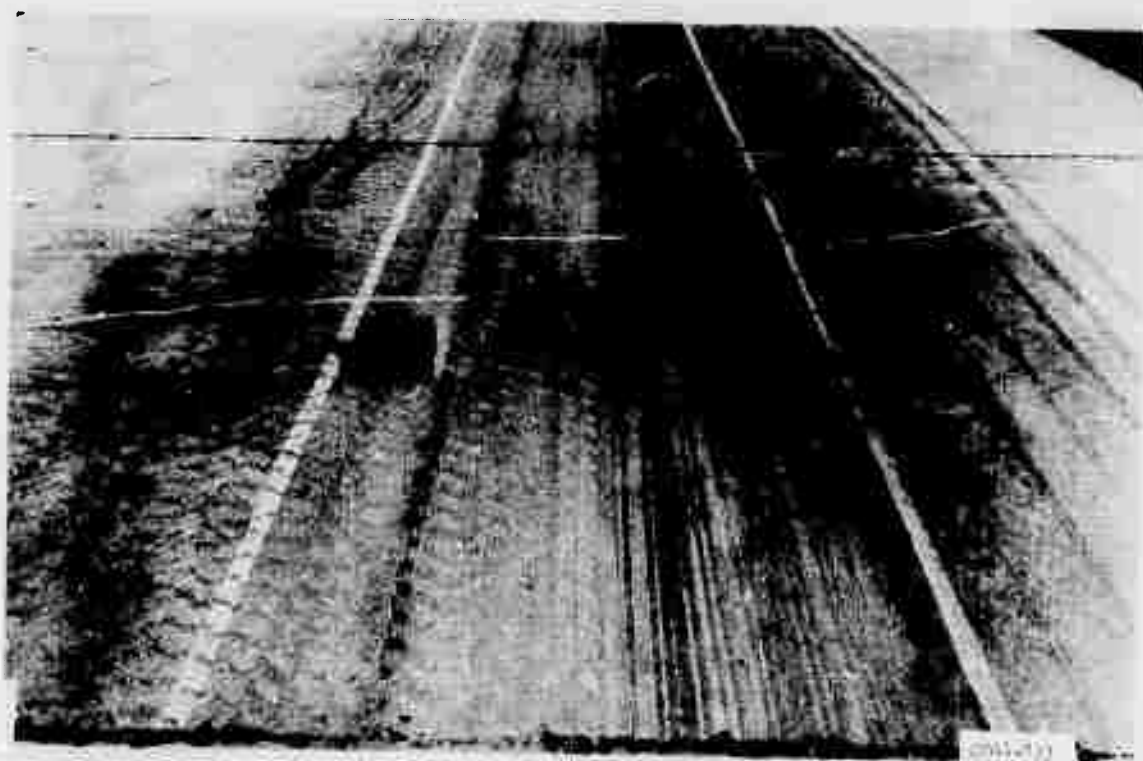
Figure A13. Item 3, lane 1, rigid pavement test section, after 200 coverages by 200-kip twin-tandem assembly

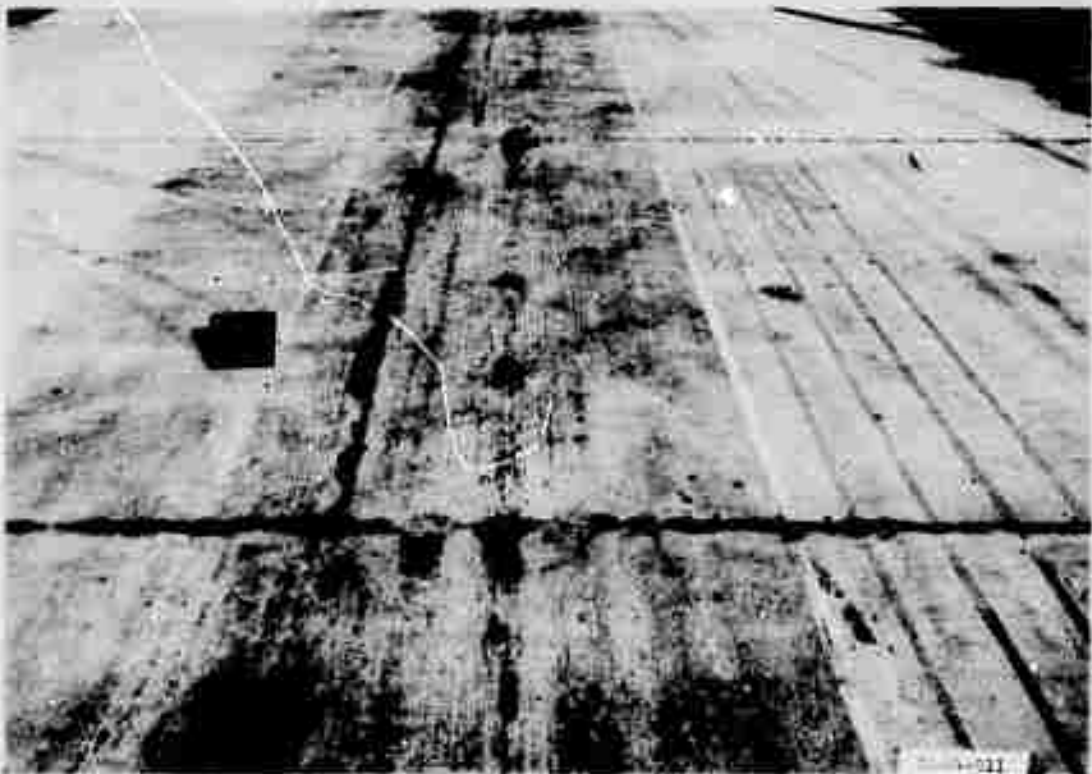
Figure A18. Item 4, lane 1, rigid pavement test section, after 1770 coverages by 200-kip twin-tandem assembly

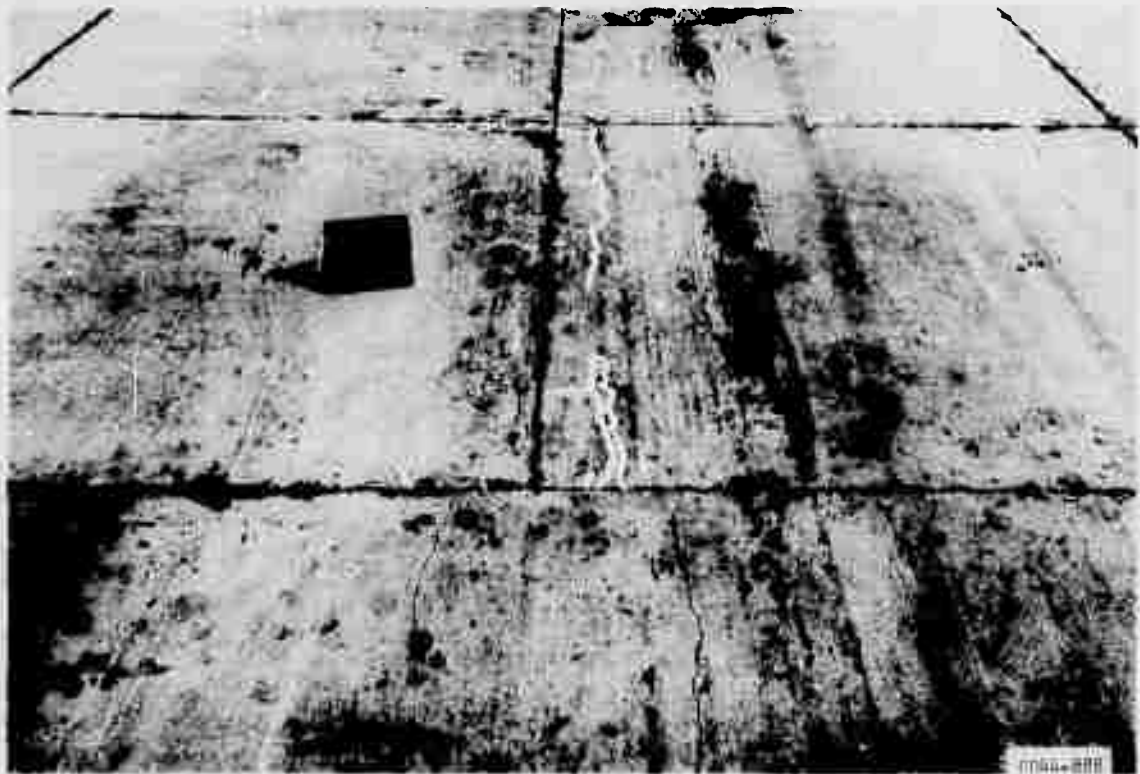
Figure A22. Subitem 5a, lane 1, rigid pavement test section, after 1770 coverages by 200-kip twin-tandem assembly

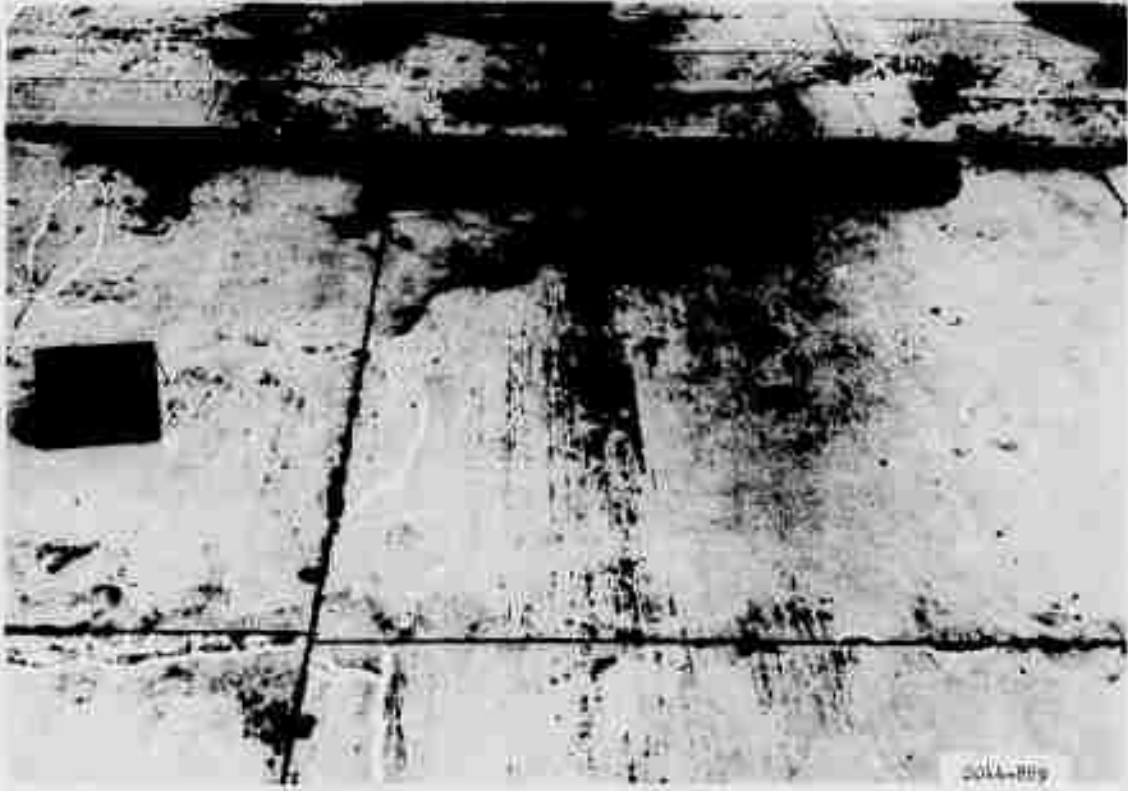
Figure A25. Subitem 5b, lane 1, rigid pavement test section, after 1770 coverages by 200-kip twin-tandem assembly

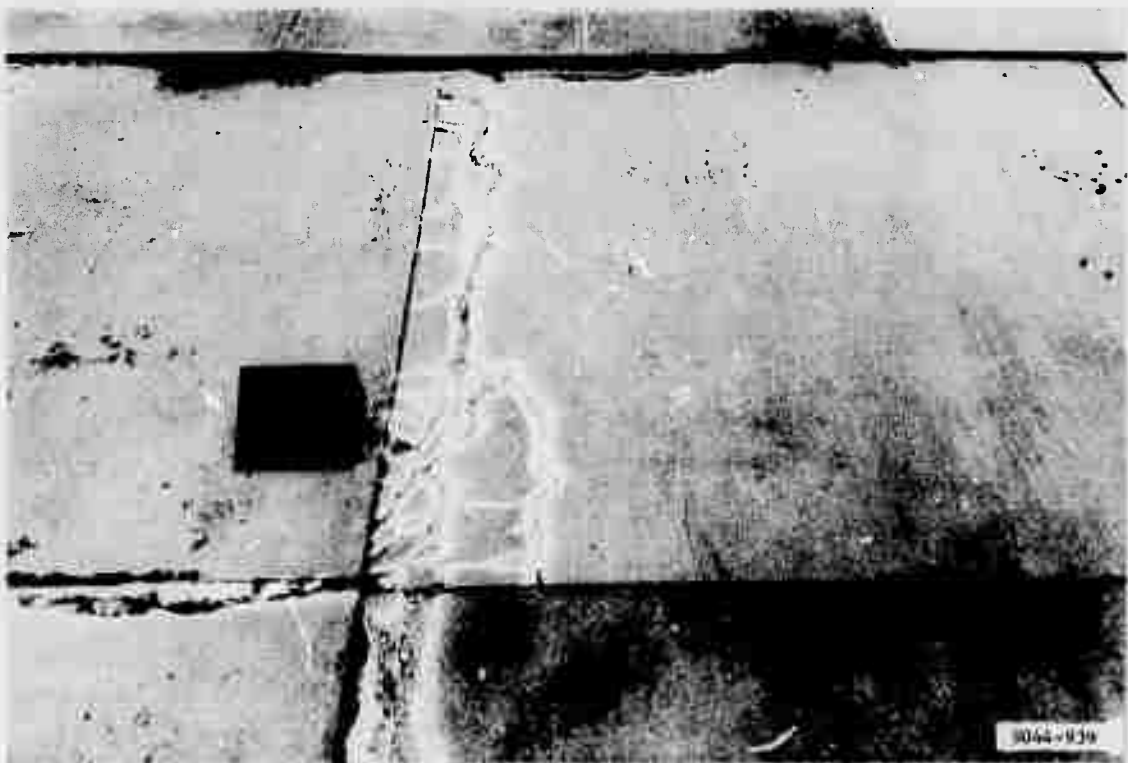
Figure A26. Subitem 5b, lane 1, rigid pavement test section, after 3000 coverages by 200-kip twin-tandem assembly

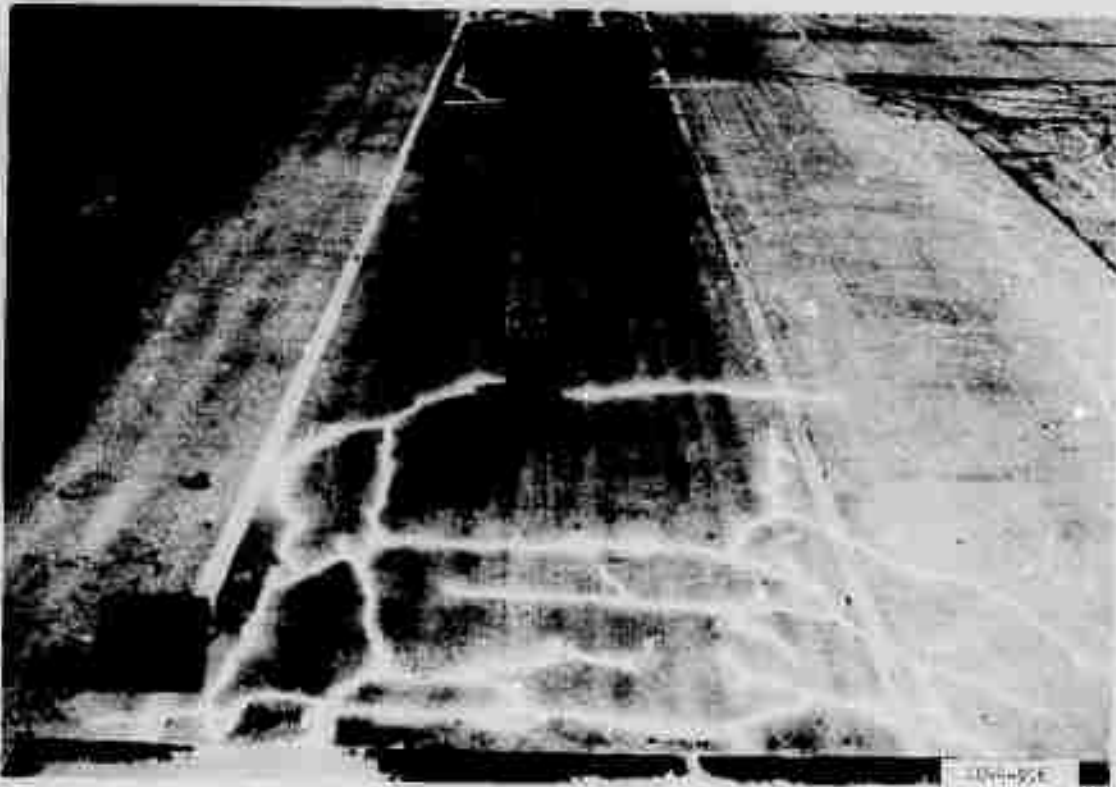
A general view of item 1 prior to traffic is shown in Figure A31. No cracks were observed in the pavement surface prior to static loading for instrumentation readings, but, during static loading, several cracks developed in the item (Figure A32). Cracks continued to develop with the application of traffic, and, at 200 coverages, cracking was heavy at the west end and moderate at the east end of the item (Figure A33). Traffic was continued, and, at 430 coverages, severe cracking had developed at the west end of the item. Landing mat was placed over the area, and traffic was continued to 1010 coverages. At 1010 coverages, cracking had become severe over the entire item (Figure A34), and the item was considered to have reached the complete failure condition. Permanent deformation of the pavement is shown in the cross sections in Figure A35. The west end of the item is not included in the profiles because the polypropylene used to encase the lean clay was torn, probably during

construction, and the lean clay became wet causing a premature failure in about 10 ft of the extreme west end. The large deformation at the east end of the item was probably due to a load transfer failure where the fibrous-reinforced concrete slab joined the transition slab. Permanent deformation in the traffic lane, not including the two ends, averaged 0.5 in. with a maximum deformation of 0.7 in. A slight upheaval (0.3 in.) of the pavement surface occurred outside the traffic lane at the north edge of the pavement.

Figure A33. Item 1, lane 2, rigid pavement test section, after 200 coverages by 240-kip twin-tandem assembly

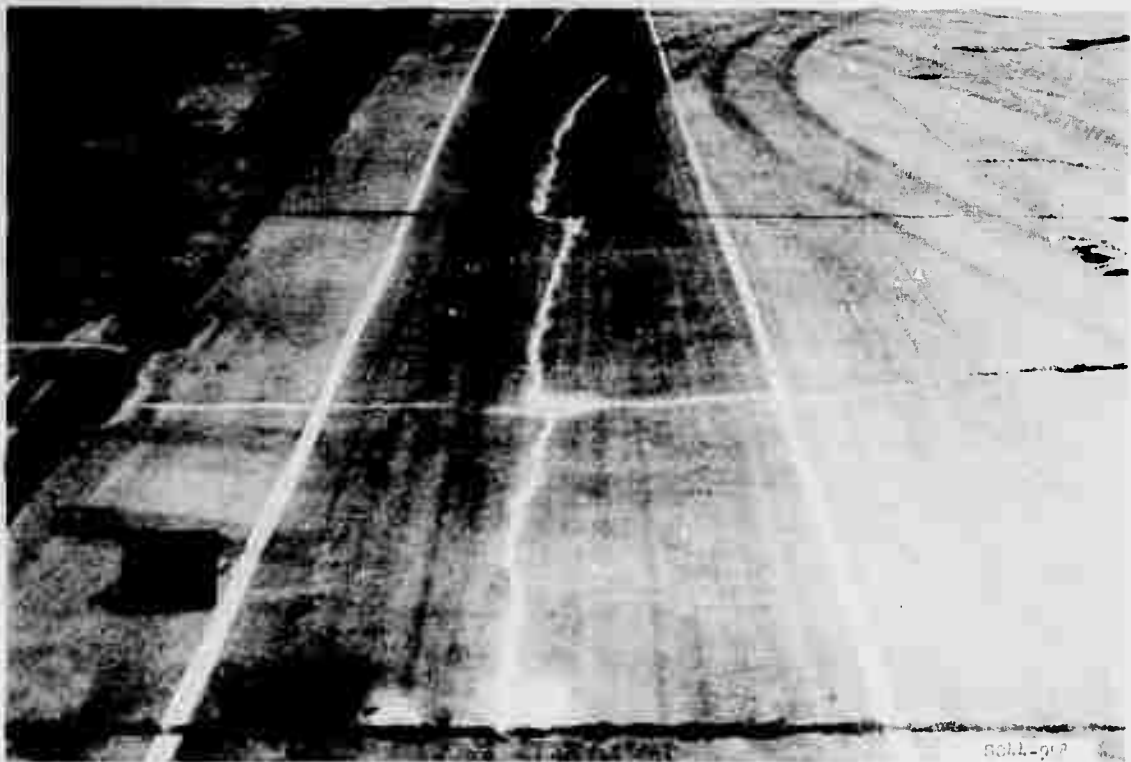
crack developed in the center of the traffic lane. After 200 coverages, these were the only cracks in the item except for minor spalling at the west transition slab (Figure A41). Traffic was continued to 1200 coverages on the west half of the item and to 1500 coverages on the east half of the item, with severe spalling occurring along the crack paths and at transverse joints (Figure A42). The progression of cracks with the application of traffic is shown in Figure A32. Cross sections of the pavement surface at selected intervals of traffic are shown in Figure A43. These profiles show that an average of 0.13 in. of permanent deformation occurred in the traffic lane during the application of traffic.

Figure A41. Item 3, lane 2, rigid pavement test section, after 200 coverages by 240-kip twin-tandem assembly

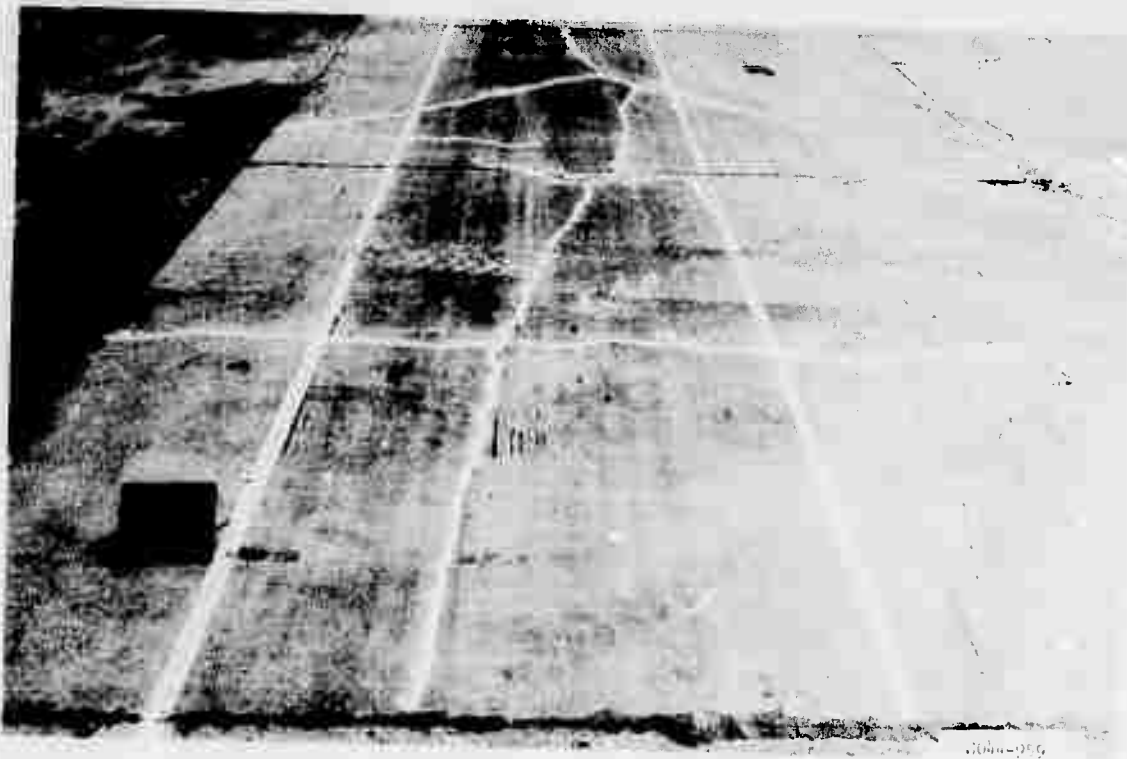
A general view of item 4 prior to traffic is shown in Figure A44. Cracks that occurred during trafficking of lane 1 extended to the south edge of traffic lane 2. During the application of static load traffic for taking instrumentation readings, a longitudinal crack developed near the center of the traffic lane in the west slab and near the south edge of the traffic lane in the east slab. During the application of traffic, the first crack developed in the northeast slab at 40 coverages. At 100 coverages, cracks had developed transverse to the traffic lane in both slabs, and the longitudinal cracks at the center of the traffic lane extended the entire length of the item (Figure A45). At 950 coverages, severe spalling was occurring along crack paths (Figure A46). The progression of cracks with the application of traffic is shown in Figure A32. Cross sections of the pavement surface at selected intervals of traffic are shown in Figure A47. These cross sections show that an average of 0.15 in. of permanent deformation occurred in the traffic lane during the application of traffic.

Figure A45. Item 4, lane 2, rigid pavement test section, after 200 coverages by 240-kip twin-tandem assembly

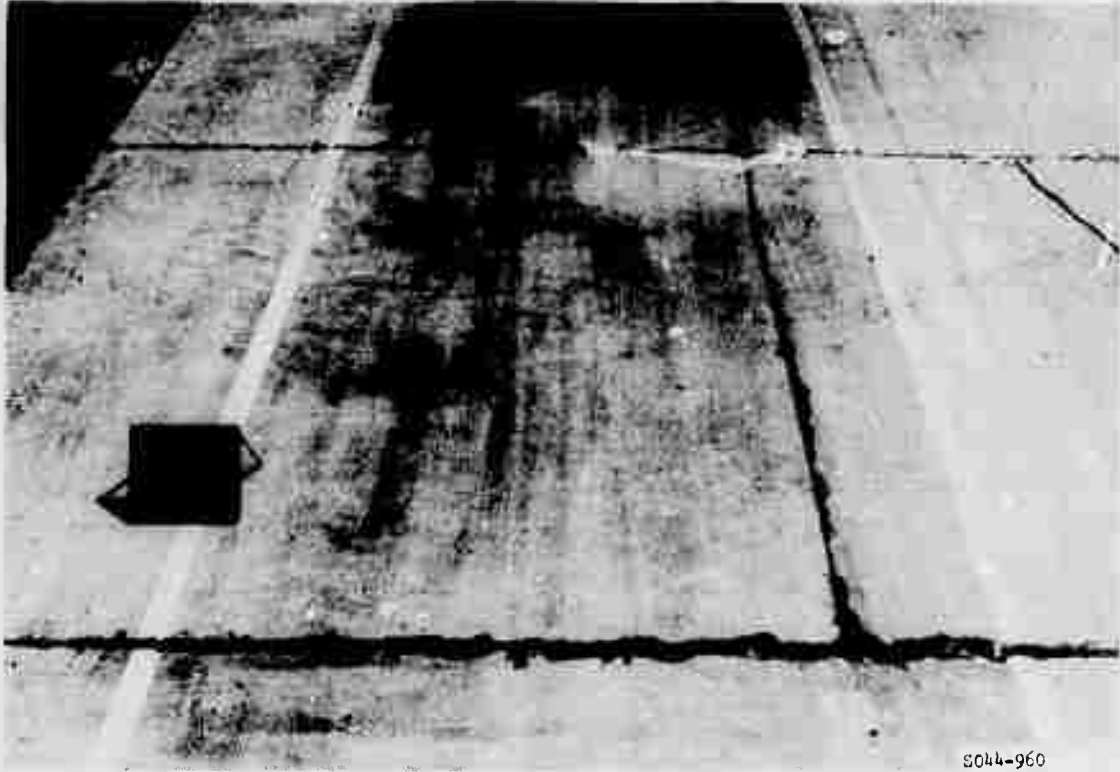
Subitem 5a. During static loading, cracks developed at the east end of the subitem at the intersection of the transverse and longitudinal weakened-plane joints. These were the only cracks to develop during the first 200 coverages (Figure A48). With continued traffic, the transverse cracks at the east end progressed across the subitem. The initial crack failure condition was reached at 290 coverages. At 500 coverages, spalling was noted at the west end of the subitem parallel to the longitudinal joint. With continued application of traffic, spalling became severe the full length of the subitem. At 740 coverages, the weakened-plane joint was considered failed, but traffic was continued to 950 coverages (Figure A49). The progression and extent of cracking at selected levels of traffic is shown in Figure A32. Permanent deformation in the traffic lane is shown in Figure A50. An average deformation of 0.63 in. and a maximum deformation of 0.7 in. were recorded. Cross sections at stations 2+46 and 2+52 taken at 950 coverages indicated that the weakened-plane joint sheared since there was definite vertical displacement between the north and south slabs. Pumping of the cement-stabilized lean clay base course material through the cracks was first noted at 350 coverages and became more severe with the application of traffic.

Figure A48. Subitem 5a, lane 2, rigid pavement test section, after 200 coverages by 240-kip twin-tandem assembly

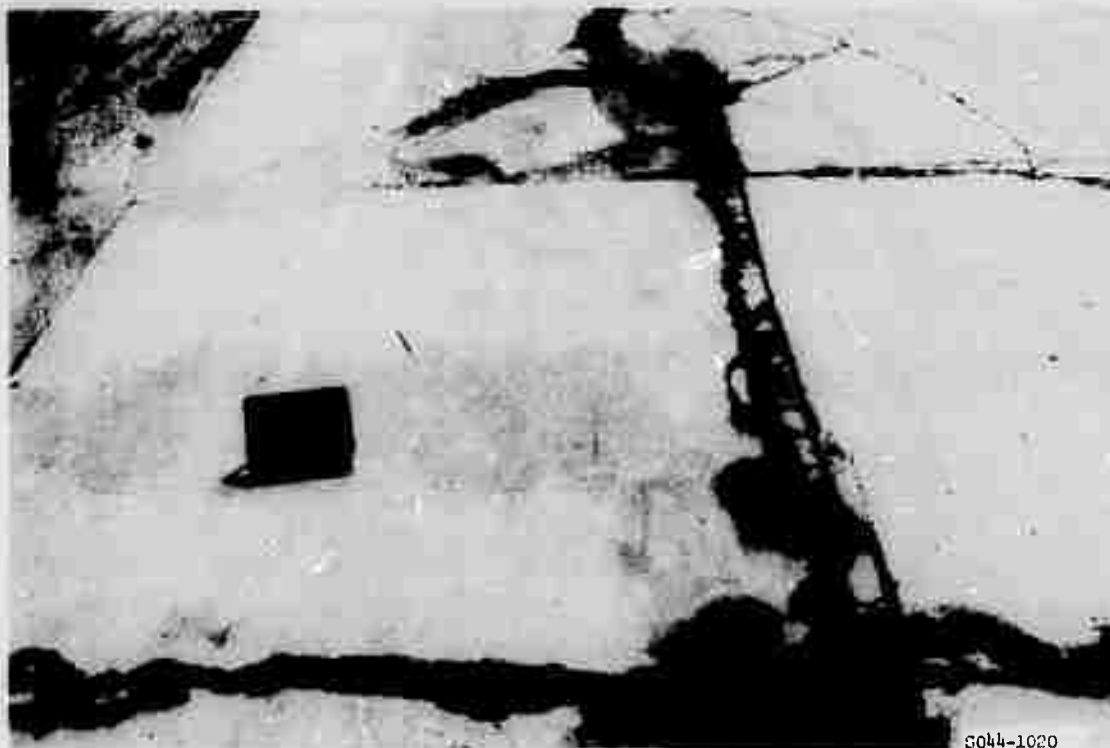
Figure A54. Subitem 5c, lane 2, rigid pavement test section, after 840 coverages by 240-kip twin-tandem assembly
