AFFDL-TR-66-43
PART VII

**AIRCRAFT GROUND-FLOTATION INVESTIGATION
PART VII DATA REPORT ON TEST SECTION 6**

W. BRABSTON and W. HILL, JR.
U. S. ARMY ENGINEER WATERWAYS EXPERIMENT STATION

AUGUST 1966

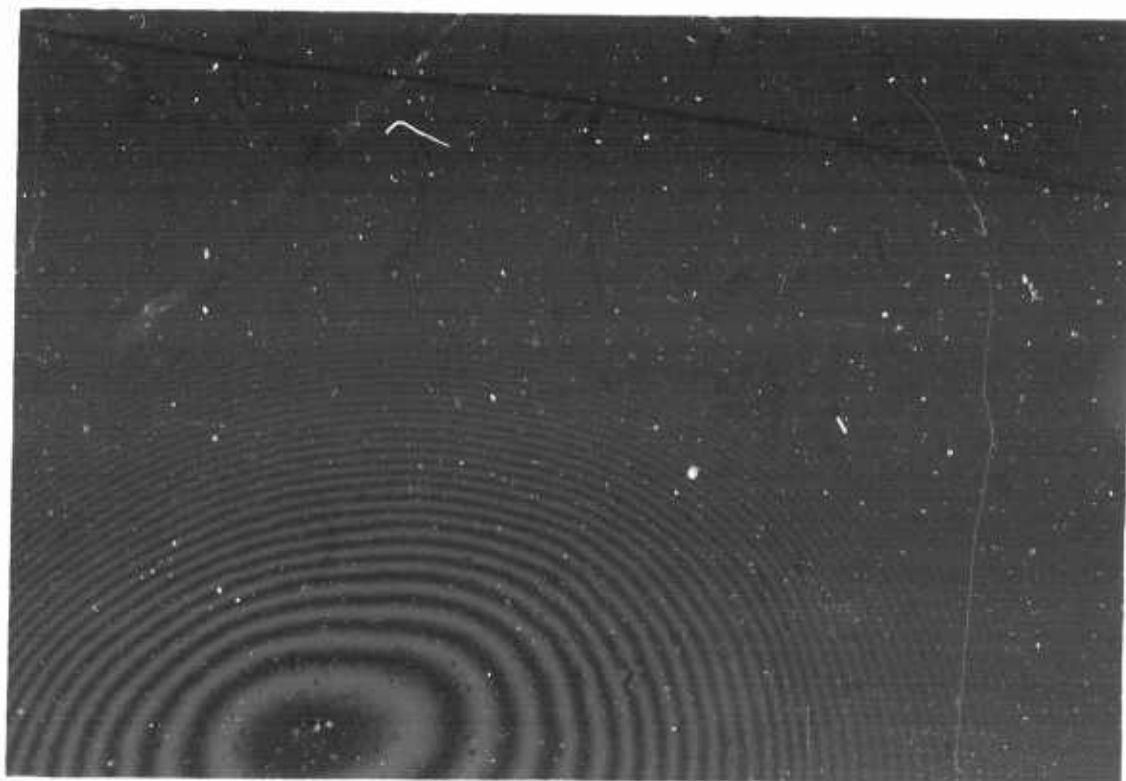
Item 1. Figure 3 shows item 1 prior to traffic. The item sustained 600 traffic coverages without developing appreciable deformations or roughness. No signs of failure were in evidence when traffic was suspended at 600 coverages (figure 4). The rated CBR of the item was 1.5.

Figure 3. Lane 11, item 1, prior to traffic

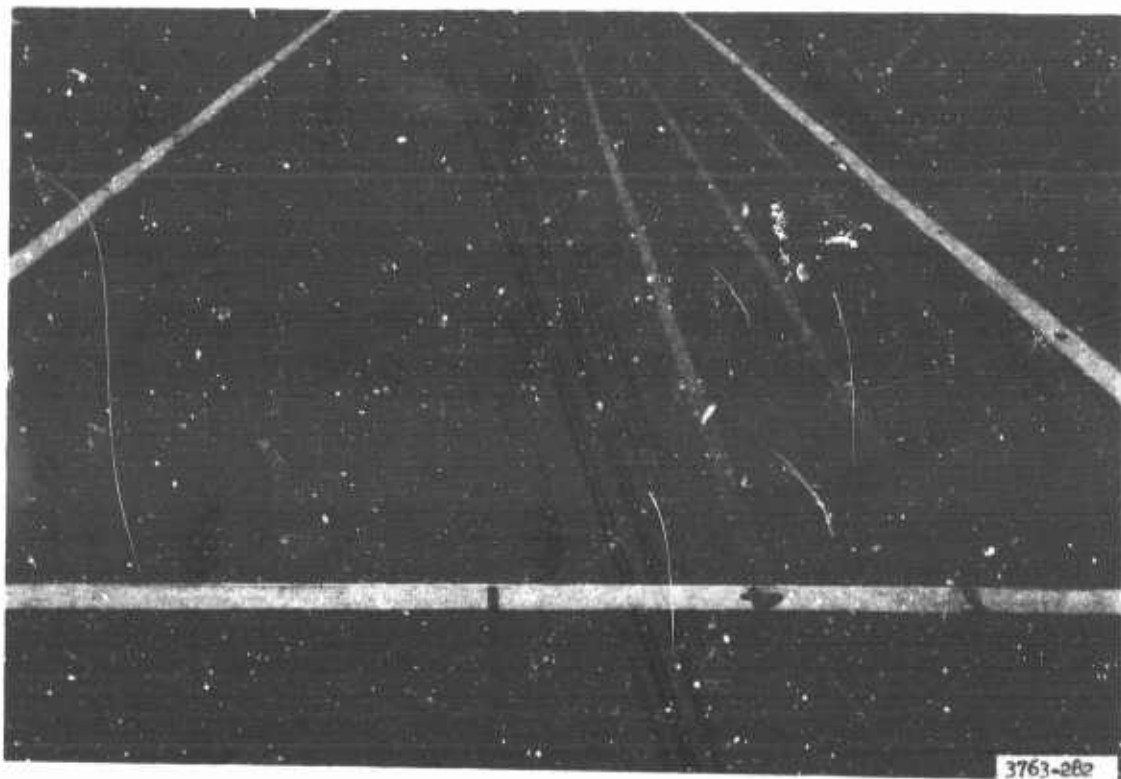
Item 1. Figure 12 shows item 1 prior to traffic. The item was still in good condition when measurements were recorded at 44 traffic coverages. Additional trafficking produced progressive deterioration of the item until it was considered failed due to roughness at 90 coverages (figure 13). The rated CBR was 2.9.

Figure 12. Lane 12, item 1, prior to traffic

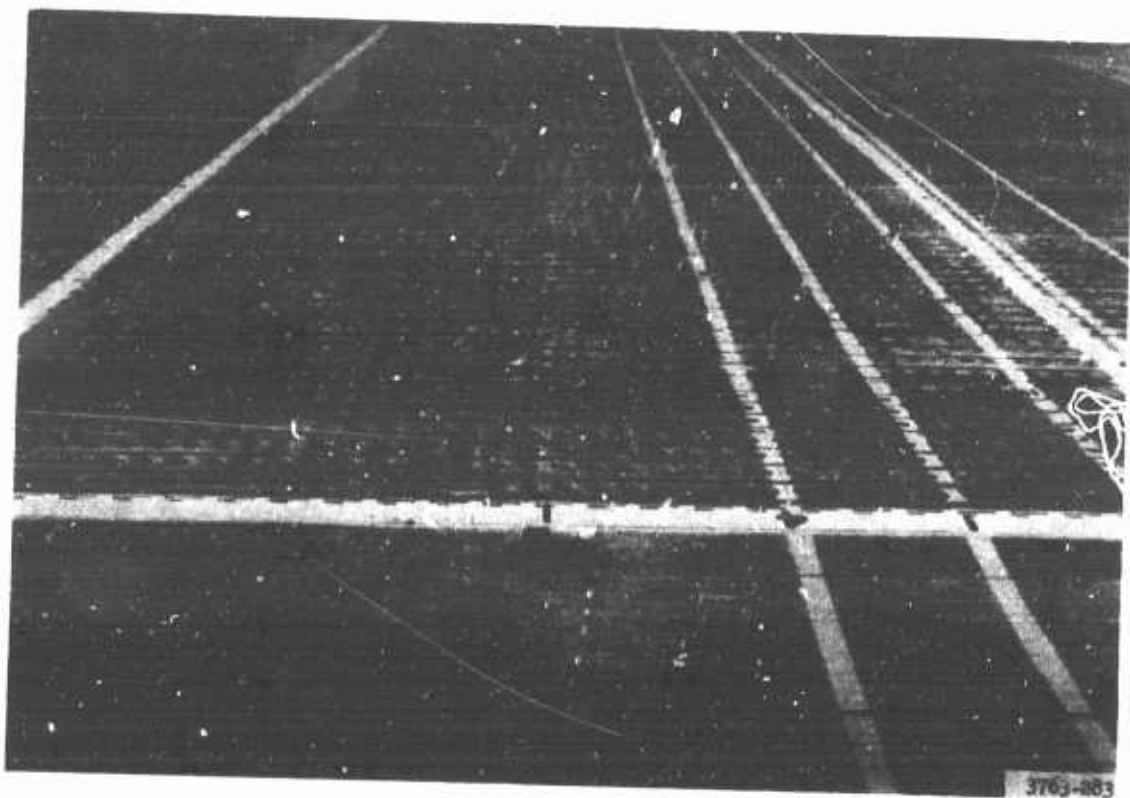
Item 2. Figure 14 shows item 2 prior to traffic. The item was considered failed due to roughness at 44 coverages (figure 15). At failure the plank ends along the mat joint line near the lane center were bent downward into the subgrade in contrast to the upward protrusion of plank ends encountered in previous test lanes. The rated CBR was 4.2.

Figure 14. Lane 12, item 2, prior to traffic

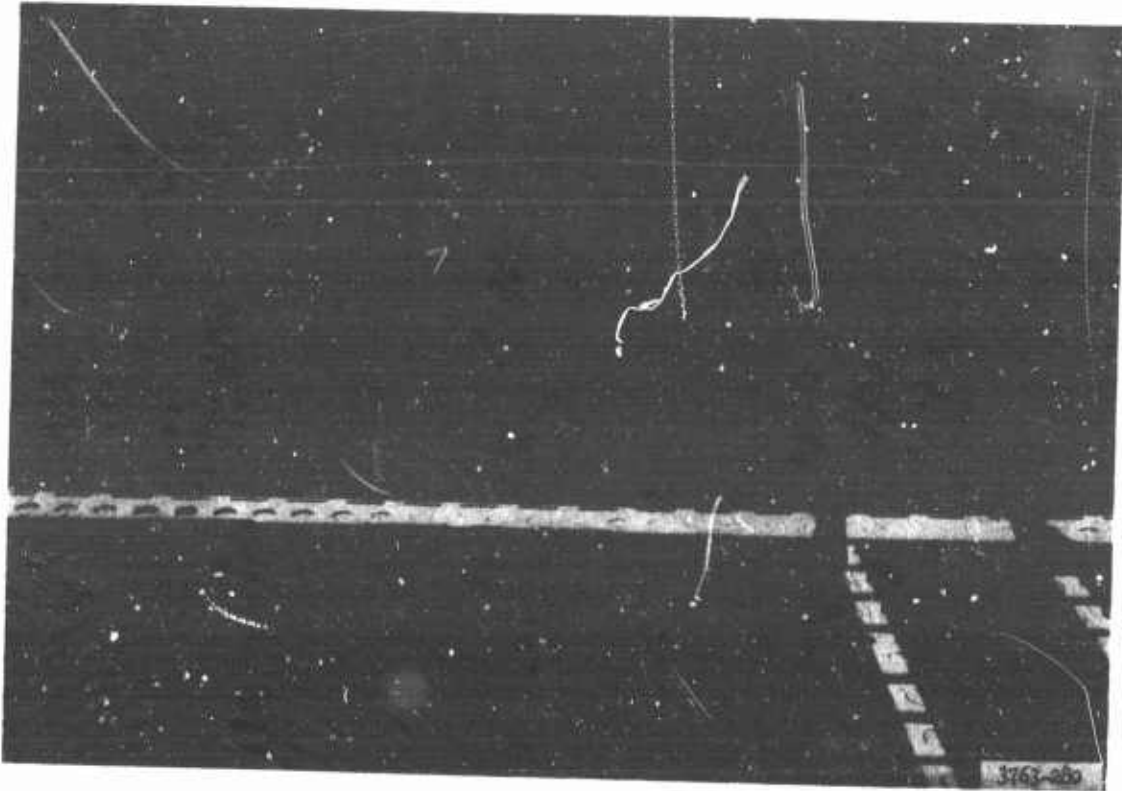
Item 3. Figure 16 shows item 3 prior to traffic. After 20 coverages the surface remained in good condition. At the 44-coverage level the

Figure 16. Lane 12, item 3, prior to traffic

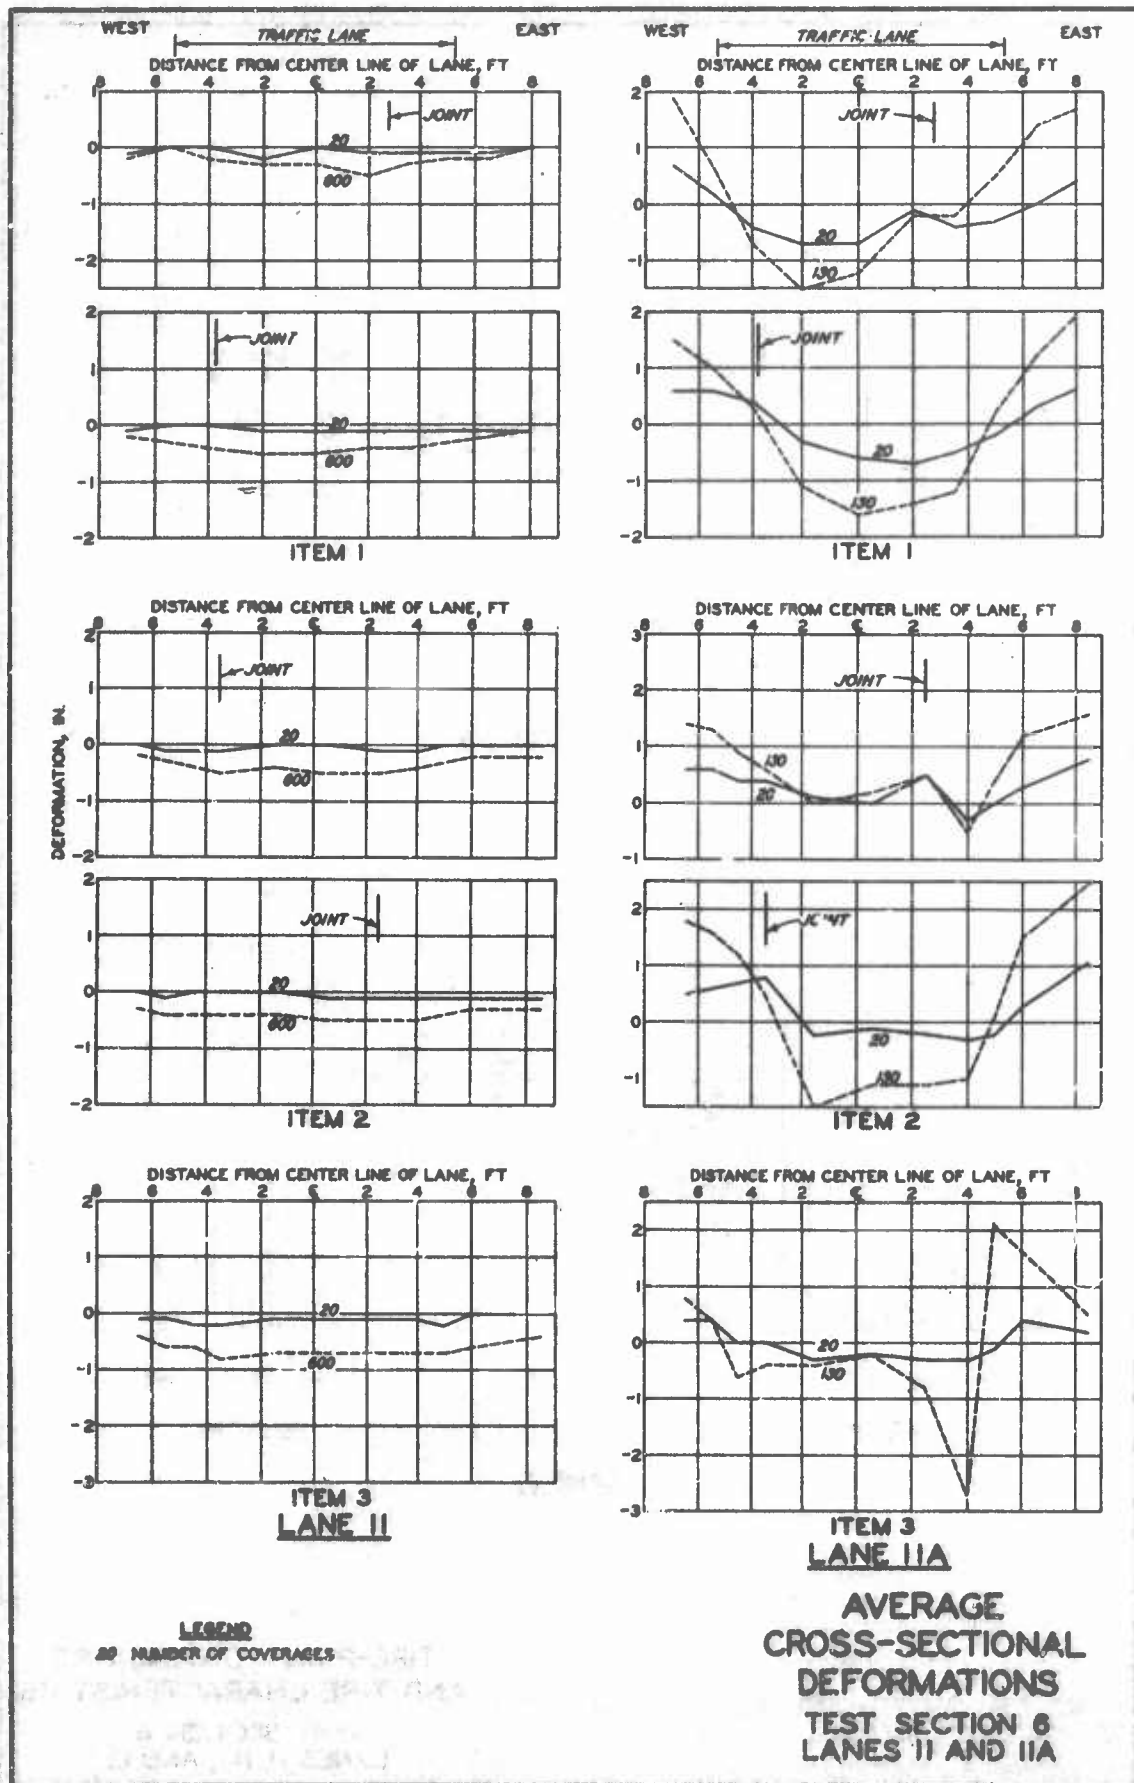
- b. Deformation. Average cross-section deformations at 20 and 600 coverages are shown in figure 21 for two typical mat runs. Center-line profiles along the item are shown in figure 22 for the 20- and 600-coverage levels. The profile plots illustrate the uniform subsidence of the item under traffic.

- a. Roughness. Table 1 shows the development of small differential deformations with traffic. There was some decrease in transverse and diagonal differential deformations between 300 and 600 coverages. Rut depths also showed a decrease at 600 coverages.
- b. Deformation. Figure 21 presents the average cross-section deformations at the 20- and 600-coverage levels. Profile plots along the item center line are shown in figure 22. Cross-section and profile plots illustrate the generally uniform subsidence of the item under traffic.

- b. Deformation. Figure 21 shows average cross-section deformations at 20 and 130 coverages for two typical mat runs. Center-line profiles at the same coverage levels are shown in figure 22.

- b. Deformation. Figure 21 shows average cross-section deformations at 20 and 130 coverages for two typical mat runs. Center-line profiles for the same coverage levels are presented in figure 22.

- b. Deformation. Figure 21 shows average cross-section deformations measured at 20 and 130 coverages. The severe rut that developed along one side of the lane is illustrated in the plot at 130 coverages. Center-line profiles along the item are shown in figure 22 for 20 and 130 coverages.

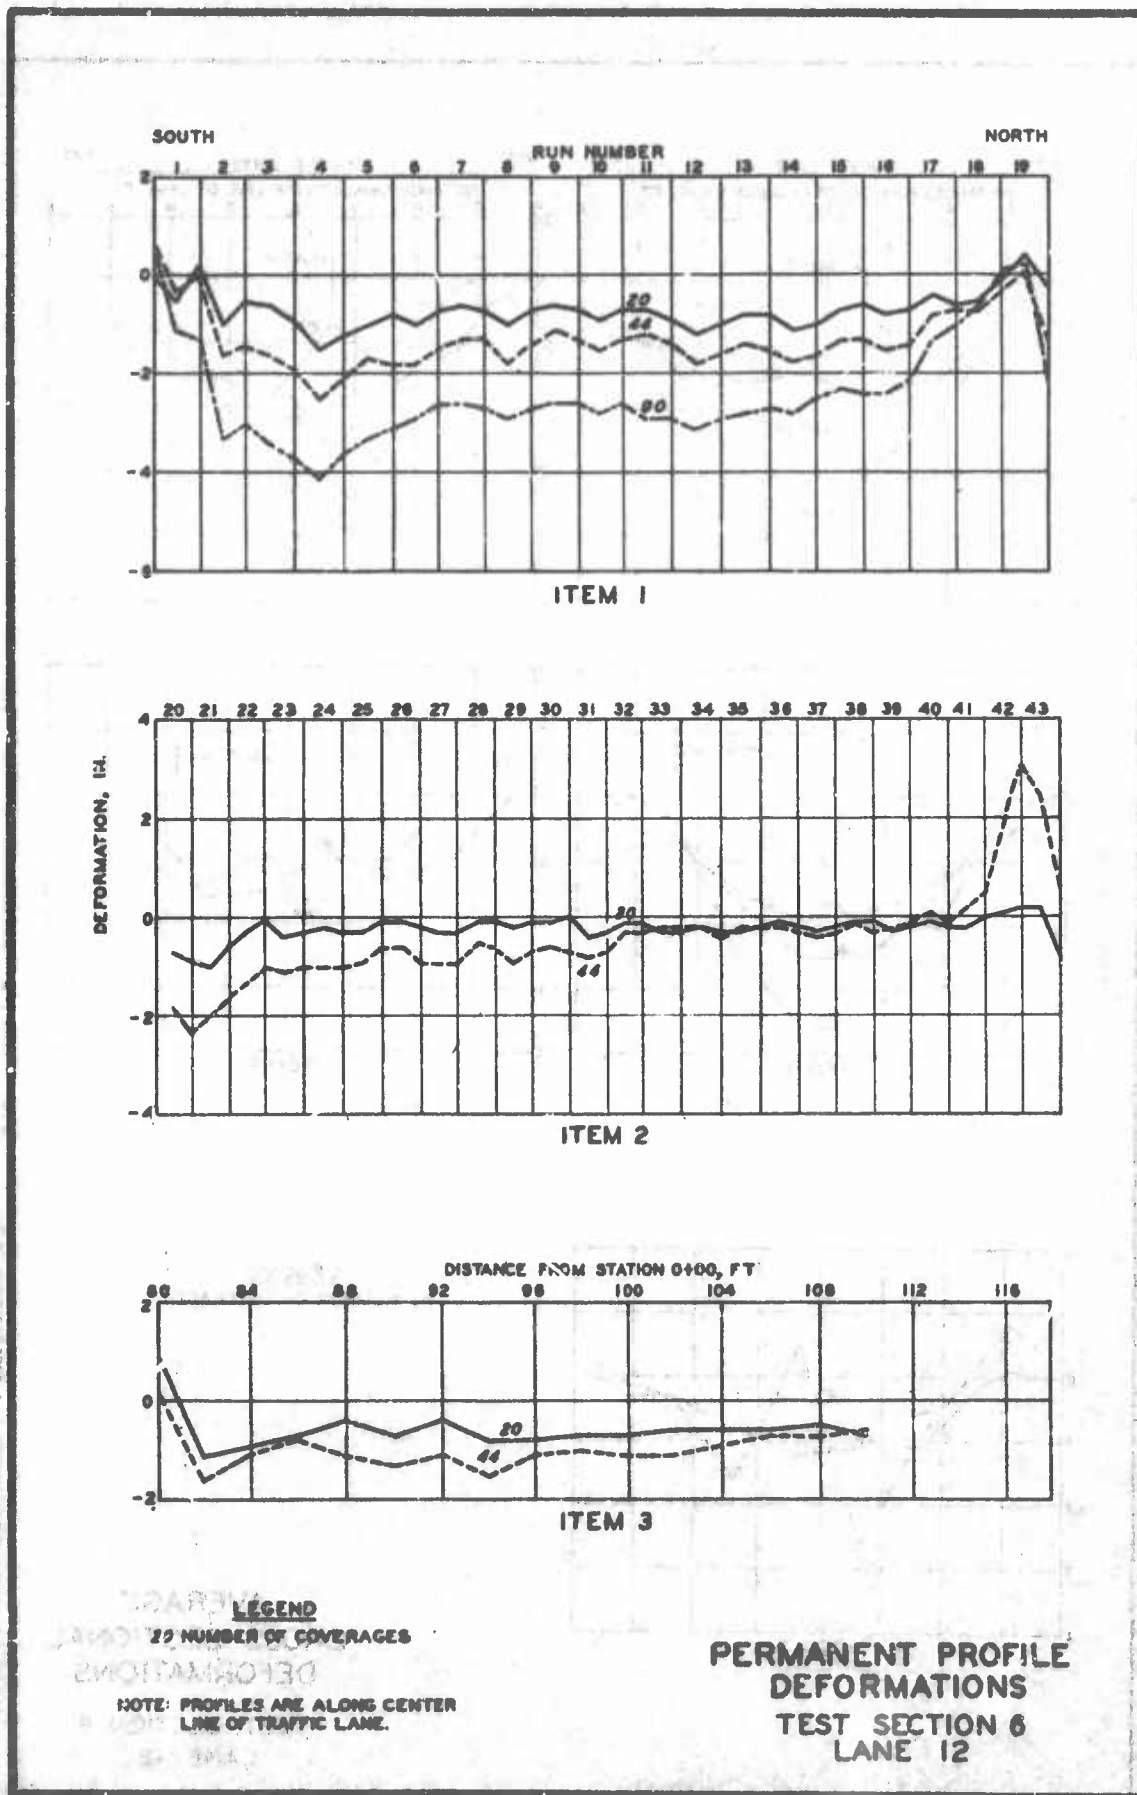
Figure 25

- b. Deformation. Figure 24 shows average cross-section deformations at several coverage levels for two typical mat runs. Center-line profiles are shown in figure 25. Deformations are seen to follow a consistent pattern of increasing severity with trafficking, reaching maximum values at failure of the item.

- b. Deformation. Figure 24 shows average cross-section deformations at 20 and 44 coverages for two typical mat runs. Center-line profiles are shown in figure 25 for the same coverage levels. The downward bend of the panel ends along the mat joint line near the lane center is illustrated in a cross-section plot (figure 24). In previous tests, the panel ends along a mat joint line most commonly protruded upward at failure, as was the case at 20 coverages in this item.

- b. Deformation. Average cross-section deformations are shown in figure 24 for 20 and 44 coverages; severe rutting of the surface is reflected. Center-line profile deformations are shown in figure 25.
