REPORT ON USATECOM PROJECT NO. 8-3-0030-08-F,

PRODUCT IMPROVEMENT TEST OF

MODIFIED AR15 RIFLES

REPORT NO. DPS-1276

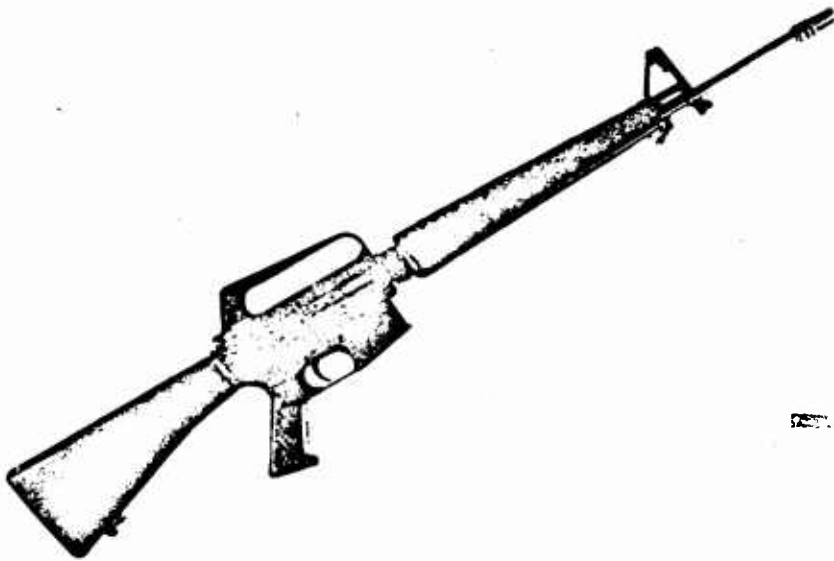
Modifications to the AR15 rifle (Figure 1) were as follows:

Figure 1: Modified AR15 Rifle.

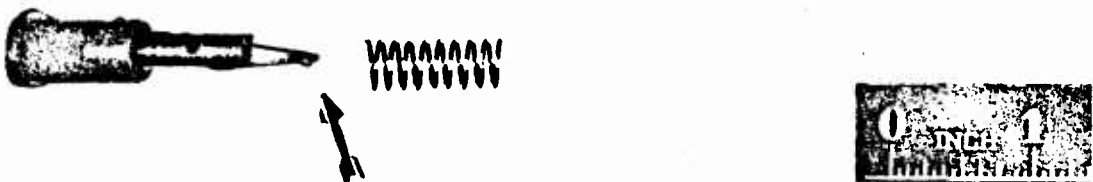
- a. The size of the plunger cap of the bolt closure device was increased. Figures 2 and 3 show the first and second designs of this device. The second design incorporated a stronger plunger spring and the pawl tip was straight instead of beveled. The pawl hardness was increased from Rockwell C 43 to C 51 at the tip.
- b. Modification of the charging handle (Figure 4) was made by enlarging the grip area so manual retraction of the bolt and carrier assemblies is easier.

Figure 2: Modified Charging Handle and Bolt Closing Devices for the AR15 Rifle.

Weakness of the bolt closure plunger spring permitted the bolt closure pawl to interfere with rearward travel of the bolt carrier during firing. This resulted in damage to the pawl and pawl retaining pin in each weapon. Failure of the pawl and the retaining pin occurred after firing an average of 1993 rounds in each weapon. A second design incorporating a stronger bolt closure plunger spring and a redesigned bolt closure pawl corrected the problem of short parts life. Figure 8 compares pawl tip deformation after completion of all firing. The bolt closure device successfully assisted the chambering of all rounds which failed to completely

- a. The frequency of feeding and chambering malfunctions indicates the necessity of a positive method of manually assisting the forward movement of the bolt and bolt carrier assemblies. The bolt closure device with 1.30-inch-long plunger spring and pawl with straight tip, hardened to Rockwell C 53, was adequate in performing its intended function (ref Figures 3 and 8 and Tables IV, V, and XV).

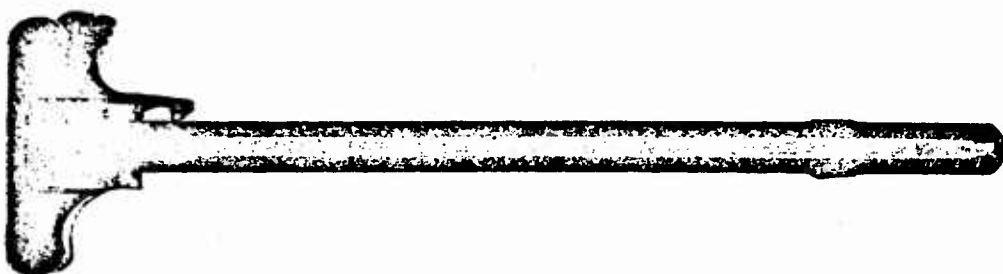
Figure 4: Charging Handle.

During previous testing of the AR15 rifle, the charging handle did not provide sufficient gripping area for manual bolt retraction under all conditions. Also, since chambering of a round is dependent solely upon the energy delivered by the action spring to the bolt, incorporation of a manually assisted bolt closing device was desirable to enable the shooter to chamber slightly deformed or dirty rounds and aid in locking if the rifle failed to function properly.

- b. The modified charging handle design provides adequate means for retracting the bolt and bolt carrier assemblies; however, fabrication should be changed to avoid separation of the tang from the handle at the weld. No other malfunctions of the charging handle were observed (ref Figure 9 and Table XVII).
