(6) 156-INCH DIAMETER MARAGING STEEL CASE  
HYDROBURST AND MATERIALS EVALUATION

(9) Final rept. Mar-Dec 66,  
Lockheed Propulsion Company  
Redlands, California  
*technical*

TECHNICAL REPORT NO. AFRPL-TR-66-350

Activities in the hydroburst of a previously fired 156-inch diameter, maraging steel motor case are described. The program encompassed discontinuity stress analysis of the large, welded vessel, an evaluation of ultrasonic inspection methods by post-test sectioning, and a detailed failure analysis.

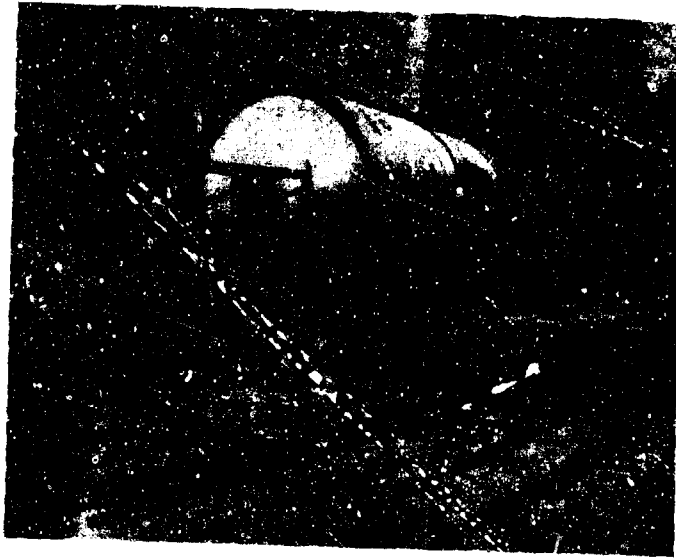
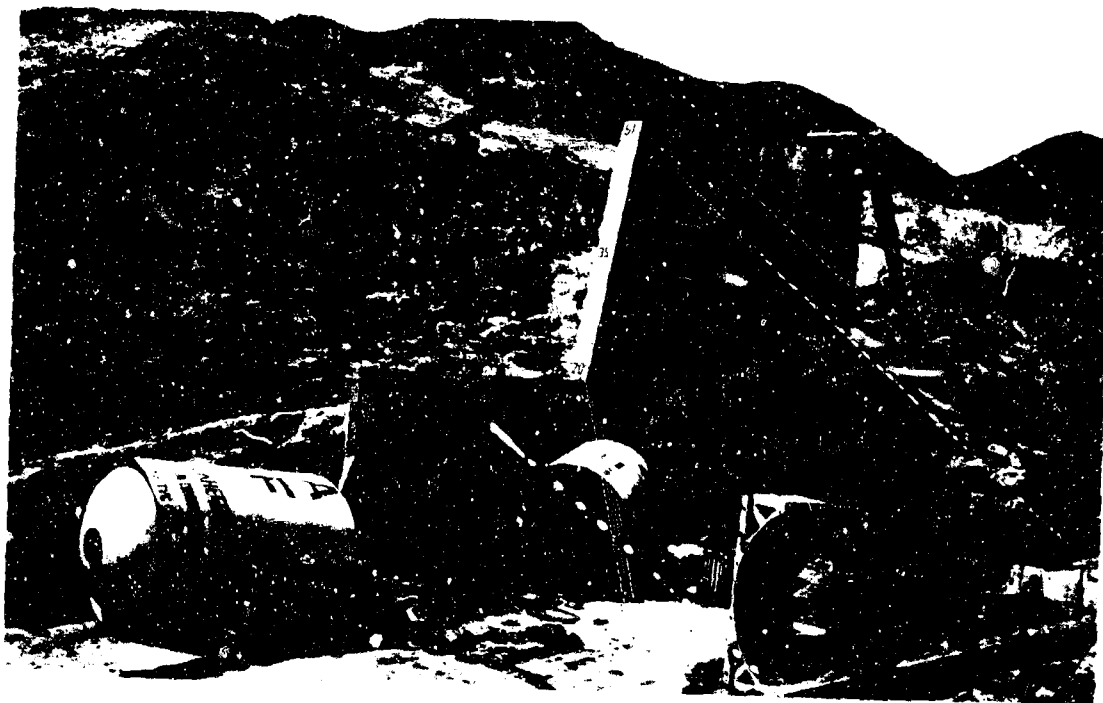
The adapter joint bolt circle was partially intact (see Figure 1); the adapter and bolts indicated a mixed tensile and tearing failure, with probable primary fracture damage to the adapter on impact with a proximate restraining cable. Of the 256 EWB 926-12-20 bolts, 133 showed tensile failure, 50 showed shear failure, and 73 remained in place. Concurrent evaluation by LPC, Mellon Institute, and SPS Laboratories was conducted. The three agencies concur in their findings of stress corrosion/hydrogen embrittlement damage to the bolts. The reports are included in Section V.

Figure 1 Pre-Test (a) and Post-Test (b) Hardware Arrangement

A reasonably specific sequence of events can be determined from the post-test hardware condition: (1) adapter failure, driving the motor forward skirt into the asphalt pavement, (2) movement of the motor upward into the restraining cables, creating severe ovality with cracking of the female joint at the lateral point of maximum curvature, and (3) sequential ejection of pins causing separation movement of the segments.

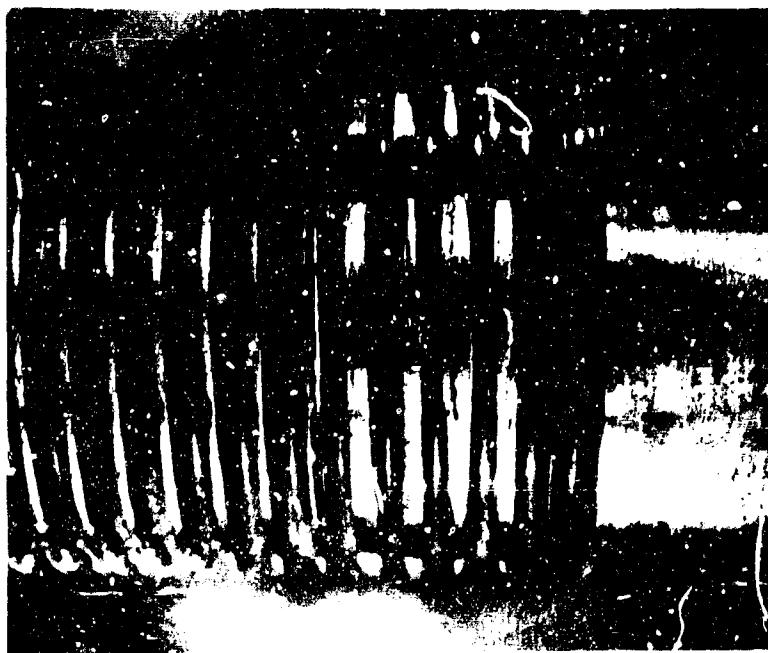
The examination showed severe thread damage on the failed bolts, (Figure 34, 35, and 36). Microscopic examination revealed that failures occurred at the corroded root of the bolt threads. No rust appeared on the shank areas.

Figure 34 Example of Severe Thread Damage of Unfailed Bent Part

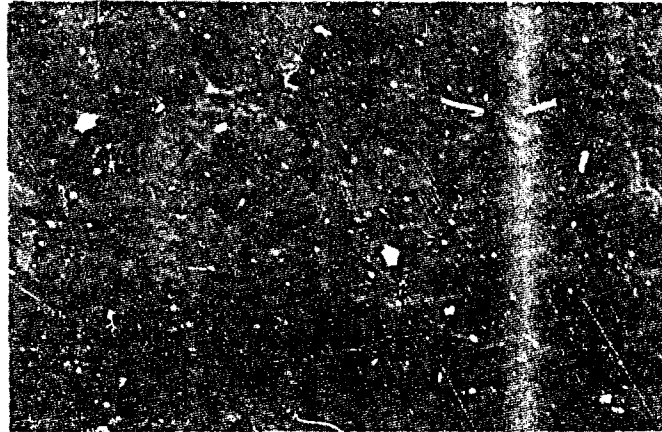
Figure 95 Fractograph Showing Quasi-Cleavage Fracture Mechanism With the Presence of a Smooth Corrosion Product (see arrows).

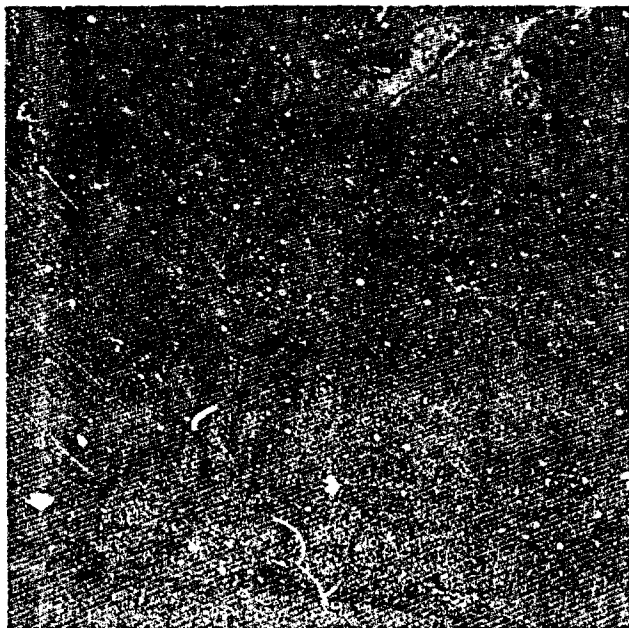
Figure 96 Fractograph Showing Quasi-Cleavage Fracture Mechanism with the Presence of a Smooth Corrosion Product (see arrows).

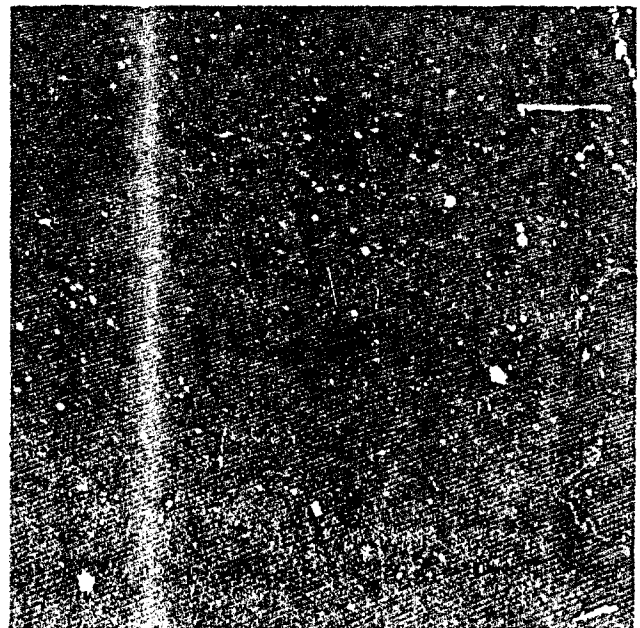
Figure 97 Fractograph Showing a Mixed Quasi-Cleavage and Dimpled Rupture Fracture Mechanism with the Presence of a Smooth Corrosion Product (see arrows).

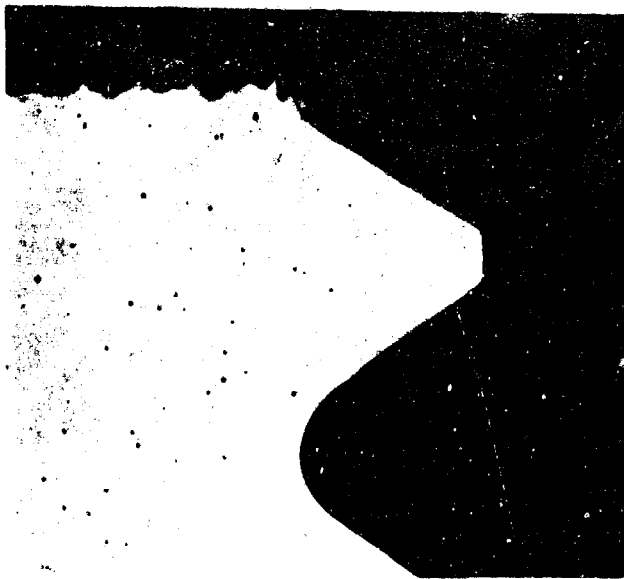
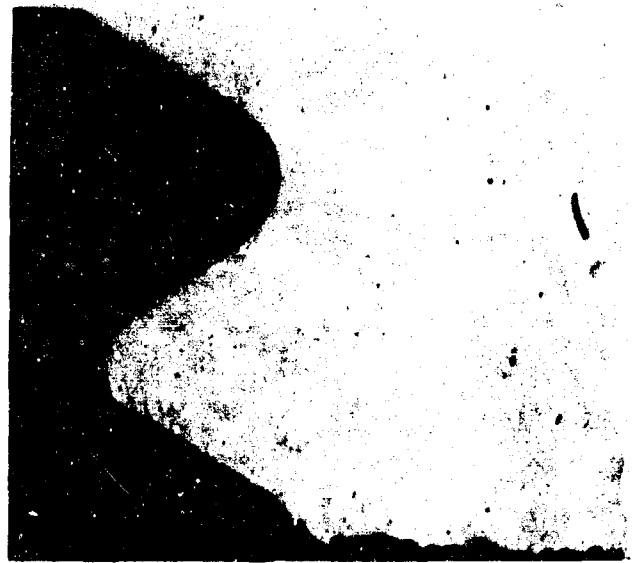
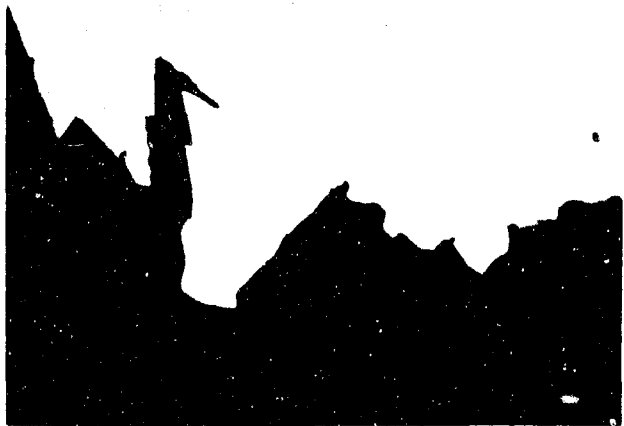
The point of origin of the fracture in bolt sample LPC 2 is shown in photomicrographs (a) and (b) in Figure 109. These represent the two halves of the sectioned bolt. As can be seen, the fracture initiated very close to the root of a thread. Visual examination of most of the bolts studied also showed the thread root region to be the most frequent point of fracture initiation. Higher magnification photomicrographs (c) and (d) in Figure 109, show the fracture profile at the origin in more detail. Apparent is the brittle nature of the fracture at its point of initiation, particularly so in Figure 109(c). Again, brittle cracking in a direction perpendicular to the fracture path can be seen.

Figure 109- Photomicrographs Showing the Location, (a) and (b), and the Profile, (c) and (d), of the Fracture Origin in Bolt Sample 2.

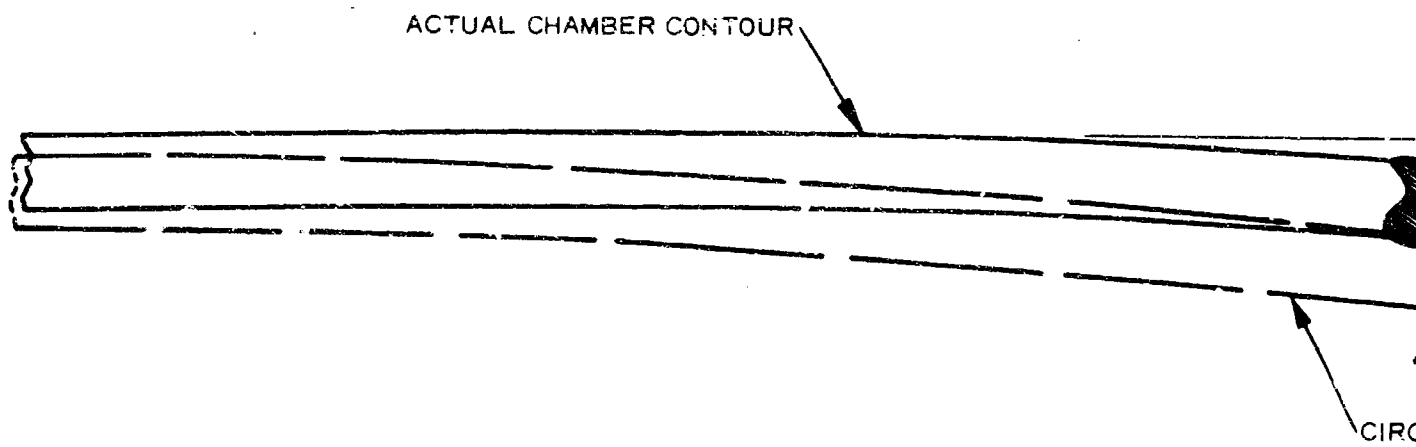
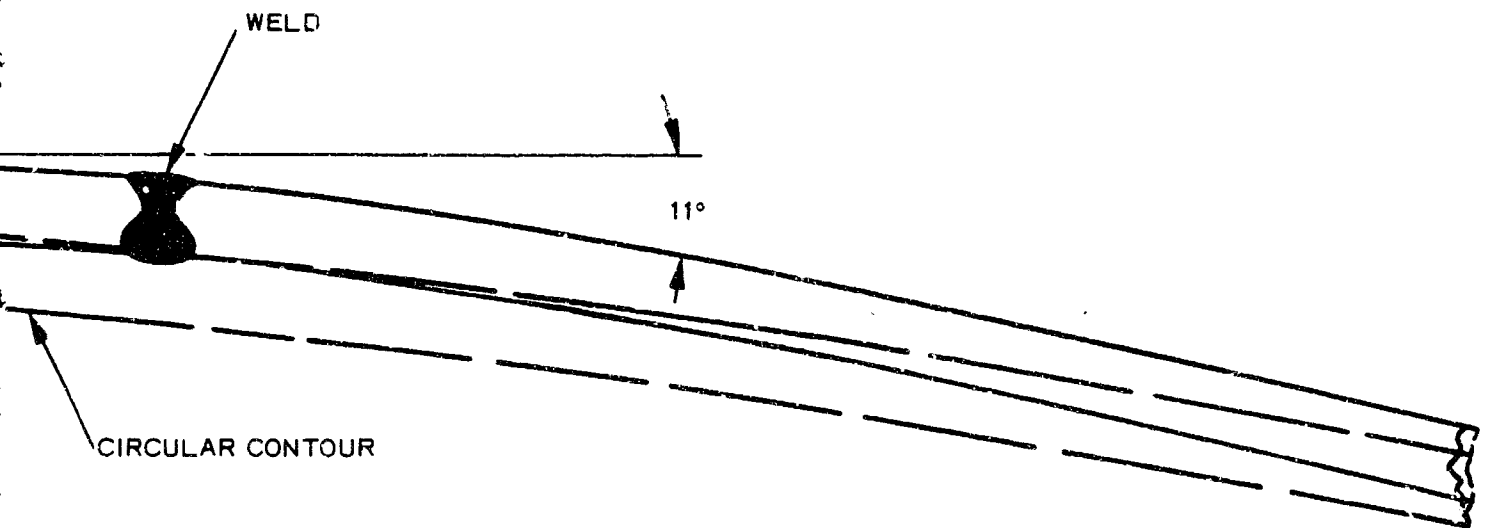
The 156-inch hydroburst program was designed to demonstrate and develop improved methods of performance prediction, including verification of analytical strength analysis methods. The assumptions for the analytical investigation included all visible and experimentally determined defects. Measurements were taken on the case in the region of the longitudinal welds prior to the hydroburst program and compared to similar measurements taken immediately after the case had been fabricated. The differences in the measurements indicated that permanent set had occurred in the interim. The most severe discontinuity in the 156-inch case was a circumferential angular mismatch as shown in Figure 119.

The most severe discontinuity in the longitudinal weld based on measured data is shown in Figure 119.

Figure 119 Typical Contour Measurement Depicting Peaking

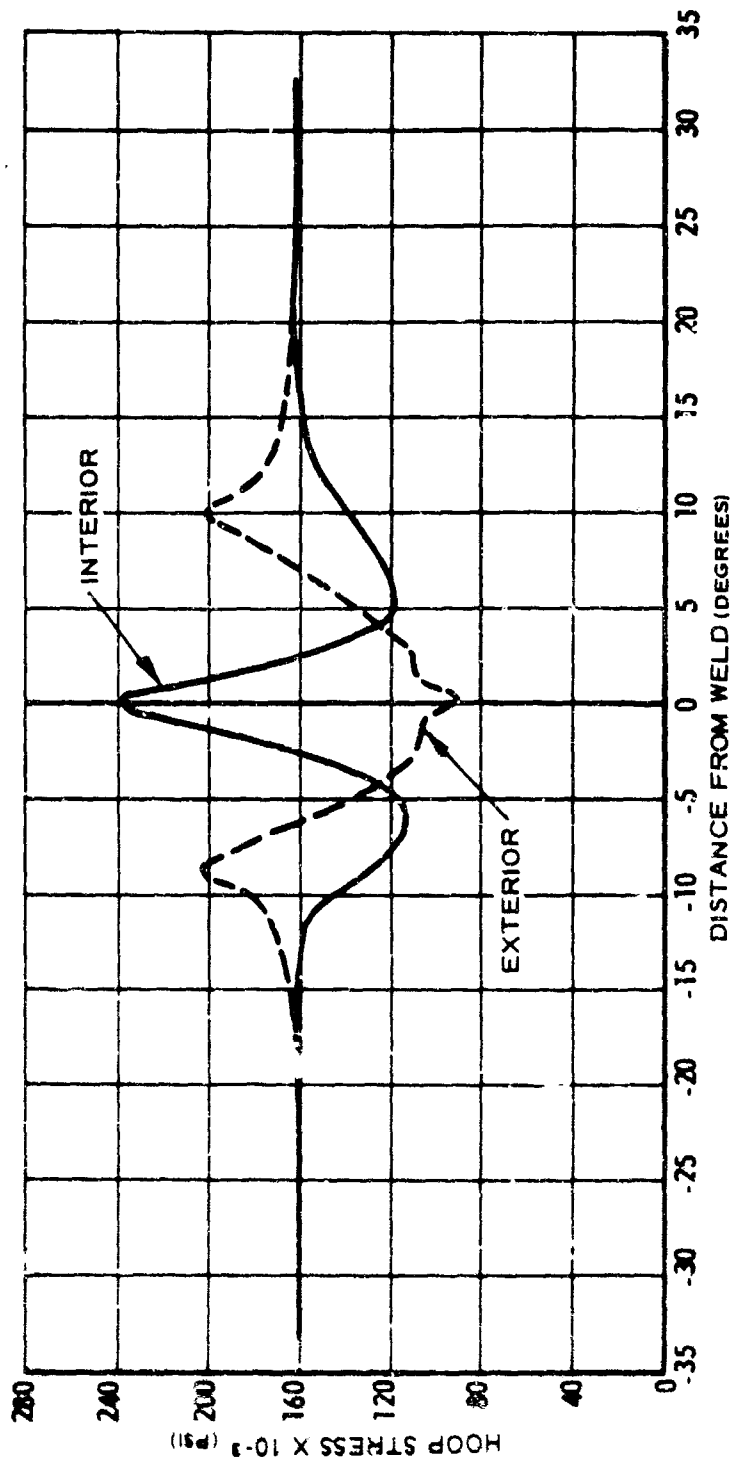
Figure 126 Hoop Stress versus Circumferential Position at Point of Greatest Discontinuity

The discontinuity stress analysis shows that failure would not occur due to the irregular shape of the chamber. The Nonlinear Plane Strain Program No. 287 was used to analyze the chamber's most severe discontinuous cross-section; the results are presented in Figure 126, where the hoop stresses versus circumferential position are plotted. The analysis showed significant effects of bending and shear stresses in the chamber.

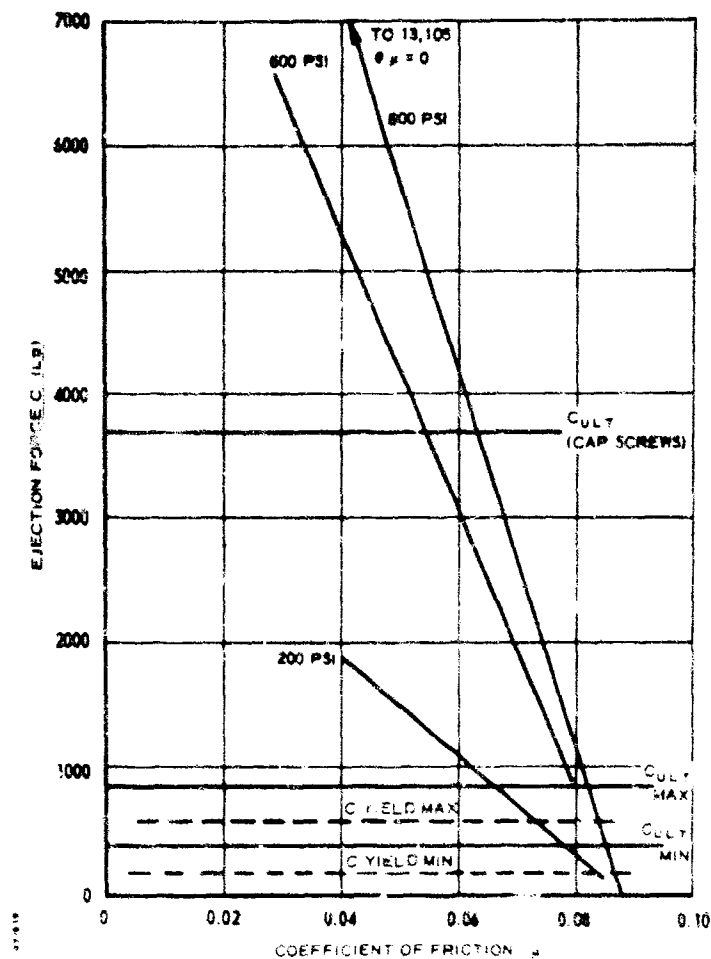
Figure 127 Ejection Force versus Coefficient of Friction

The case consisted of two segments attached by 200 pin clevis joints. The ejection loads on the pins were determined for various levels of pressure loading from 200 psi to 800 psi and are plotted in Figure 127.

The load calculated to fail the retainer bars is 396 pounds, minimum; 857 pounds, maximum. These loads correspond to anticipated ejection loads for static friction coefficients of 0.085 to 0.082. It is also necessary to keep in mind that dynamic coefficients of friction are much lower than static. The lack of the empirical dynamic data suggests that rapid rate (vibration) tensile tests should be initiated. Calculations for the tapered pin joint are shown in the appendix, subsection 8.

- (4) To evaluate the assumptions on dynamic ejection of the pins, it is recommended that laboratory tests be performed to simulate those conditions in the motor. Simple pin extraction under rapid-rate vibration and analog tests of the assemblage would give better foundation for analytic assumptions.

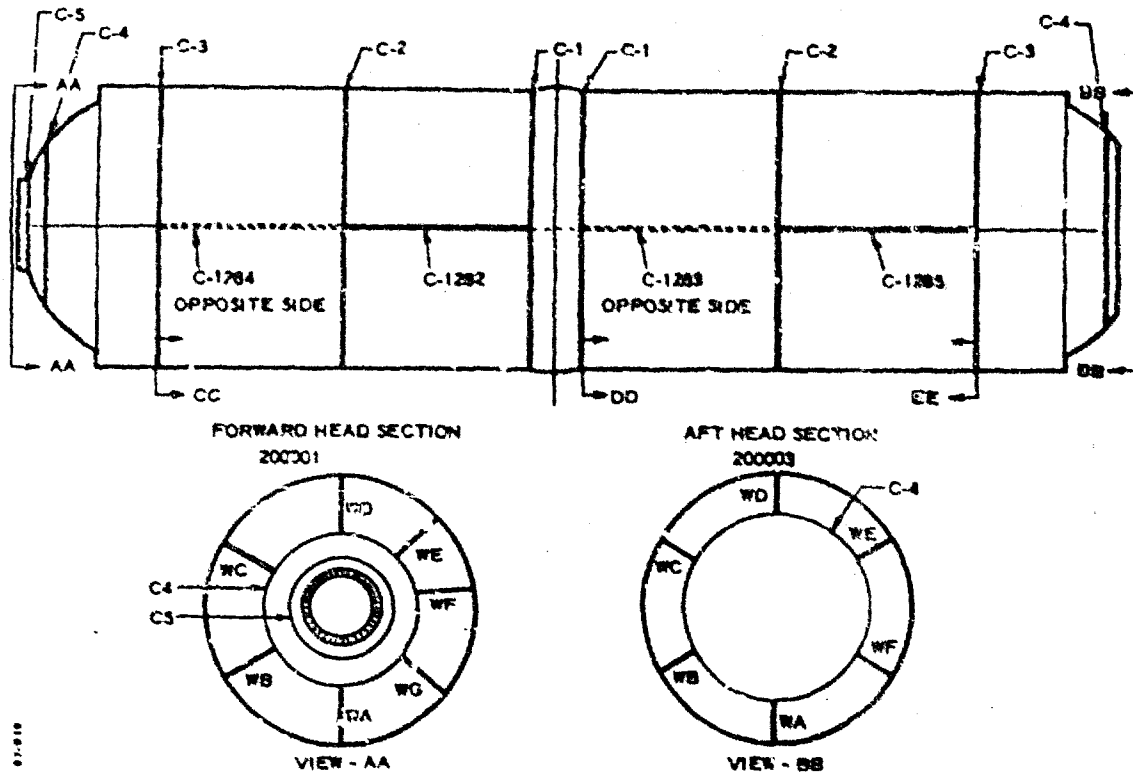
Figure 128 156-Inch Diameter Hydroburst Weld Identification

The weld orientation and identification utilized on this chamber are illustrated in Figure 128. Records obtained from the original manufacturing log book, regarding defect size and location in the parent metal adjacent to the weld area, are shown in Table X, and illustrated in Figures 129 through 133. The original tests by the manufacturer utilized longitudinal wave methods and indicated no defects in the parent material adjacent to the longitudinal welds or in the weld bead. Nondestructive testing of the weld consisted of radiographic and dye-penetrant inspection before and after hydrotest at the manufacturer's plant. The longitudinal wave ultrasonic tests were applied to detect banding or delaminations in the plate material adjacent to the weld. Because the longitudinal welds were reported free of delaminations, shear wave testing was used exclusively during pre-hydroburst inspection at LPC.

Based upon case visual evaluation and previous strain gage results, the longitudinal welds in both segments were considered to be the critical areas. Thus, nondestructive inspections conducted prior to hydroburst were concentrated in these regions. In preparation for testing, the protective paint coating was stripped from the longitudinal welds to provide an eight-inch, bare metal band on either side of the welds on the case outside diameter. Insulation and liner from the previous test was not removed from the inner surface.

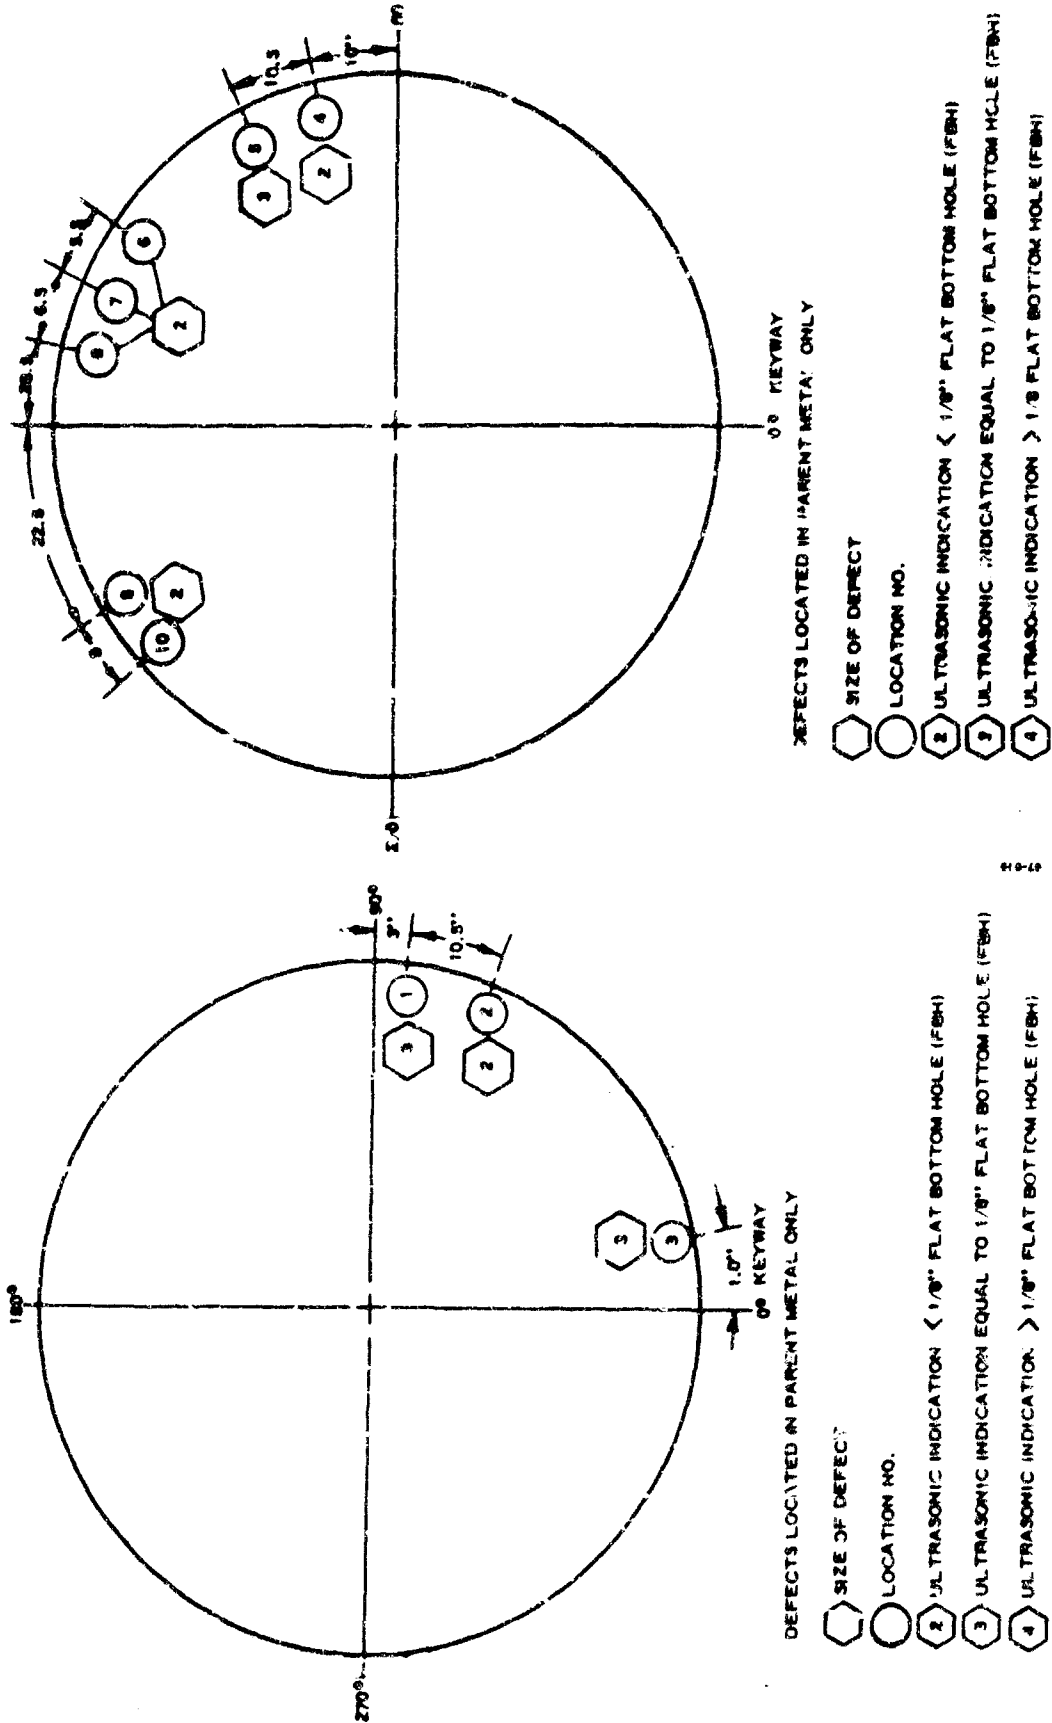
Figure 129 Forward Head Section, Weld C-5, Igniter Boss Weld, View AA

C-5	Igniter boss weld	See Figures 129
C-4	Forward dome weld	(No delaminations)
C-3	Dome to cylinder girth weld	See Figure 130
C-2	Center girth weld	(No delaminations)
C-1	Cylinder to joint forging	(No delaminations)
C-1284	Forward longitudinal weld	(No delaminations)
C-1282	Aft longitudinal weld	(No delaminations)

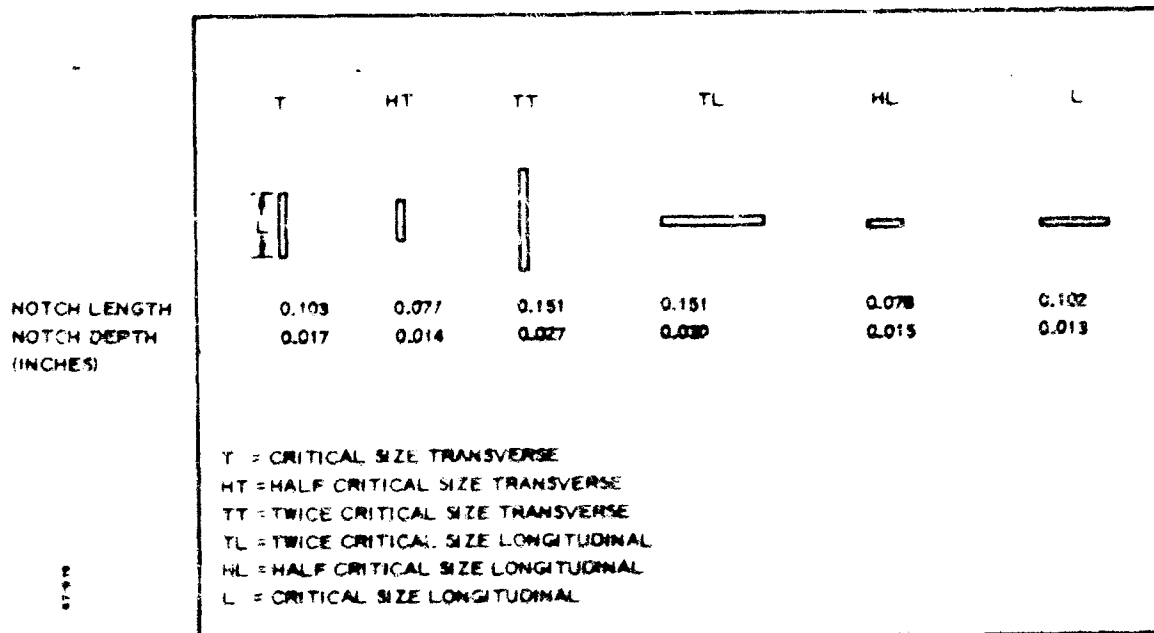
Figure 134 Ultrasonic Calibration, LPC Shear Wave Test Plate, 250 Grade Marage, 0.375 to 0.400-inch Thickness

of 001, 002 and 004 square inches. Figure 134 illustrates the calibration plate removed from the case and subsequently elox-notched. The ultrasonic response from these notches is illustrated in Figure 135. The notch depth and length are tabulated below:

Based on the work and conclusion of Strawley (Ref. ) in connection with the failure investigation of Thiokol's 260-inch diameter hydro-burst, the shear wave calibration and inspection methods may not have been adequate to detect either surface or subsurface zero-gap flaws (cracks); however, the dye penetrant means employed in the longitudinal weld inspections would have detected any existent surface flaw.

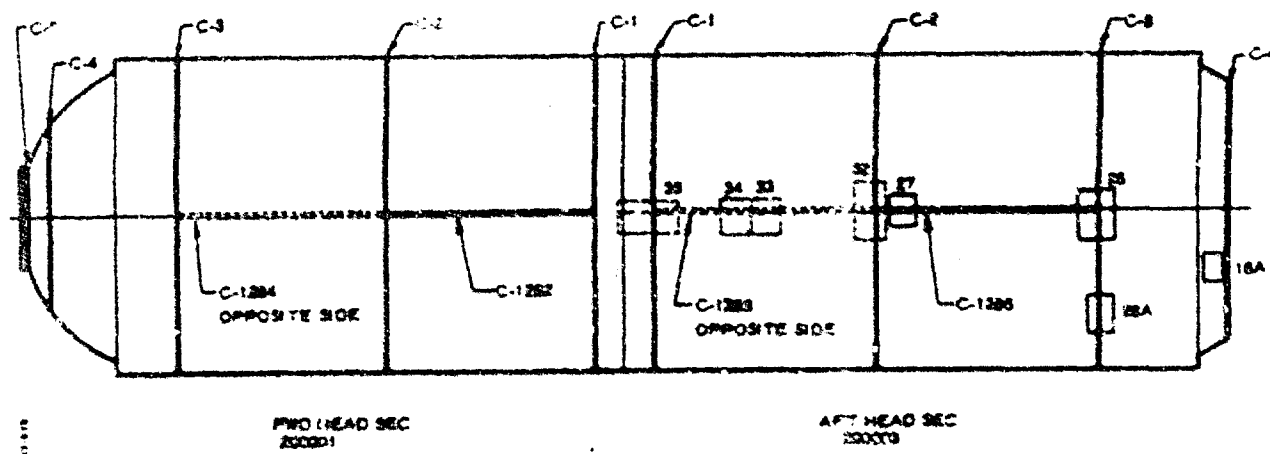
Figure 136 156-Inch Diameter Hydroburst Weld Identification and Test Plate Location (Post-Hydroburst)

Girthweld C-1 is "O" station; all locations are aft of C-1. Defect areas are illustrated in Figure 136.

After hydroburst, test plates were removed from the damaged aft-head section by carbon-arc cutting. The plates contained representative ultrasonic indications detected during the pre-hydroburst inspections. The areas from which the plates were removed and plate identification are shown in Figure 136. After removal of the plates from the case section they were solvent cleaned to remove the old liner and insulation materials so that additional ultrasonic testing could be accomplished from both side of the plate.

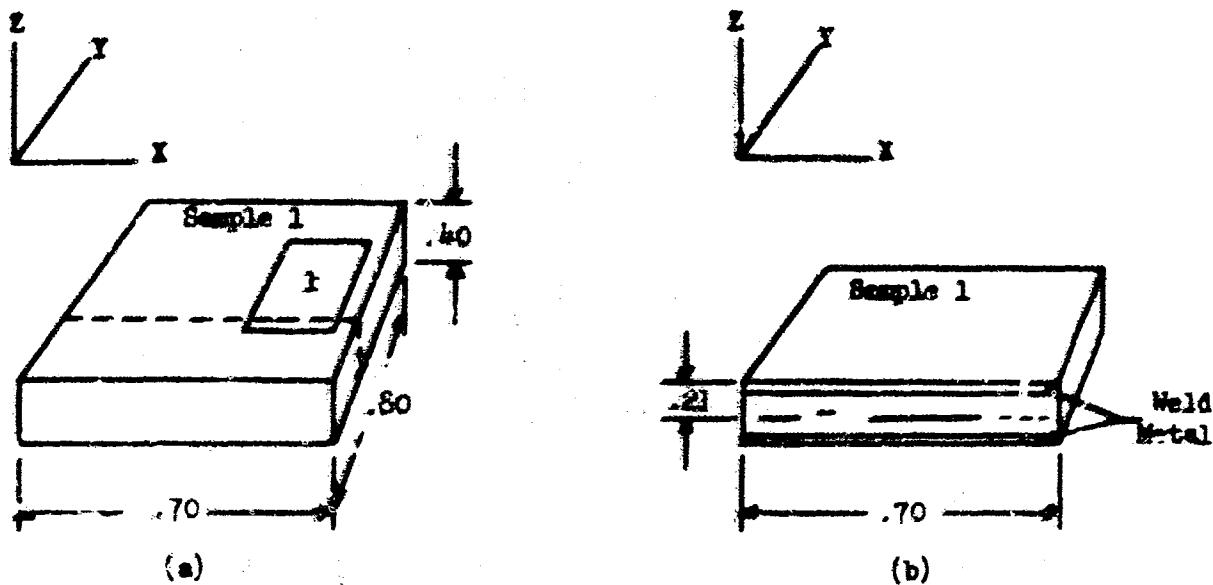
All defects were thin delaminations generally located in one plane which was parallel to the sample surfaces and located approximately equidistant from them.

Figure 151 "Lead-Off" Page for Sample 1 Showing (a) a Sketch of the Sample, (b) a Sketch of the Sectioned Metallographic Specimen, (c) an Cathodoluminescence Display of the Defect, and (d) a Photomicrograph of the "Most Open" Portion of the Crack.
