THIRD SUMMARY REPORT
ON
STRUCTURAL STUDIES OF BEARING STEEL
UNDERGOING CYCLIC STRESSING

May 20, 1967

RESEARCH LABORATORY
SKF INDUSTRIES, INC.
ENGINEERING AND RESEARCH CENTER
KING OF PRUSSIA, PA.

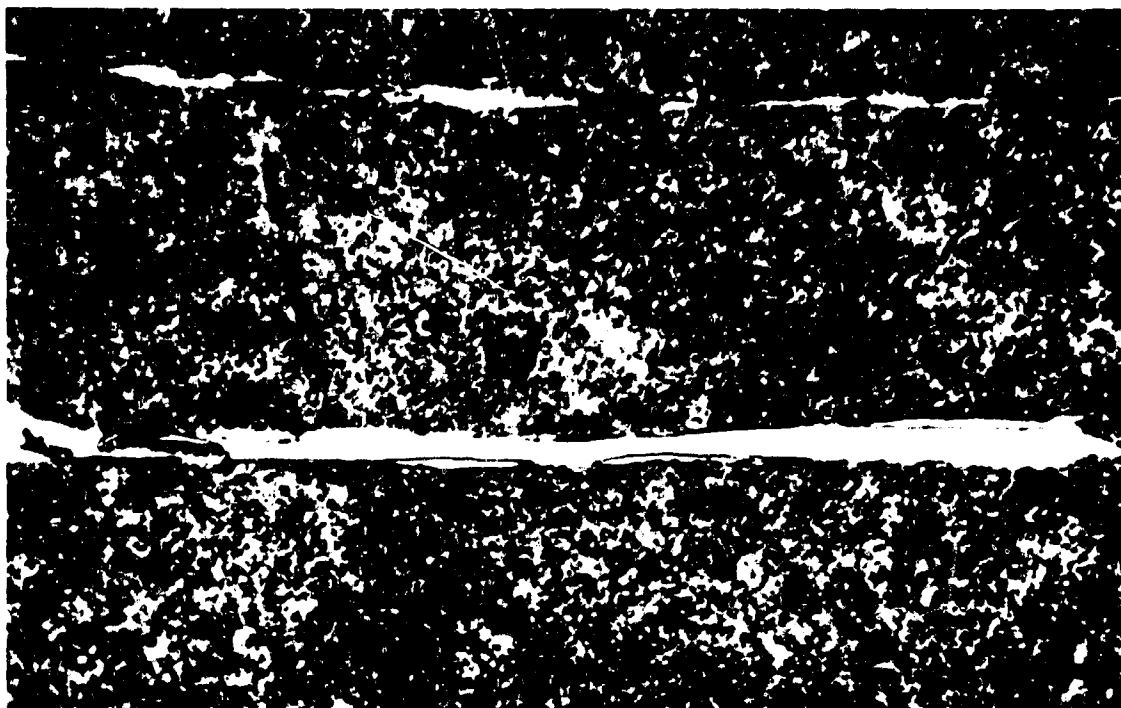
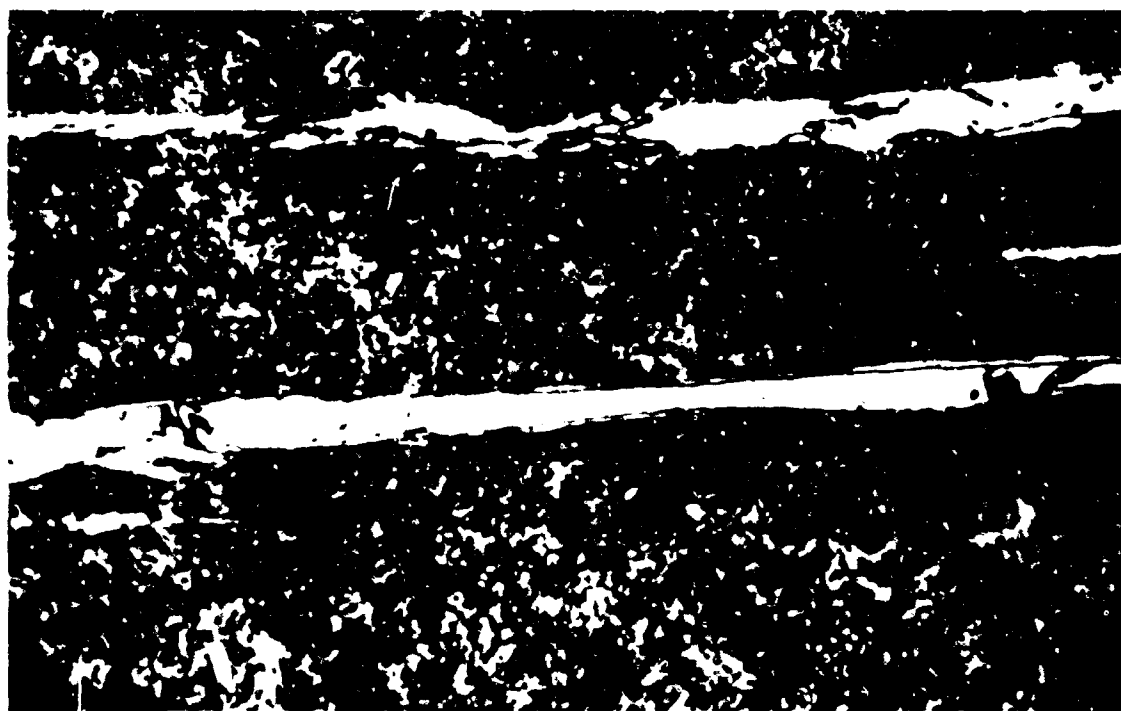
ENCLOSURE 1

DEFORMATION BANDS WITH LARGE LENTICULAR CARBIDES AT THE BORDERS

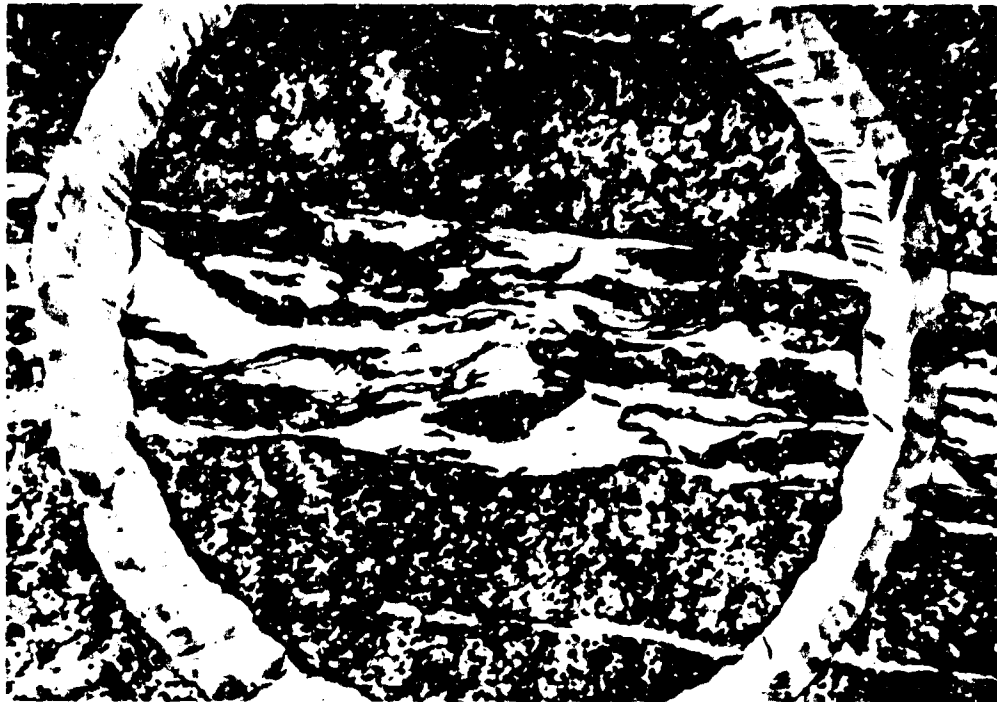
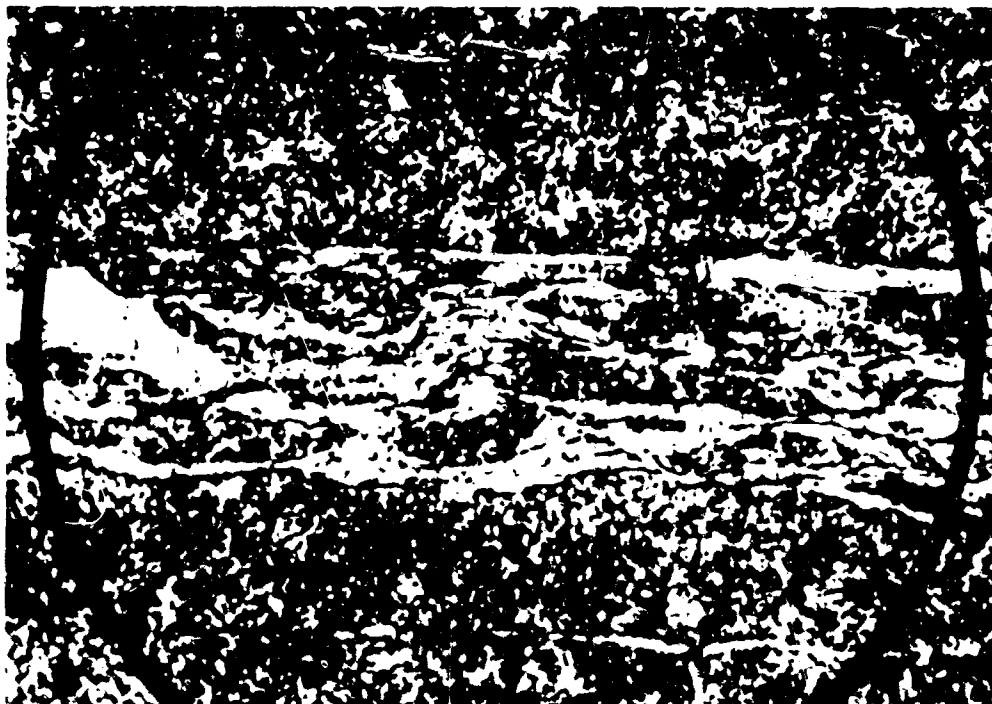
ENCLOSURE 2

DEFORMATION BANDS BEFORE AND AFTER TEMPERING AT 500°C FOR 1 HOUR

The circle was scratched on with a micro-hardness diamond indenter to facilitate relocation of the same area after tempering.

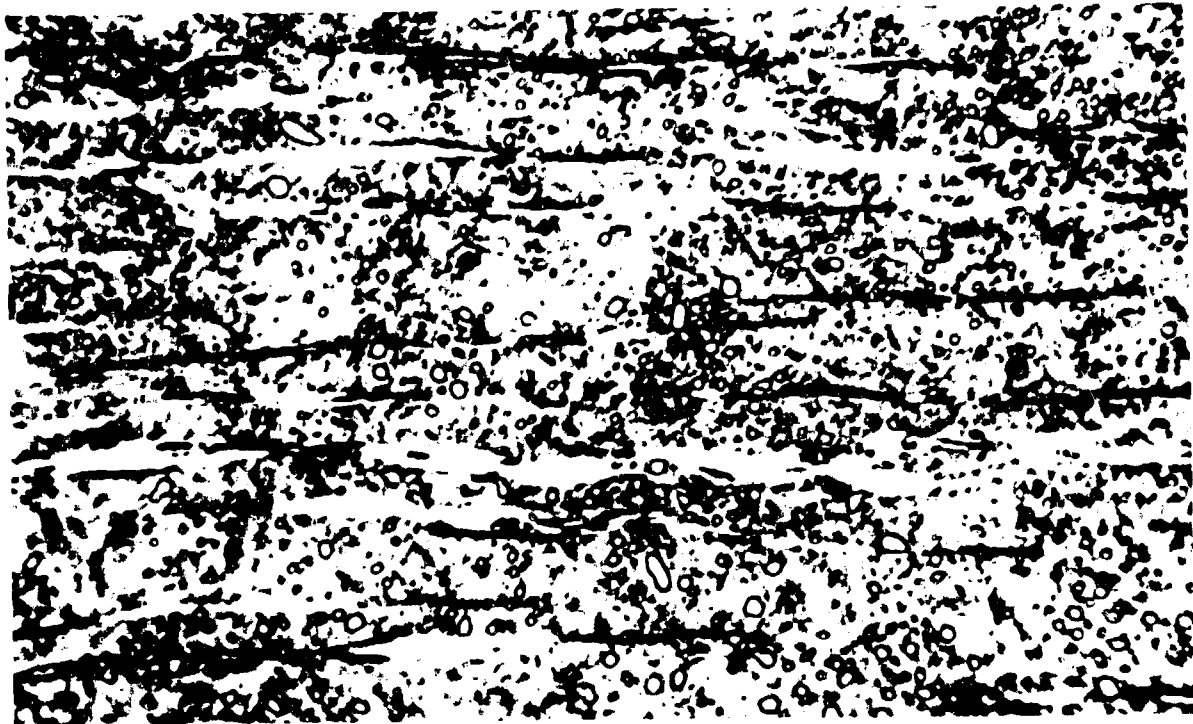
ENCLOSURE 4
DEFORMATION BANDS DEVELOPING IN BULK MATERIAL UNDER THE
INFLUENCE OF CYCLIC STRESS

Deformation bands in their earlier stage of development
Bearing 849-234 Life 157 Million Revs. 52100 steel

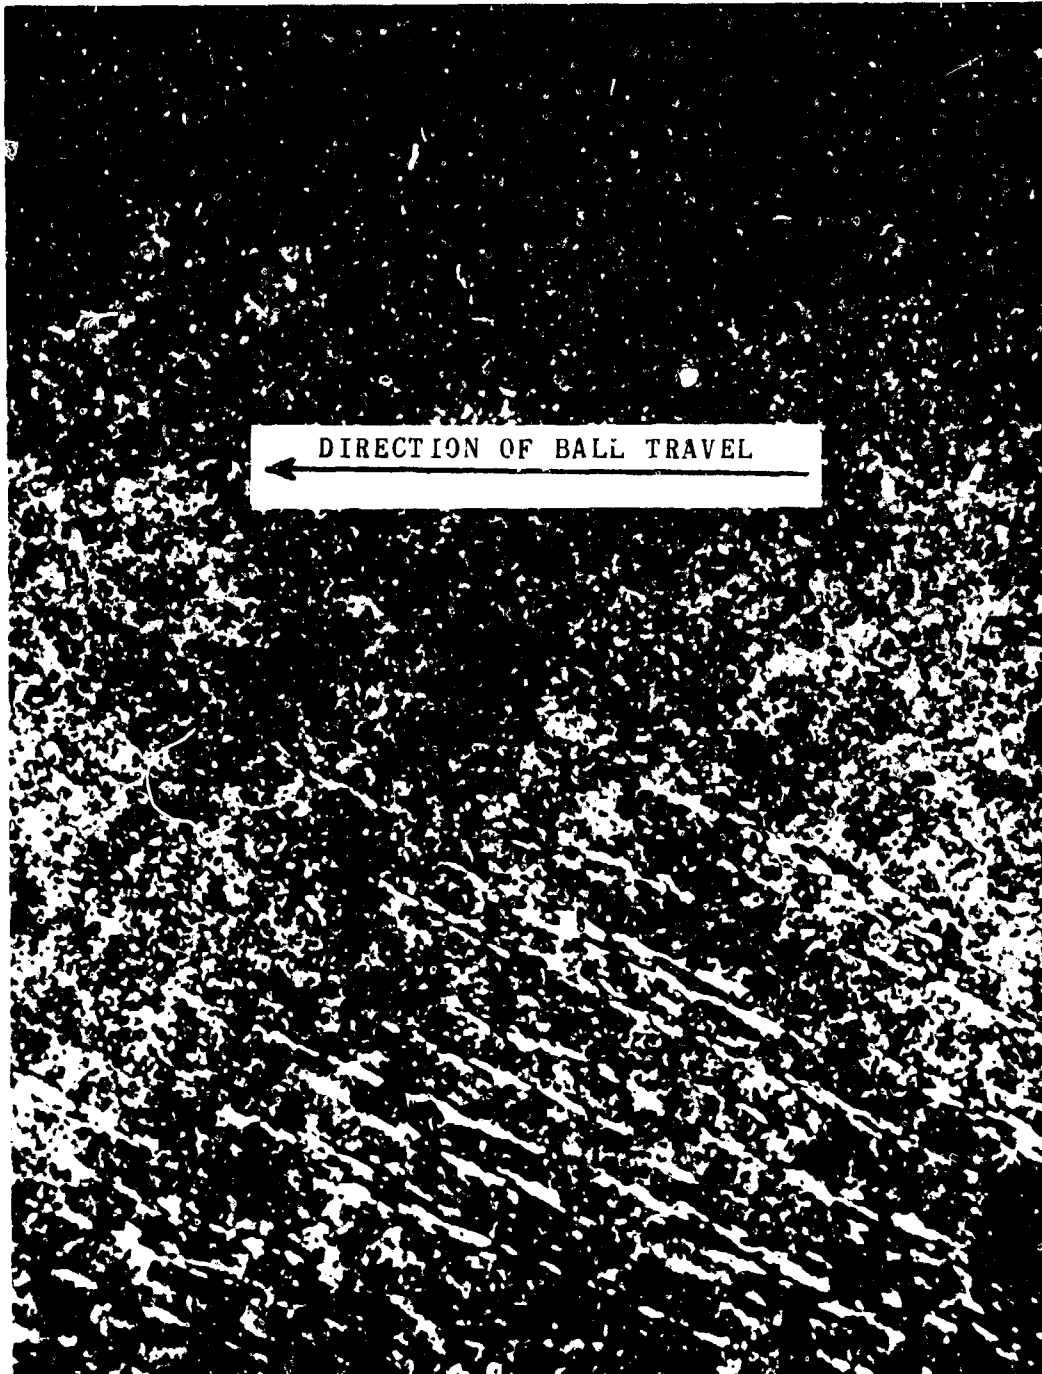
ENCLOSURE 9

LOW MAGNIFICATION PHOTO OF DEFORMATION BANDS SHOWING THEIR 23° ORIENTATION
TO THE SURFACE AS VIEWED ON A CIRCUMFERENTIAL PLANE

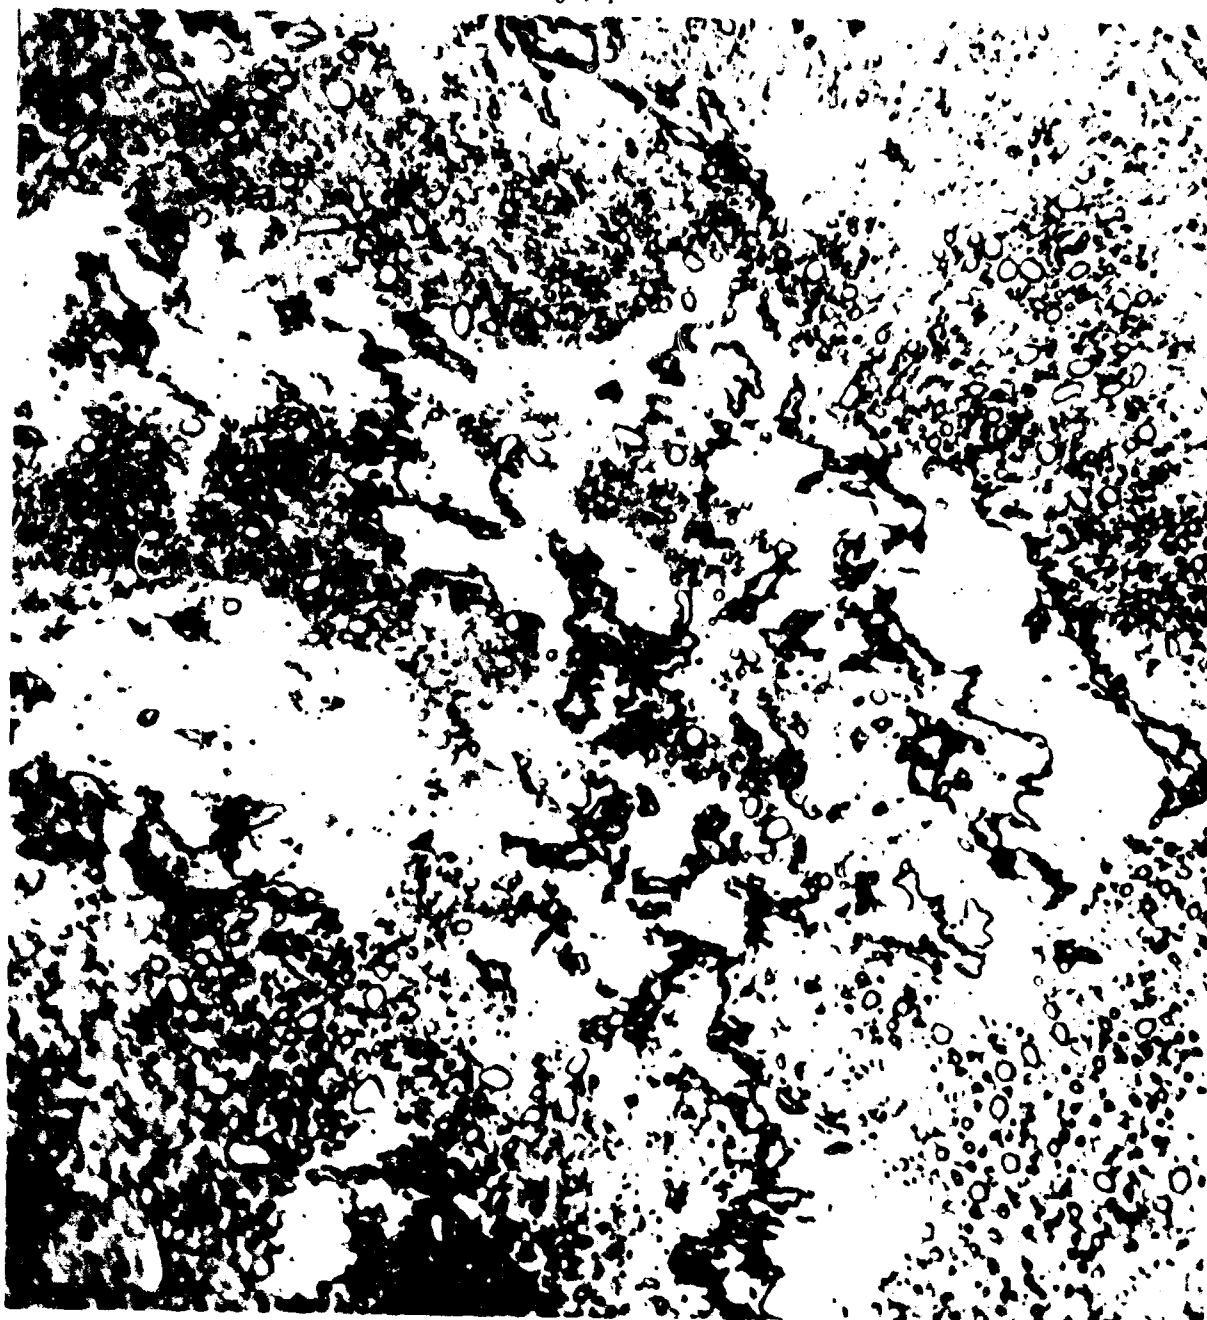
VIEW ON PLANE LYING PARALLEL TO THE PLANE
OF THE DEFORMATION BANDS

Light Micrograph of Plane Cut 23° to the
Ring Groove Tangent-Picral Etch 2000X

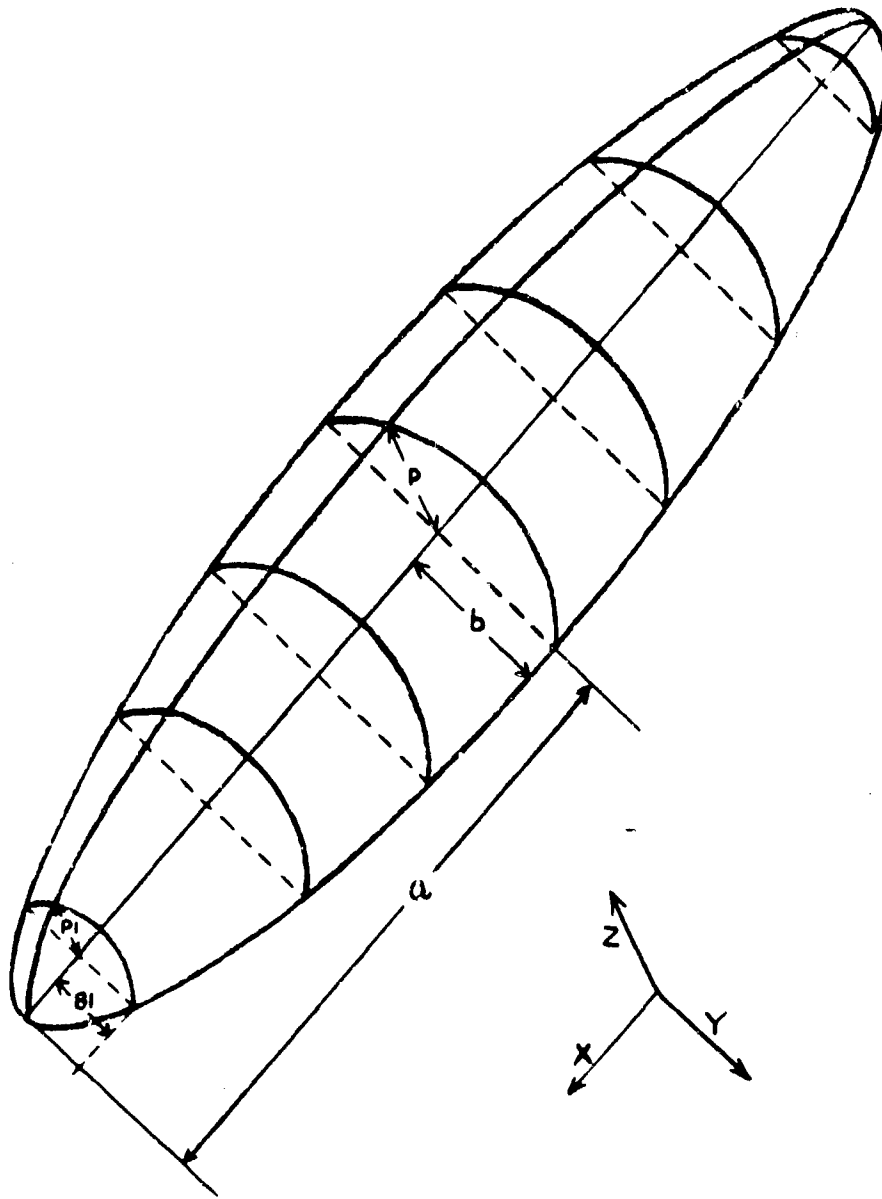
ENCLOSURE 11

CONTACT ELLIPSE ON THE SURFACE OF A 6309 DEEP GROOVE
BALL BEARING INNER RING

Load - 4240 lbs radial load
Dynamic Capacity to Load Ratio (C/P) - 2.15
Maximum normal Hertzian stress (τ_{max}) = 474,900 psi
Maximum alternating shear stress ($\tau_{zy max}$) = 118,800psi
Depth of max alternating shear stress ($Z_{\tau_{zy max}}$) = 7.6×10^{-3} in.
Maximum 45° shear stress (τ_{max}) = 148,000 psi
Depth of max 45° shear stress (Z_0) = 11.7×10^{-3} in.
Major and minor semi-axes of contact ellipse

$$a = 0.1547''$$
$$b = 0.01511''$$

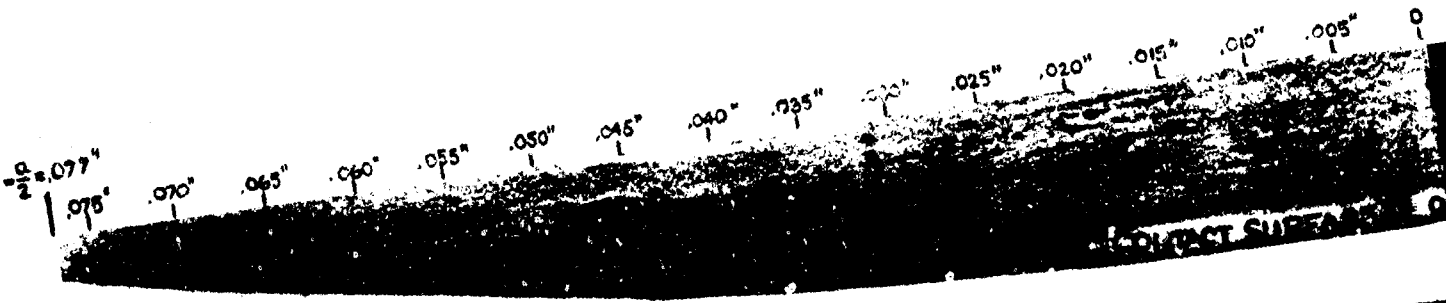
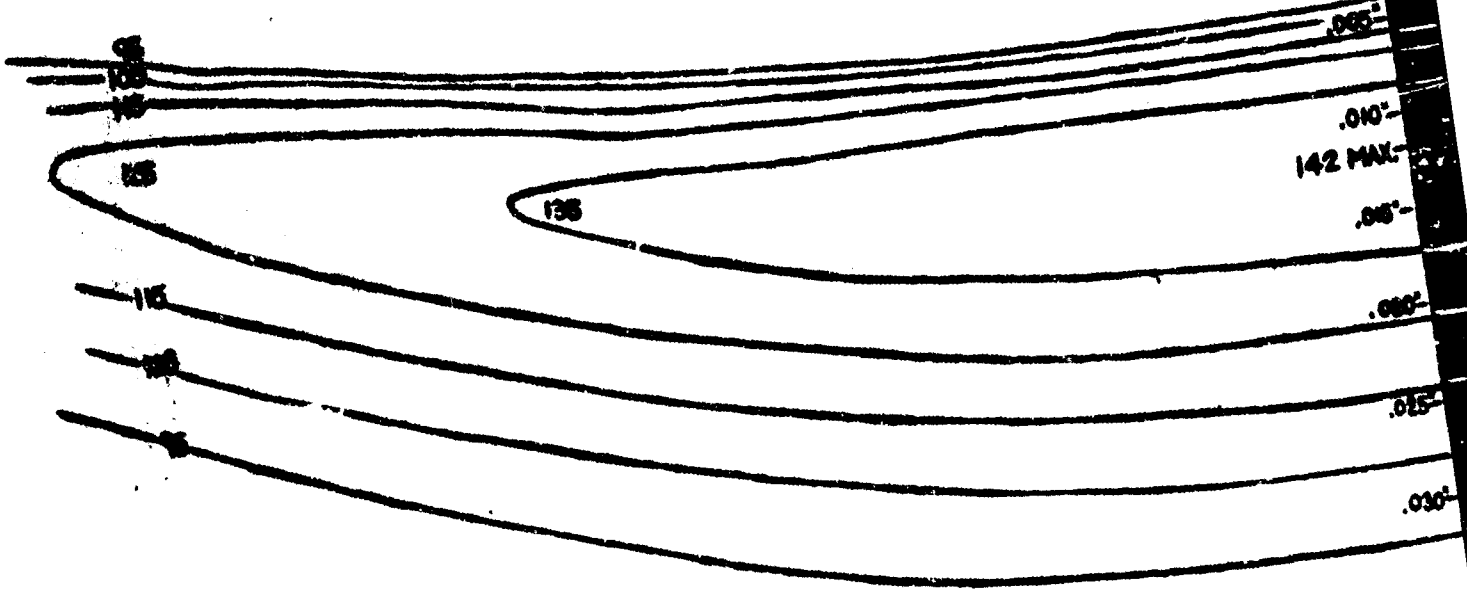
MAXIMUM SHEAR STRESS

Maximum shear stress distribution (τ_{45°) loaded as described in Enclosure 9. The maximum shear stress are superimposed on a The horizontal white streaks in the body of Values shown on the contour lines are τ_{max} below the contact surface is shown on the line at the contact surface is an artifact

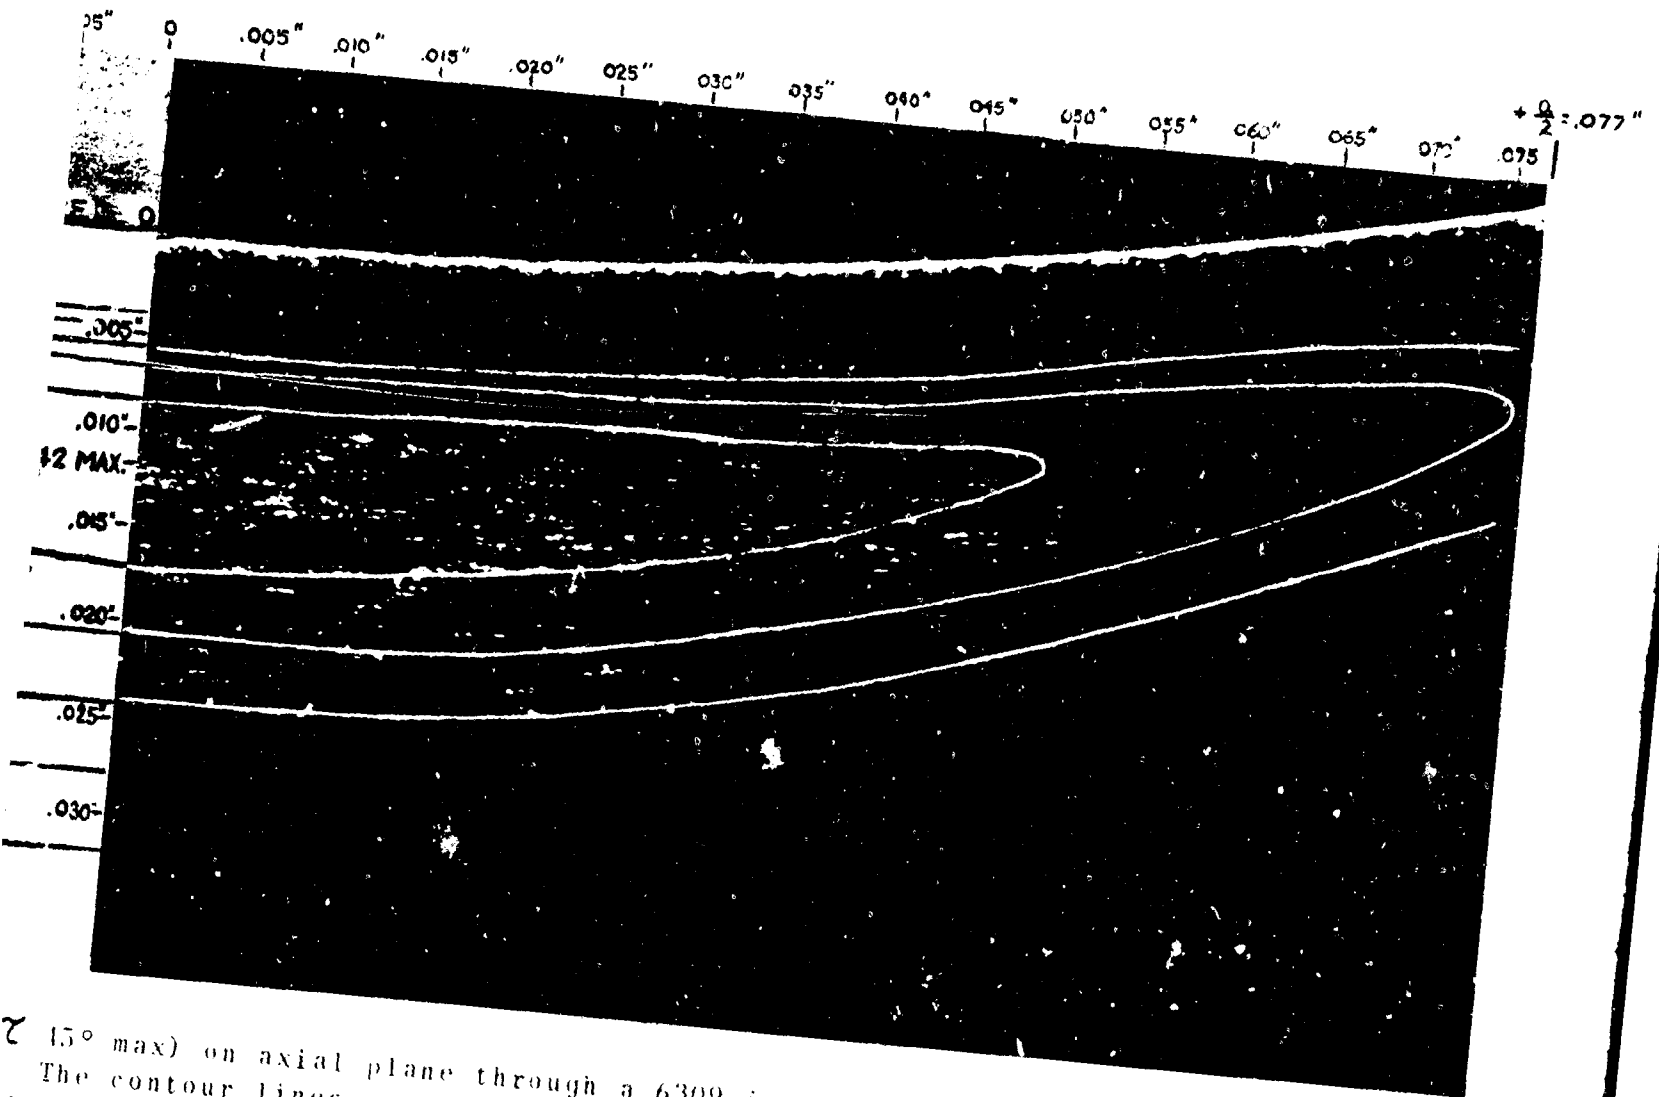
STRESS ON AN AXIAL PLANE

τ (5° max) on axial plane through a 6309 inner ring
• The contour lines connecting points of equal
stress on a 100X microphotograph of an actual specimen.
The white lines are deformation bands.
The τ max values are in thousands of psi. Distance
is on the depth scale at the center. (The white
line is artifact due to reflected light).

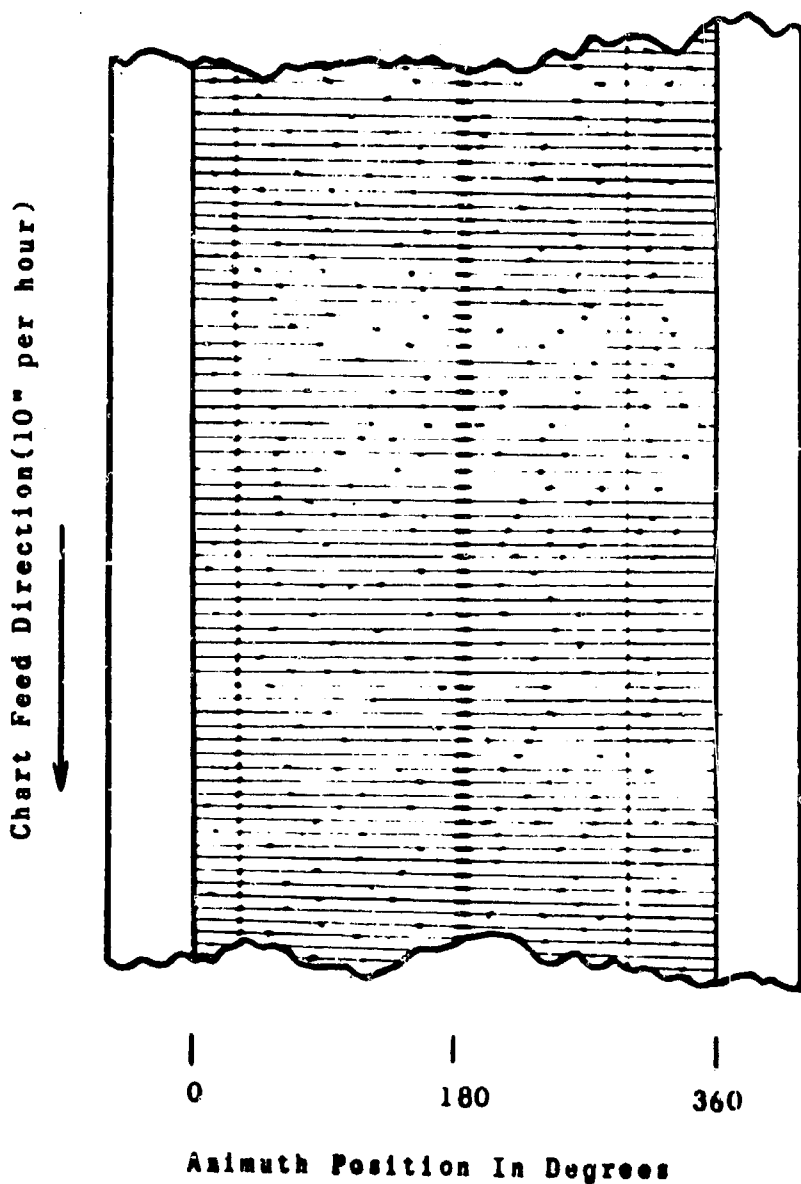
ENCLOSURE 31

SCHEMATIC OF ALFAX RECORDER CHART

Legitimate defect indications are aligned vertically.

Random noise indications are not repeated at the same azimuth locations and do not line up vertically.

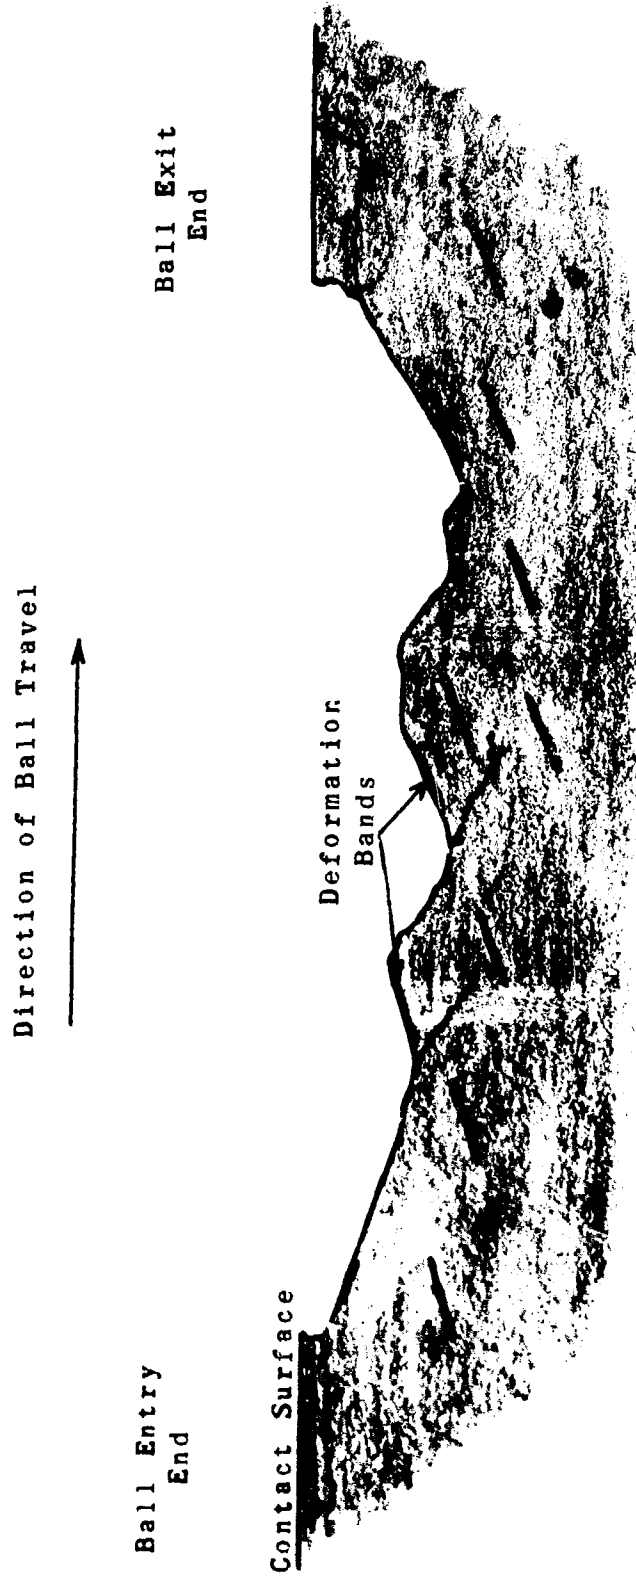
SCHEMATIC SHOWING THE TYPICAL FEATURES
OF SPALLS AND THE RELATIONSHIP BETWEEN
CRACK PROPAGATION AND DEFORMATION BANDS
