**Three Full-Scale Dynamic Crash Tests
of a CNU-103/E Shipping Container**

Aviation Safety Engineering and Research
a Division of
Flight Safety Foundation, Inc.

Technical Report AFATL-TR-67-55

MAY 1967

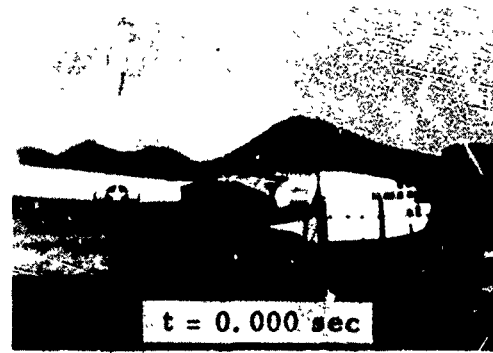
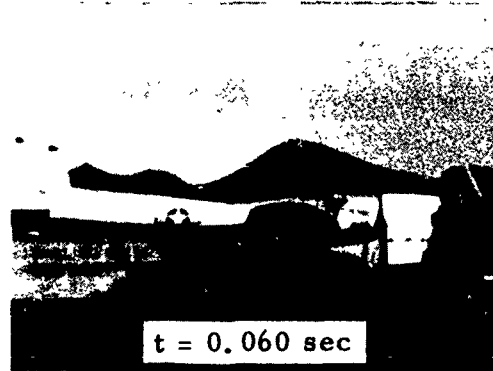
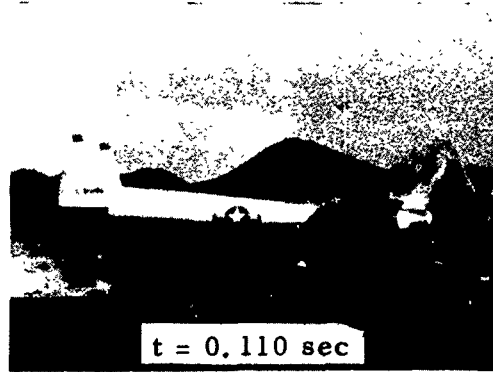
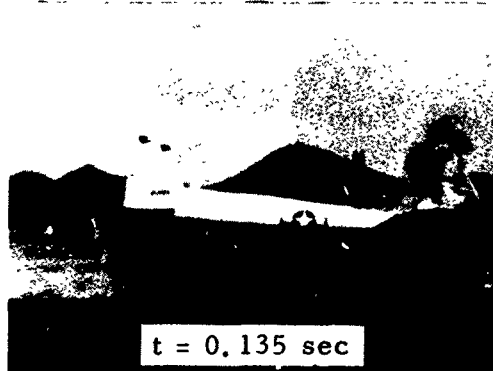
Figure 13. Crash Sequence - Test 1.

The impact sequence for the CNU-103/E Shipping Container as reconstructed from high-speed photography indicates that the container remained attached to the pallet and fuselage floor during the crushing of the forward aircraft fuselage. At contact of the propellers and engine nacelle with the concrete wall, sufficient longitudinal deceleration was generated to release the container from the pallet. However, at this point there could have been only 17 inches between the forward edge of the Shipping Container and the wall. This 17 inches was filled with the crushed portion of the forward fuselage so there was little, if any, forward motion of the container, relative to the pallet, at any time during the impact. Therefore, the longitudinal velocity of the Shipping Container at point of contact with the wall was the same as the aircraft fuselage. Analysis of the high-speed film and integration of the fuselage acceleration-time history has determined this velocity to be 190 feet per second.

As the impact sequence continued the Shipping Container hit the crushed fuselage structure and concrete wall, rebounded, and came to rest with the forward end of the container in the crushed aircraft structure and the rear edge of the container outside the rear fuselage bulkhead resting on the nose gear guide rail.

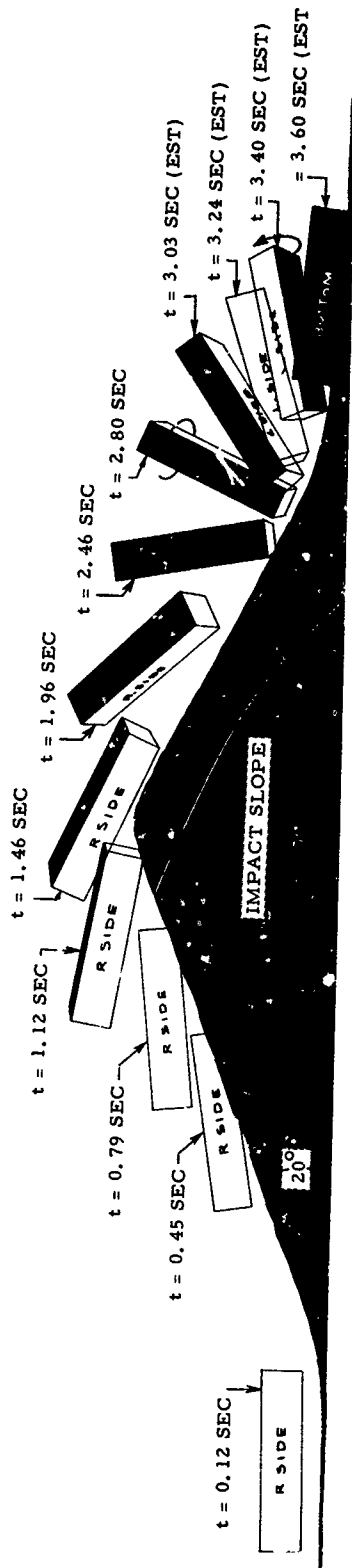
Figure 23. Shipping Container Crash Kinematics - Test 3.

A graphic display of container crash kinematics as determined from the high-speed film analysis is presented in Figure 23.

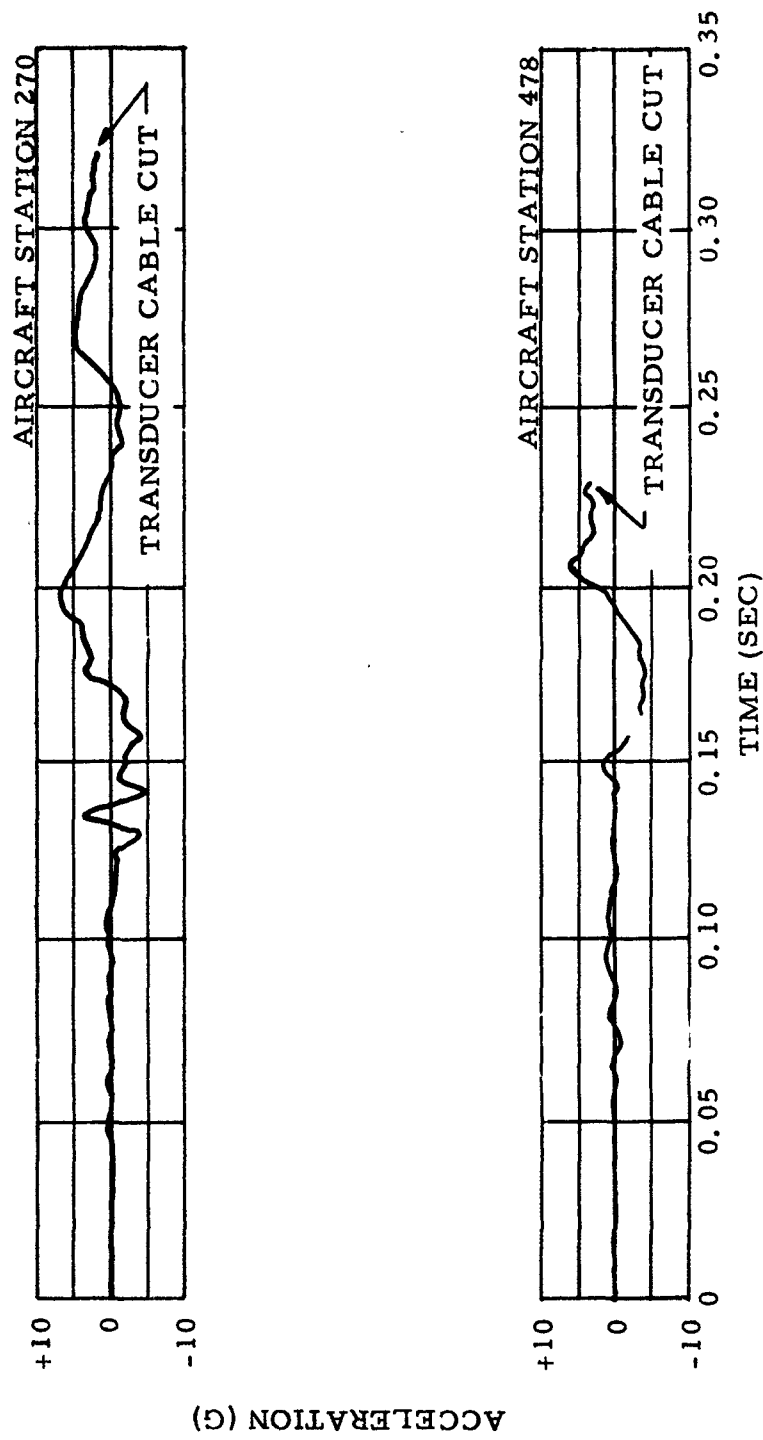
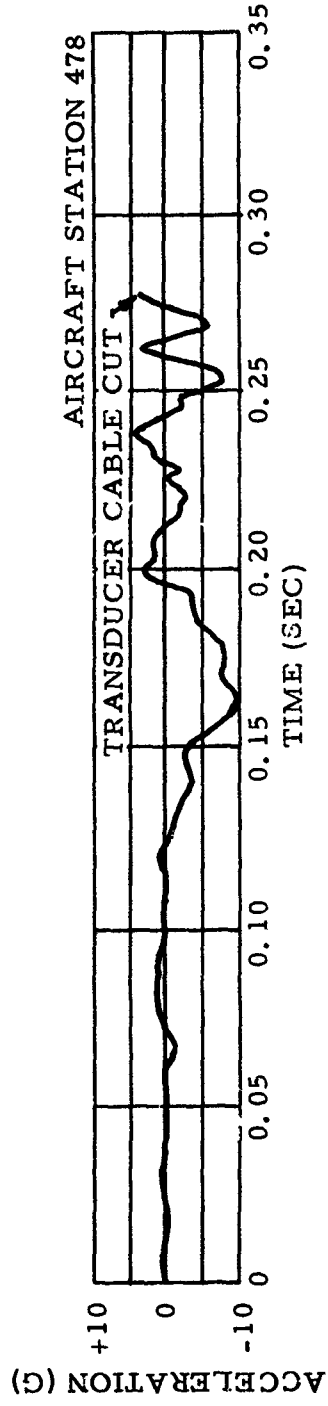
AIRCRAFT STATION 270

DATA FROM THE LOCATION WAS NOT RECORDED
DUE TO FAILURE OF TRANSDUCER PRIOR TO TEST
