**FLIGHT TEST-WHIRLING ARM CORRELATION
OF RAIN EROSION RESISTANCE
OF MATERIALS**

GEORGE F. SCHMITT, JR.

TECHNICAL REPORT AFML-TR-67-420

SEPTEMBER 1968

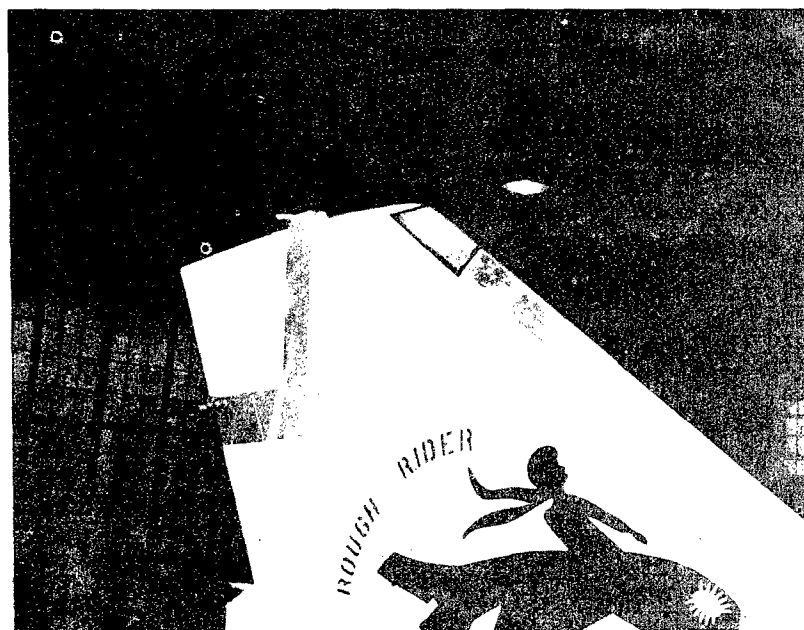
This material remained in its initial condition as shown in Figure 11 until Flight 18 when the leading edge began to peel. This peeled segment was torn from the aircraft during Flight 22. The shoe had no surface roughness, breaks, or other peeled sections. Figure 33 shows the condition at the end of the program.

Figure 11. Two Erosion Resistant Samples on Vertical Stabilizer of F-100F Aircraft

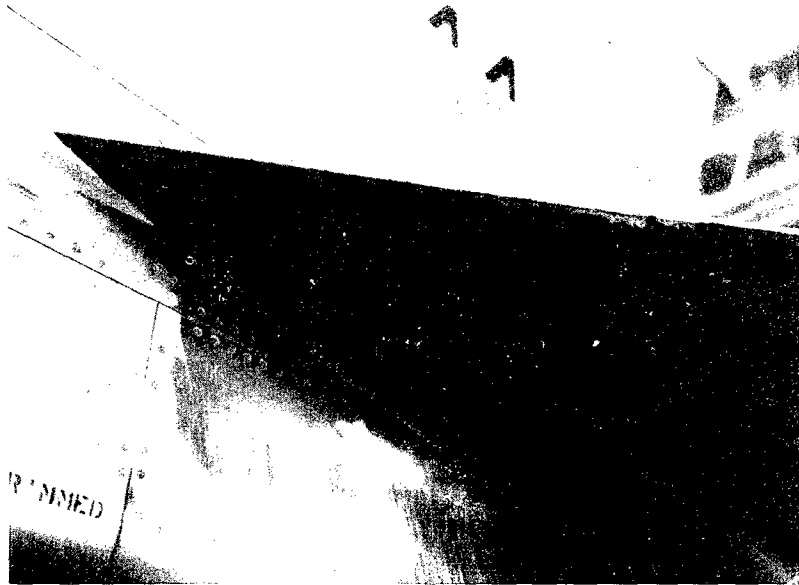
Figure 16. Specification Neoprene Sample on Lower Surface of Left Stabilizer After Hail Encounter During Flight 7

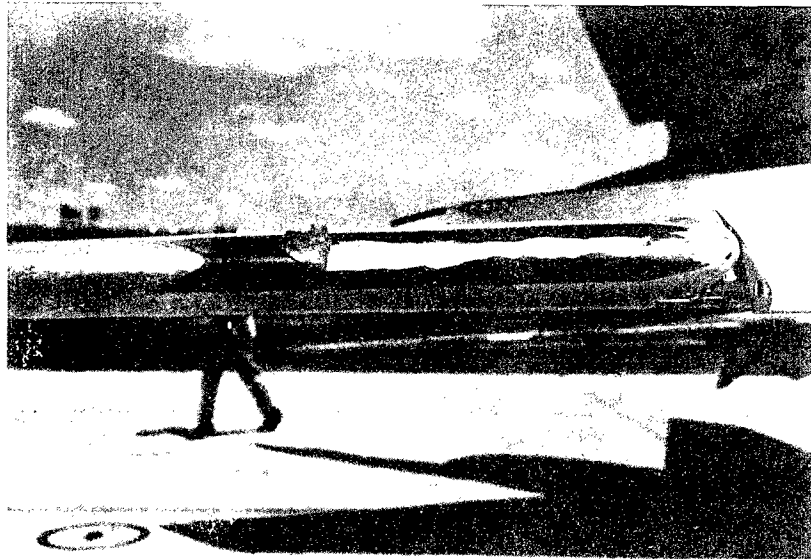
Figure 73. Leading Edge of Inboard Sample on Right Wing Tip Removed 31 May; Leading Edge of Outboard Sample Peeled From Half of Shoe
