AFFTC-TD-69-4

FLIGHT PLANNING AND CONDUCT OF THE X-15A-2 ENVELOPE EXPANSION PROGRAM

Technology Document No. 69-4

JULY 1969

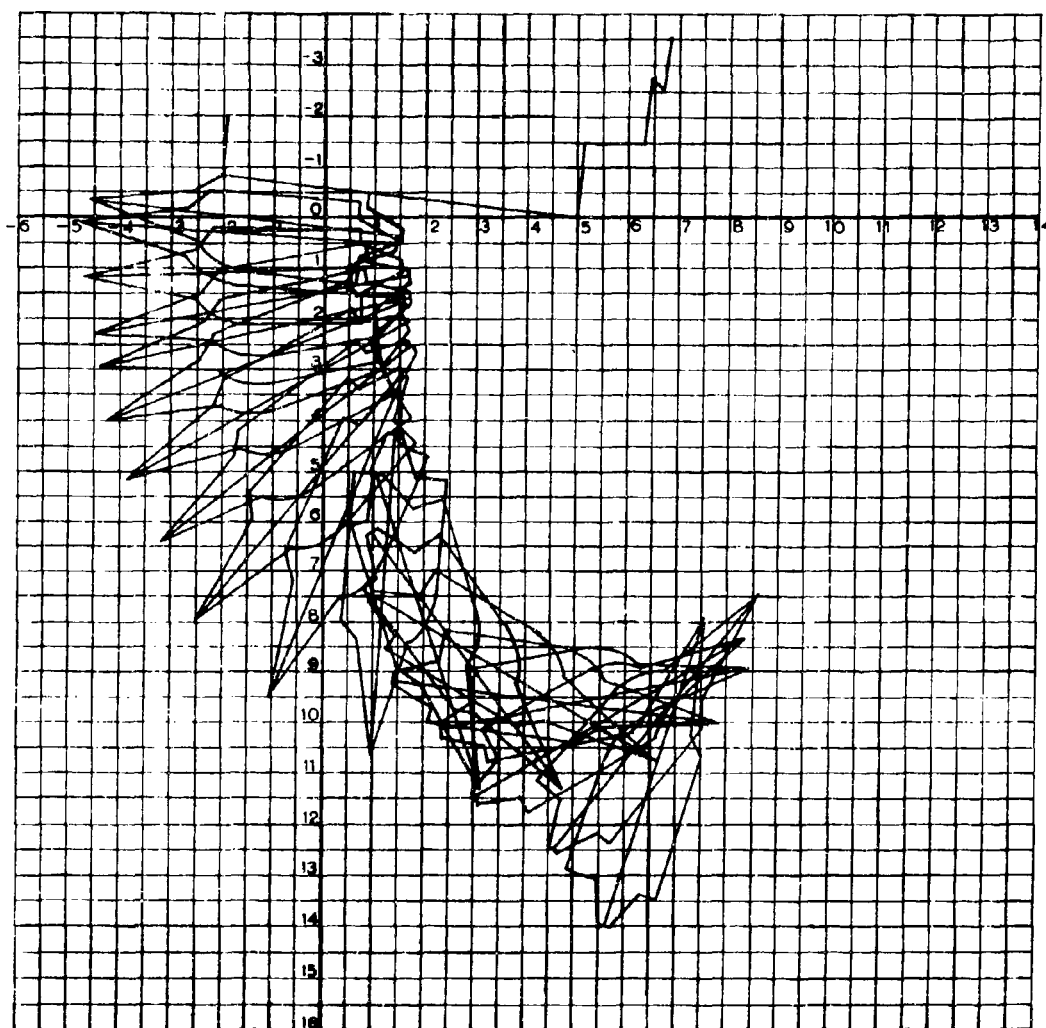
Figure 27 FLIGHT 2-51-92 DUMMY RAMJET SEPERATION FROM MOBILE TRACKER PICTURES

On final approach the pilot jettisoned the ramjet, and there were no aircraft trim changes associated with the event. Ramjet separation characteristics were calculated by the contractor and under certain conditions the ramjet could recontact the aircraft, therefore a recommended ejection envelope and cg limits for the unit were established. To obtain data on the actual ramjet separation, a mobile tracker with telescopic cameras was located normal to the final approach track at the point of expected ramjet ejection. The pictures obtained were excellent and detailed analysis of the film was possible (figure 27). The agreement of the actual separation with the theoretical calculations was good, with the actual clearance being better than predicted (figure 28). The ramjet recovery system operation was unsatisfactory. The stranded cable attaching the recovery parachute to the ramjet failed as the chute deployed: however the impact damage was not major and the unit was refurbishable.

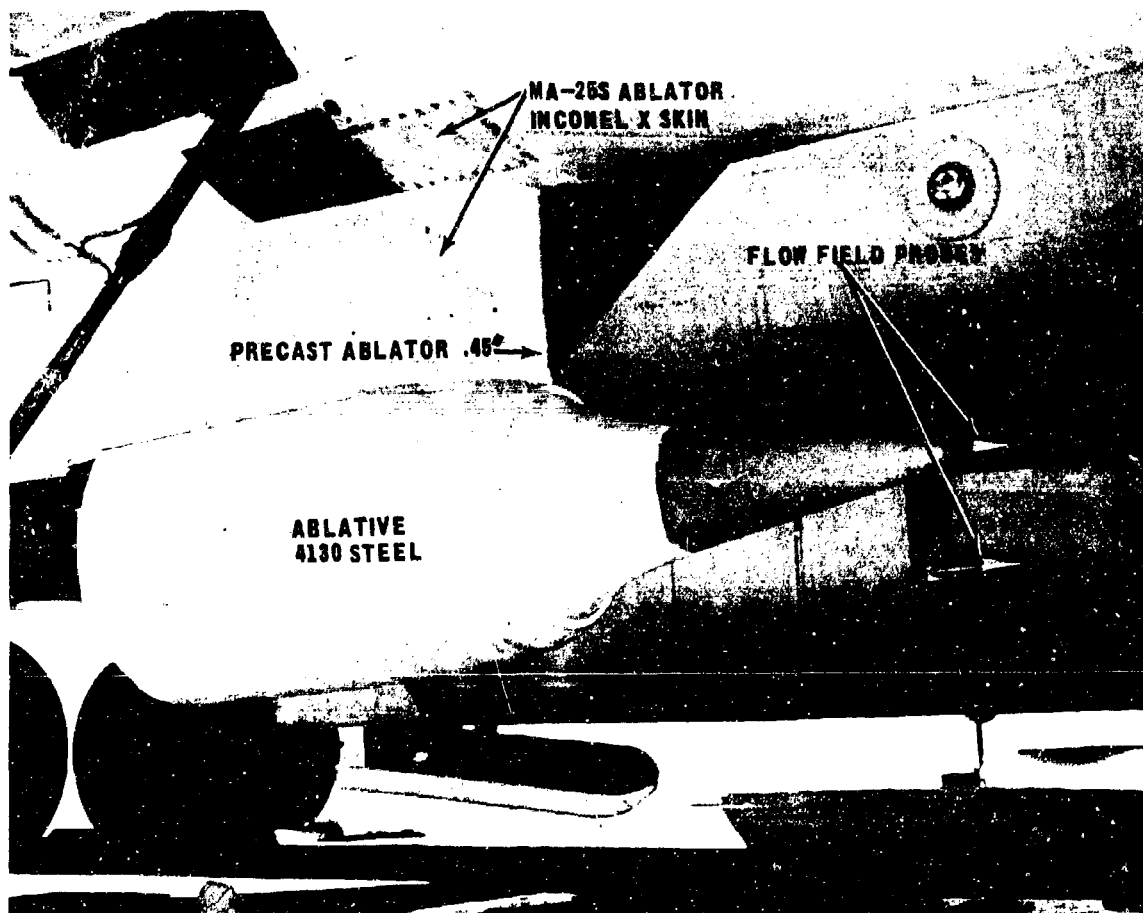
Figure 50 PRE-FLIGHT CONDITION OF RAMJET AND PYLON

The severe structural damage to the dummy ramjet and pylon during the flight to Mach 6.7 was the result of local aerodynamic heating due to shock impingement and flow interference effects. Figure 50 shows the preflight condition of the ramjet, pylon, and lower fuselage.
