Air Force Report No.
SAMSO-TR-69-353

**THE DETERIORATION OF STAINLESS STEEL REGENERATIVELY
COOLED THRUST CHAMBERS**

J. K. STANLEY
Materials Sciences Laboratory

Laboratory Operations
THE AEROSPACE CORPORATION

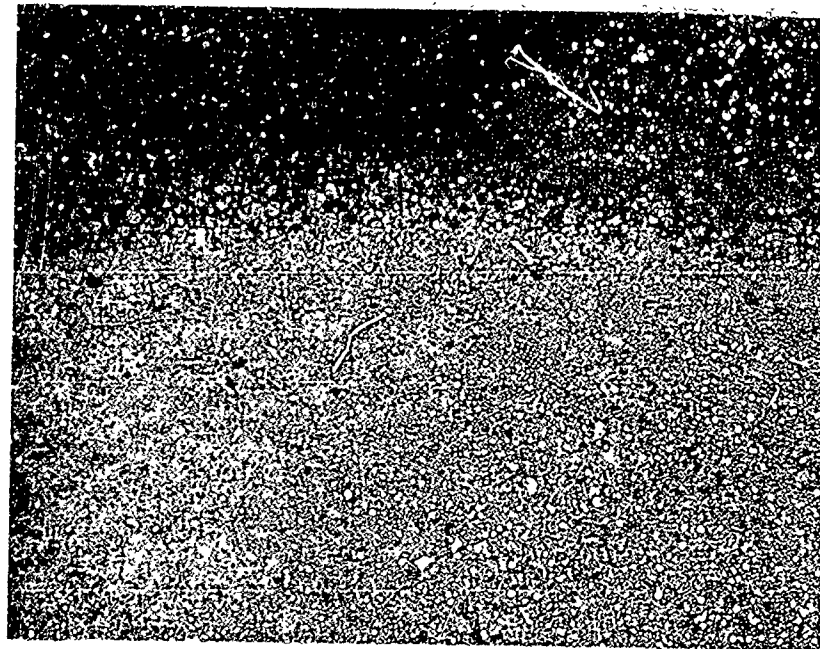
Carburization of Type 347 stainless steel only occurs above about 780°C (1530°F) (Ref. 7). Carburization at high temperatures can be quite rapid. As shown in Fig. 7(a) significant carburization of Type 347 can occur in 1 min at 1095°C (2000°F); Fig. 7(b) shows some of the carbide that has melted and resolidified (thin white layer). This is not an unreasonable temperature to be experienced by these tubes in this application. Note coarse grain size in Fig. 8, which attests to this temperature range. Also note the carburized (mottled) layer on the tube.

(b) Carburized 1 min @ 1120°C (2250°F)

If the temperature in the thrust chamber increases to about 1095°C (2000°F) or higher, the carbide melts and may be blown out of the engine in the high-pressure gas stream. See Fig. 7(b).

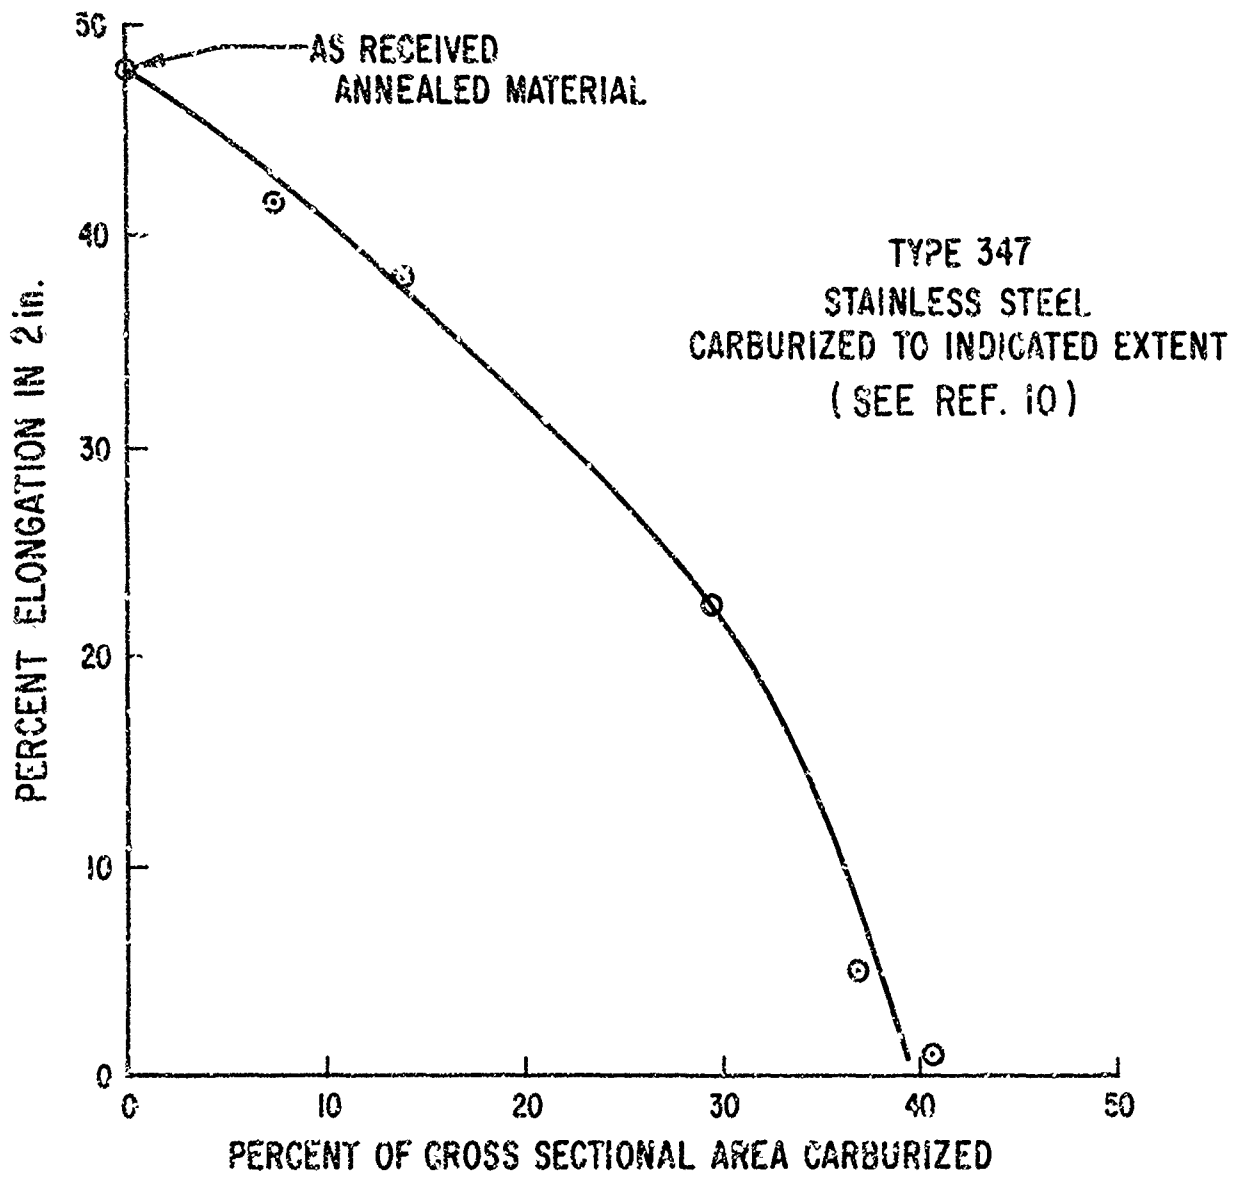
One unfortunate consequence of carburization in Type 347 stainless steel is the loss of ductility (Ref. 10). See Fig. 15. Figure 16 shows the cracking that develops when a carburized steel is pulled in tension. The specimen was originally carburized in 1-1/2 vol % methane in hydrogen for 1 hr at 980°C

Figure 15. Decrease in Ductility in Relation to Carburization in Type 347 Stainless Steel
