Technical Note N- 1081

DEEP-OCEAN BIODETERIORATION OF MATERIALS -  
SIX MONTHS AT 6,000 FEET

NAVAL CIVIL ENGINEERING LABORATORY  
Port Hueneme, California 93041

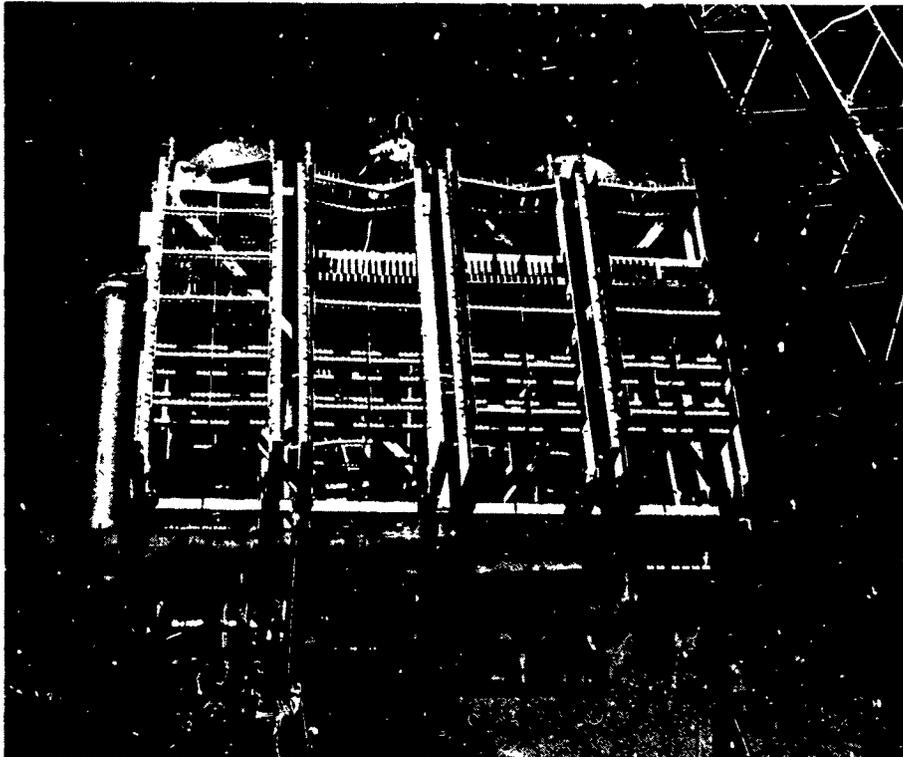
The STU structure with test specimens recovered from the sea after 6.3 months of exposure on the sea floor in 6,000 feet of water is shown in Figure 6. The results obtained from exposing materials in the deep ocean environment are summarized in Tables 3, 4, 5, 6, 7 and 8. The effects of deep sea organisms on various materials are discussed in the following pages.

Figure 6. STU I-5 recovered from the sea.
