AFRPL-TR-70-43

**LONG-TERM STORABILITY
OF
PROPELLANT TANKAGE AND COMPONENTS
INTERIM REPORT #1**

R. B. MEARS, 1st LIEUTENANT, USAF

MAY 1970

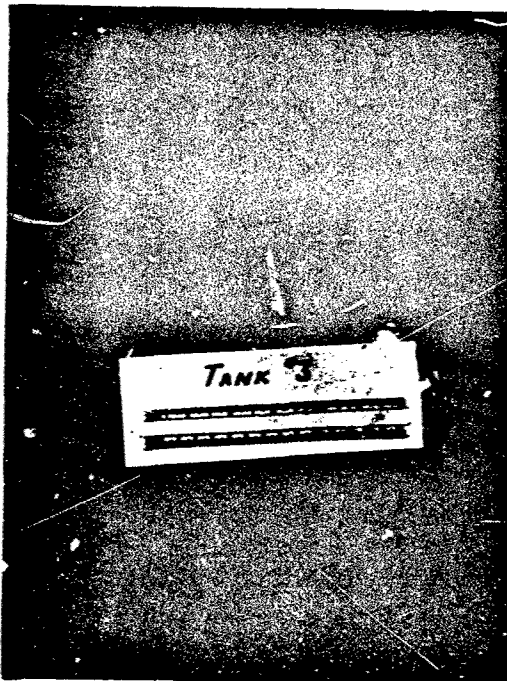
Figure 3. End Views of Tank No. 3

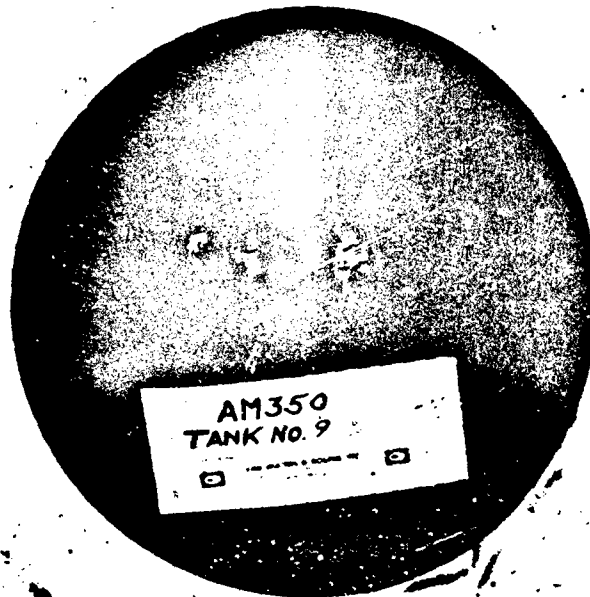
10. The 85% relative humidity and close proximity of this tank to a leaking N_2O_4 vessel, resulted in condensation of HNO_3 on the top of the tank, and caused tank S/N 9 to leak. The HNO_3 then drained down the sides of the tank and concentrated on the bottom. Corrosion occurred generally over the outer surfaces of the tank and heavy pitting occurred on the bottom of the tank with two pits penetrating the wall thickness of the tank. Actually, HNO_3 is the suspected oxidizing acid that caused corrosion in this case since there were no fluorides or significant amounts of chlorides present in the corrosion residue.

Figure 2. Bottom View of Tank No. 9.
Circled areas are leaks.

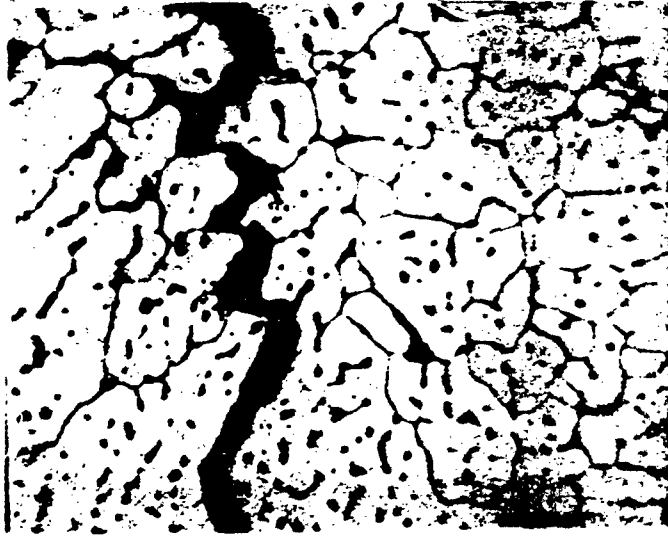
Figure 13. Photomicrograph showing representative intergranular corrosion through the weld area of the 32 x 10 leak area in small tank no. 12. 200X
