**COATINGS FOR LIGHTING PROTECTION OF  
STRUCTURAL REINFORCED PLASTICS**

**TECHNICAL REPORT AFML-TR-70-303 Pt. I**

March 1971

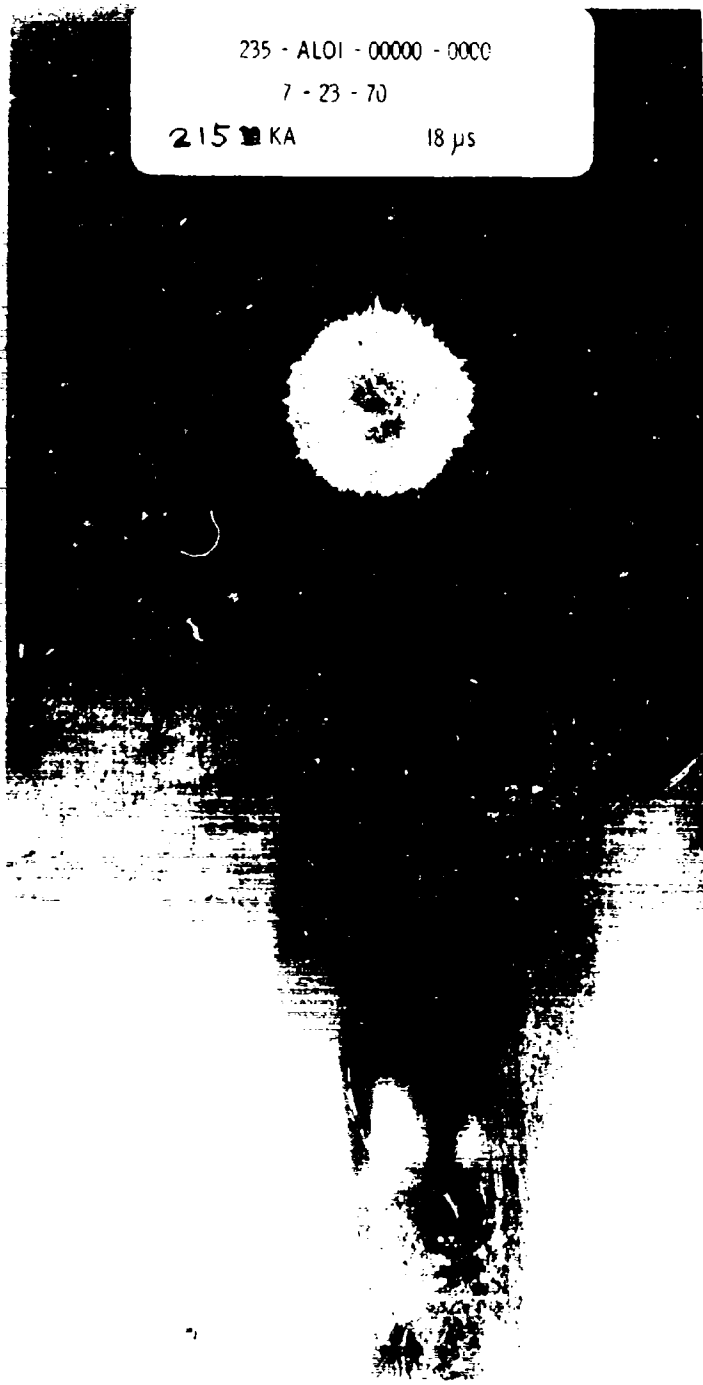
235 - ALOI - 00000 - 0000  
7 - 23 - 70  
215 KA 18  $\mu$ s

For comparable lightning discharge currents the progression of damage is: boron > graphite > aluminum. This is shown in Figures 10, 11 and 12. Whereas the boron panel was completely shattered, the graphite panel was only punctured. The aluminum sheet was dented and noticeably mauled at the test zone. It should be noted also that the impedance of a boron/epoxy composite is almost 50 percent higher than that of a graphite/epoxy composite.

Figure 12 HIGH CURRENT DAMAGE TO ALUMINUM SHEET

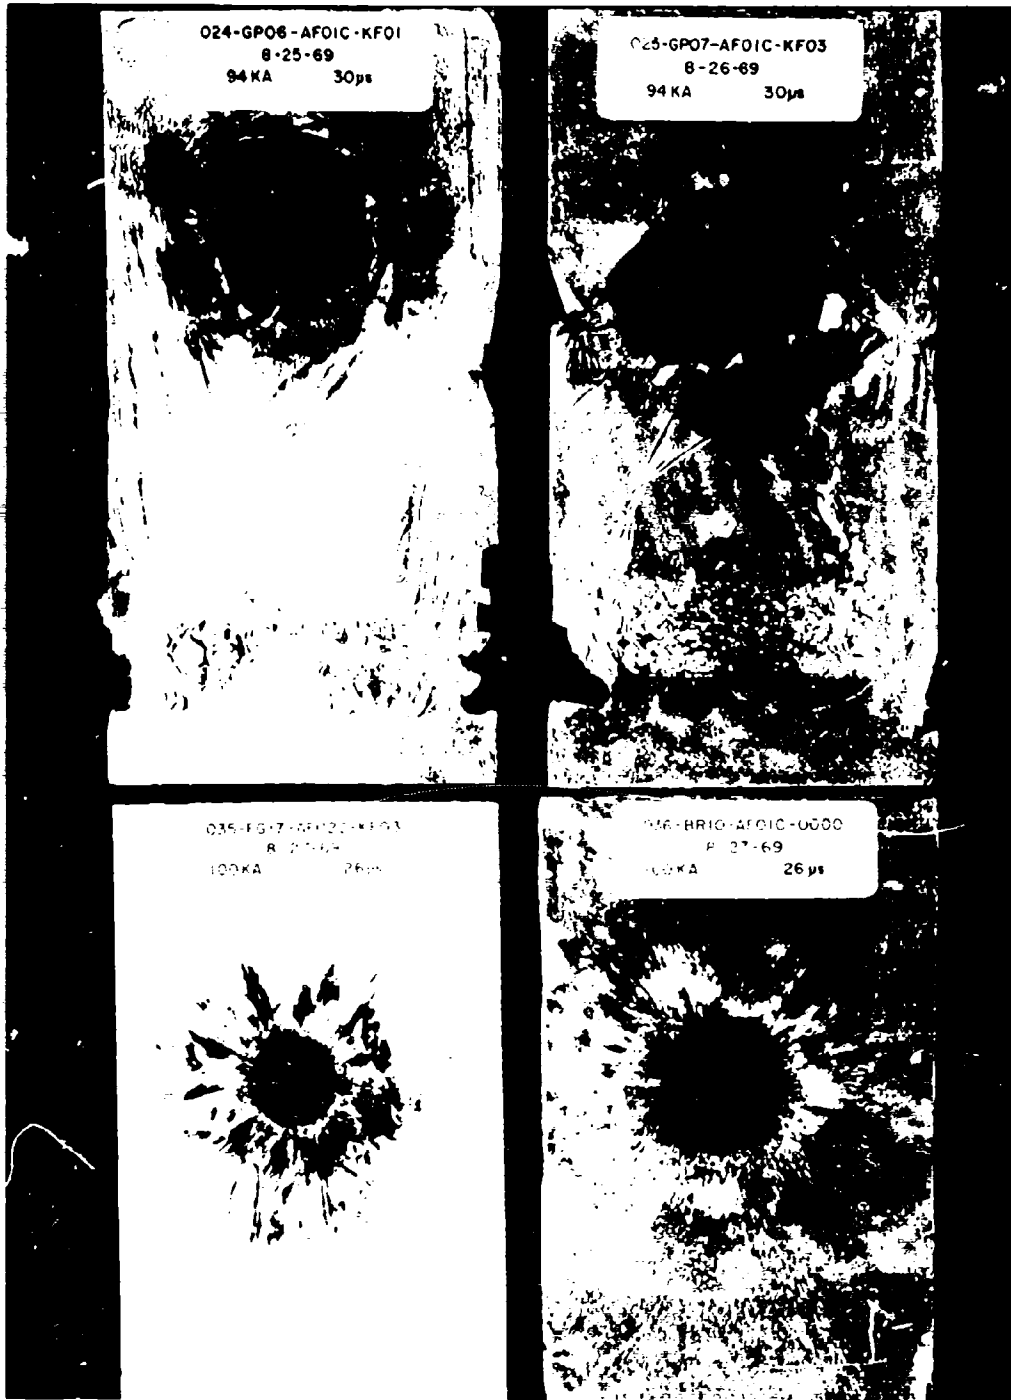
Figure 17. LIGHTNING DAMAGE TO VARIOUS MATERIAL COMPOSITES

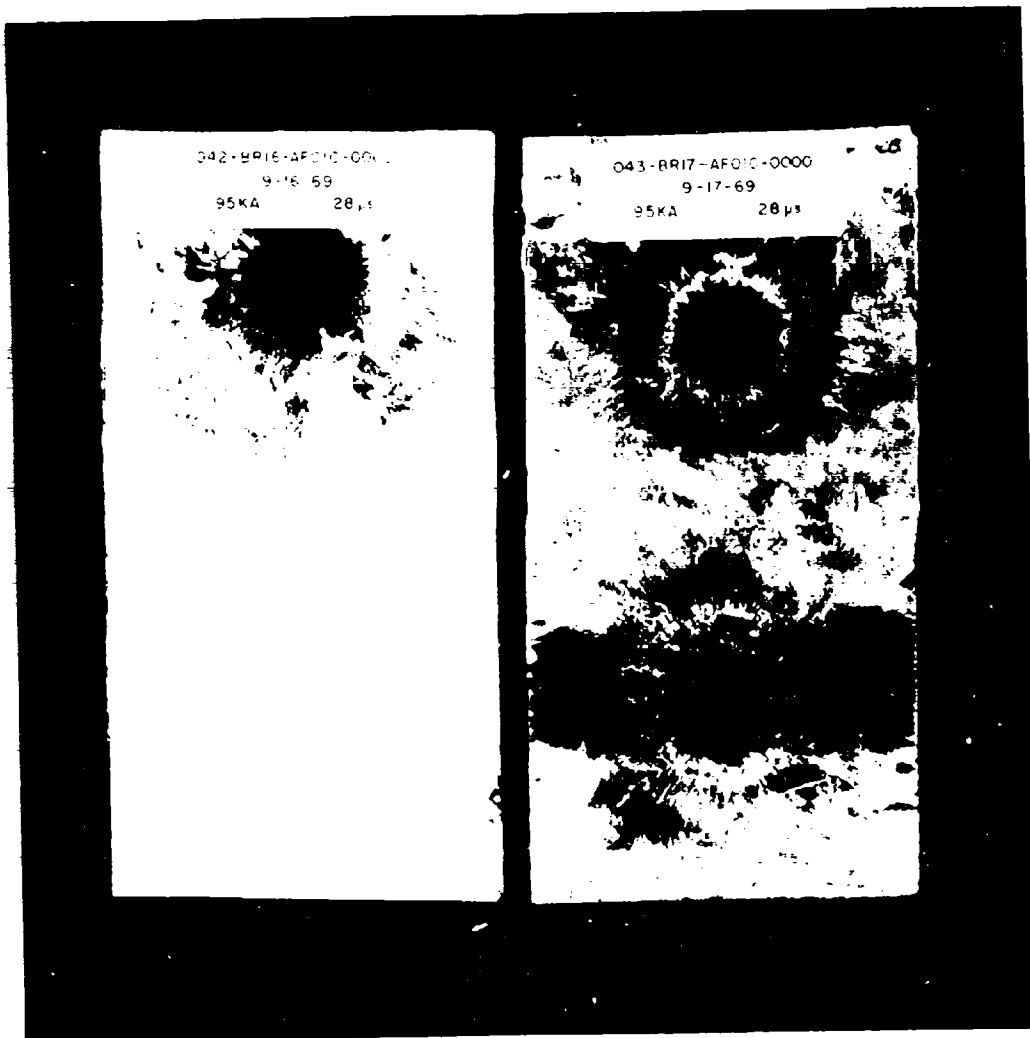
Figure 18: RESTRIKE DAMAGE TO ALUMINUM FOIL COATED BORON EPOXY LAMINATI

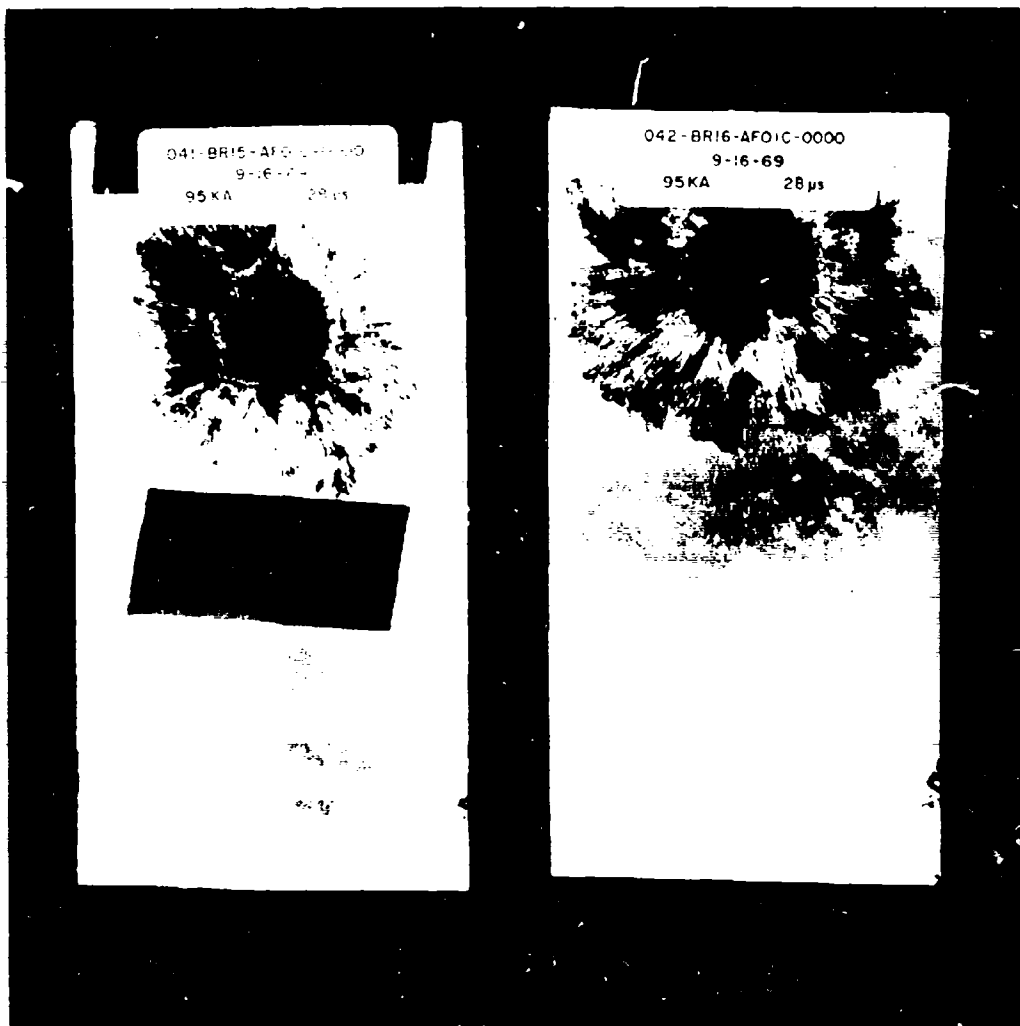
Figure 20 EFFECT OF FILAMENT ORIENTATION ON LIGHTNING DAMAGE TO FOIL COATED BORON EPOXY LAMINATES

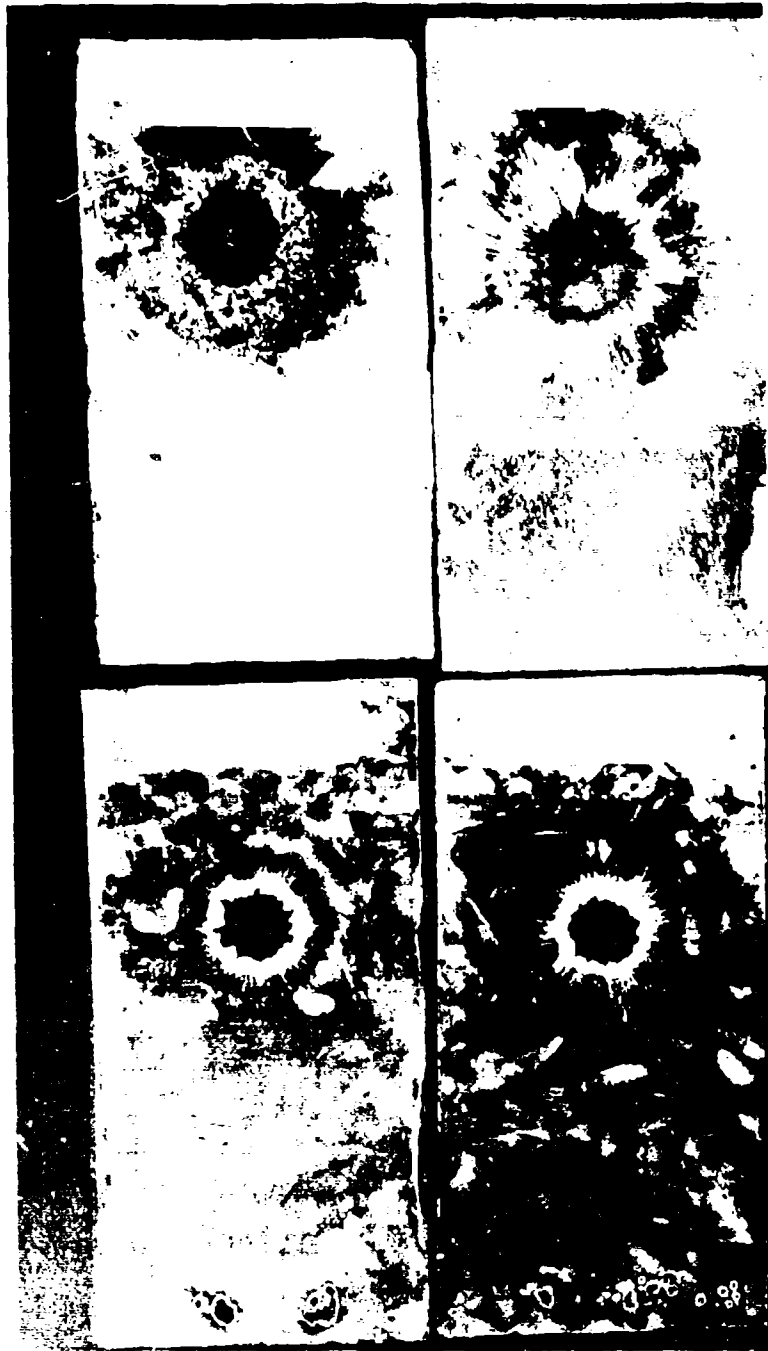
Two mil copper foils (Panel No. 099, 101) behave much like comparable thickness aluminum foils in the protection they offer to boron and graphite reinforced plastics (Figure 24). At 100 KA discharge levels, foil damage was restricted to the vaporization of a circle approximately one and a half inches in diameter and no damage to the substrate under the vaporized foil was observed. The rough edge of the circle has peeled away from the composite and displays heat discoloration. Burning and vaporization of the metal at the ground connection also occurred and

Figure 24. LIGHTNING DAMAGE TO ALUMINUM AND COPPER FOIL COATED COMPOSITES

resulted in a series of small holes in the foil; however, the epoxy matrix under these holes was not damaged. In comparison with aluminum foils, the additional conductivity of copper does not markedly improve its lightning protection characteristics, and the higher density of copper yields a weight penalty. This weight penalty exists for all conductive metals and their alloys, except aluminum.

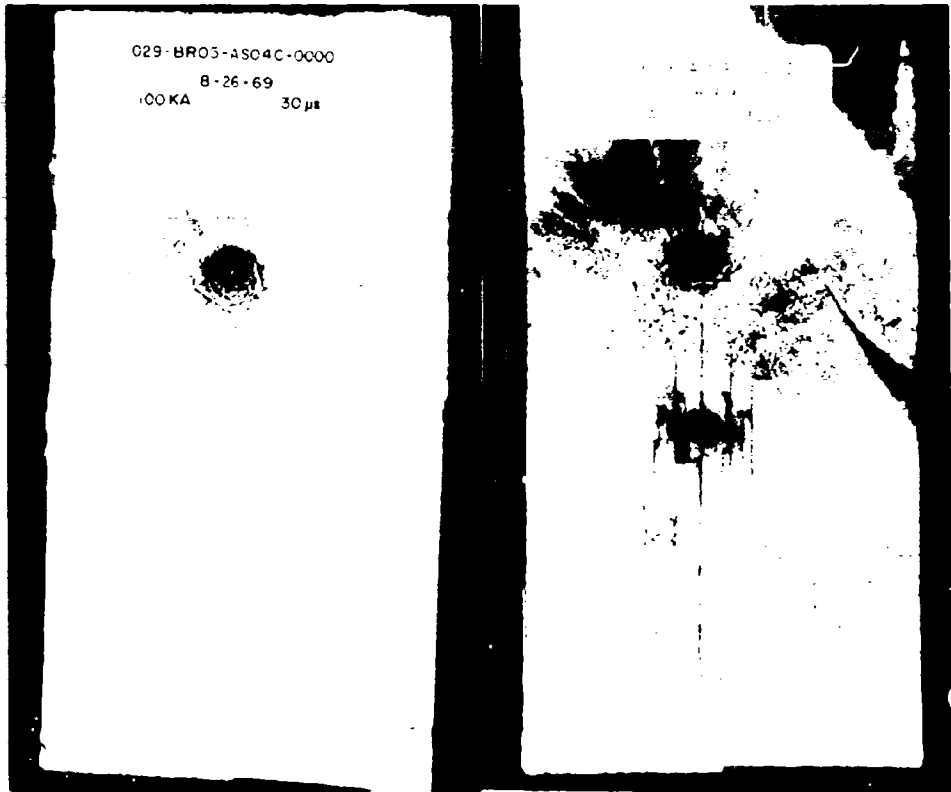
Surface coatings of flame sprayed aluminum were very effective in preventing damage to boron composite panels for 100 KA discharges (Panel 029, Figure 45). The 4 mil coating showed discoloration and some cracking in the immediate vicinity of the probe, but no other damage. A 160 kiloampere oscillatory discharge caused extensive damage to the coated panel (Panel 030, Figure 45).

Figure 45: DAMAGE TO FLAME-SPRAYED ALUMINUM COATED COMPOSITE LAMINATES

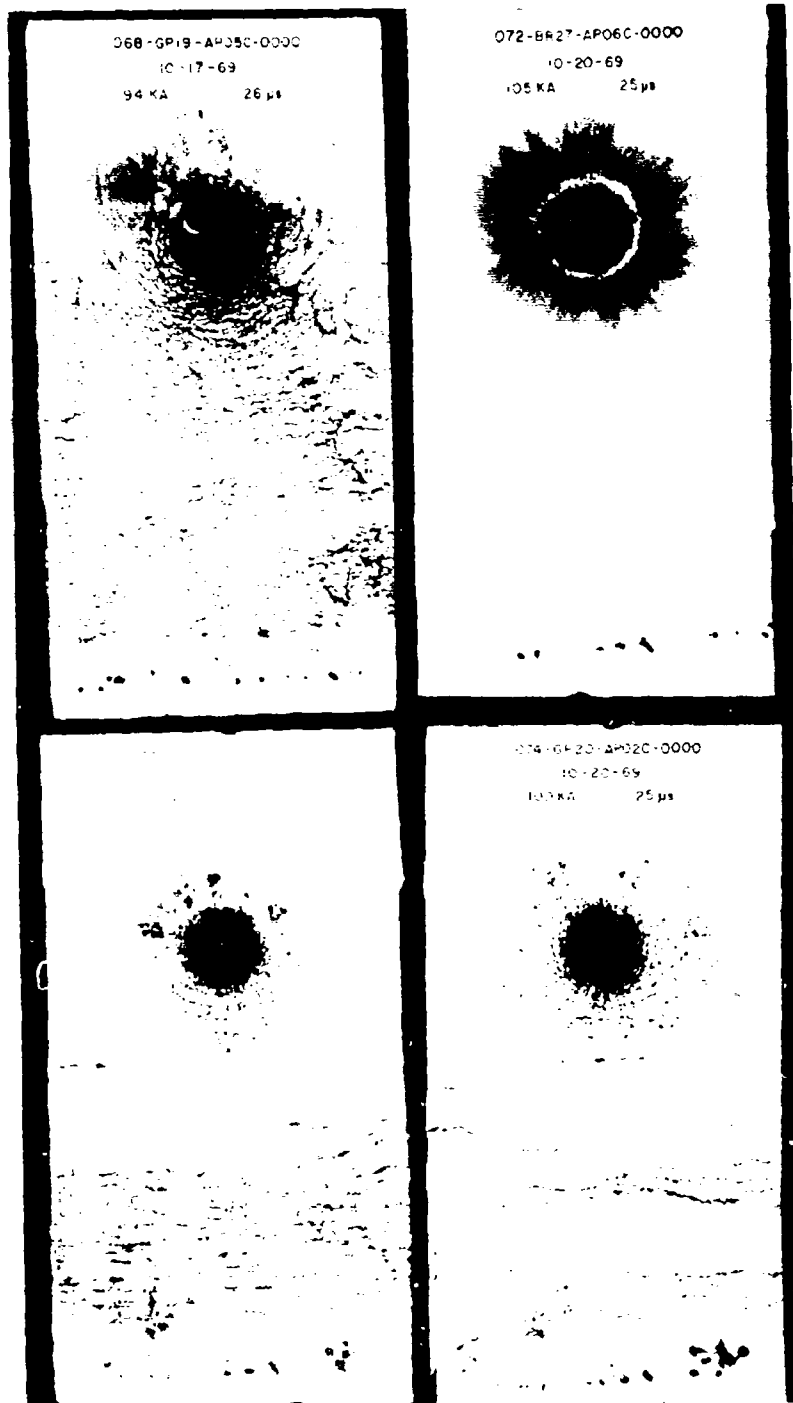
Plasma sprayed aluminum displayed quite a different protective behavior. Two and six mil plasma sprayed coatings on boron substrates (Panel 072, 073, Figure 46) were vaporized at the contact zone, much like the aluminum foil. In addition, the 2-mil coating was severely cracked. Plasma sprayed aluminum provides a less effective protection of graphite composites (Panel 068, 074, Figure 46). In this case, the panels with 2 and 5-mil coatings were severely cracked and evidence of current conduction by the fibers is present. The damage to Panel 068 is somewhat ambiguous as the outer plies of the graphite were burned during the plasma spray process. Consequently, this coating presented a worst case configuration to the discharge. The plasma spray coating on the panel was severely cracked along the two fiber axes and there was significant puncture damage on the back side of the substrate.

Figure 46: DAMAGE TO PLASMA-SPRAYED ALUMINUM COATED BORON EPOXY AND GRAPHITE EPOXY COMPOSITES

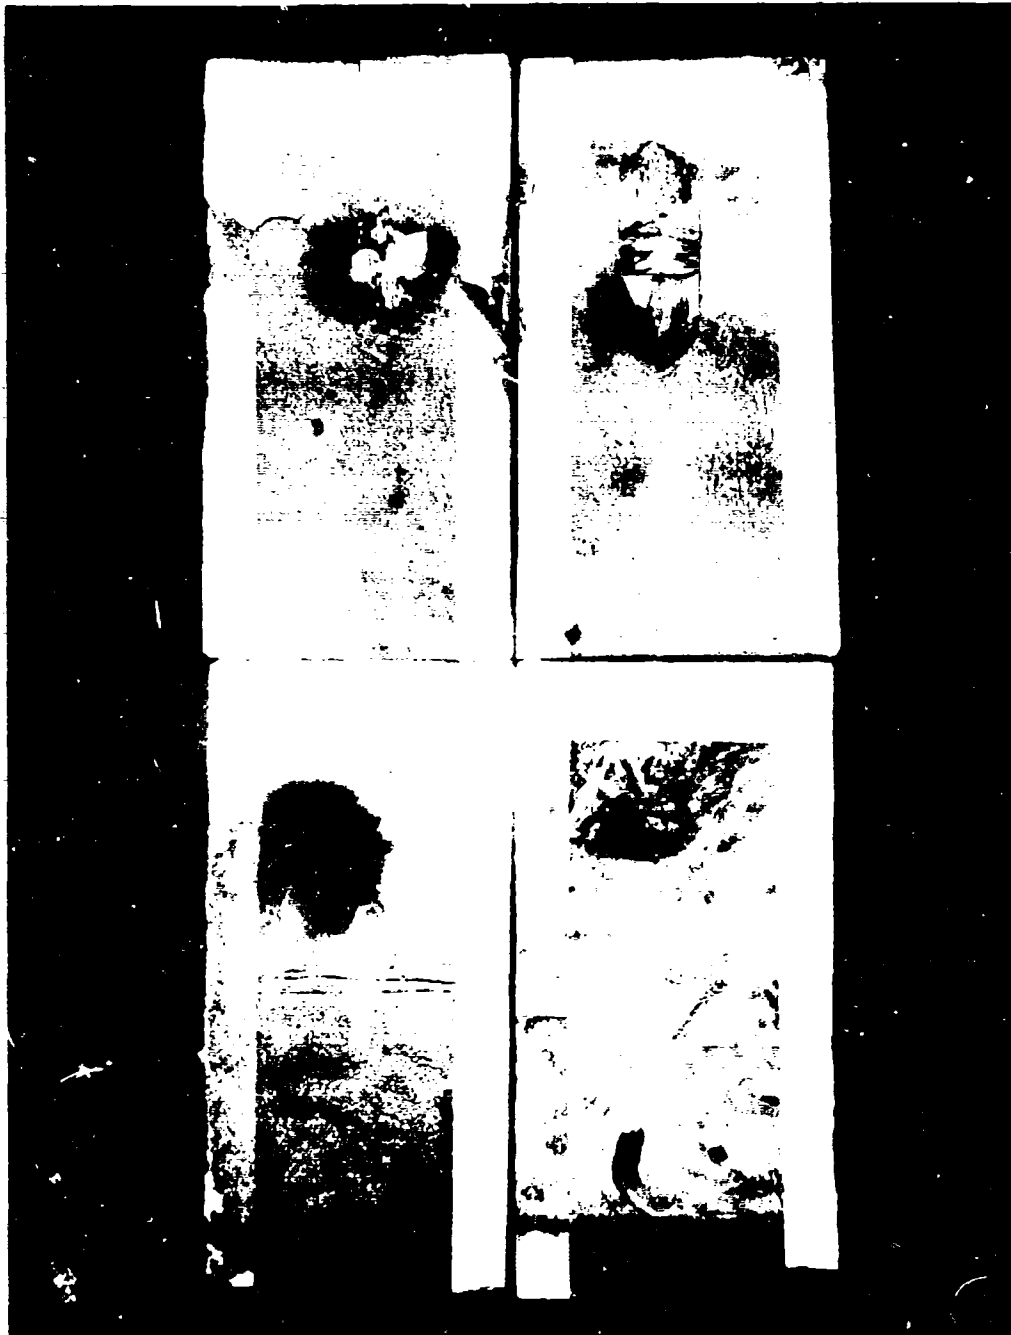
The potential of polyimide insulating layers with carbon black pigmented paints was also studied. One mil thick Kapton film was integrally bonded to the outer composite surface (Panel No. 156, 168). The carbon black pigmented coating was then applied over the Kapton. Discharge to this series of panels resulted in panel puncture and no reduction in structural damage. This same system was tested with expendable aluminum strips along the panel edges (Panel No. 157, 158). Again, the discharge punctured the panel and no evidence of surface flashover to the aluminum was apparent. These results are shown in Figure 57 and 58.

A successful coating combination was found when the Kapton film thickness was increased to 3-mils. This film was also integrally bonded to the composite surfaces and expendable aluminum strips were provided along the panel's 12-inch dimension side (Panel No. 181, 182). The test results in Figure 58 show the protective capability of the 1 and 3 mil thick Kapton insulative layers. As shown in the figure, surface flashover for 100 KA discharges is very apparent; the expendable strips are largely destroyed and the panel face is covered with a smoky deposit. The success of this coating is undoubtedly due to the additional insulating properties of Kapton film.

FIGURE 10 SIMULATED LIGHTNING DISCHARGE DAMAGE TO CONDUCTIVE BLACK KAPTON FILM COATED BORON EPOXY AND GRAPHITE EPOXY LAMINATES

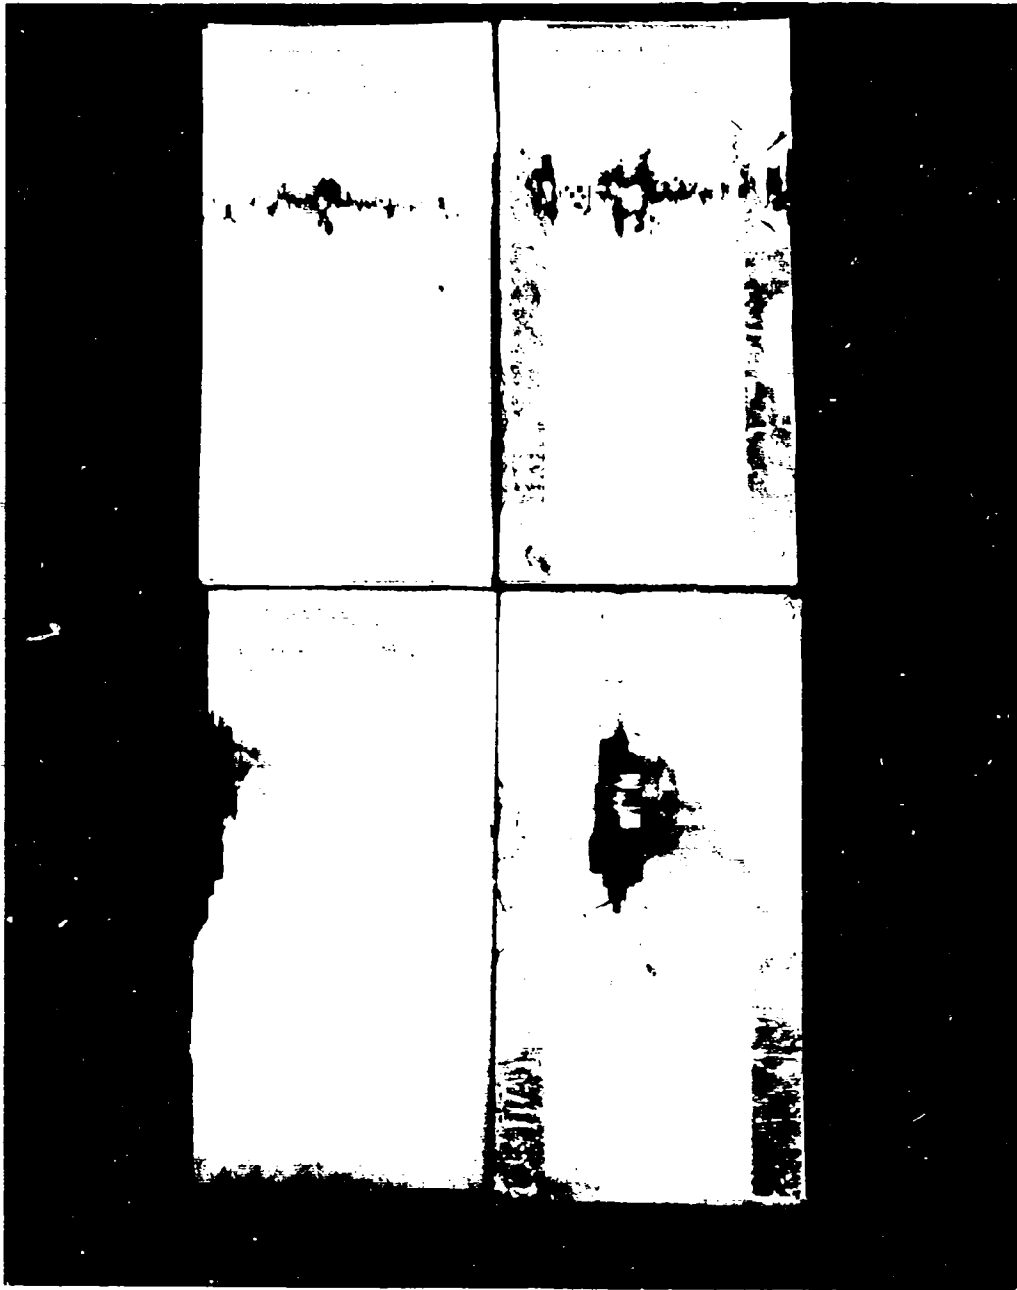
$Al_2F_6$  was added to a carbon black epoxy system and applied over the boron nitride dielectric undercoating. This system was not successful in reducing the damage sustained by the boron and graphite reinforced composites (Figure 59, Panel No. 142, 146 and 148).

FIGURE 1 SIMULATED LIGHTNING DISCHARGE DAMAGE TO LAMINATE  
PAINTED WITH INORGANIC PIGMENTED COATINGS

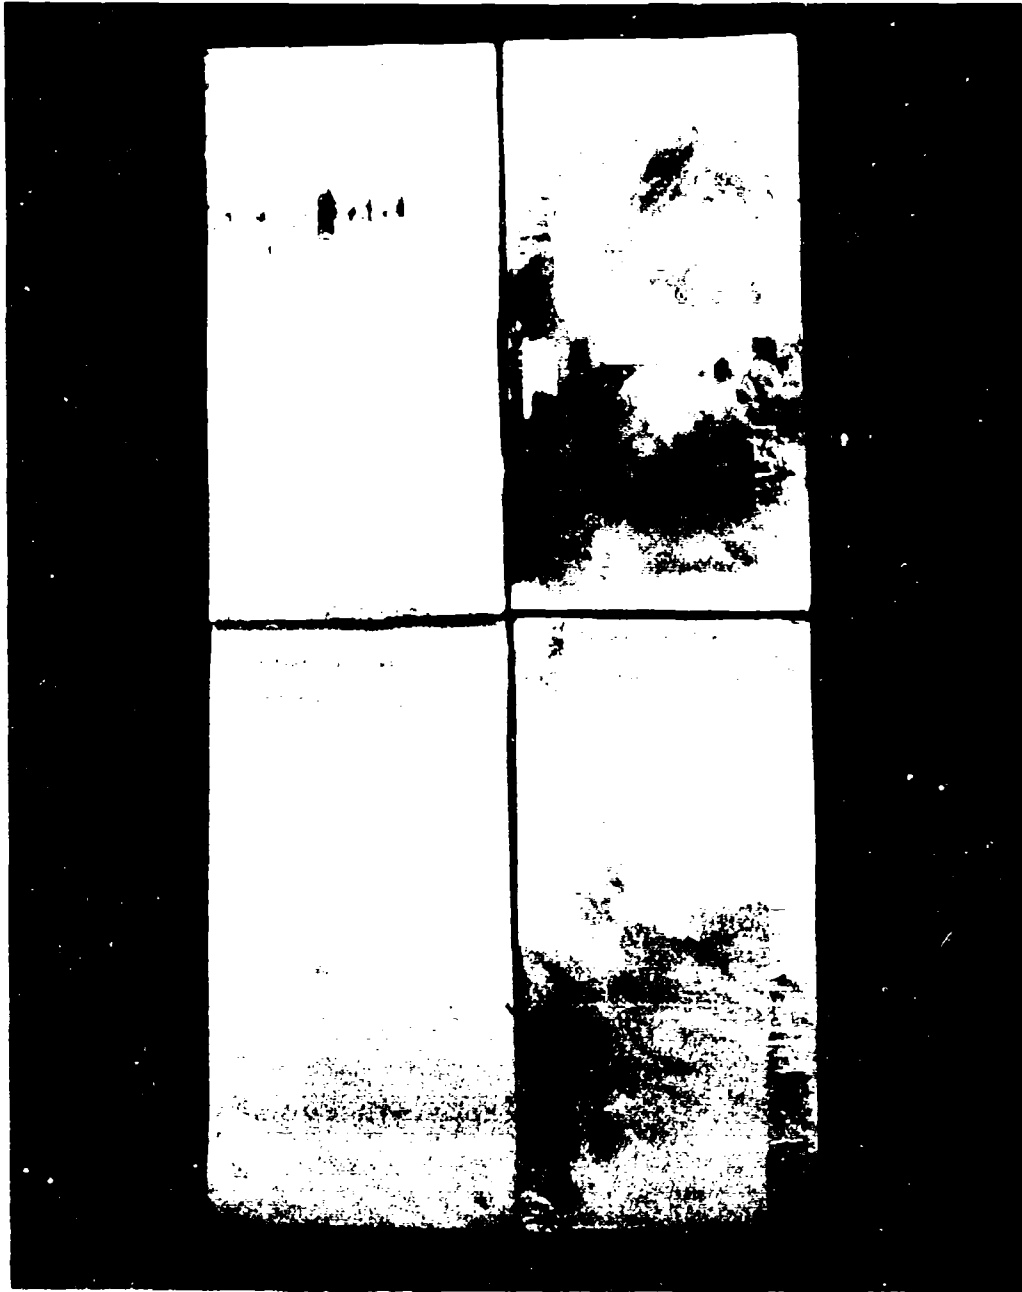
A 10 mil epoxy coating containing 40 percent pigment volume concentration (PVC) of this salt was applied to boron and graphite composite panels with and without expendable aluminum diverter strips (Panel No. 163, 166, 171 and 175). As shown in Figure 60, 50 KA and 110 KA discharge to the boron panel resulted in panel damage and puncture; however, 94 KA discharge to graphite panels (No. 171) led to surface flashover to the laminate edge with subsequent conduction by the outer fibers. This is a surprising result, since all previous tests have indicated boron to be the easier fiber to protect; consequently, these results prompted several additional coating formulations. Panels were prepared with expendable aluminum strips along the outer edges and a 1-mil Kapton film undercoating (Panel No. 167, 174). One hundred KA tests revealed this to be a satisfactory coating system (Figure 61). It was also found that coated panels with diverter strips but without Kapton film undercoating were severely damaged (Figure 61, Panel No. 166 and 175).

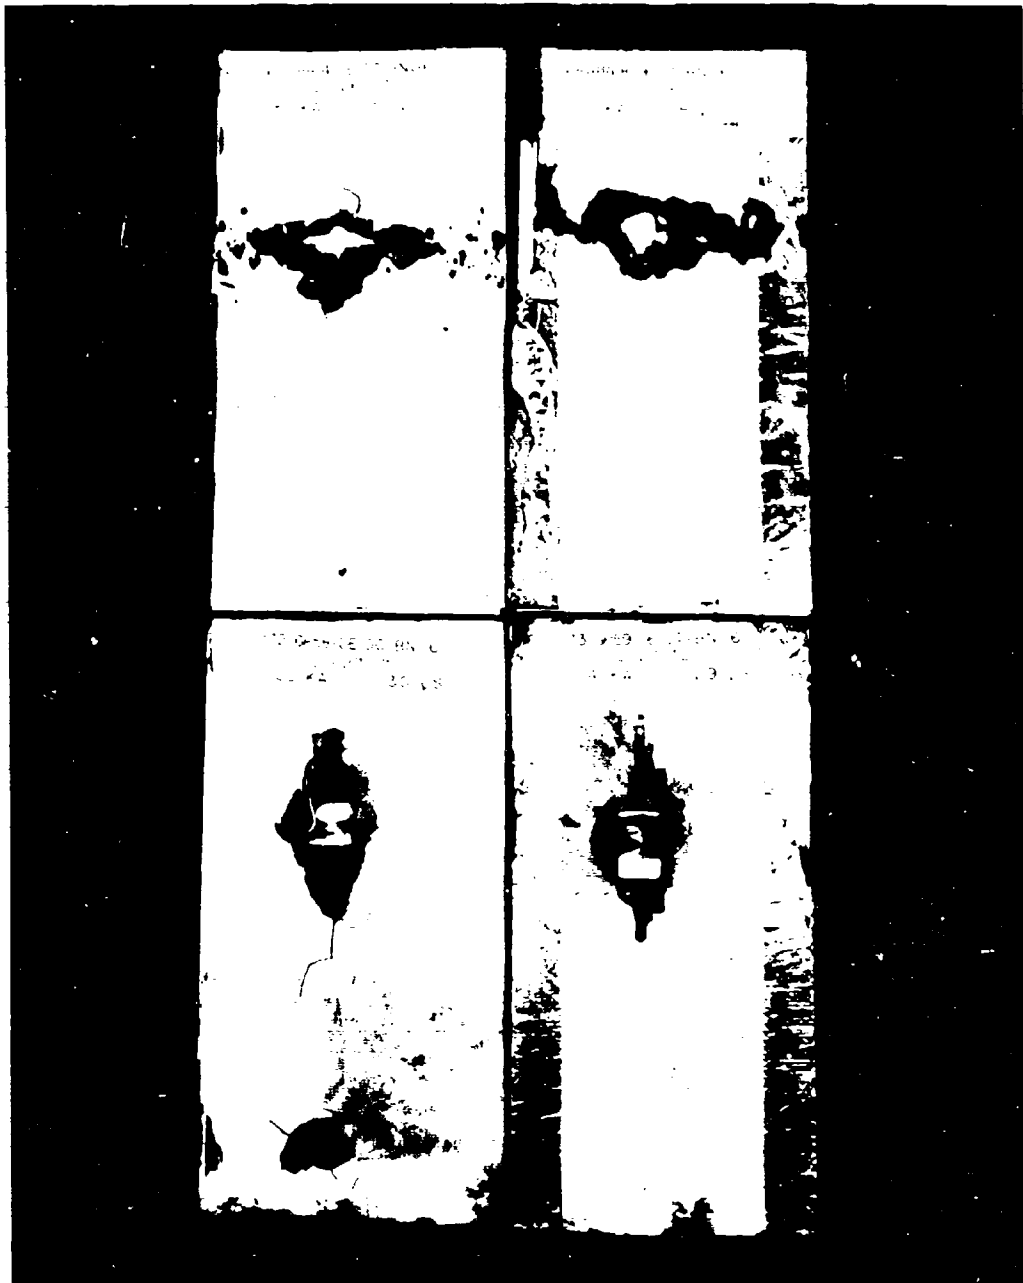
A 6-mil boron nitride (BN) filled epoxy paint as an insulative layer did not prevent severe panel damage with or without diverter strips (Figure 62, Panel No. 160, 165, 172 and 173). In addition, the insulative coating was resin poor and displayed poor adhesion; the coating was badly cracked and peeled from the panel following the discharge test. This attempt to substitute a 40 percent PVC boron nitride pigmented epoxy for the Kapton film was unsuccessful.

Figure 62 SIMULATED LIGHTNING DISCHARGE DAMAGE TO LAMINATES PAINTED WITH INORGANIC PIGMENTED EPOXY

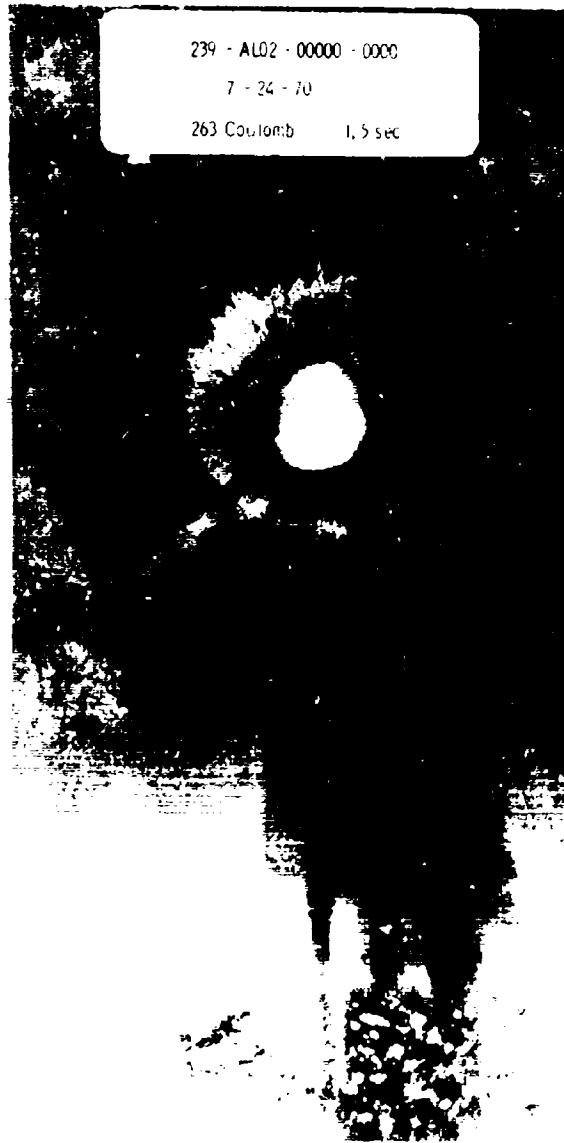
It is apparent from these tests that the coating does not provide complete protection against high coulomb transfer. The coating dissipates some of the charge but significant burn damage to the composites occurs. For comparison purposes, the degree of damage to aluminum sheet is illustrated in Figure 77. This 263-coulomb transfer test burned a 1 inch hole completely through a sheet of 0.040" aluminum. That the arc temperatures can destroy boron or graphite is illustrated in Figure 78. This electron scanning view of the boron at the arc contact shows re-solidified boron, aluminum and tungsten at the high temperature burn

Figure 77. 262 COULOMB TRANSFER DAMAGE TO AN 0.040 SHEET OF ALUMINUM.

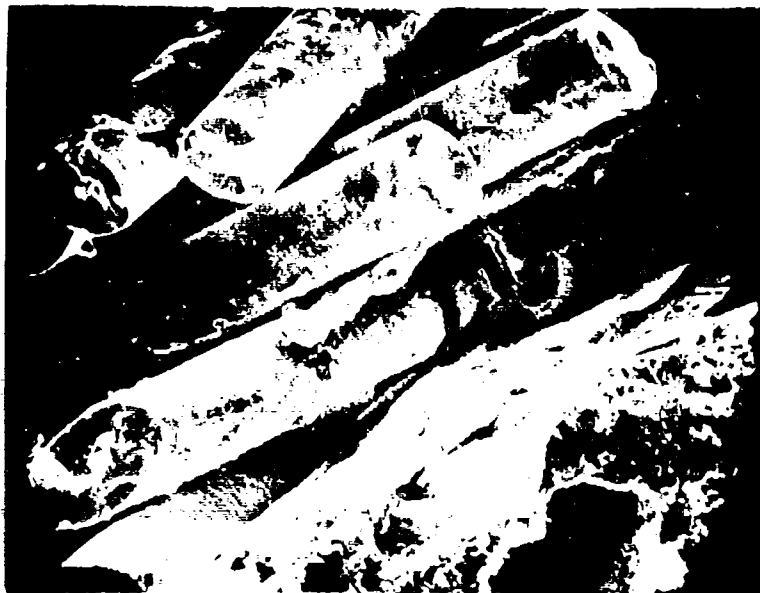
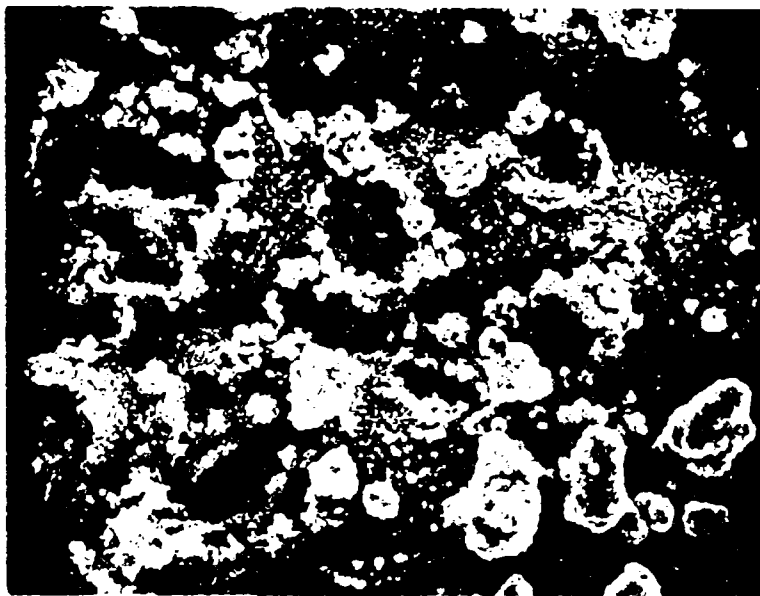
Figure 28 SEM VIEW OF DAMAGED BORON FILAMENTS

Figure 29 SEM VIEW OF DAMAGED BORON FILAMENTS

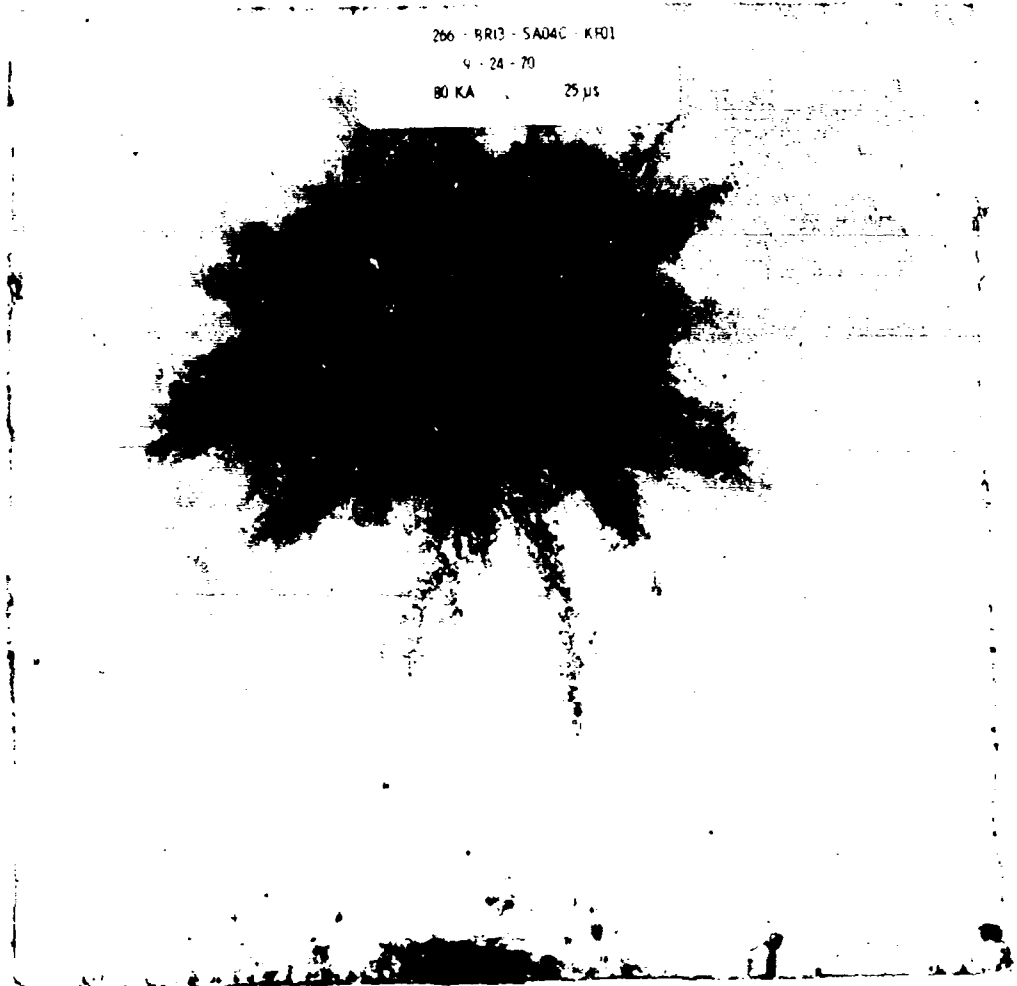
The coating did not protect the boron composite from an 80 KA discharge. A 1 by 5-inch piece of the outer ply was destroyed and some resin scorching in the remaining plies was observed (Figure 81). The lesser degree of discoloration of the surface indicates the fibers carried a large amount of the discharge. In addition, the coating was burned at the ground attachment. This is due to arcing from the fibers to the ground attachment. At the 120 KA discharge level, the panel was punctured and a sizable area of boron was delaminated. Blistering at the ground attachment was also observed (Figure 82).

Fig. 81 80 KA DISCHARGE DAMAGE TO SILVER COATED BORON EPOXY LAMINATE

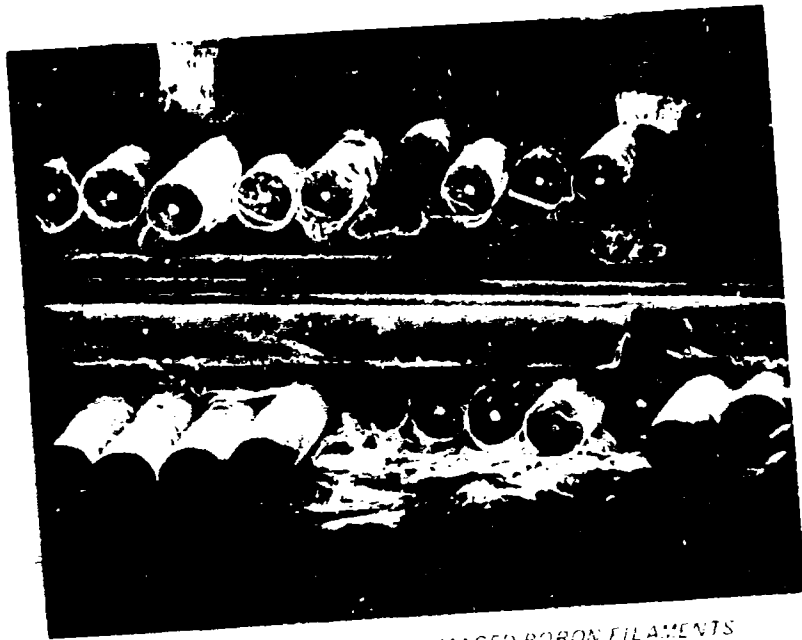
An interesting sidelight to these tests was revealed by an electron scanning microscope investigation of damage to boron filaments. A portion of the damage area is shown in Figure 87. Clearly visible is the filamentary nature and bidirectional character of the composite. The area shown is nearly free of resin as this was burned away by the electric current. The actual fracture of the filaments probably occurred as a result of rapid expansion of pyrolysis gases during the test.

Figure 87 SEM VIEW OF DAMAGED BORON FILAMENTS

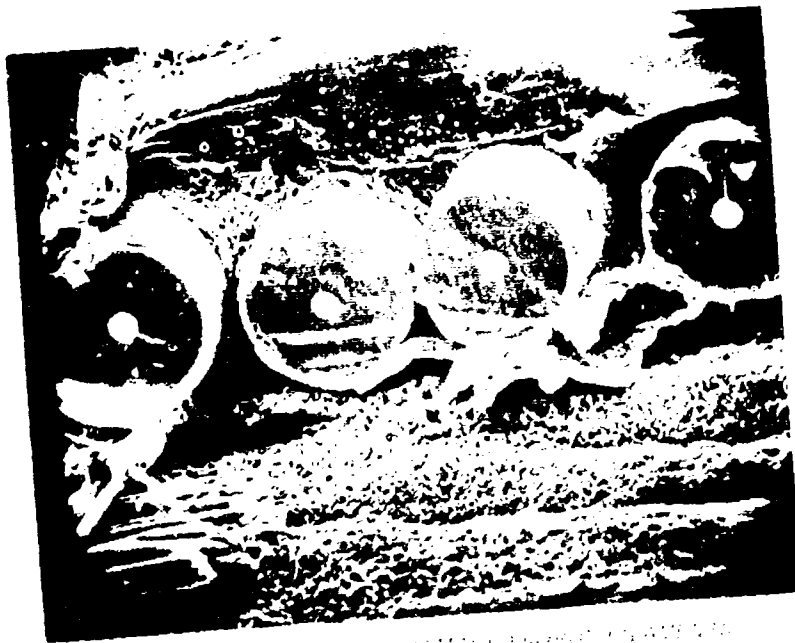
A closer view of the composite is shown in Figure 88. The lower right hand side of this picture is a view of residual resin. The upper portion is of the scrim backing material which supports the prepregged filaments. The boron filaments clearly illustrate the boron sheath which surrounds the tungsten containing core. Three additional features are prominent in this view. The core of all of the filaments displays evidence of melting and resolidification. This is particularly obvious when compared with other views such as that in Figure 15b. While the filaments of Figure 15b are fractured, the core material is homogeneous. The core material of Figure 88 is not homogeneous, but shows distinct grain boundaries. These are more clearly illustrated in Figure 89. In this view of the core, the black area represents the boron sheath while the lighter area is the 0.0005-inch diameter core. Clearly visible are the grain boundaries in the core section. Additionally, both the lack of a grain structure at the edge of the core and the darker shading of this section indicate this material is different in its chemical nature to be boron rich, which accounts for its different behavior (7). The thickness of the boron rich portion of the core was determined from this photograph to be nearly 0.0005 inches (1.2 microns). This is in good agreement with electron microprobe X-ray analysis which reported a boron rich region 2 to 3 microns thick (7).

Another prominent feature of Figure 88 is the interior crack displayed by the filament on the left side. This flaw is not visible from the outside of the filament. Finally, all of the filaments display a series of holes which are generally near their outer boundaries although some of the filaments have holes nearer their centers. These are more prominently displayed in Figure 90. This shows the holes to be deep and of non-uniform cross-section. Additionally, an unidentified sheath exists about the filaments. This too is very porous.

These filament flaws undoubtedly lead to poor structural performance and the loss of strength and modulus of the filaments. It appears probable that these flaws are inherent in the material and are not due to lightning currents. This is because the void areas do not display an indication of the cracking which would accompany melting or vaporization due to joule heating.

Figure 88 SEM VIEW OF DAMAGED BORON FILAMENTS

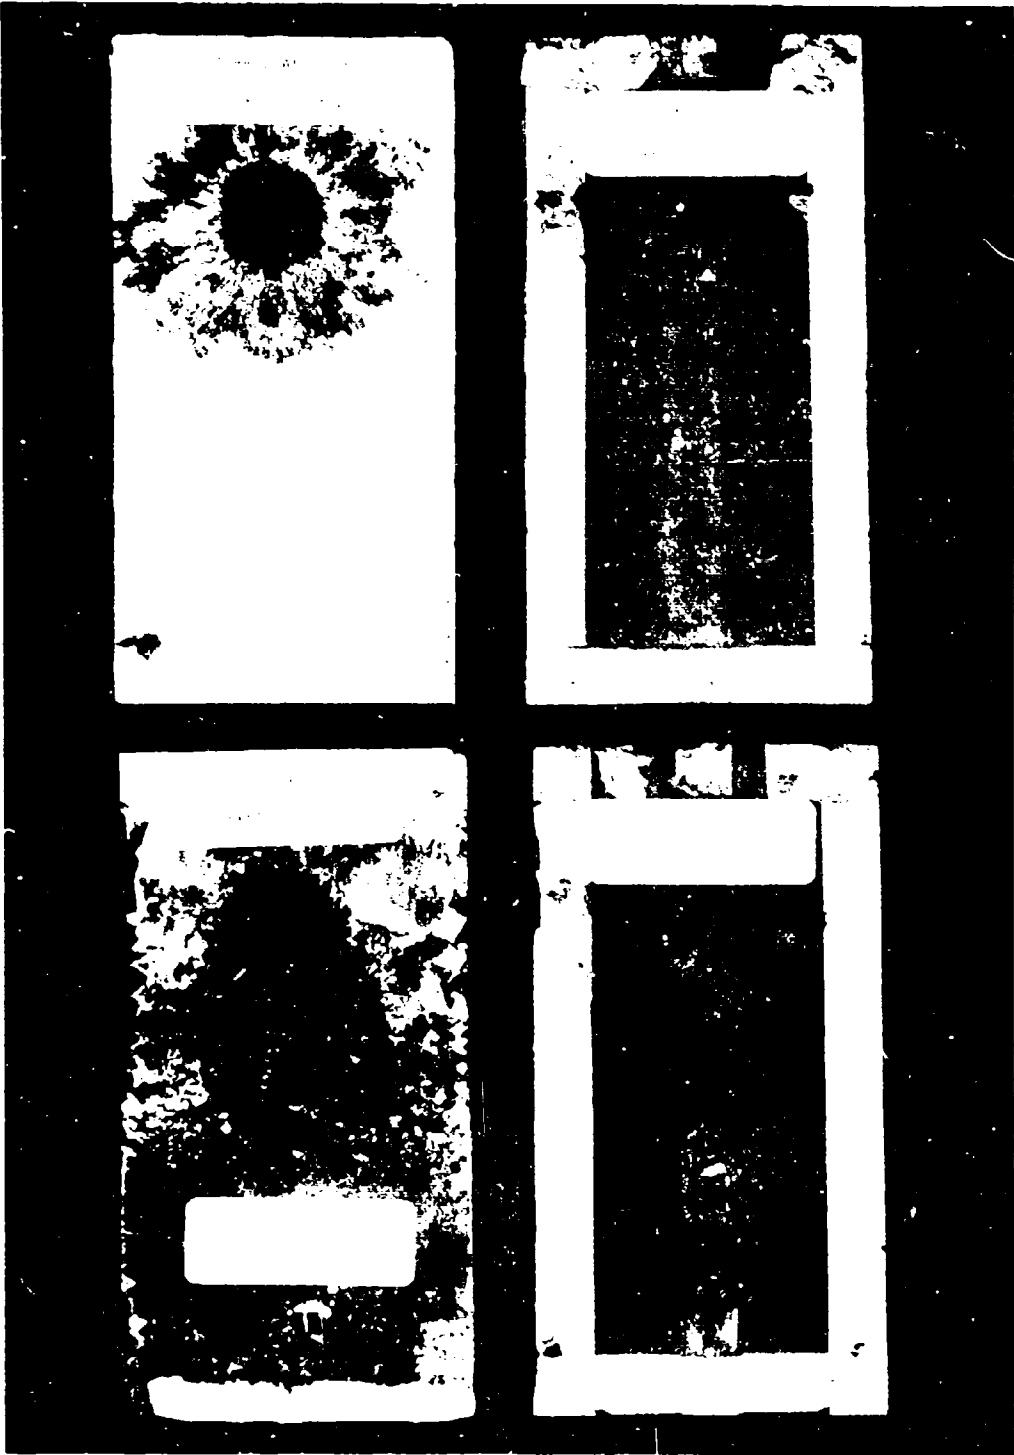
019-GP01-AF01C-0000

No visible damage to the substrate was observed. However, the center tape was completely vaporized, the top tape (the tape on the end other than the grounded side) was severely burned and there was also very bad bubbling and pitting between the overlapped area of the tapes.

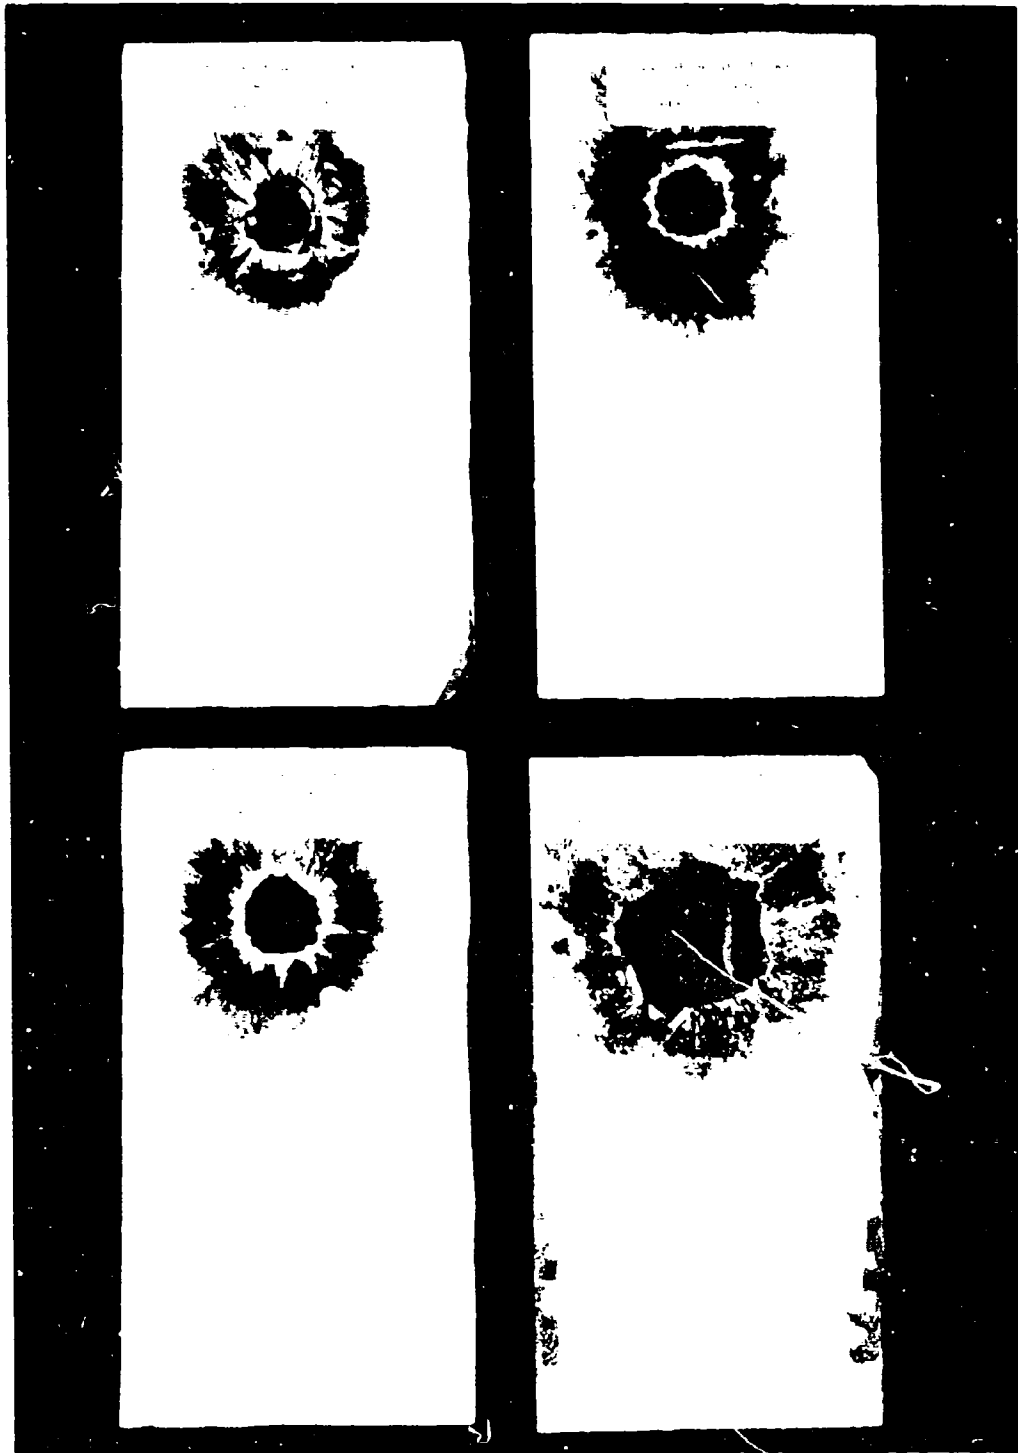
024-GP06-AF01C-KF01

No visible damage to the substrate was observed.
