**COATINGS FOR LIGHTING PROTECTION OF  
STRUCTURAL REINFORCED PLASTICS**

**TECHNICAL REPORT AFML-TR-70-303 Pt. I**

March 1971

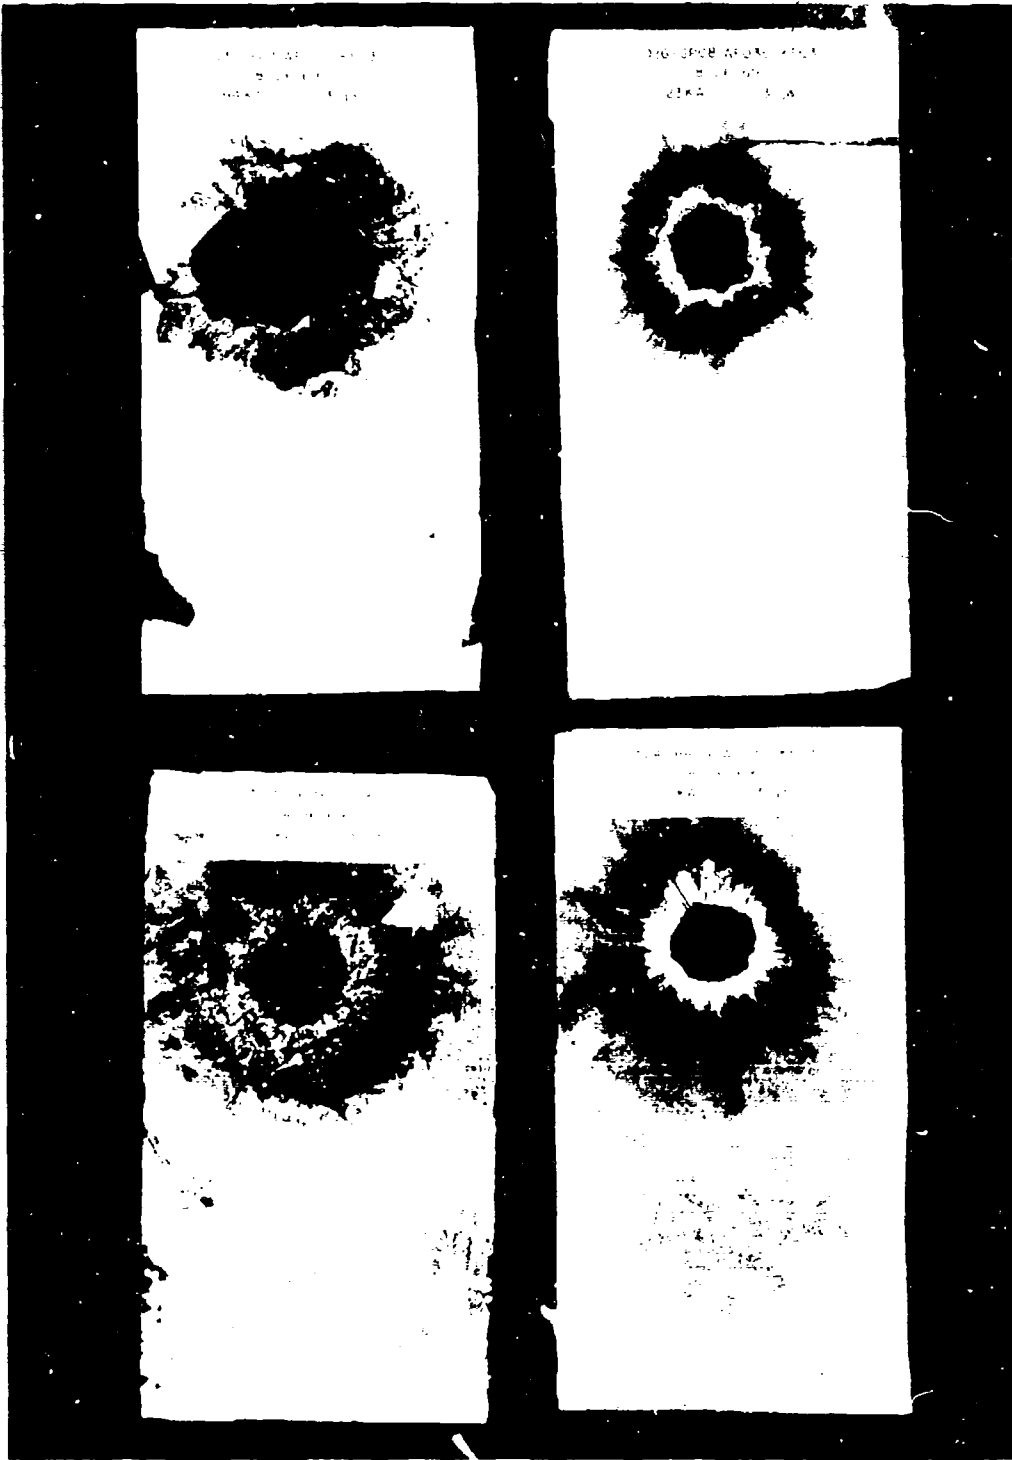
029-BR05-AS04C-0000      Figure A-8

No visible damage to the substrate was observed.

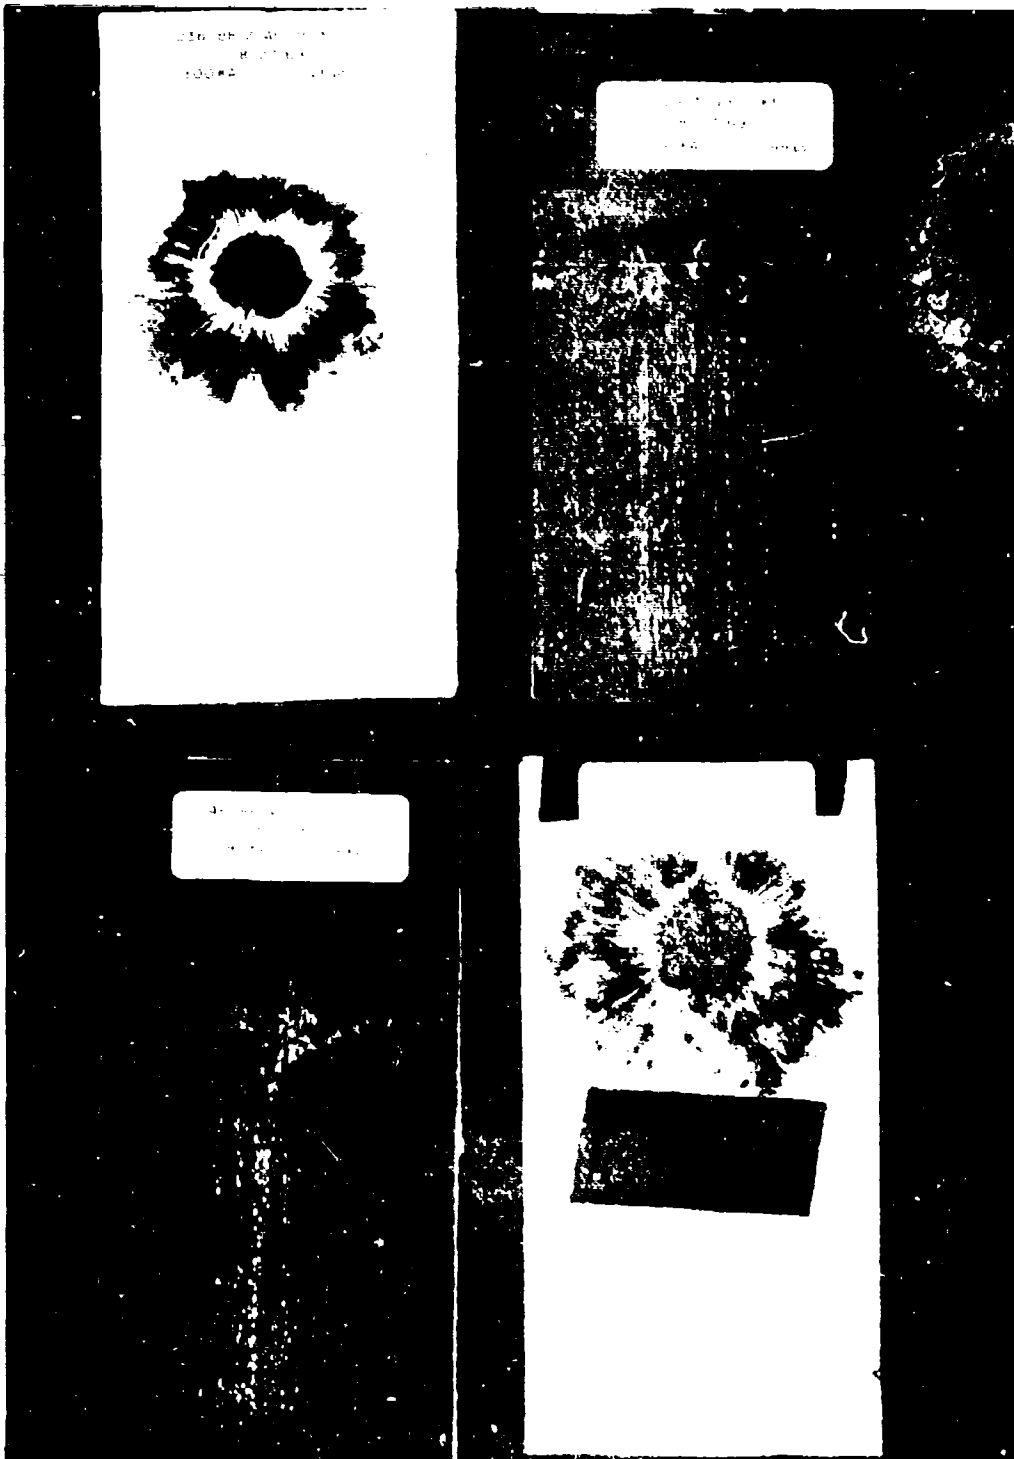
A 1-mil aluminum foil was integrally bonded to this boron panel on the scrim cloth side of the tape, and no undercoating was applied. An 18 KV discharge was directed to the coated panel; the discharge current had an amplitude of 95 KA with a risetime of 15  $\mu$ s and a duration of 28  $\mu$ s.

A crack was observed on the back side of the substrate.

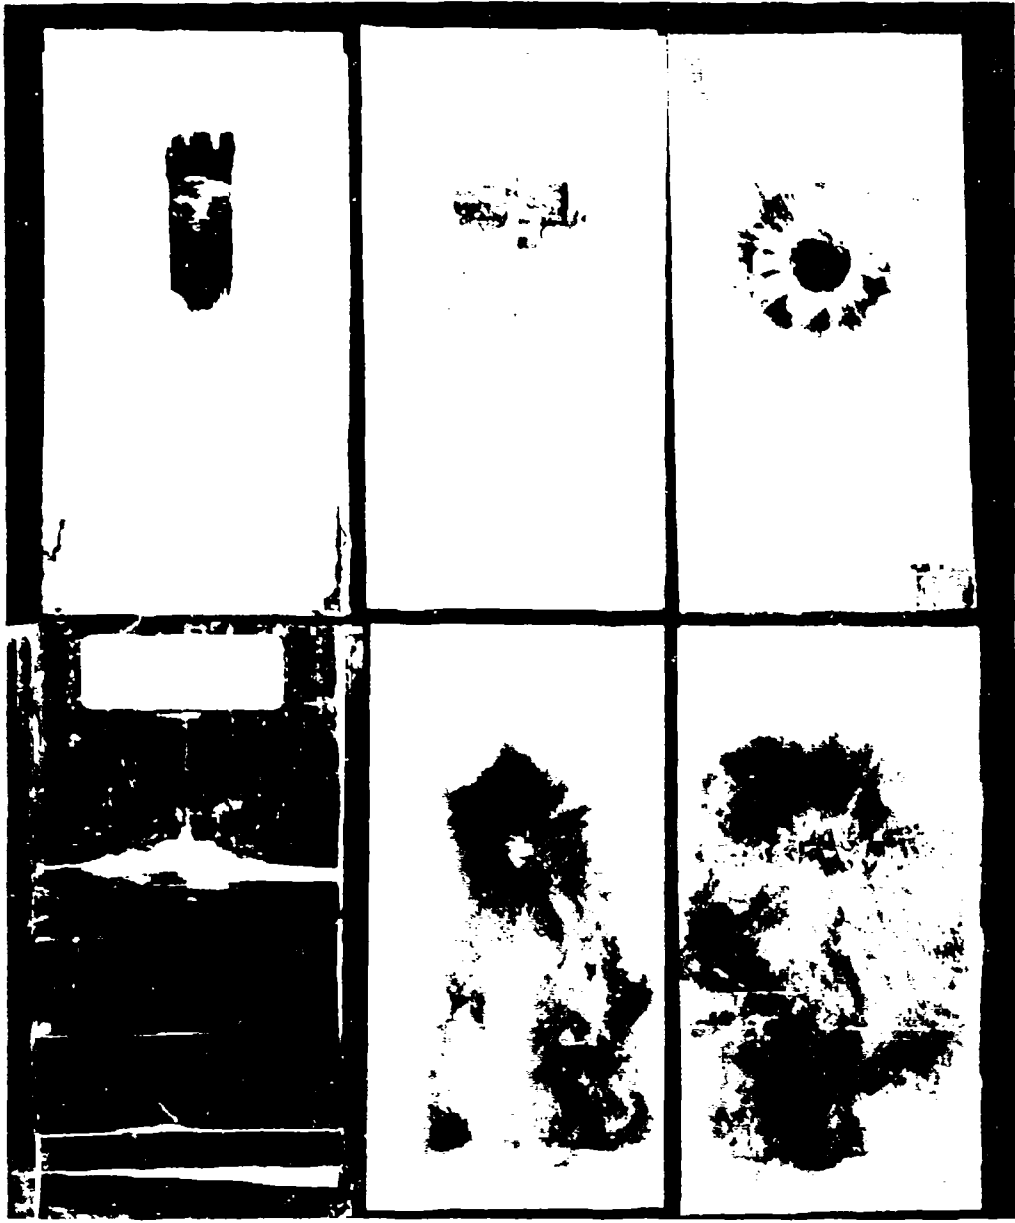
Figure A-24

A 7-mil silicone paint filled with copper powder was applied to the panel by spraying; no undercoating was applied.

The crowbar switch was disconnected from the simulator. A 20 KV discharge was directed to this coated panel; the discharge current had a peak of 114 KA with a ring frequency of 24 kHz.

No damage to the control panel was observed; however, the coating was discolored and partially burned. Surface flashover was also produced.
