TECHNICAL REPORT 4321

IN - BORE PREMATURE  
MALFUNCTION INVESTIGATIONS  
OF THE  
81 MM HIGH EXPLOSIVE MORTAR CARTRIDGES  
WITH THE  
M526, M524A5 AND XM176  
POINT DETONATING FUZES

FEBRUARY 1972

PICATINNY ARSENAL  
DOVER, NEW JERSEY

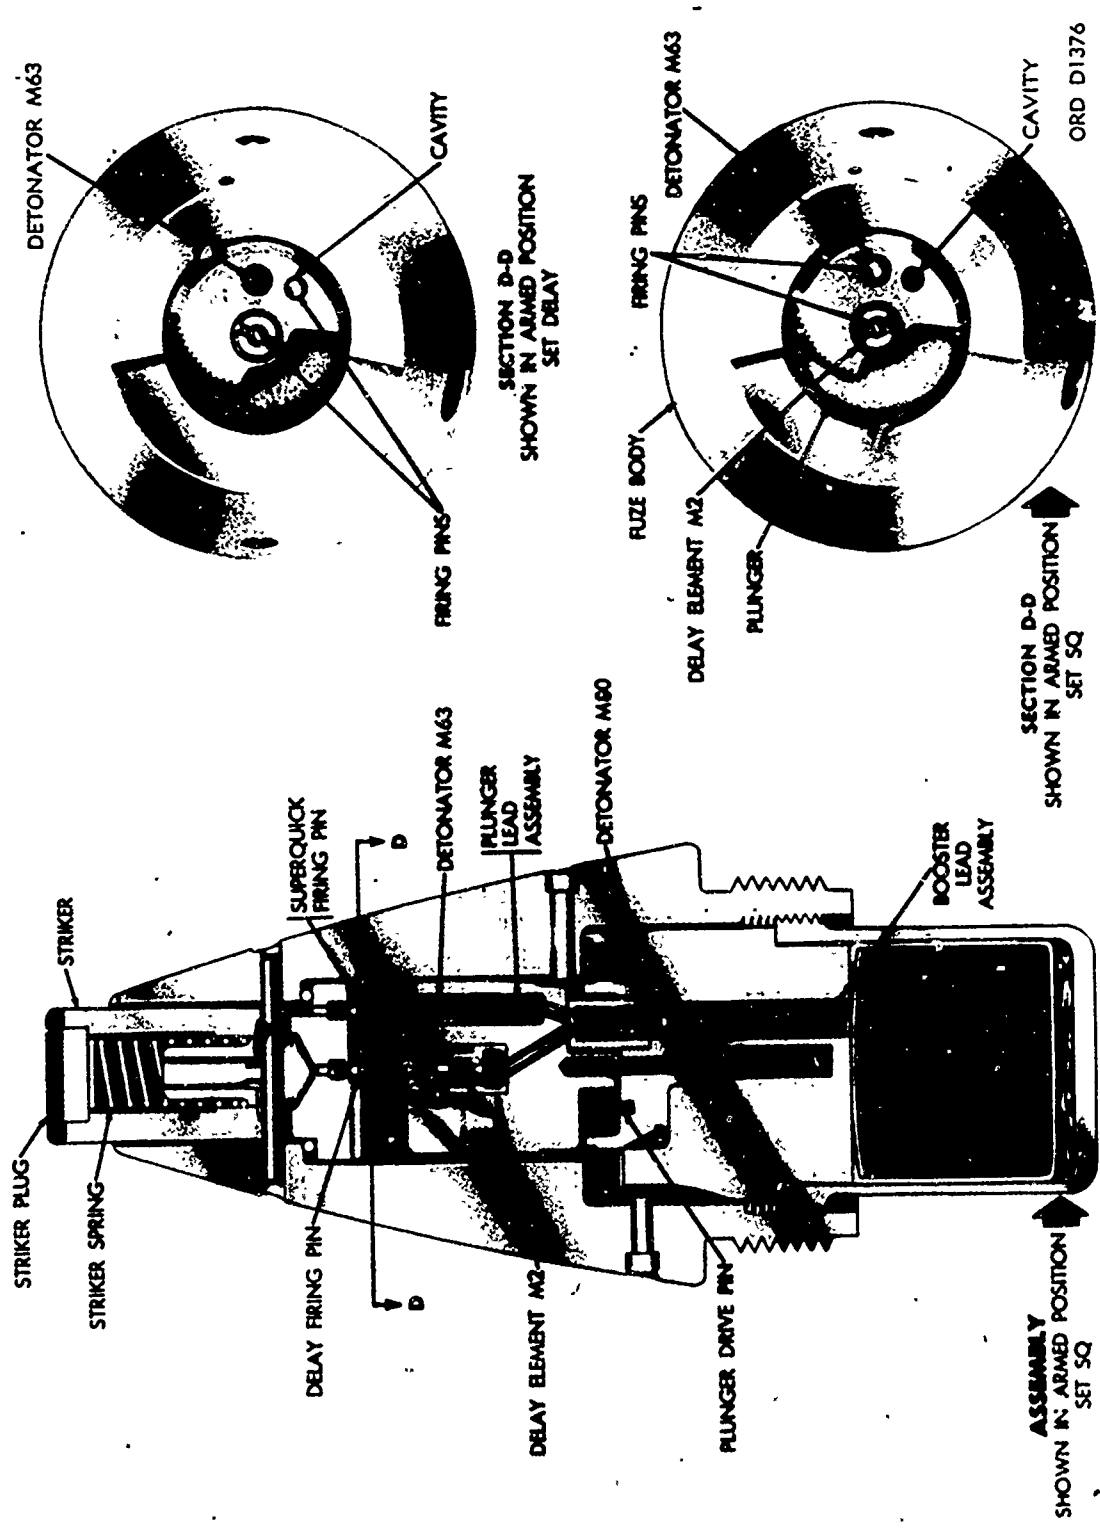
Figure 3. Fuze, PD, M524A5 in armed position

Five of the 17 incidents of in-bore prematures covered by these investigations were proven, or evidence indicated, to be caused by double loading (misfired round not removed, next round dropped into tube). Fuzes with a protruding rivet head on the striker will probably cause a low order, in-bore premature at a rate of 1:1 if the ammunition is double loaded. Fuzes with a flush rivet head, or no rivet on the striker (such as the M524A5 Fuze), probably will not result in an in-bore premature.
