UH-1N

# CATEGORY II AIRFRAME AND SUBSYSTEMS EVALUATION

TECHNICAL REPORT No. 71-37

AIR FORCE FLIGHT TEST CENTER  
EDWARDS AIR FORCE BASE, CALIFORNIA  
AIR FORCE SYSTEMS COMMAND  
UNITED STATES AIR FORCE

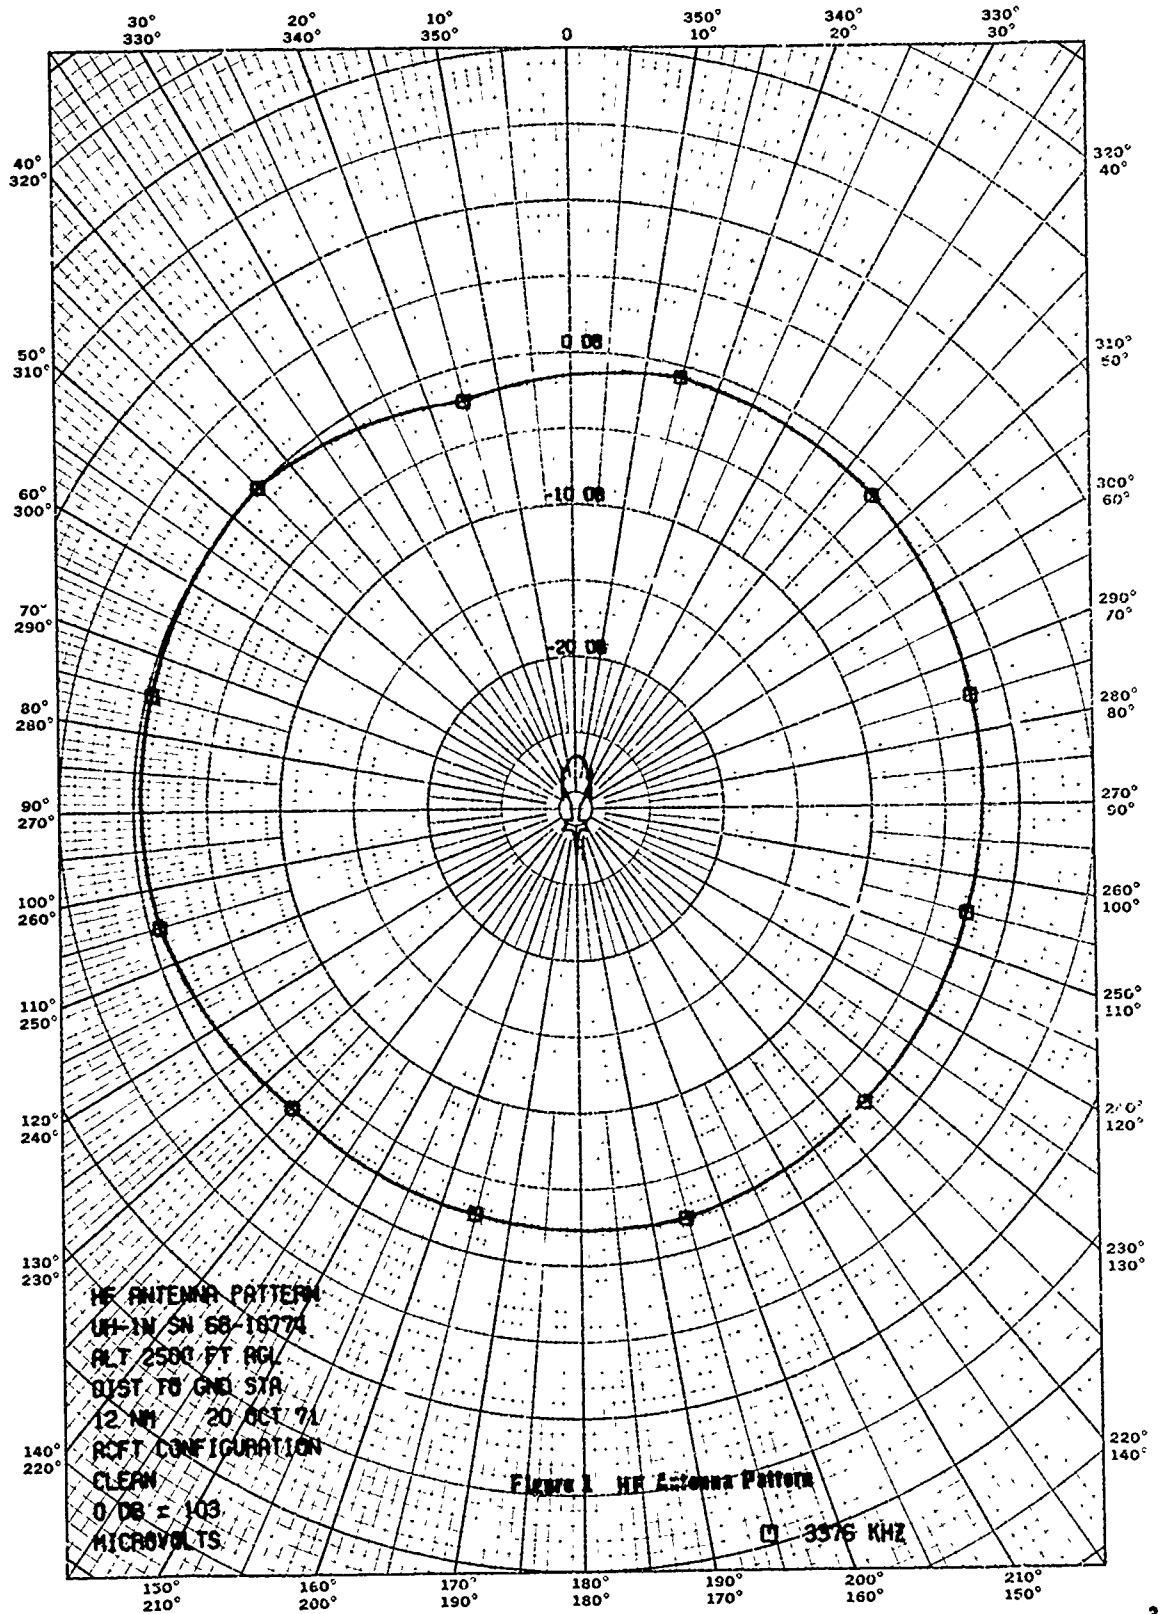
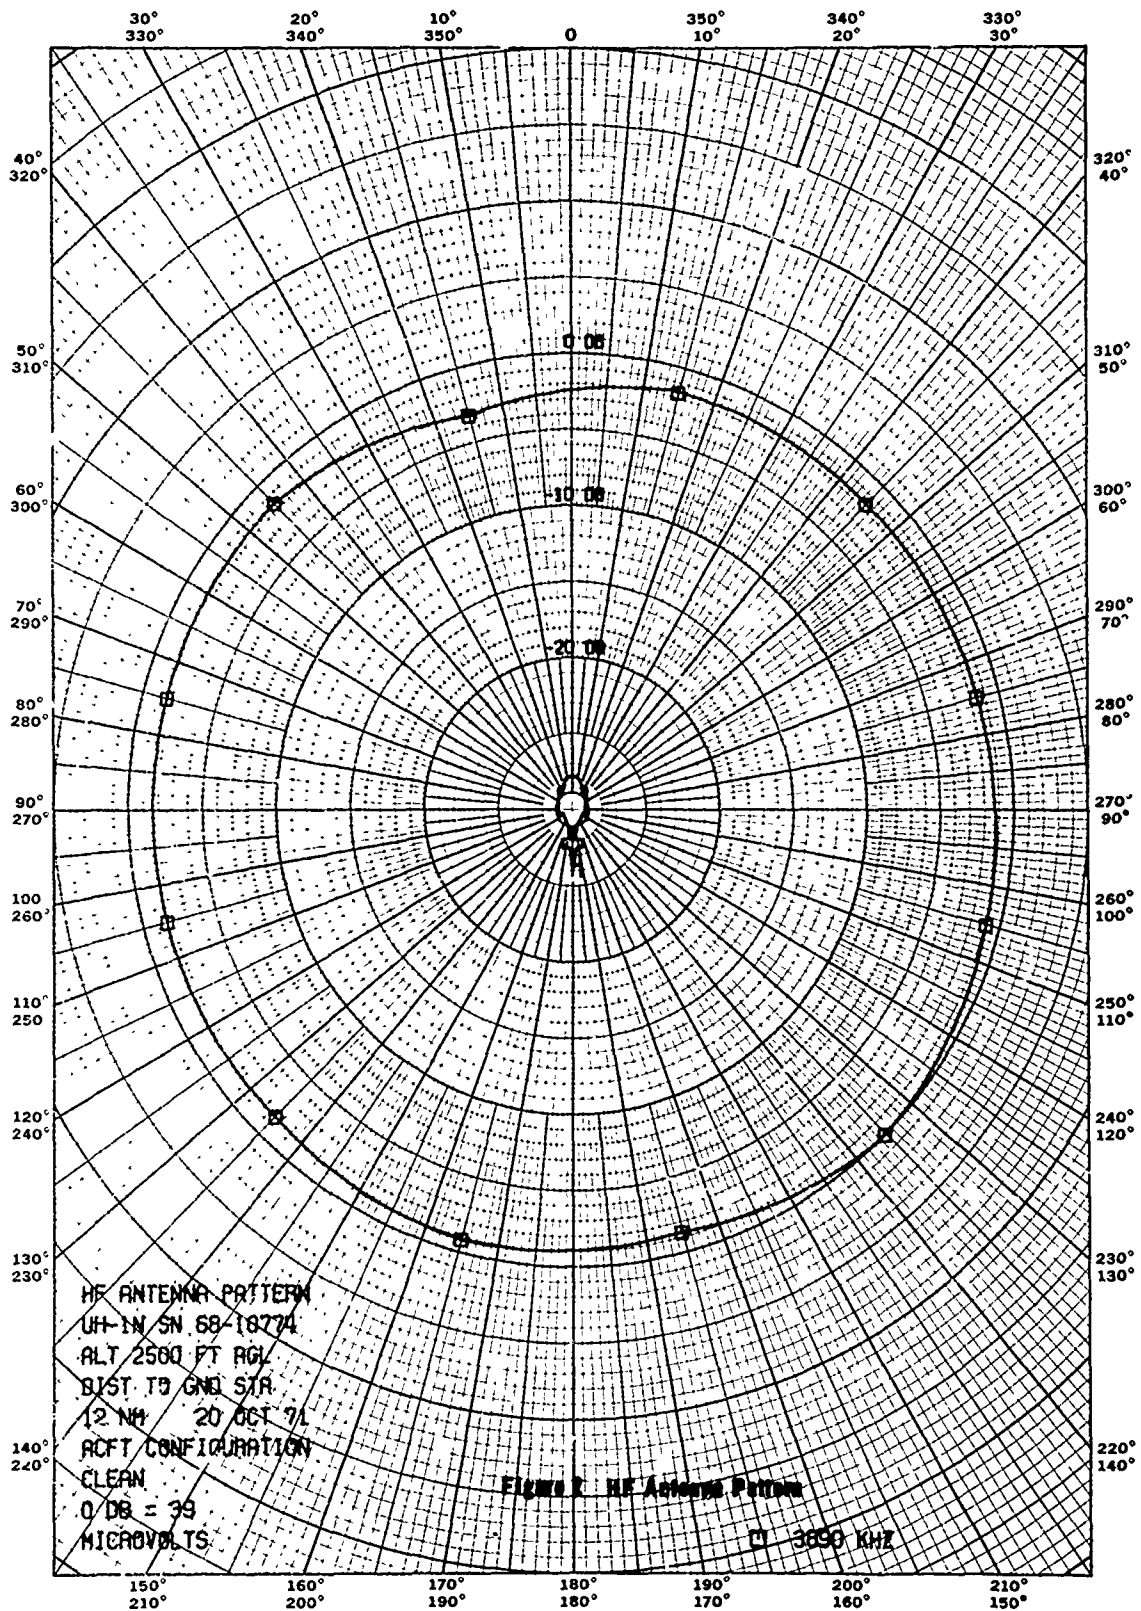
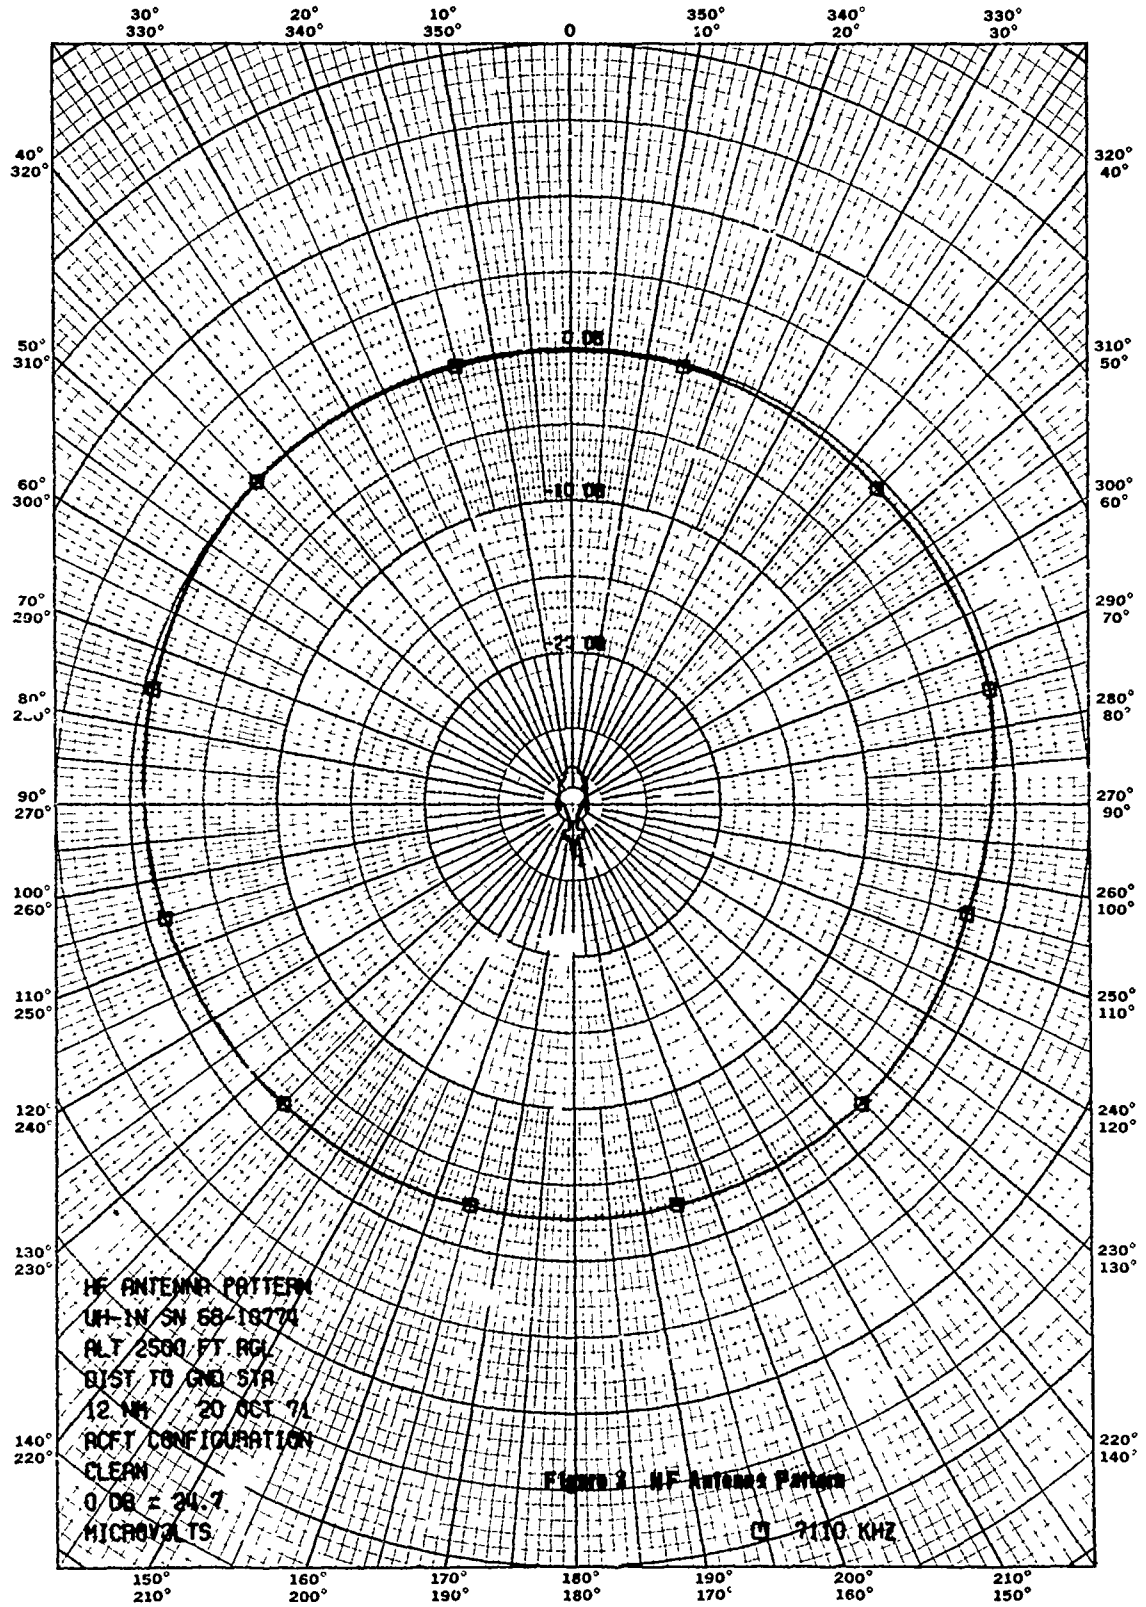
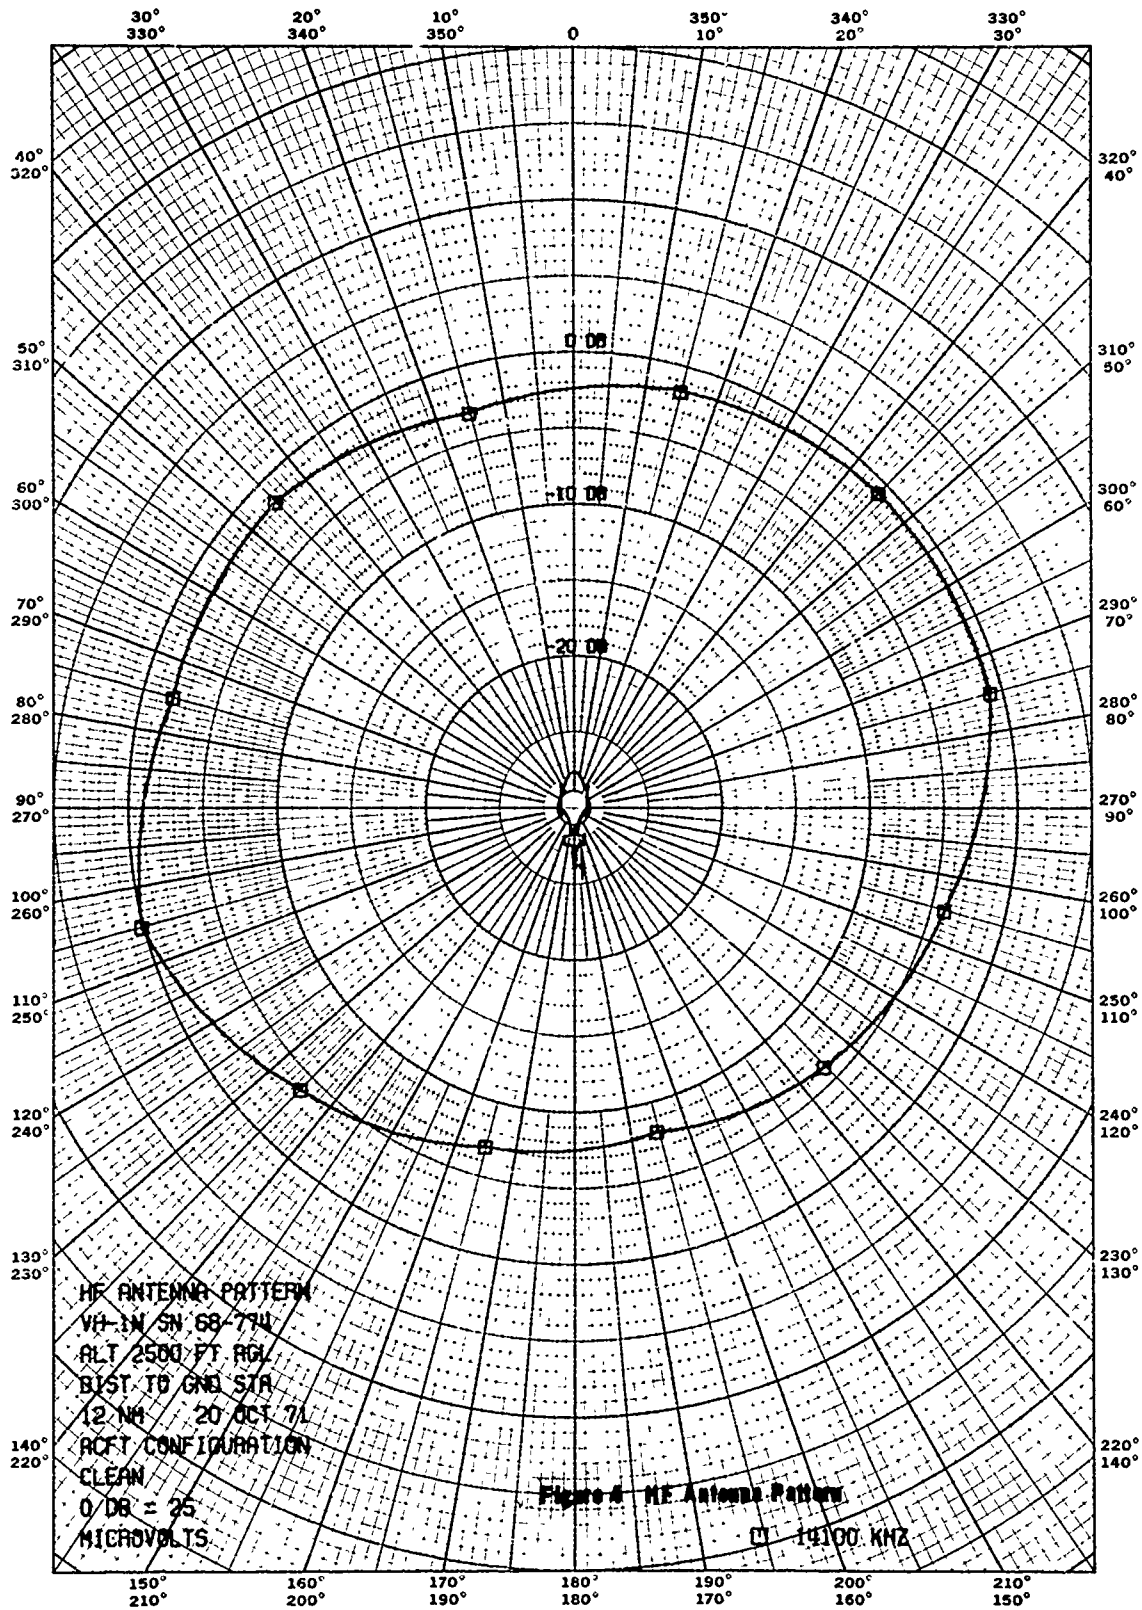
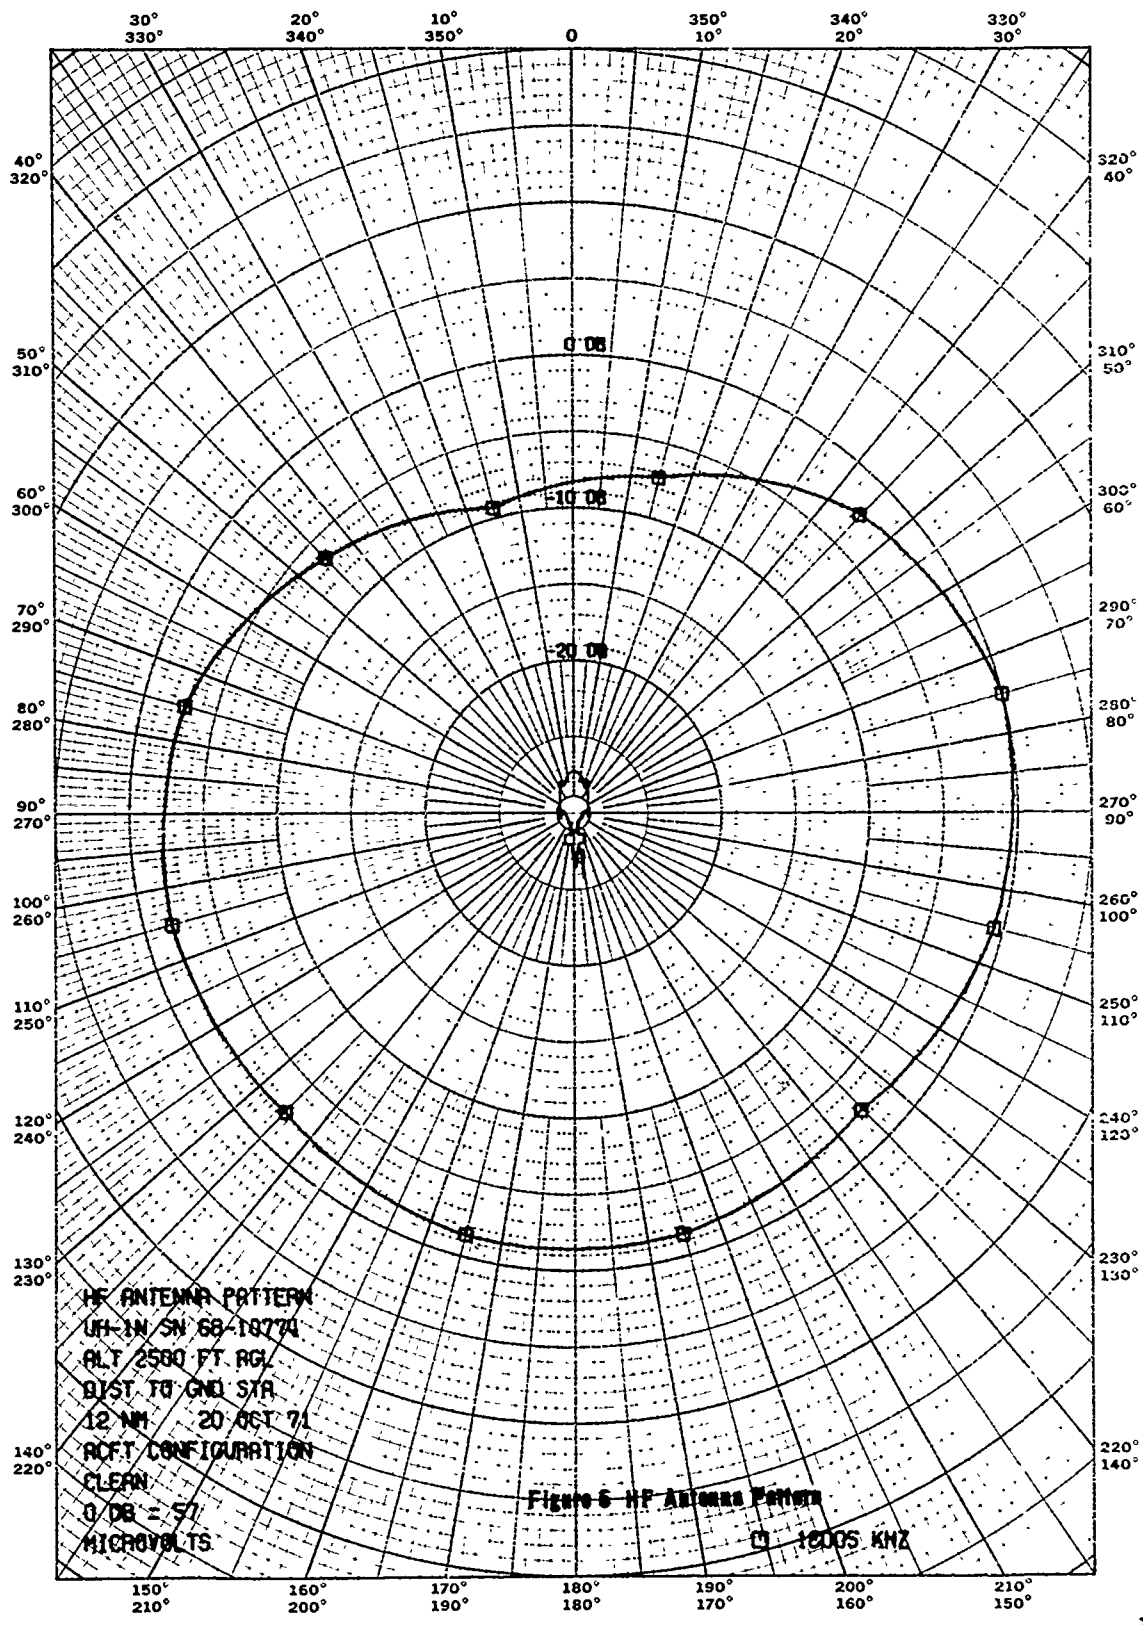
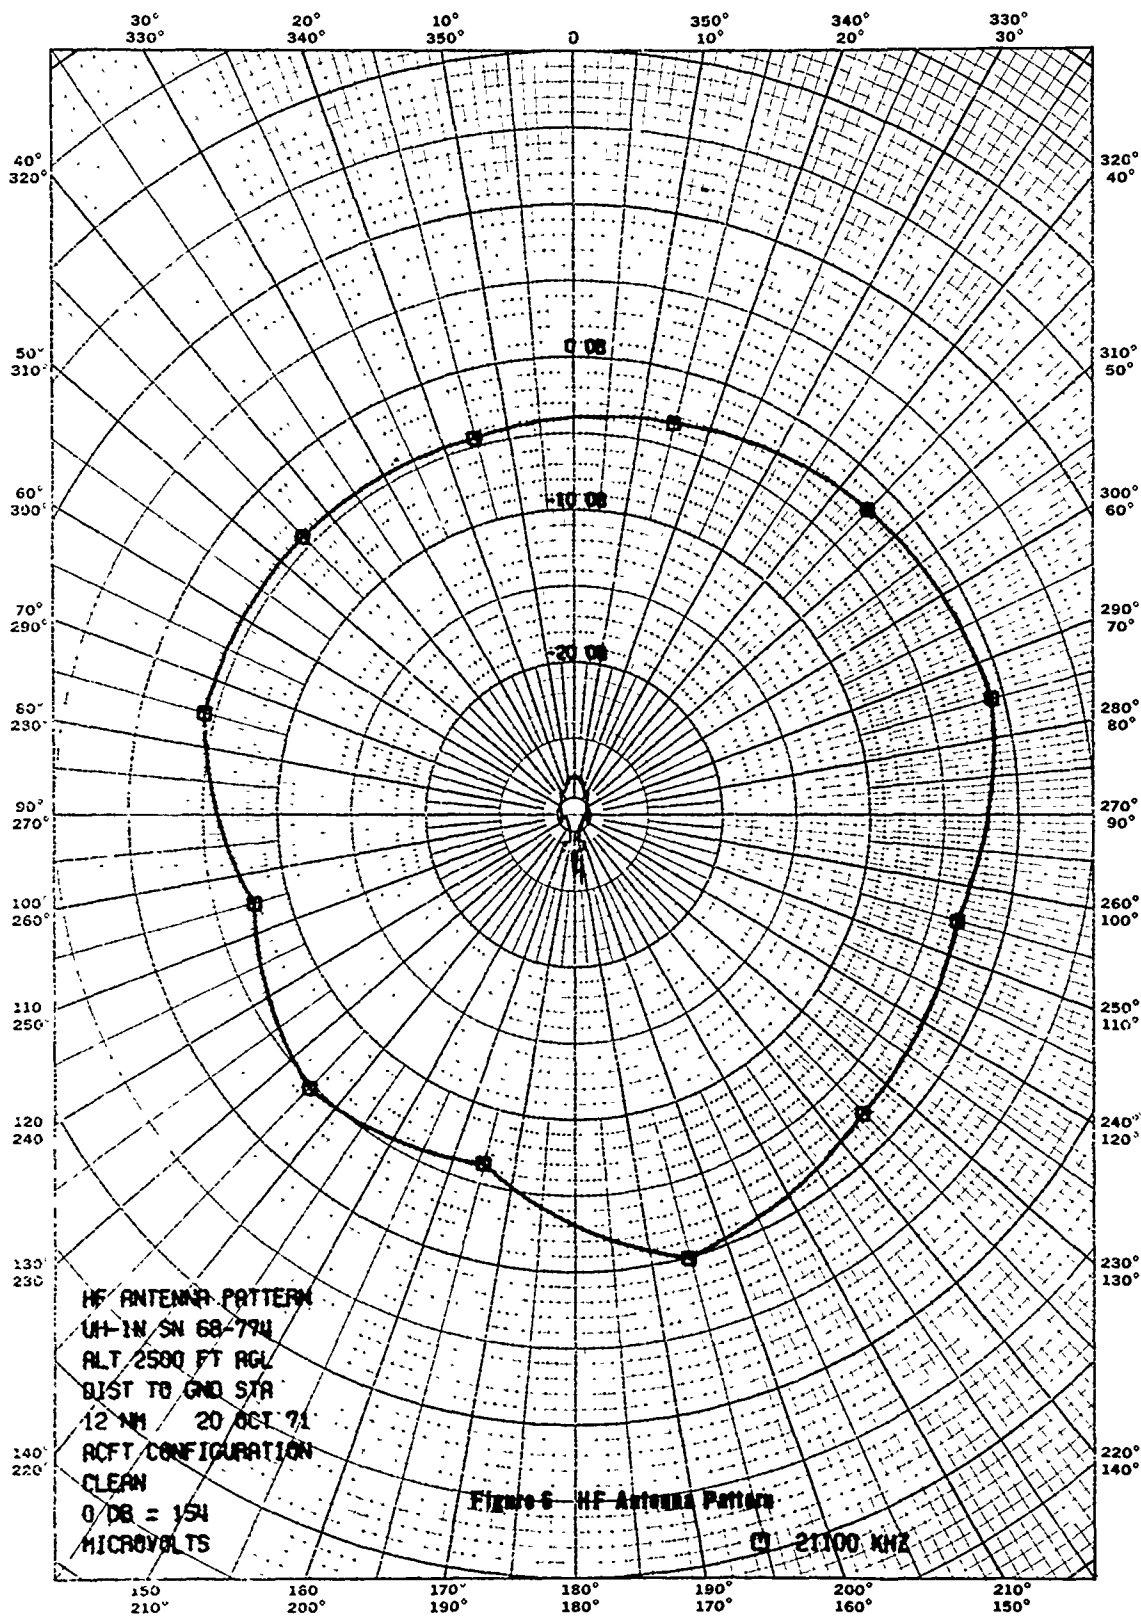
The antenna radiation patterns were essentially non-directional with pattern nulls of 2.67, 3.35 and 2.86 db, respectively, on frequencies 3,376, 3,890, and 7,110 kHz. More pronounced pattern nulls of 8.09, 9.40, and 7.75 db, respectively occurred on frequencies 14,100, 18,005 and 21,100 kHz. The bearing of antenna pattern nulls were different for each frequency tested. However, in all cases the signal strength improved at a bearing of 90 degrees from the pattern nulls.

The overall antenna patterns were acceptable on all frequencies tested. However, the nulls on the higher frequencies were significant and could cause communication difficulties (weak signal strength) if the station was on the same relative bearing from the aircraft as the pattern null.

1. If communication difficulties (weak signal strength) are encountered, changing the aircraft heading by 90 degrees may improve the transmitter and receiver signal strength. This information should be included in T.O. 1H-1(U)N-1, the UH-1N helicopter Flight Manual.

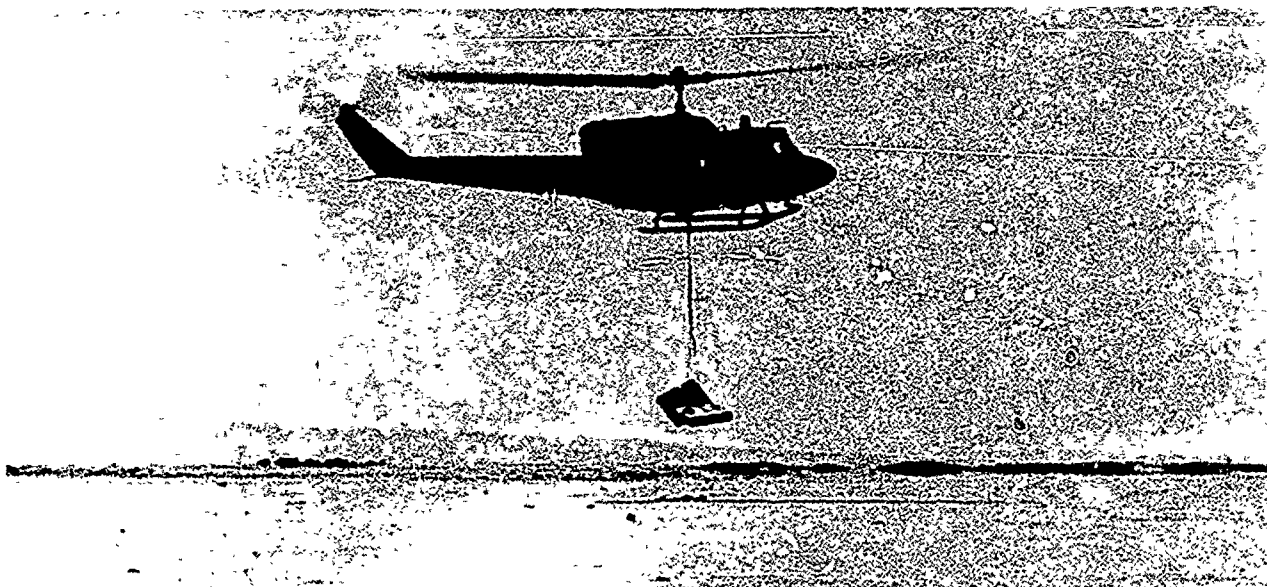
Figure 4 UH-1N Hover with External Cargo

The aircraft lifted and translated to forward flight with concrete deadloads weighing 200, 1,000, and 2,000 pounds (figure 4). All hook release controls were tested. Release was confirmed with the 200 pound load deflected in all four directions beneath the aircraft. Aircraft handling with these loads was explored at up to 80 KIAS.

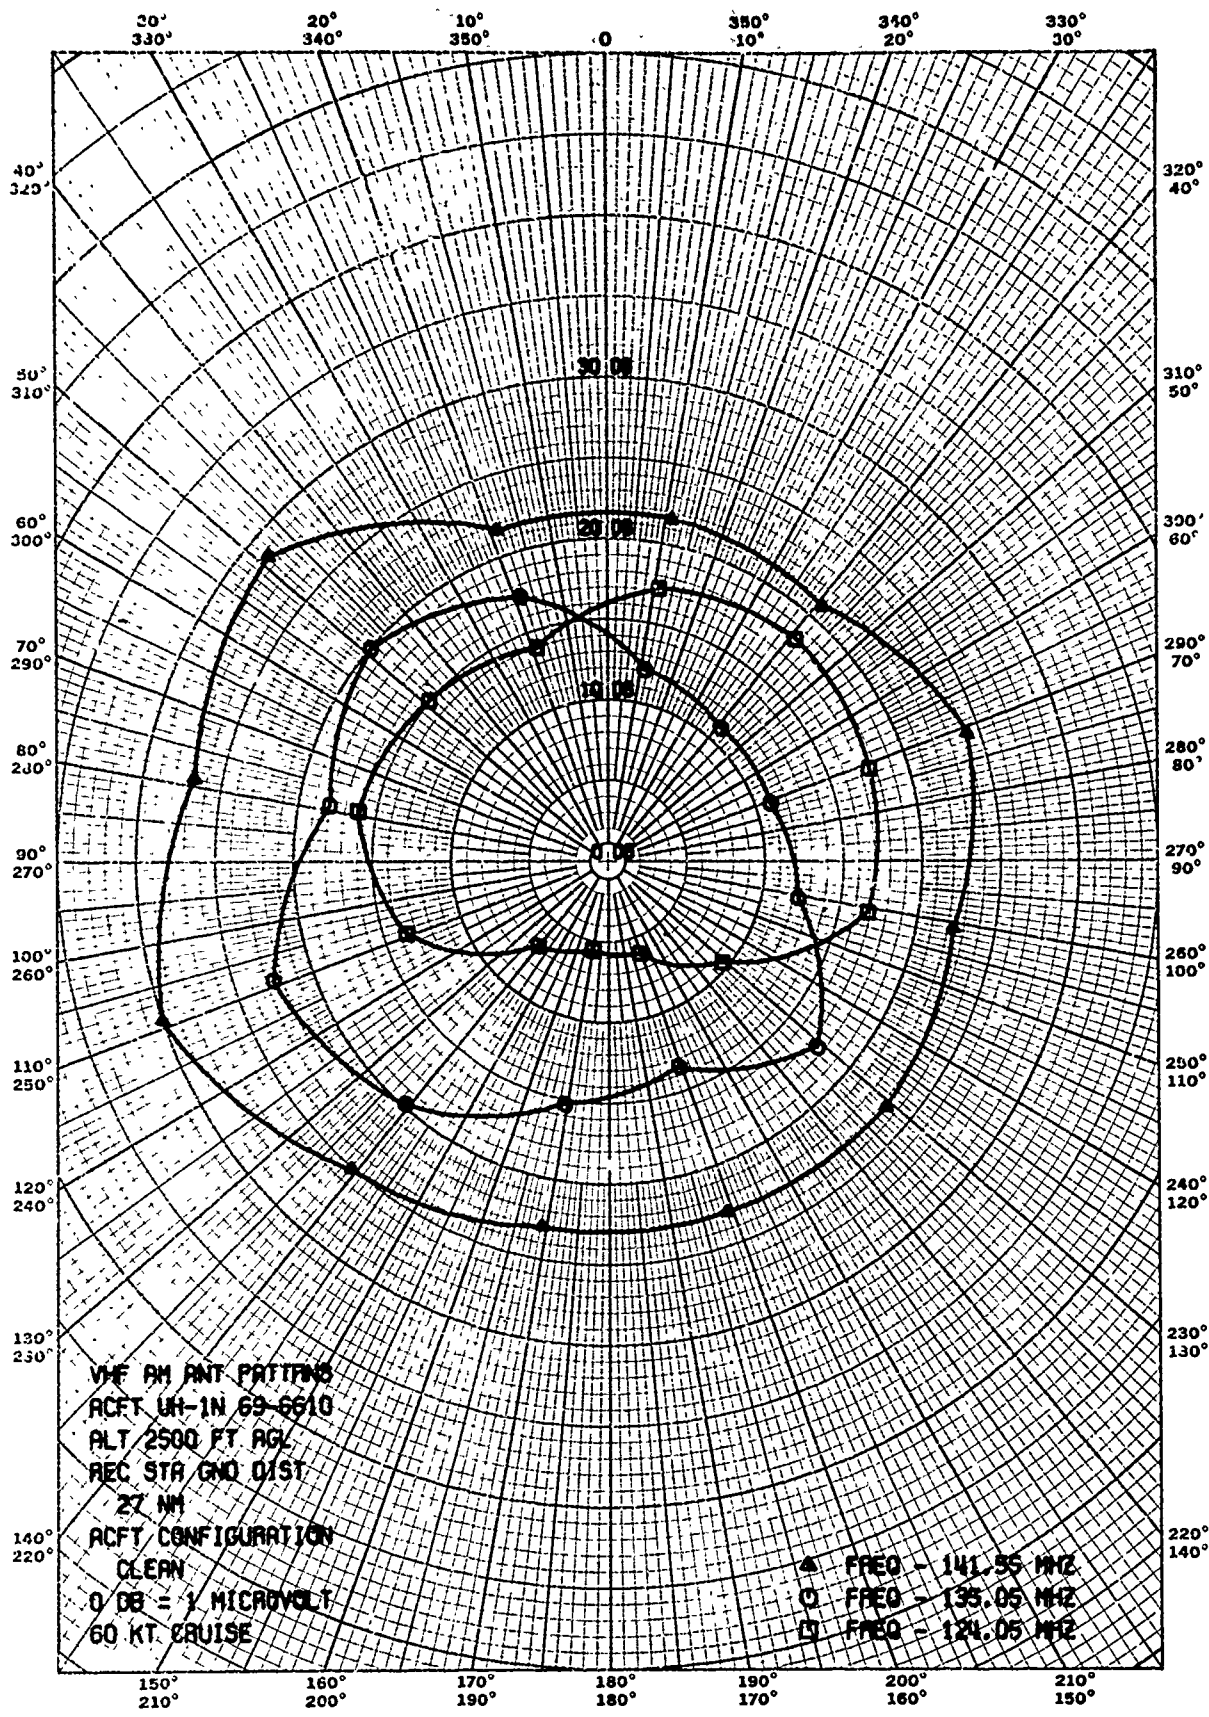
Figure 6 Pre-ECP VHF-AM Antenna Patterns

Antenna radiation patterns were measured while flying a 12-heading cloverleaf pattern at 27 NM from the ground station at 2,500 feet above ground level (AGL). Each system was tested at high, medium and low frequencies. Signal strength was so weak on UHF-AM at 27 NM range that reliable, usable signals could not be received at the ground station. The aircraft was then flown to 1 nautical mile distance and 2,500 feet AGL and a 12-heading cloverleaf flown. A strong signal was obtained at this position. The results of the antenna pattern tests are shown in figures 5 and 6. The criterion for an acceptable antenna pattern for these sets (per SCL-T-0045B and SCL-T-0046B) was, "no more than 58 percent of nulls shall be more than 6 db below than the pattern maximum". The patterns for frequencies 135.05 MHz and 141.55 MHz did not meet specification and were not acceptable. The antenna patterns for frequencies 124.05 MHz and 304.0 MHz, while acceptable per specifications, were marginal because of the large decibel loss in several of the nulls.

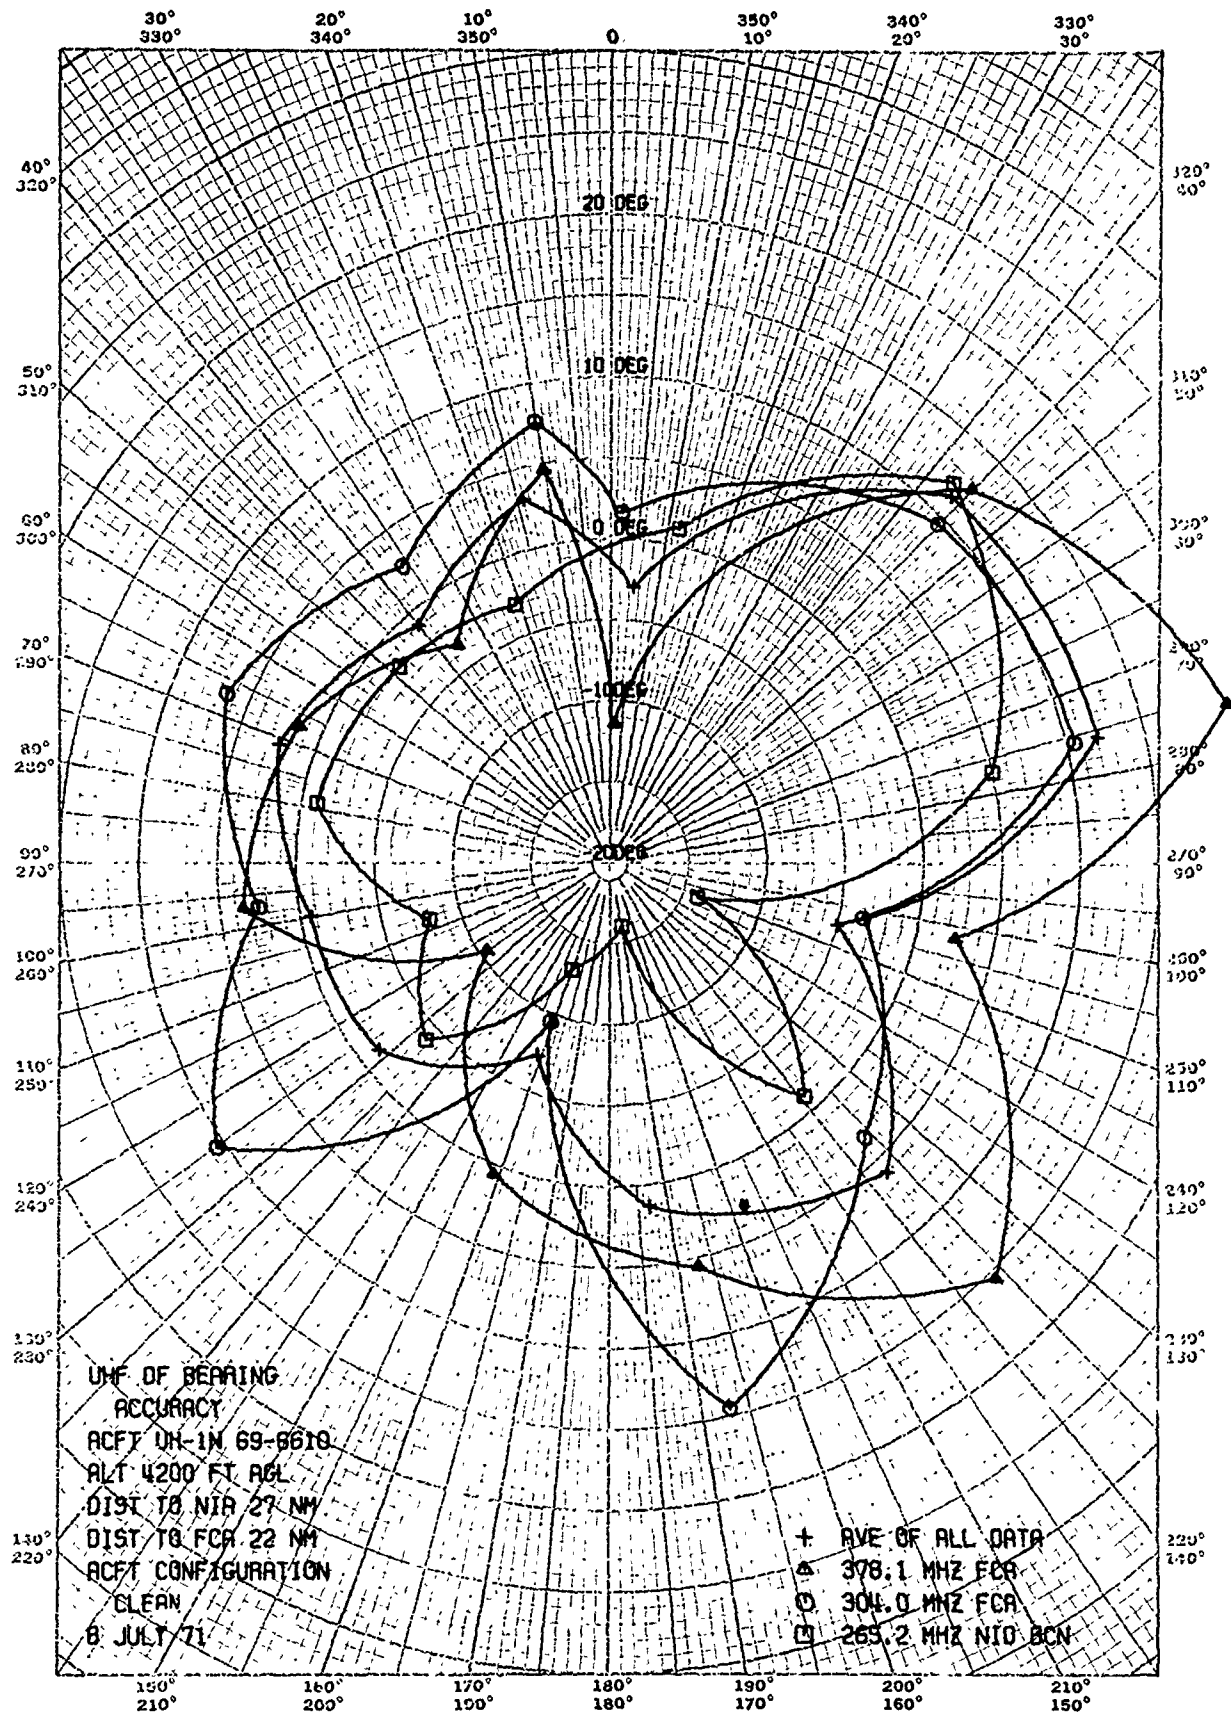
Figure 11 UHF DF Bearing Accuracy

Table XVII shows the results of the bearing accuracy tests for 265.2 MHz, 304.0 MHz, and 378.1 MHz. Figure 11 shows the UHF DF error relative to the aircraft heading. The average deviation for the three tests indicates that the error was consistently positive at 045 degrees, 076 degrees, and 136 degrees. The error was consistently negative at 010, 105, and 200 degrees. This indicated that there were disturbances due to the airframe which affected all three test frequencies. The system did not meet the bearing accuracy specifications of  $\pm 7.00$  degrees root mean square (RMS) value in MIL-D-38402, reference 18.

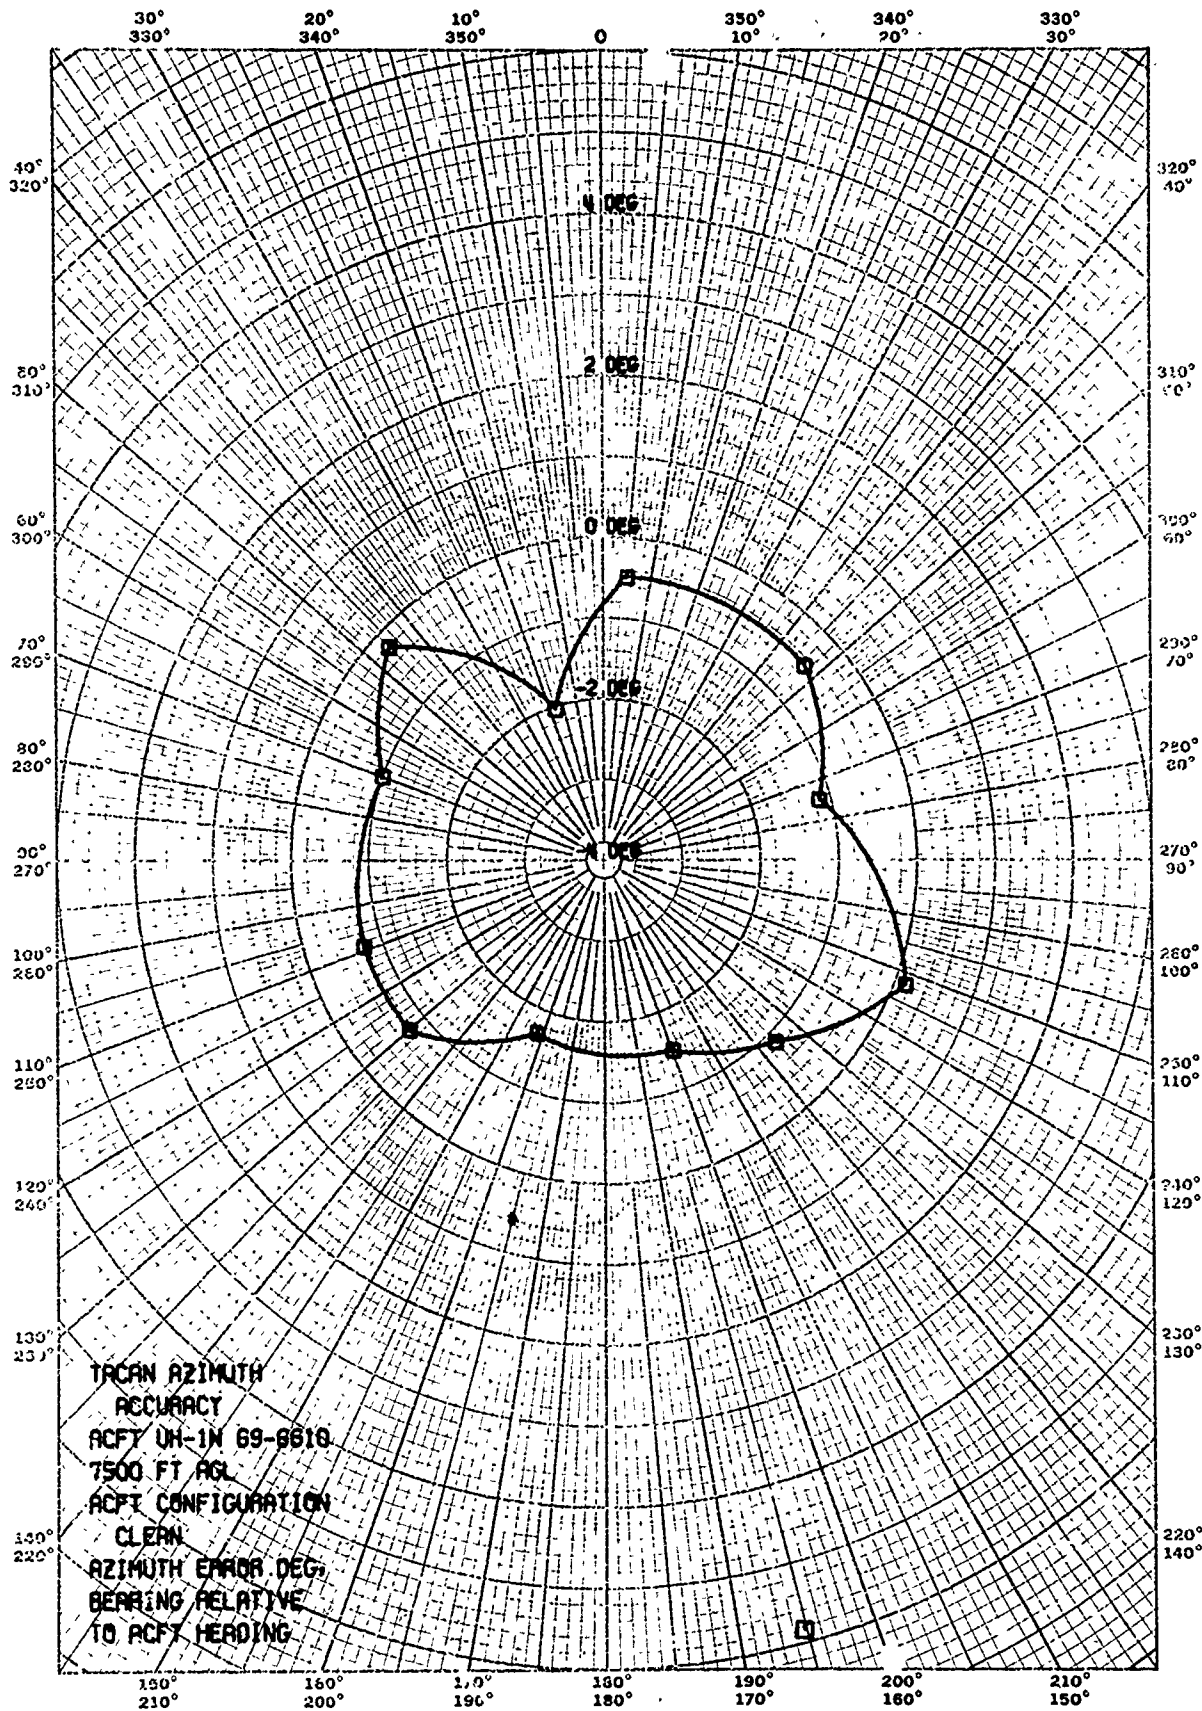
Figure 12 Tacan Radial Accuracy

At any point on a tacan radial the number 2 BDHI indication should be the same regardless of aircraft heading; if it is not, aircraft antenna pattern irregularities are the probable cause. In order to investigate the antenna pattern, the error data was grouped into 12 30-degree segments of a circle. The average error for all data points in each segment was calculated and plotted on polar coordinates. The resulting pattern would reveal antenna-related problems in tacan operation. Figure 12 shows the tacan radial error and figure 13 shows the DME error relative to aircraft heading. The test was conducted under actual operating conditions using tacan channel numbers between channels 21 and 108. The
