UH-1N

# CATEGORY II AIRFRAME AND SUBSYSTEMS EVALUATION

TECHNICAL REPORT No. 71-37

AIR FORCE FLIGHT TEST CENTER  
EDWARDS AIR FORCE BASE, CALIFORNIA  
AIR FORCE SYSTEMS COMMAND  
UNITED STATES AIR FORCE

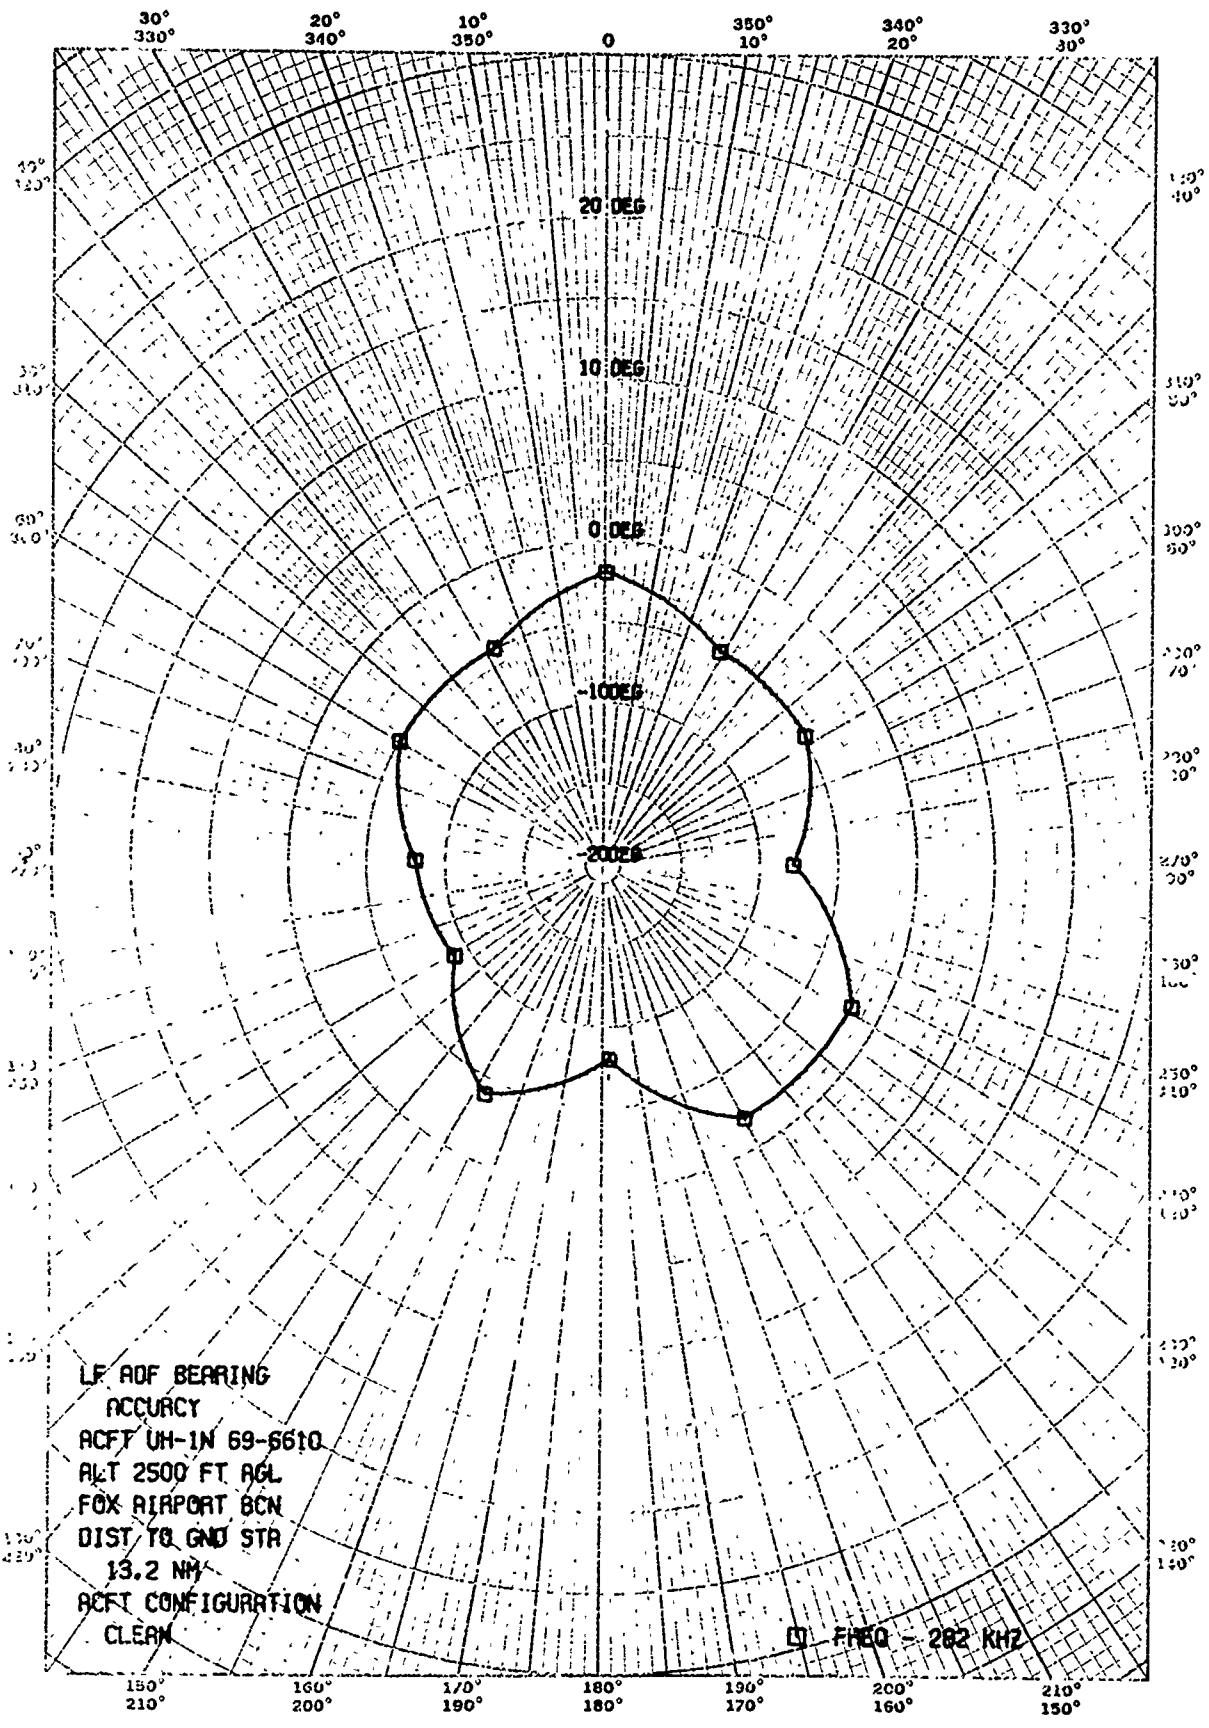
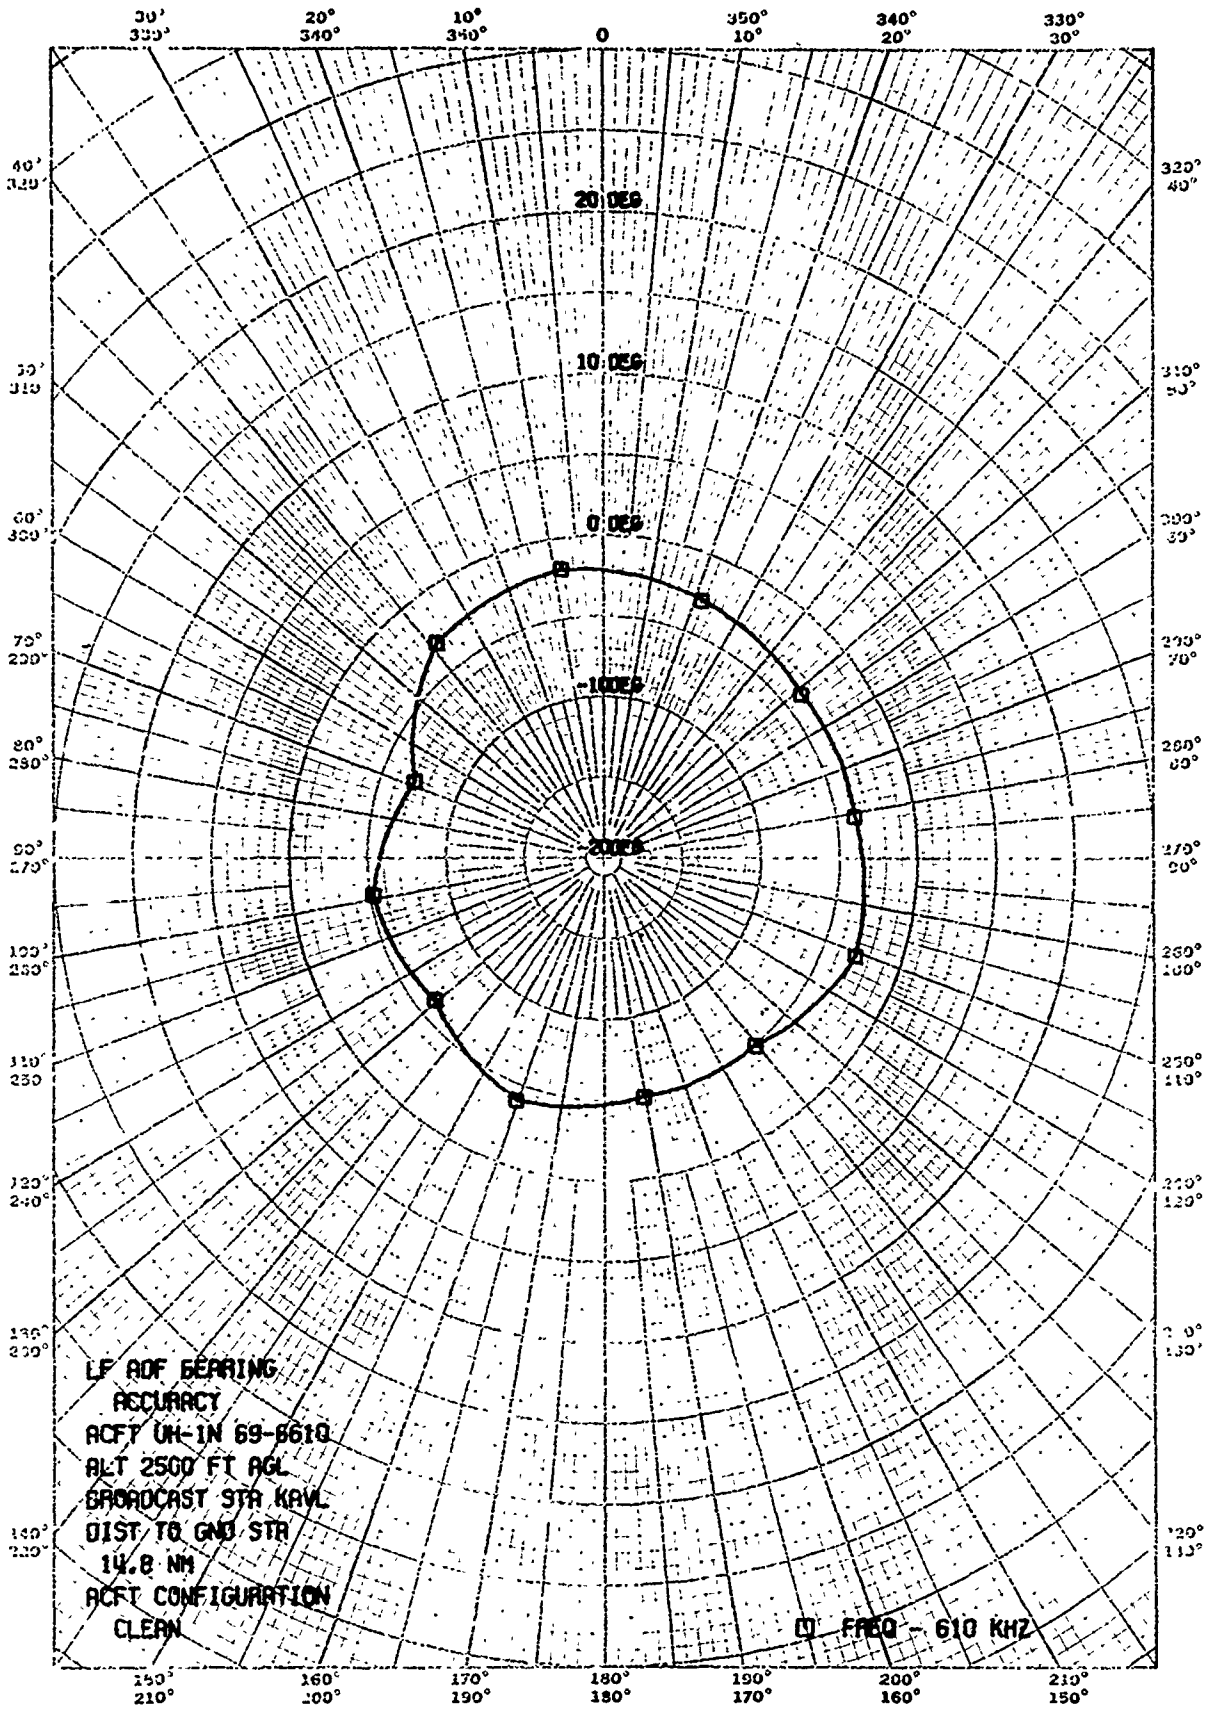
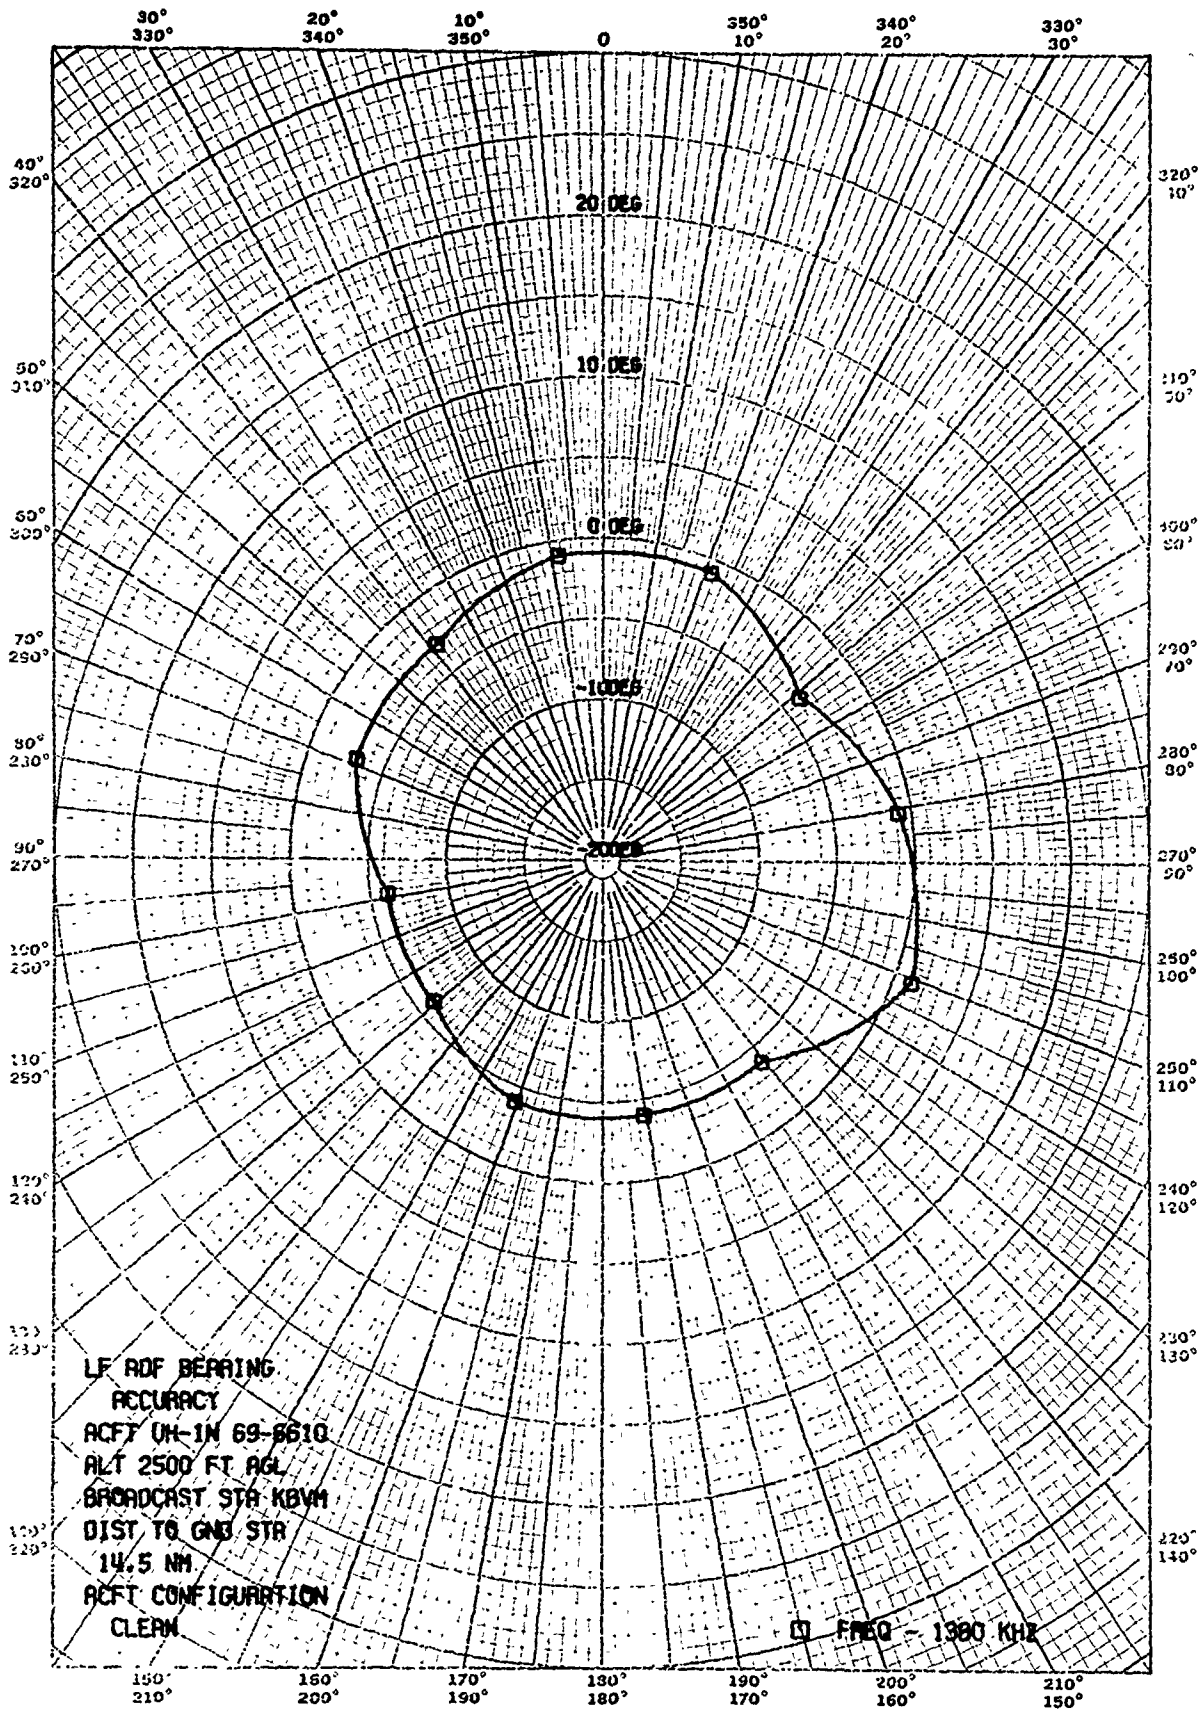
Twelve-heading cloverleaf patterns were flown over a ground reference point approximately 14 NM from a 20-watt low frequency aeronautical beacon transmitter operating on 282 kHz, a 5,000-watt broadcast station operating on 610 kHz, and a 1,000-watt broadcast station operating on 1,380 kHz. The actual bearing to the transmitter station was measured from an aeronautical chart for comparison with the indicated bearings on each heading of the cloverleaf pattern. Figures 14 through 16 show plots of the data obtained. The average value of the error was -5.25 degrees for 282 kHz, -4.25 degrees for 610 kHz, and -3.00 degrees for 1,380 kHz. Reference 19 states that bearing errors may not exceed +5 degrees of actual bearing to the station. The ADF system did not meet the specified accuracy requirement on any of the test frequencies; however, the consistent negative difference between the actual bearings and the indicated bearings revealed that a system error existed that could be removed by recalibration. Additional testing should be conducted to determine proper compensation settings for the ADF system. (R 24)

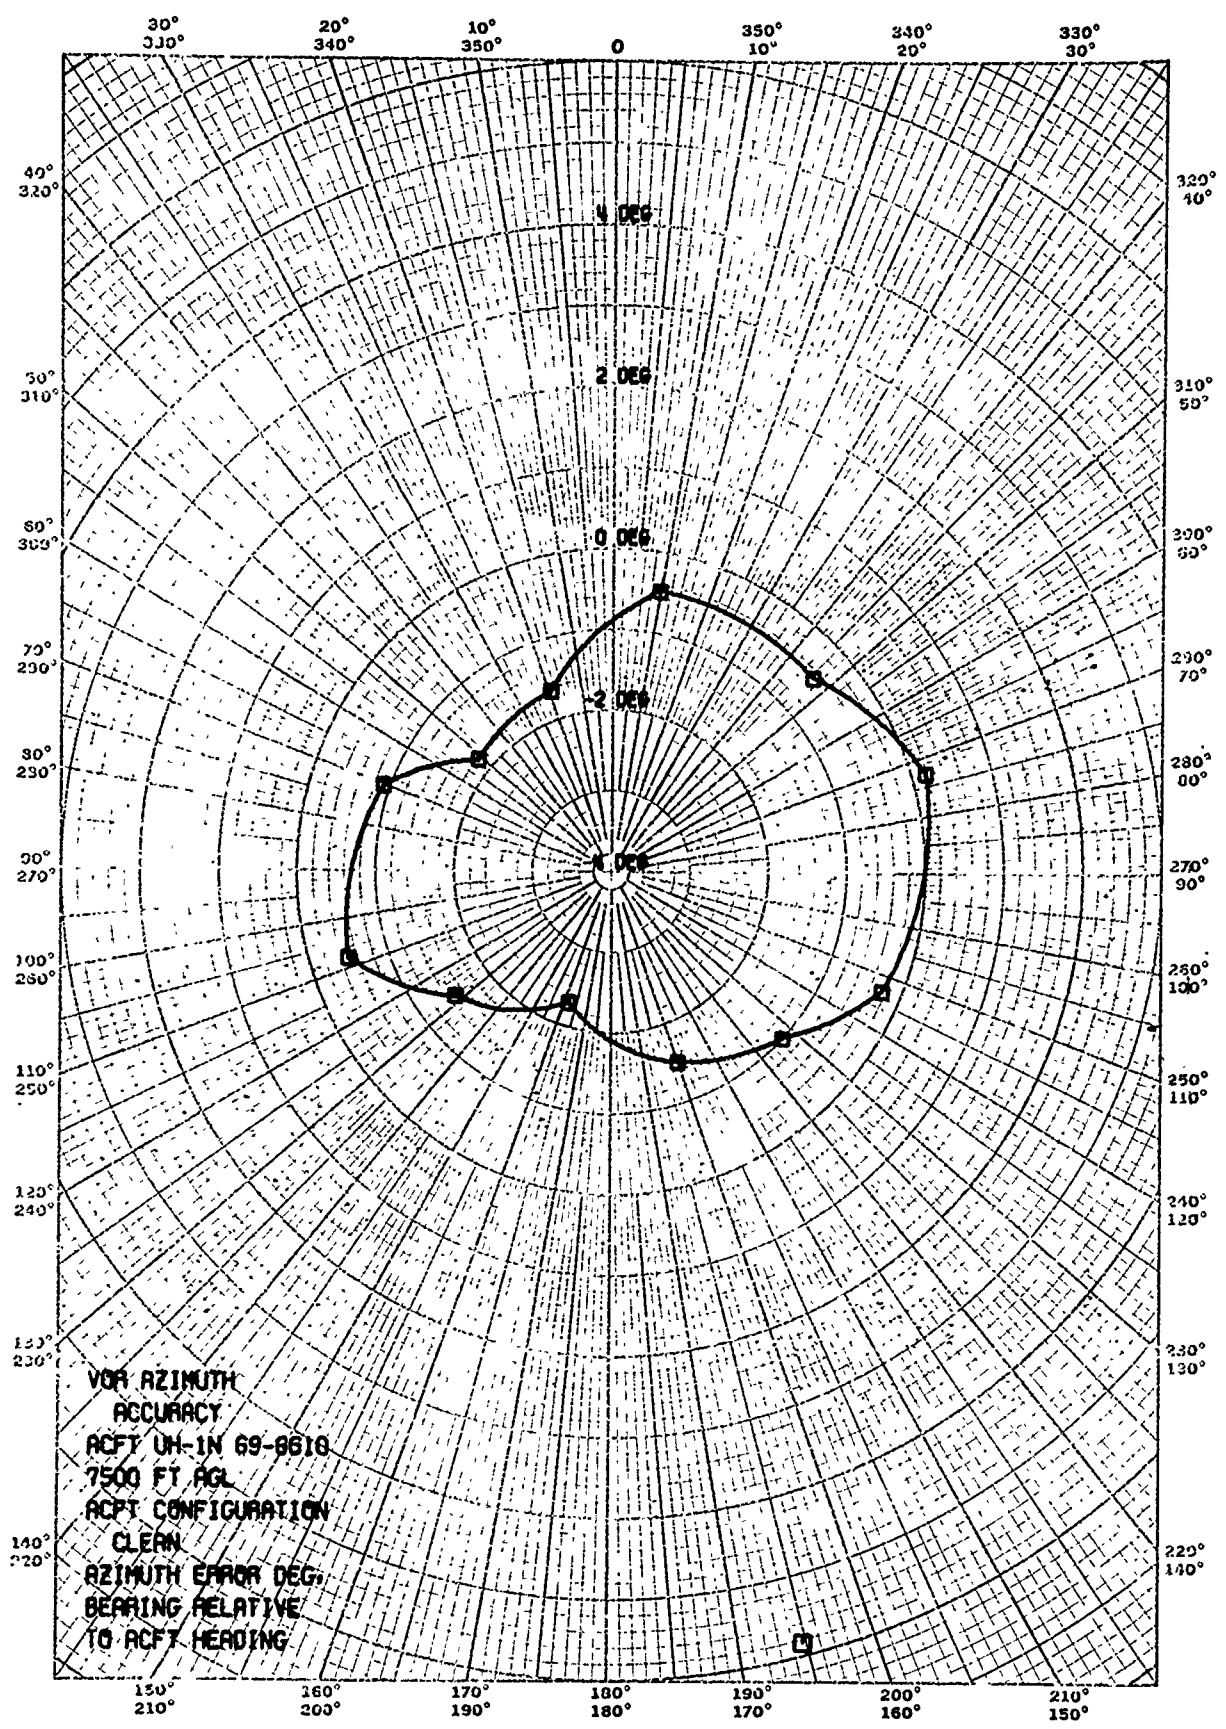
Figure 17 VOR Radial Accuracy

At any given point on a radial the indicated VOR radial should be the same regardless of aircraft heading; if it is not, aircraft antenna pattern irregularities are the probable cause. To investigate this, the error for each data point was grouped into 12 30-degree segments of a circle. The average error for all data points in each segment was calculated and plotted on polar coordinates. The resulting pattern revealed antenna-related problems in VOR operation. Figure 17 shows the VOR errors relative to aircraft heading. The test was conducted under actual operating conditions using five VOR stations on frequencies between 108.4 and 116.4 MHz. The distance between the aircraft and the VOR station varied between 7 and 70 NM. The VOR antenna system was found satisfactory.

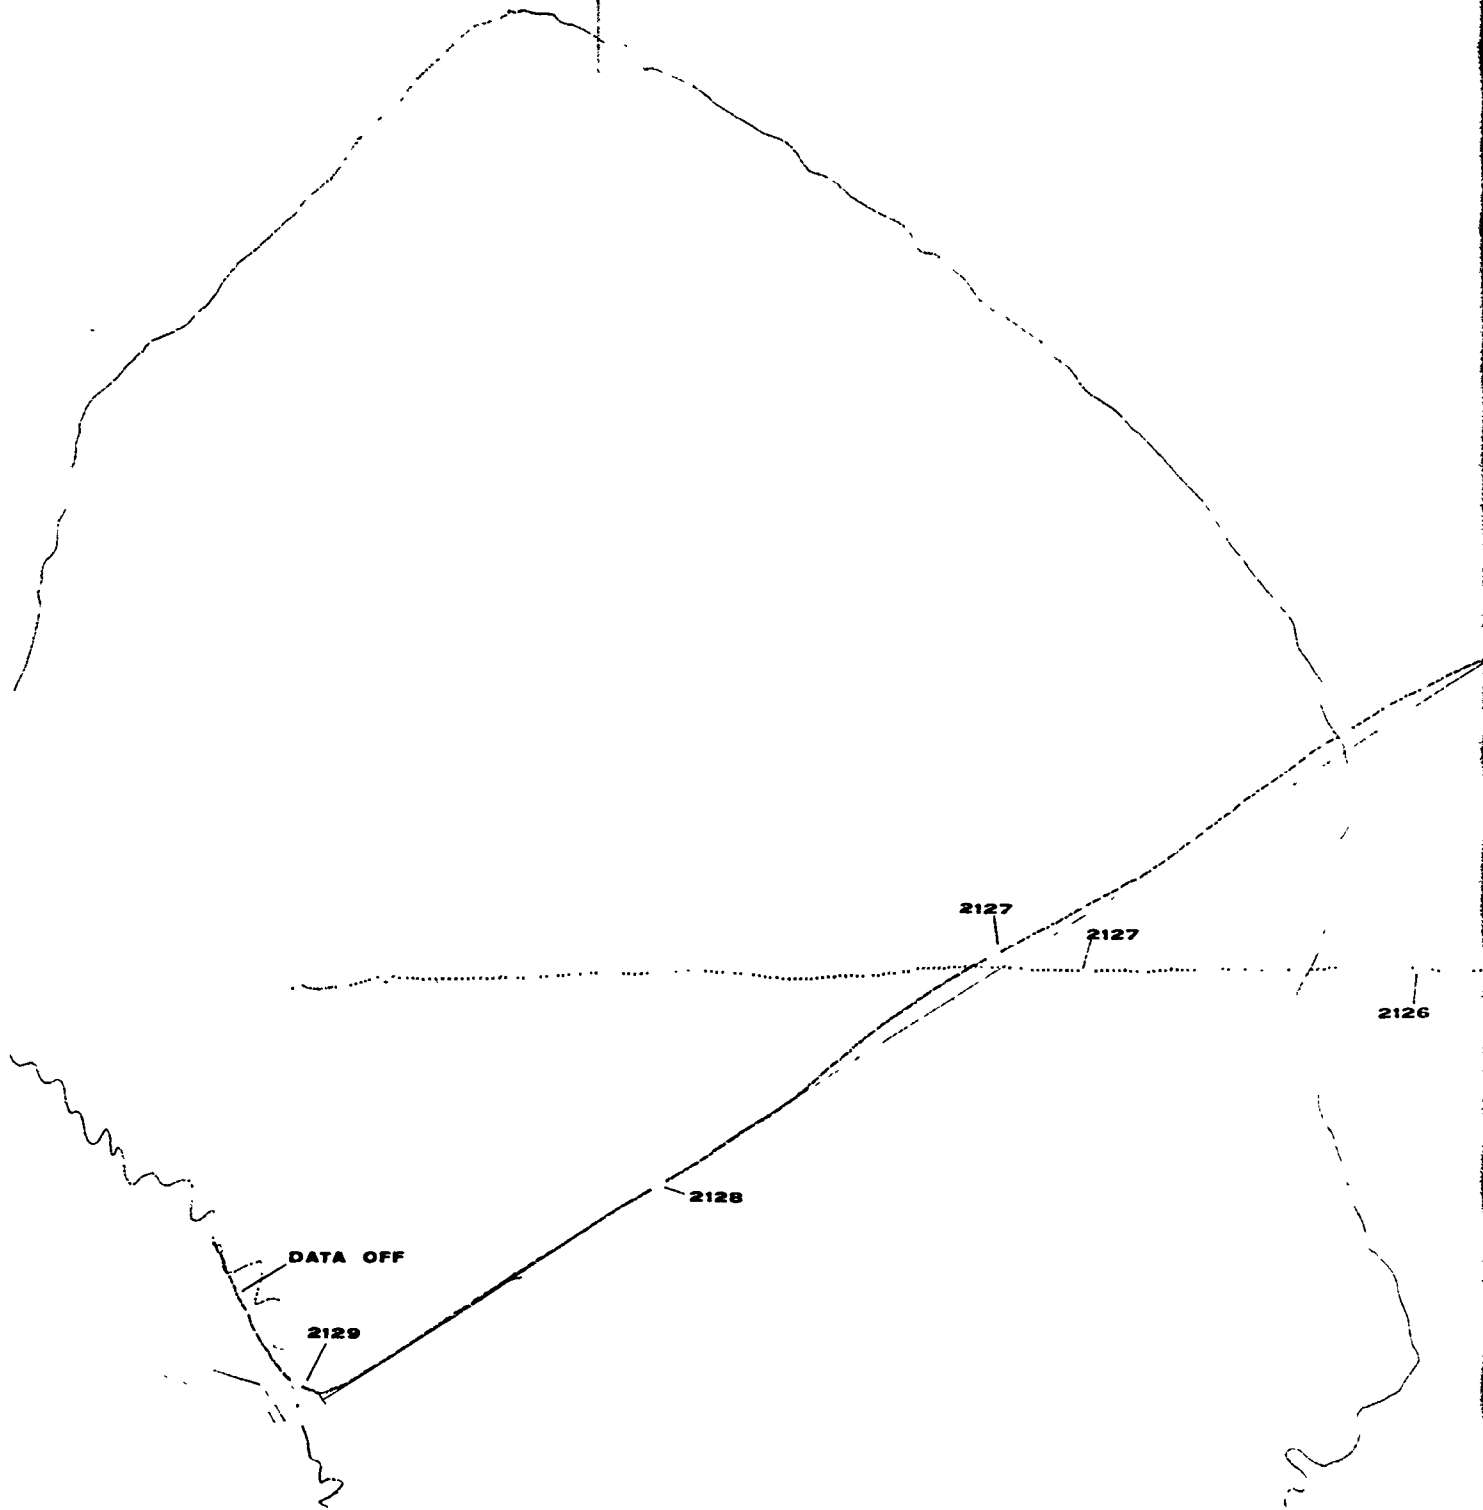
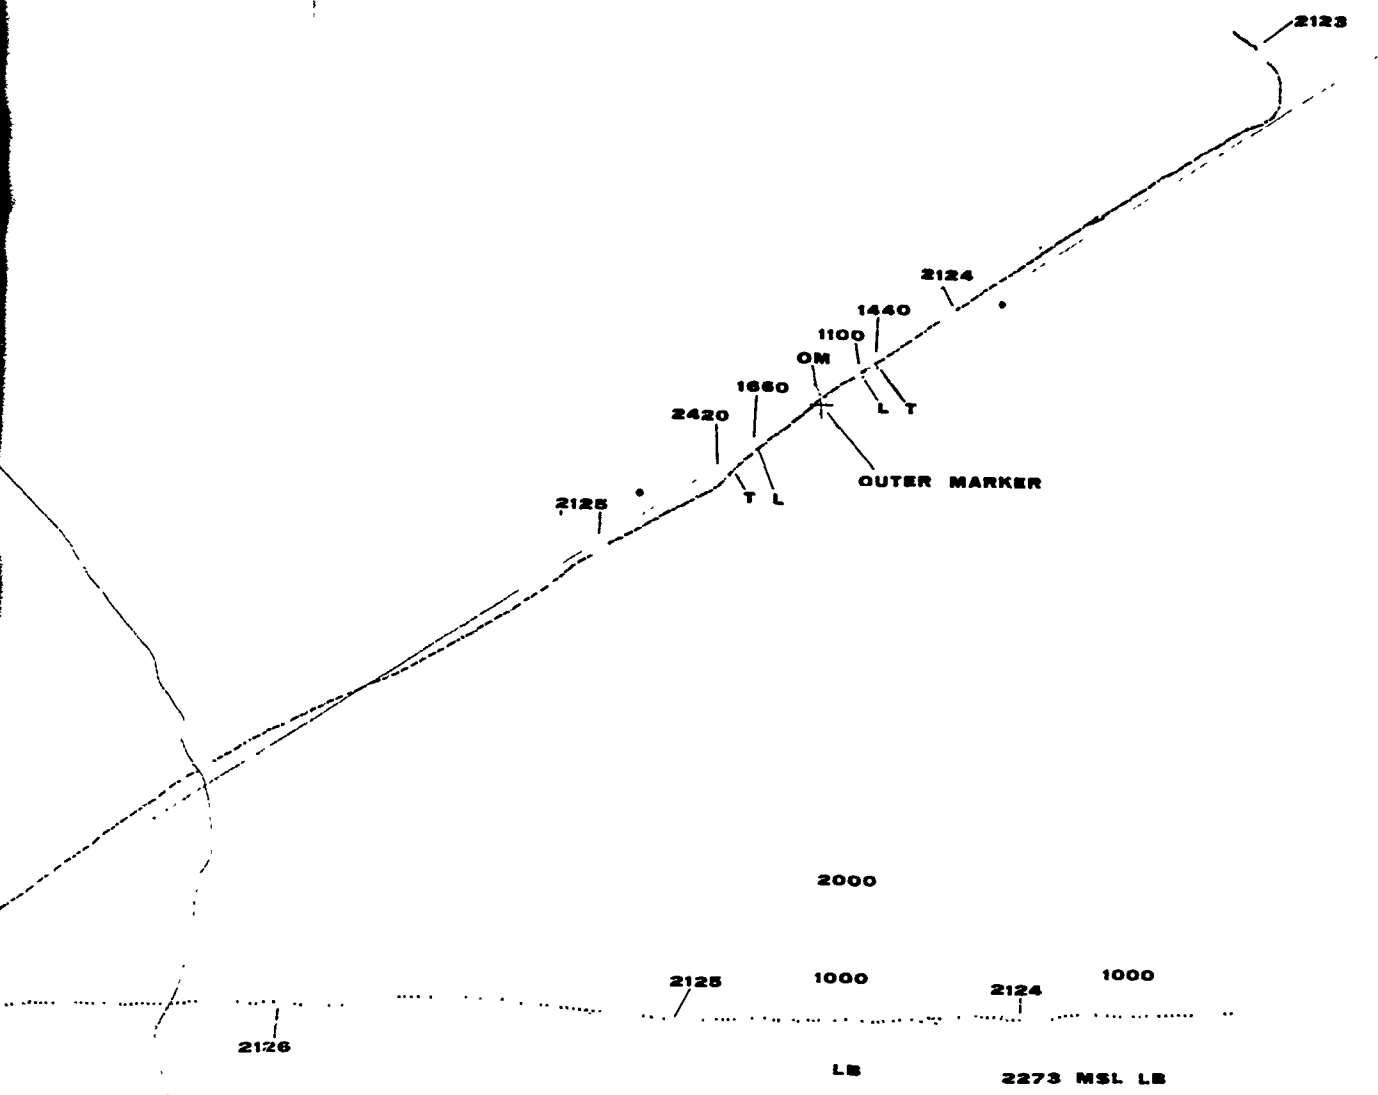
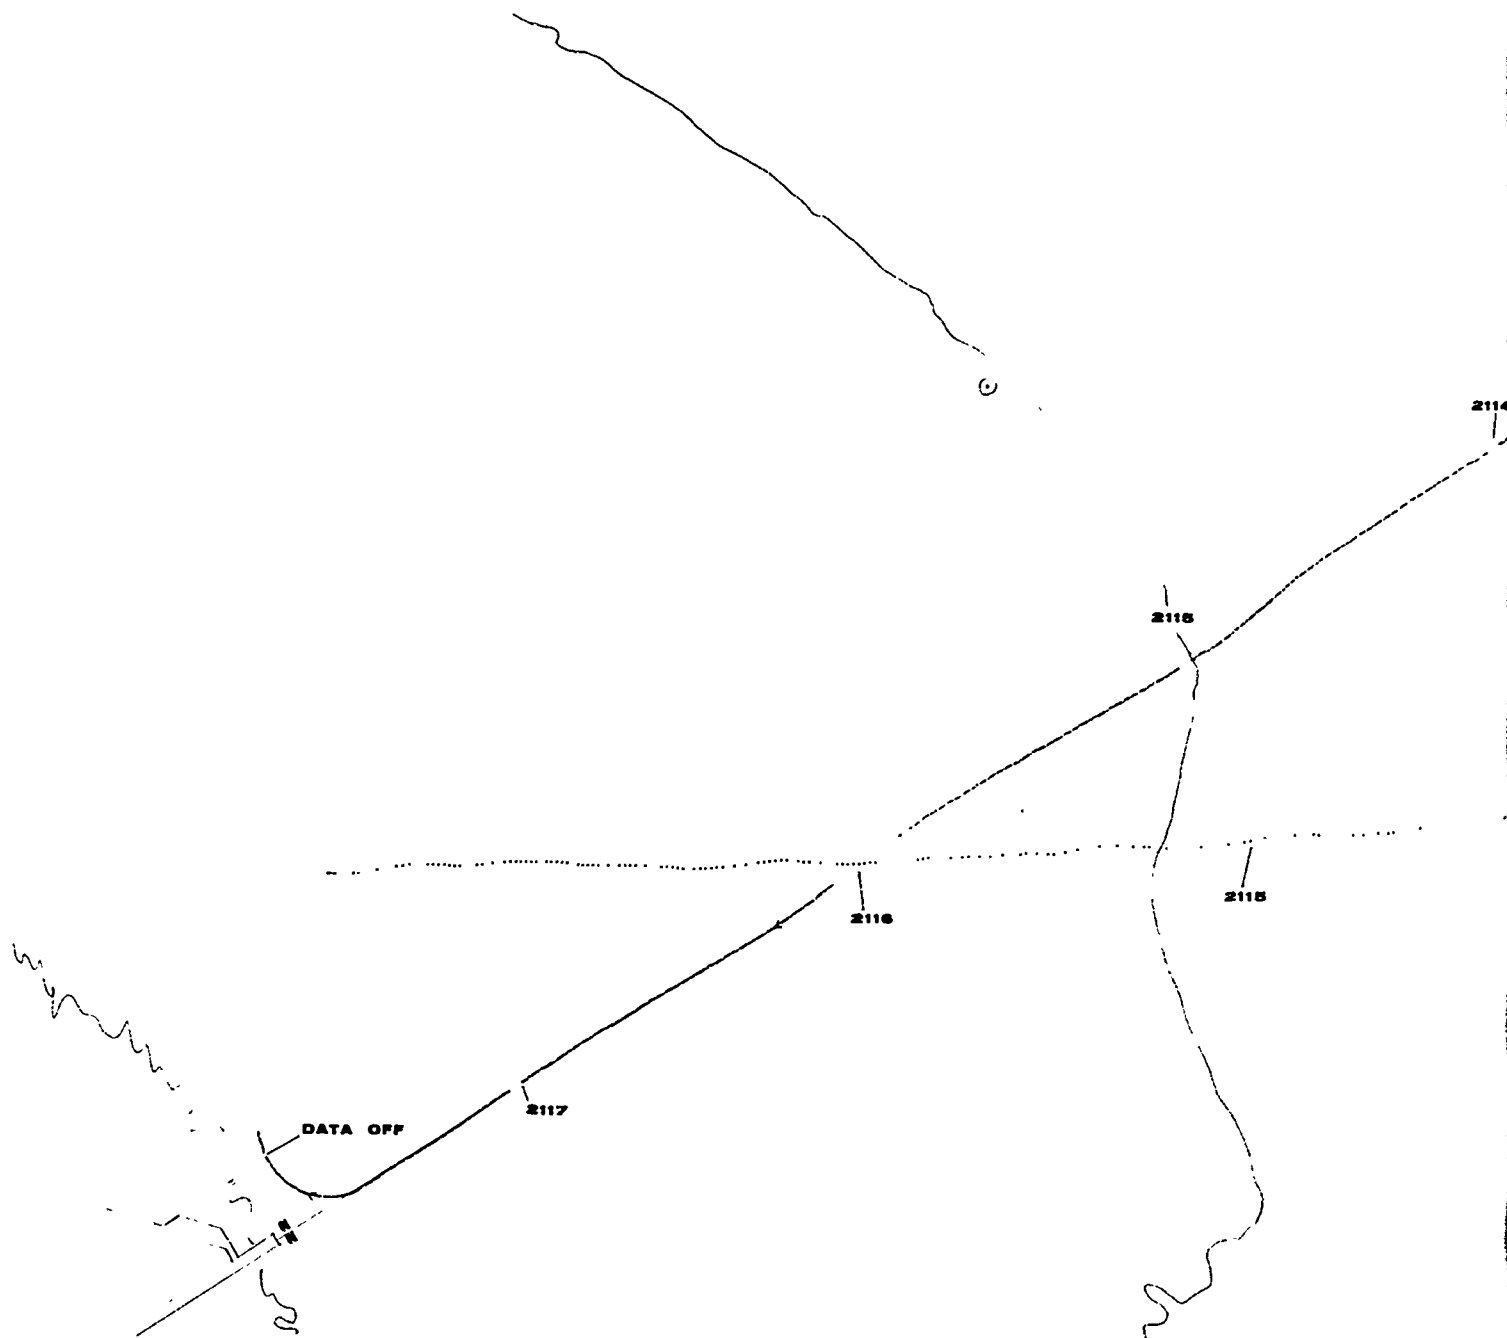
To evaluate the ILS localizer function of the systems, the aircraft was flown in both level and normal descent approaches along the Edwards AFB ILS localizer beam. The pilot attempted to keep the course indicator centered at all times. The aircraft was tracked with a tracking radar and its position relative to the localizer beam (extended runway center line) was plotted. The radar data plots are shown in figures 18 and 19. The maximum deviation from the centerline was approximately 200 feet. During the final 1.5 miles of the approach the deviations were negligible. The ILS localizer receiver function of the ARN-82 VOR receiver was satisfactory.

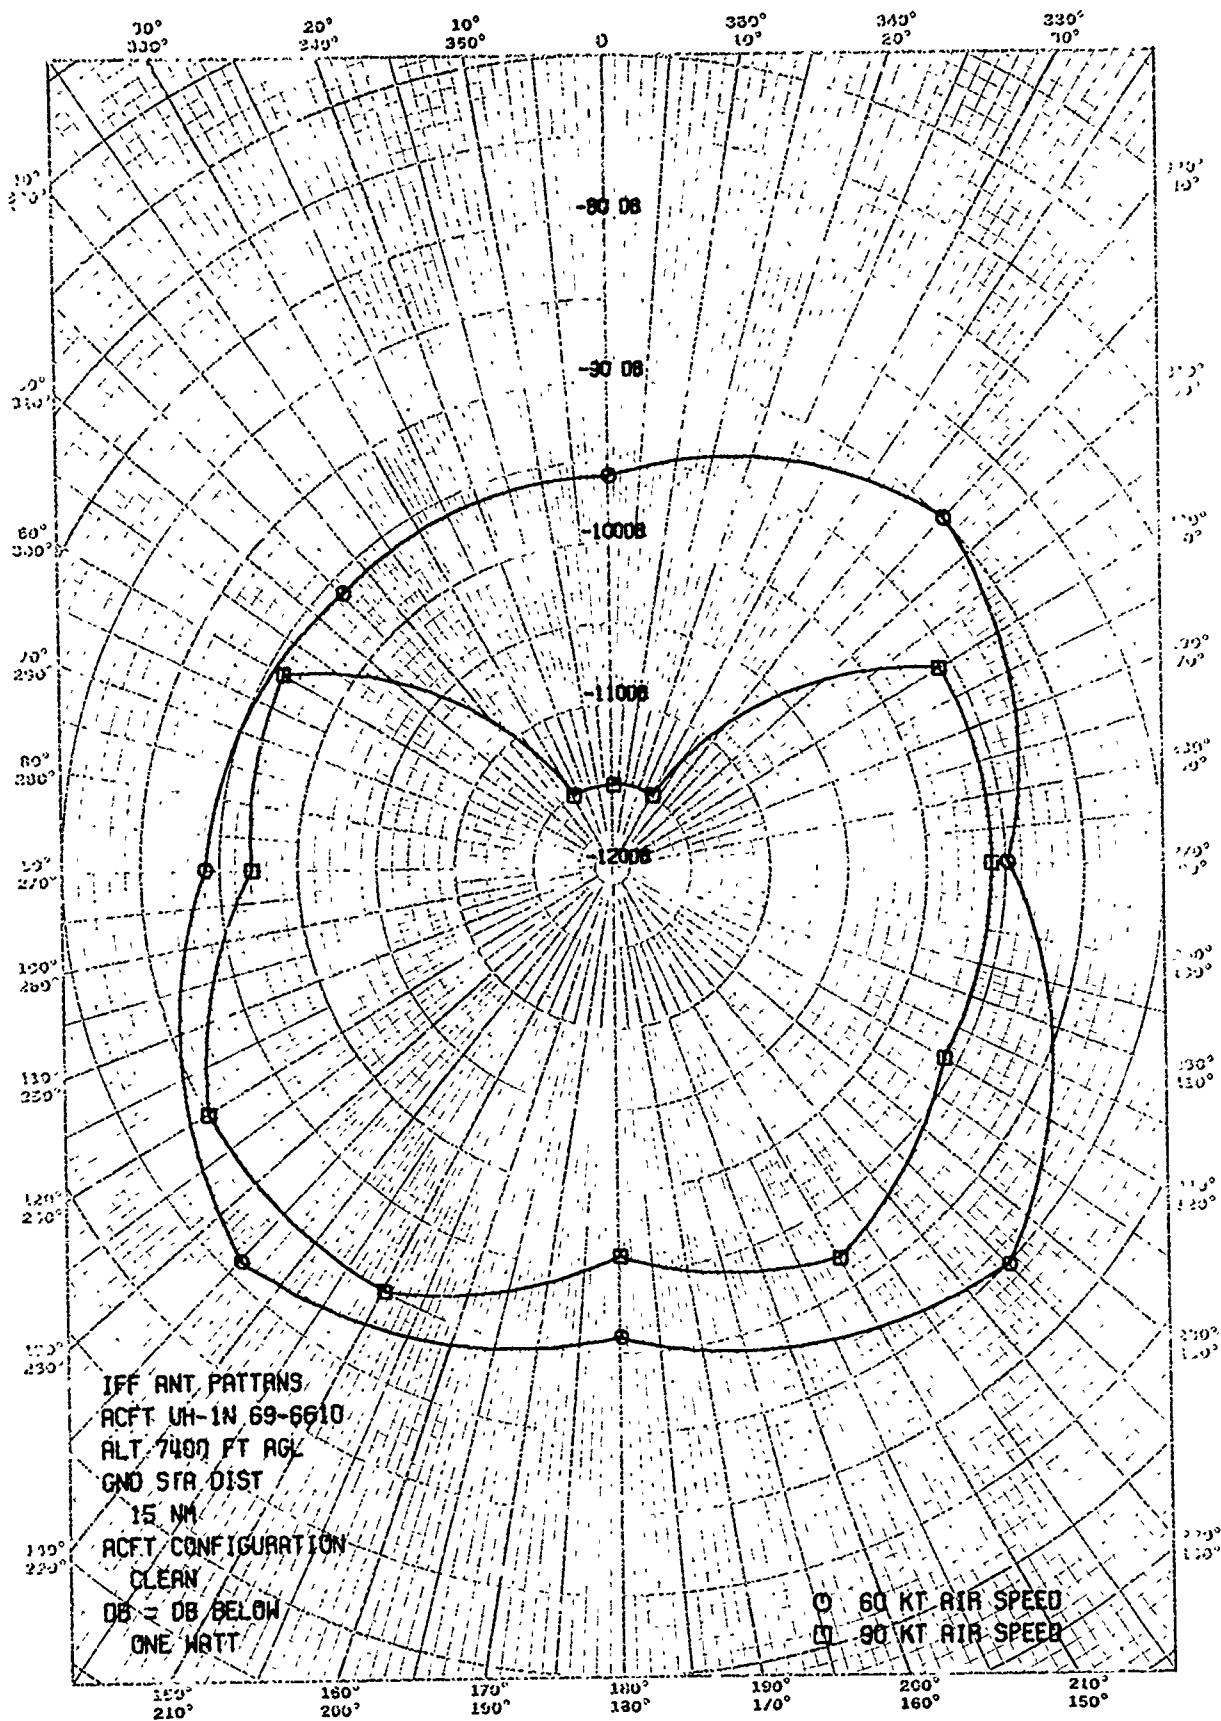
Figure 21 IFF Antenna Patterns

The radiation pattern of the AT-741A Antenna was measured by flying cloverleaf patterns over a point 15 NM from the PACF, at 10,000 feet pressure altitude. Radar tracking was used to vector the aircraft over the reference point on each heading. The relative signal strength was measured while interrogating the transponder in mode 2. The UH-1N aircraft used one IFF antenna located on the bottom of the aircraft near the rear of the fuselage. The antenna radiation pattern obtained at 90 KIAS (figure 21) was unacceptable due to the deep null off the nose of the aircraft. This null was not observed at 60 KIAS, when the nose-down attitude of the aircraft decreased approximately 4 degrees. An additional top-mounted fuselage antenna with an antenna switching unit should be installed to improve the radiation pattern. (R 31)

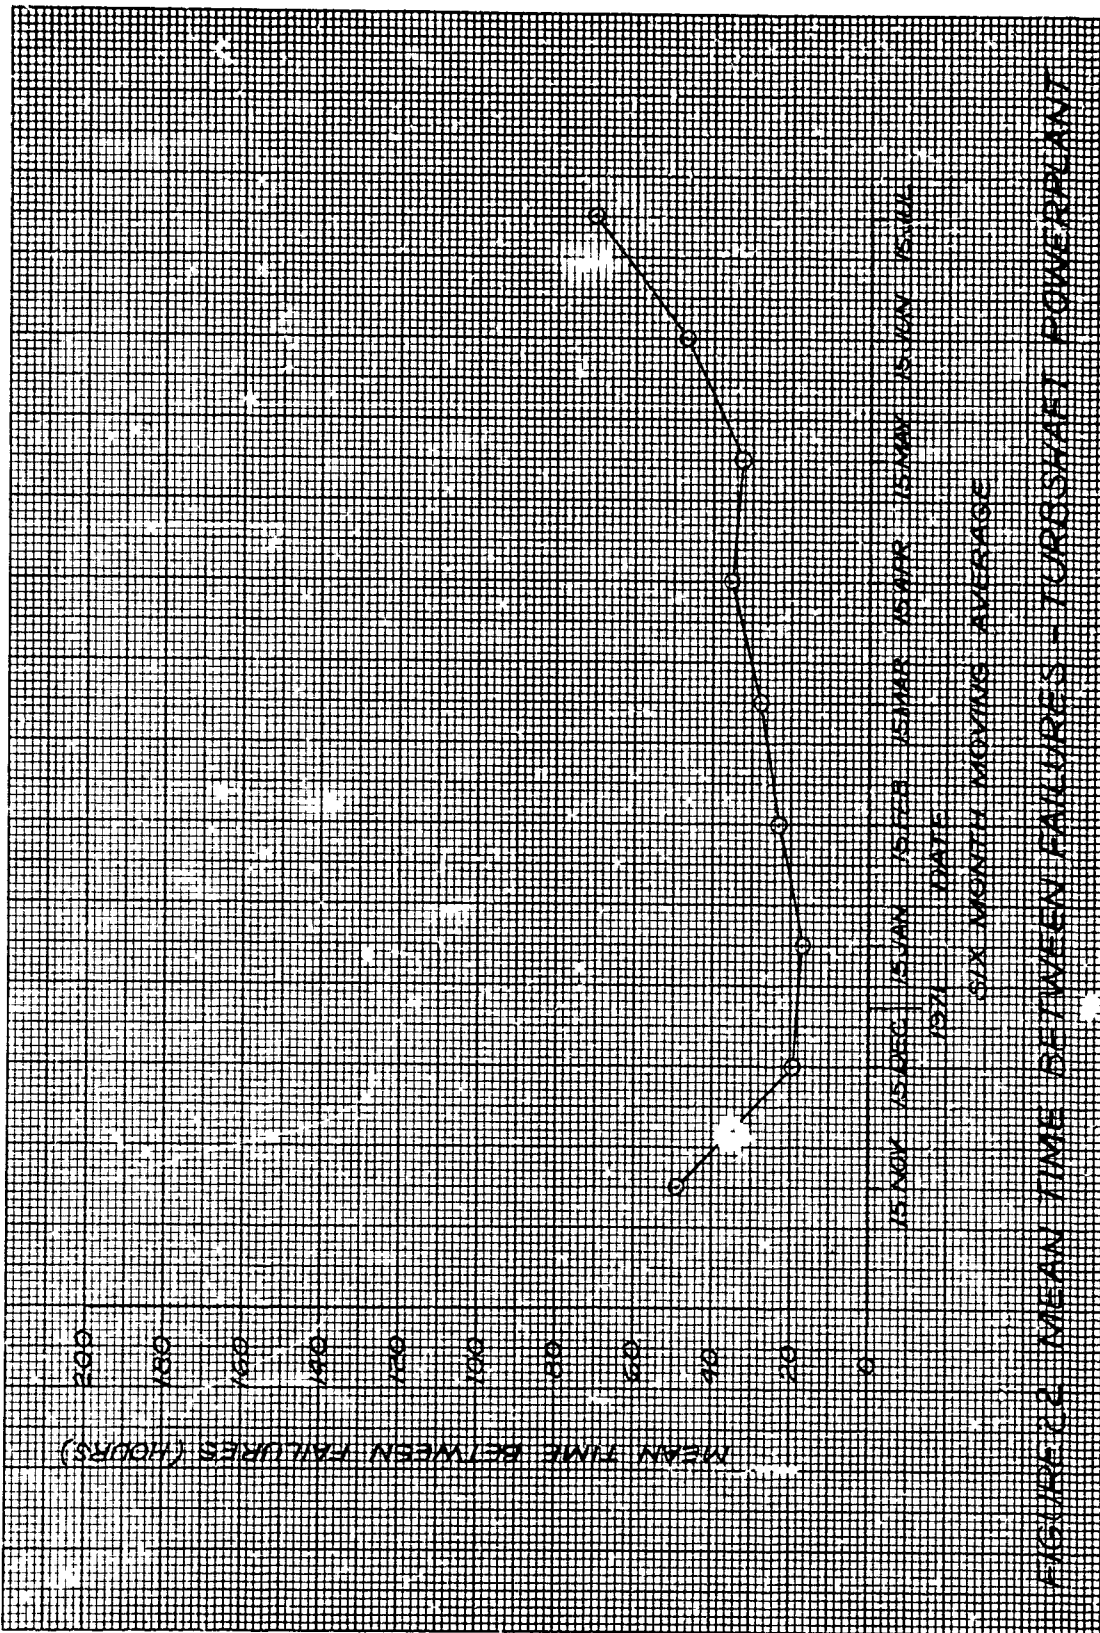
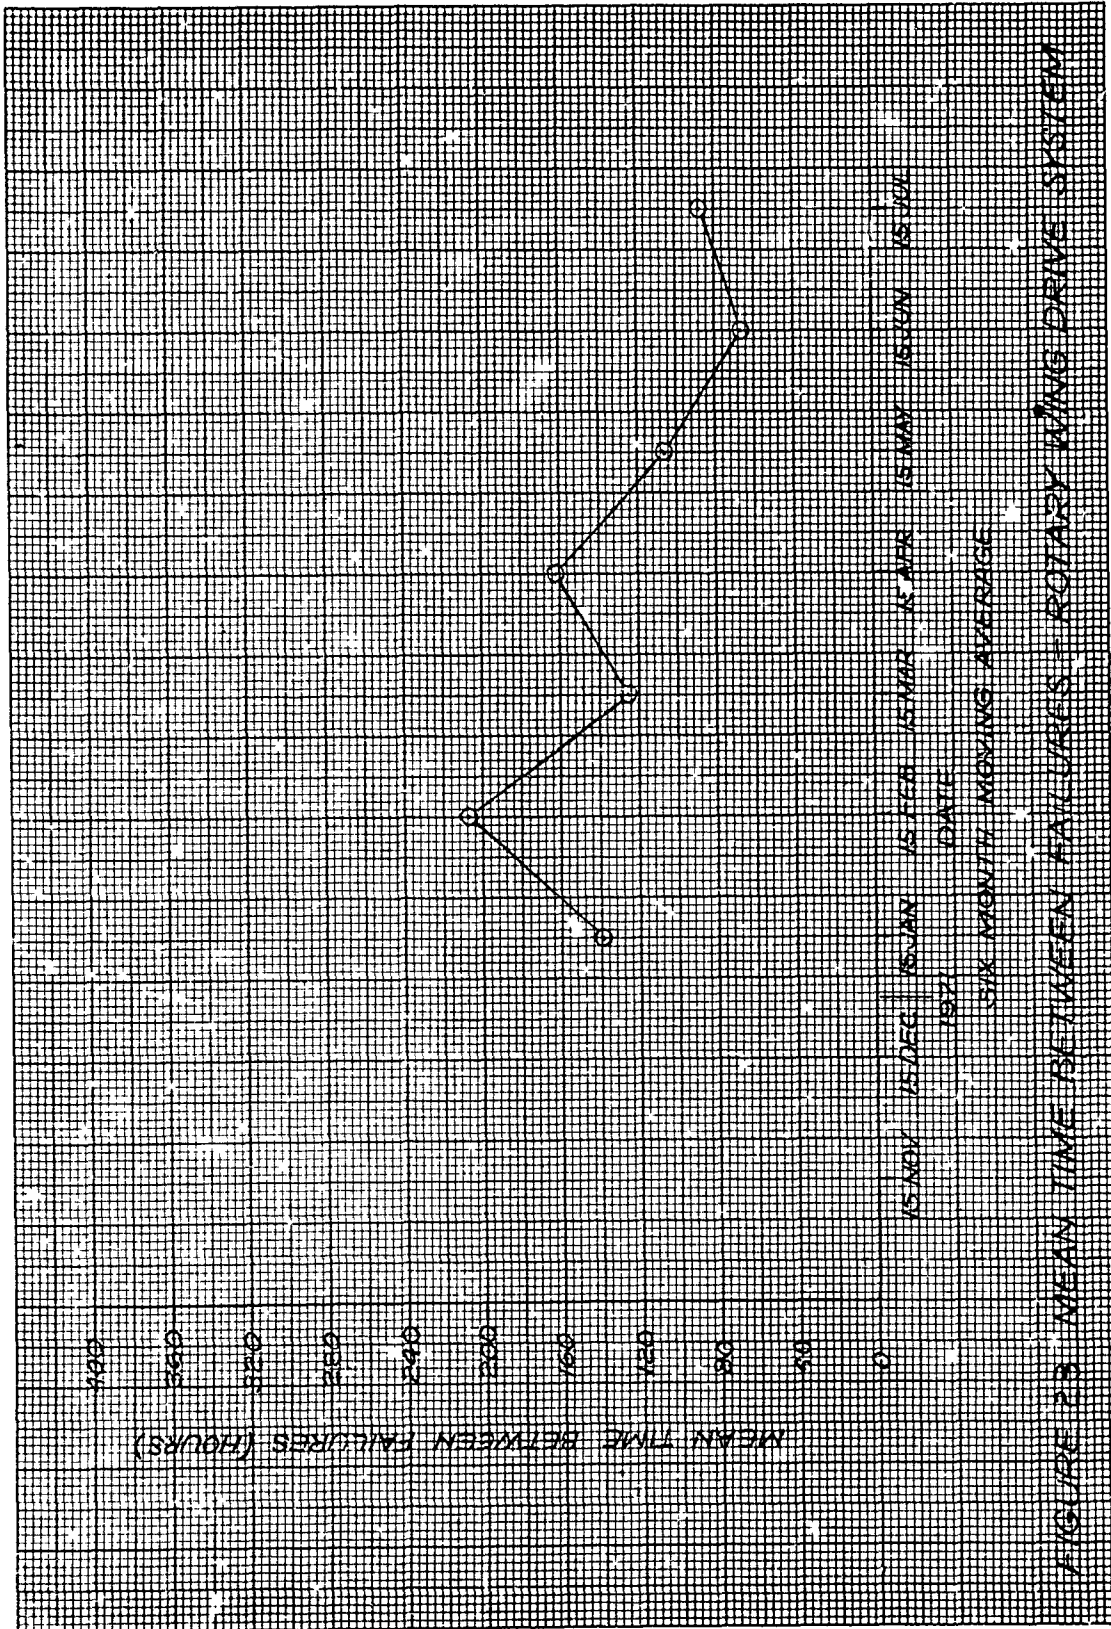
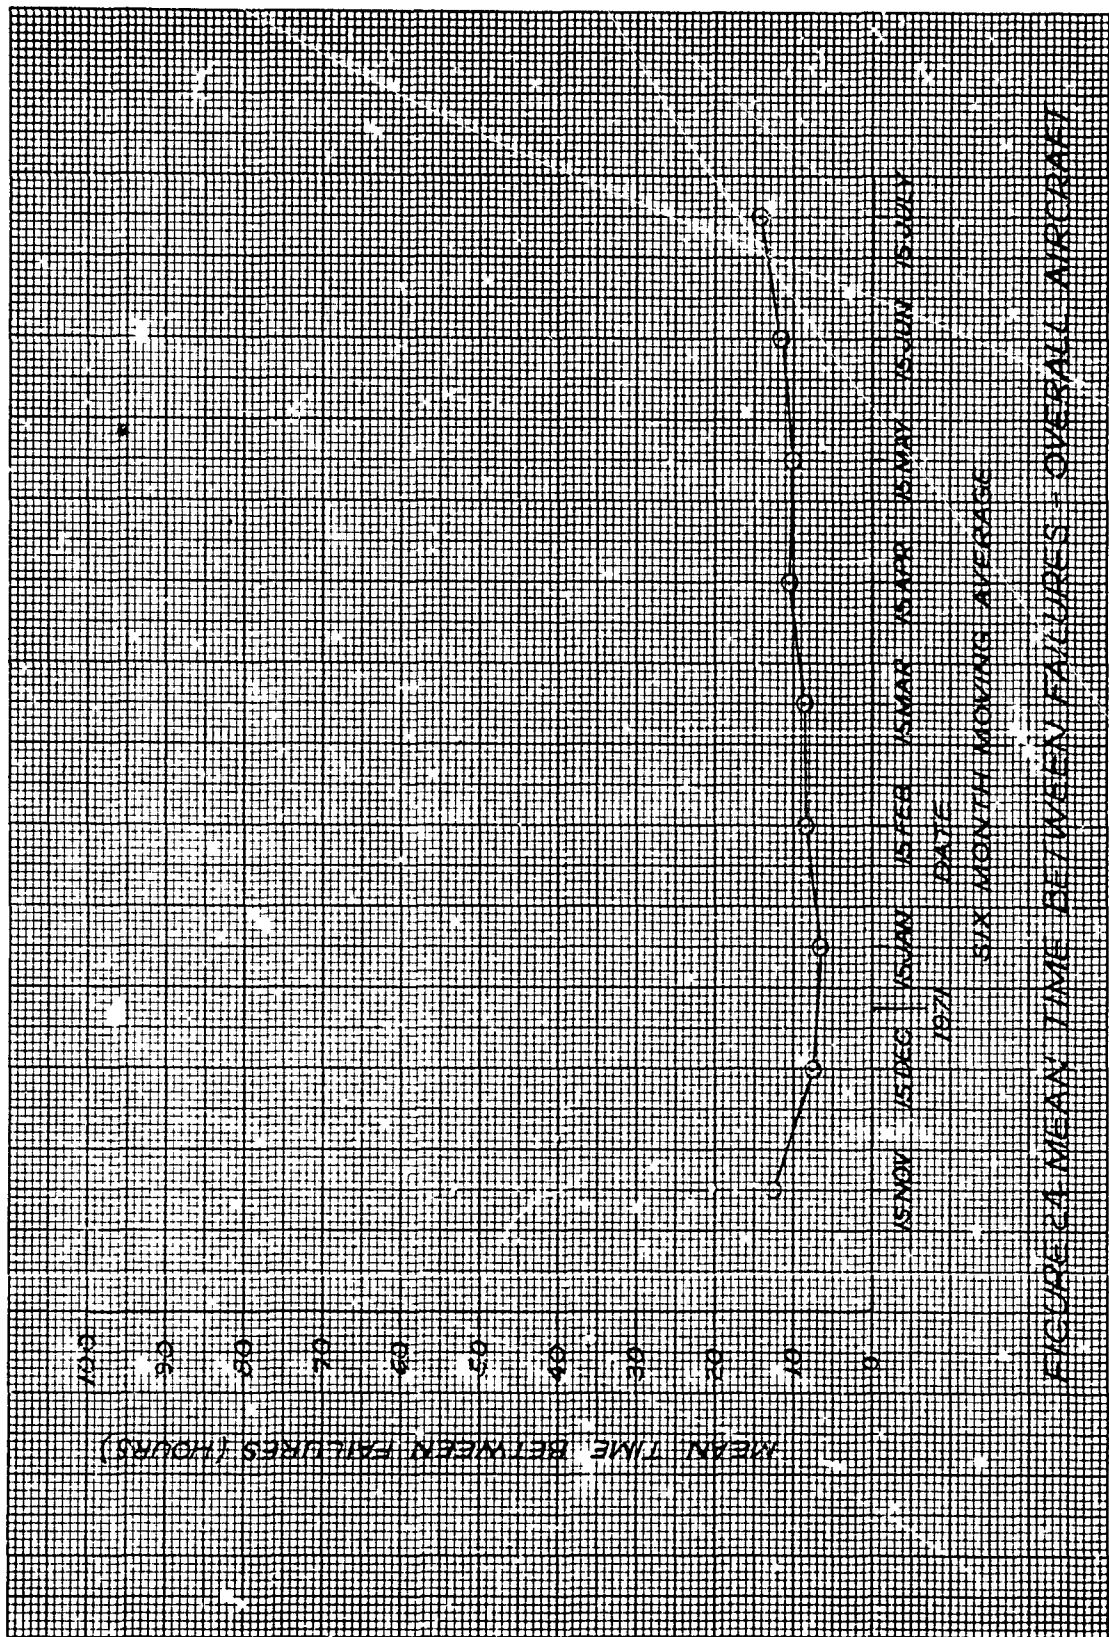
The trends in measured subsystem MTBF's for several work unit code (WUC) groups are shown in figures 22 and 23. The data presented in these graphs are averages for the previous 6 months, except for the first 4 months; that is, the MTBF shown for 15 December 1970 includes all data from 16 October 1970 through 15 December 1970. WUC groups not shown had an insufficient number of failures to develop any type of trend. Figure 24 presents the trend in mean time between subsystem failures for the overall UH-1N aircraft.
