UH-1N

# CATEGORY II AIRFRAME AND SUBSYSTEMS EVALUATION

TECHNICAL REPORT No. 71-37

AIR FORCE FLIGHT TEST CENTER  
EDWARDS AIR FORCE BASE, CALIFORNIA  
AIR FORCE SYSTEMS COMMAND  
UNITED STATES AIR FORCE

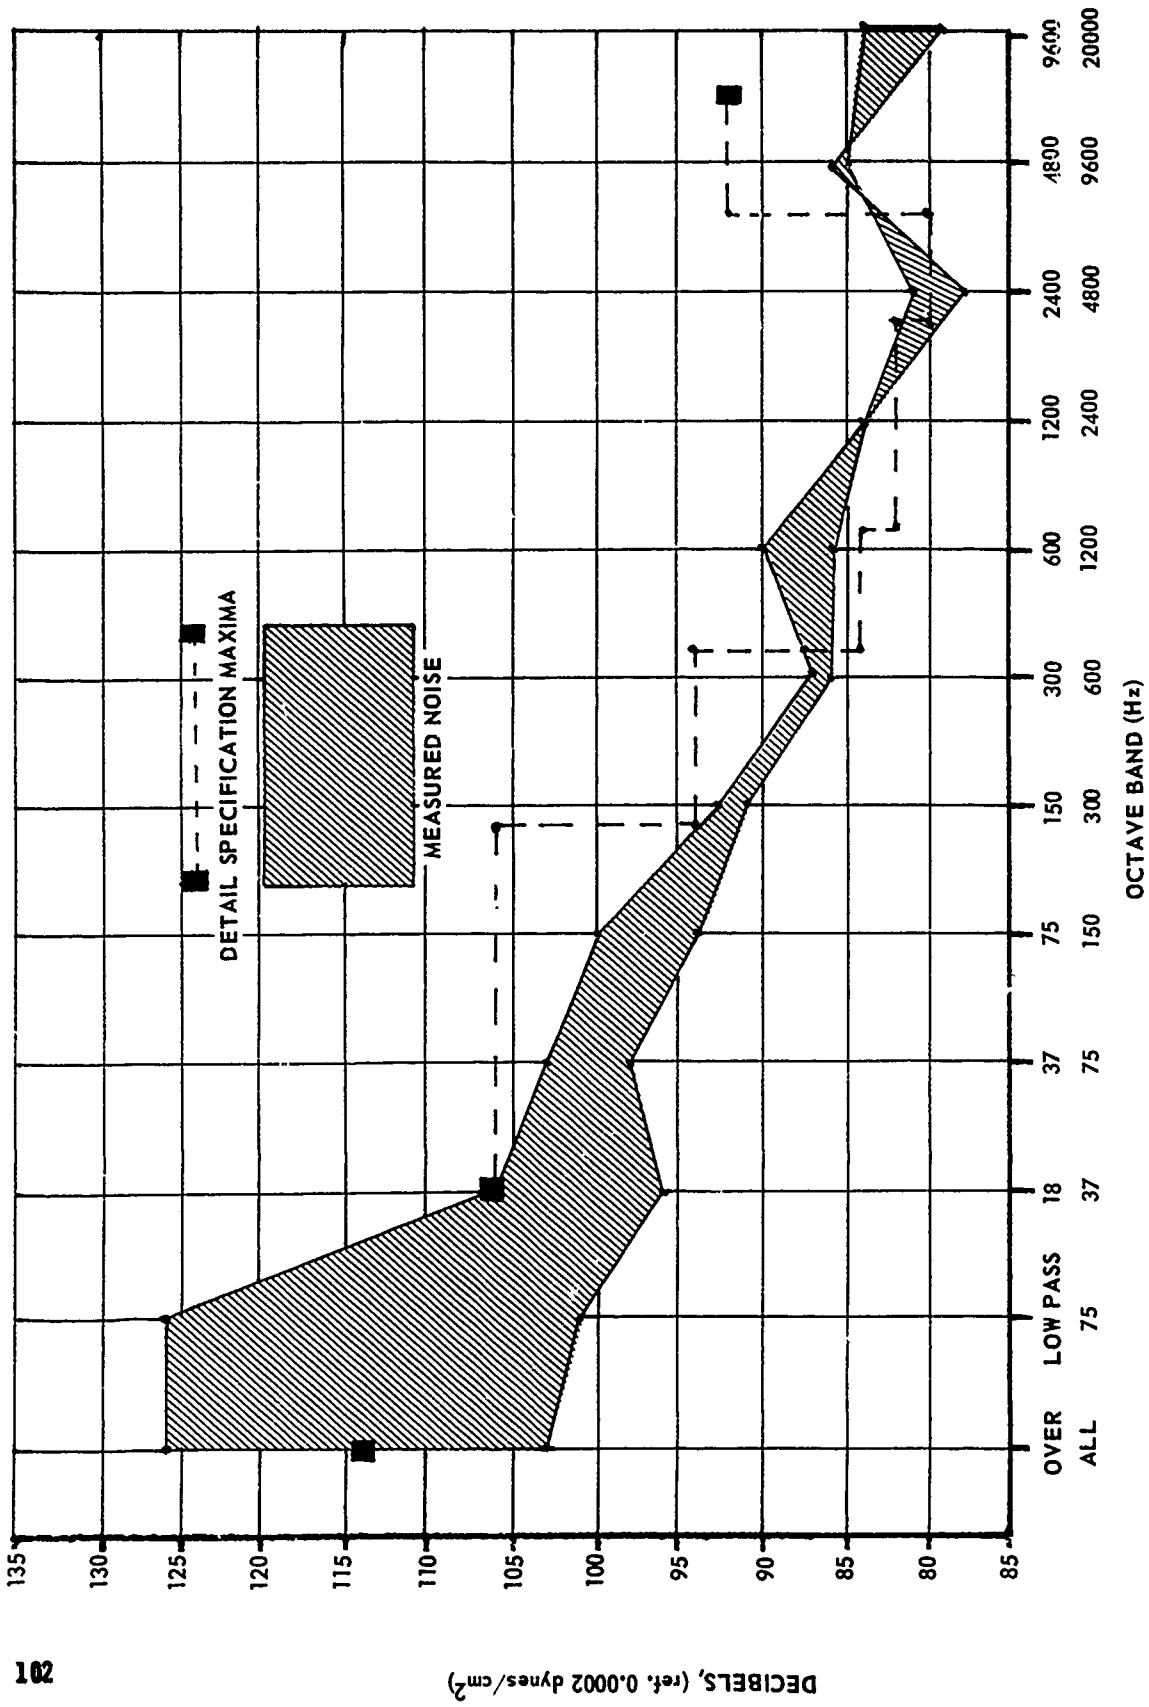
Figure 40 Comparison of Measured and Specified Noise Levels, 90-Knot Cruise

Figures 39 and 40 were prepared from the data in table XXXII to illustrate the internal noise levels compared with those in reference 27. Although internal noise levels exceeded those specified, the condition was not significant with respect to aircraft mission requirements and was not considered serious enough to warrant attempts to reduce noise levels in the aircraft. Noise levels in the 75 to 9,600 Hz frequency bands indicated that for all operations ground and flight crews should use hearing protectors in the form of sound suppressing flight helmets, earplugs, or ear muffs. The noise environment of the UH-1N was generally comparable to that of other aircraft and standard hearing conservation practices currently in use provided adequate personnel protection. (R 54)

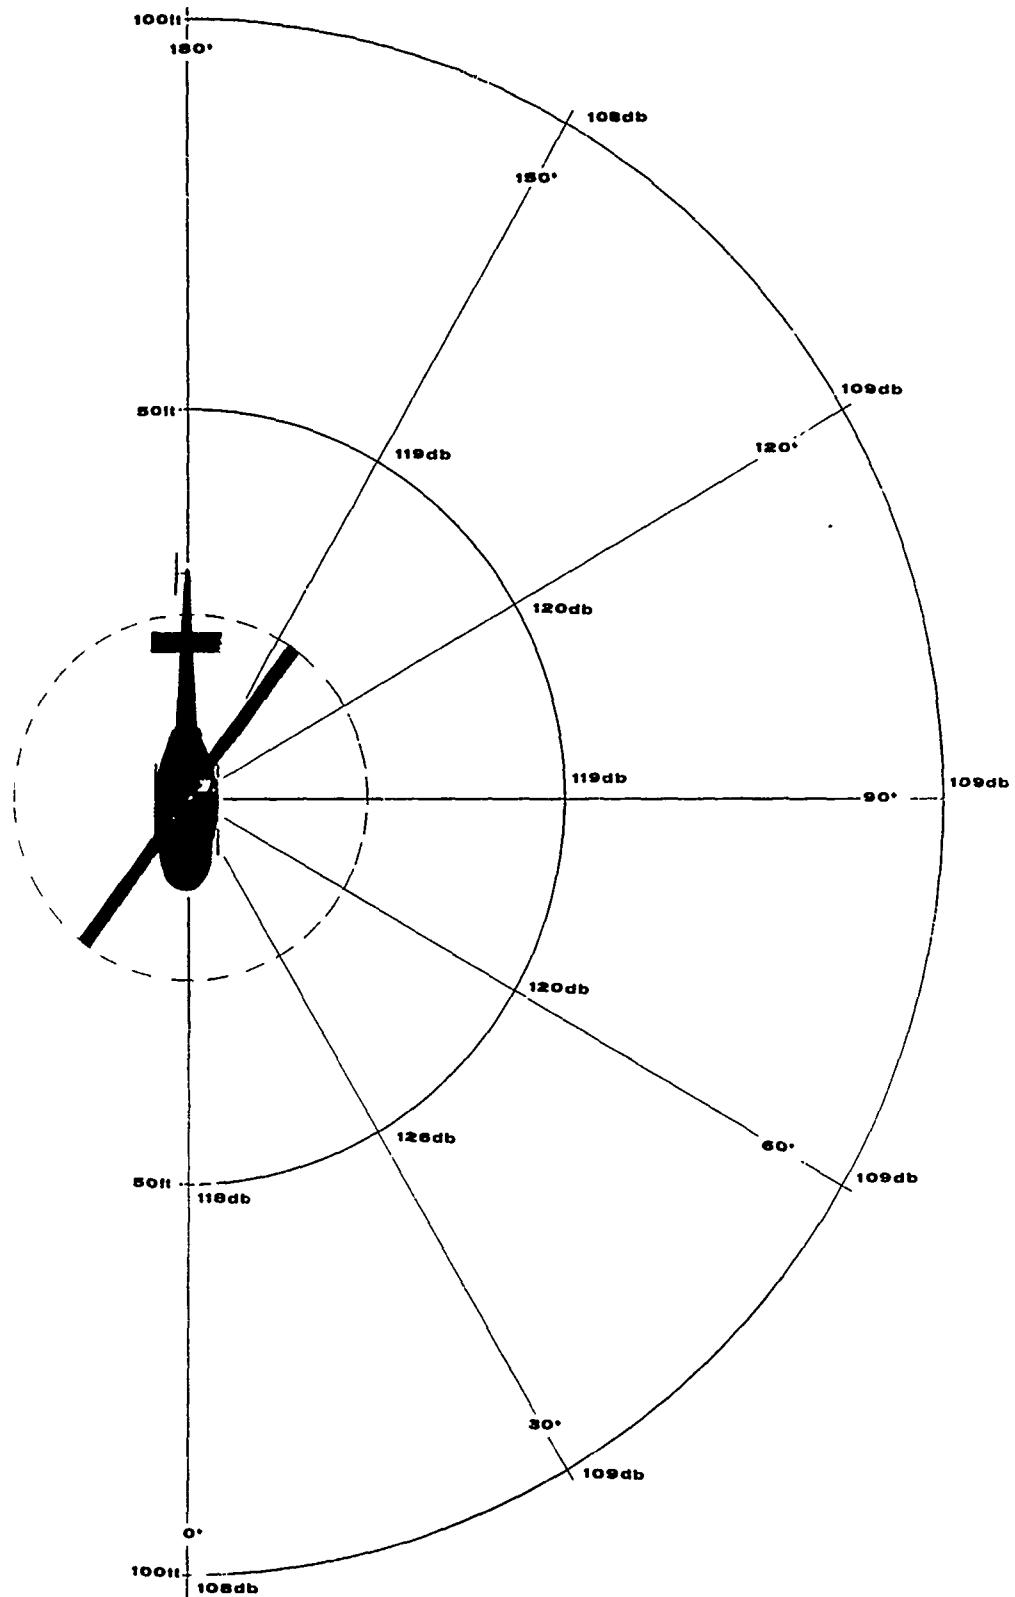
Figure 41 Loudspeaker Acoustical Energy Radiation Pattern

Figure 41 illustrates the relative power radiation pattern. The measurements were made at ground idle with a background noise level near the speaker of 115 decibels. The power setting employed was that required to produce 135 decibel signal and noise at the speaker. The sound radiation pattern close to the aircraft was most intense in the forward diagonal quadrant; however, at 100 feet no differences were observed. Inflight measurements of this type were not performed.
