# LIGHTNING EFFECTS RELATING TO AIRCRAFT PART I - LIGHTNING EFFECTS ON AND ELECTROMAGNETIC SHIELDING PROPERTIES OF BORON AND GRAPHITE REINFORCED COMPOSITE MATERIALS

F.A. Fisher High Voltage Laboratory General Electric Company

W.M. Fassell Materials and Processes Laboratory Aeronutronic Division Philco-Ford Corporation

Technical Report AFAL-TR-72-5

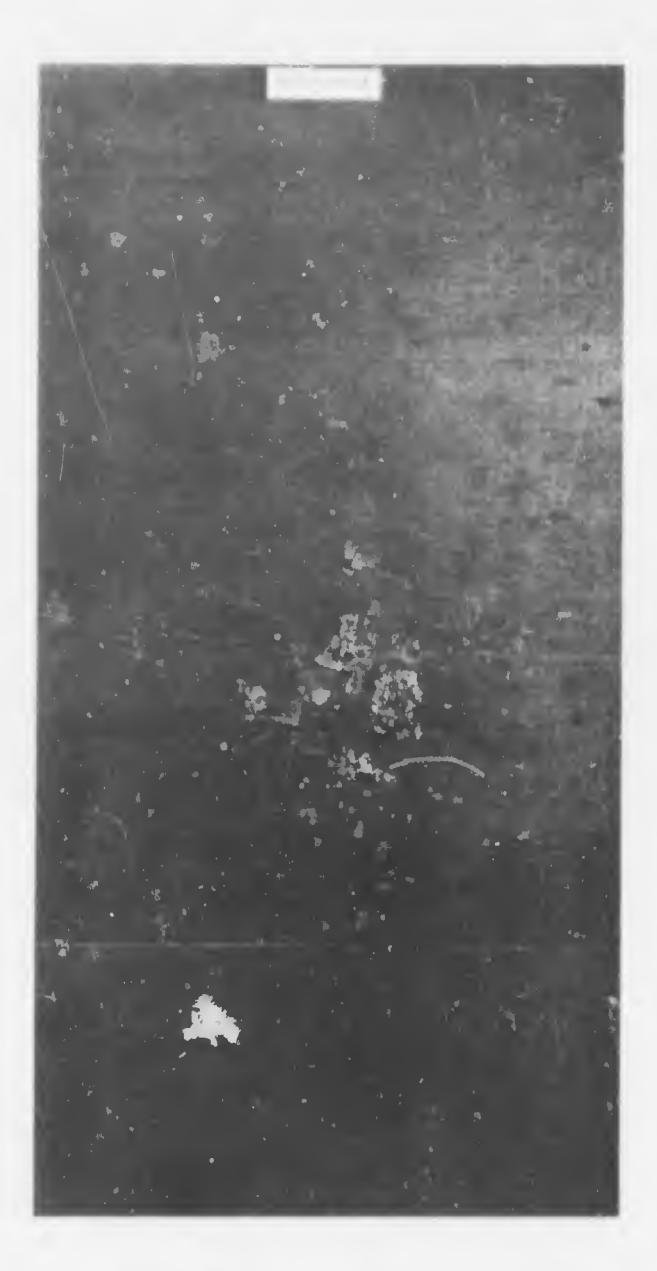
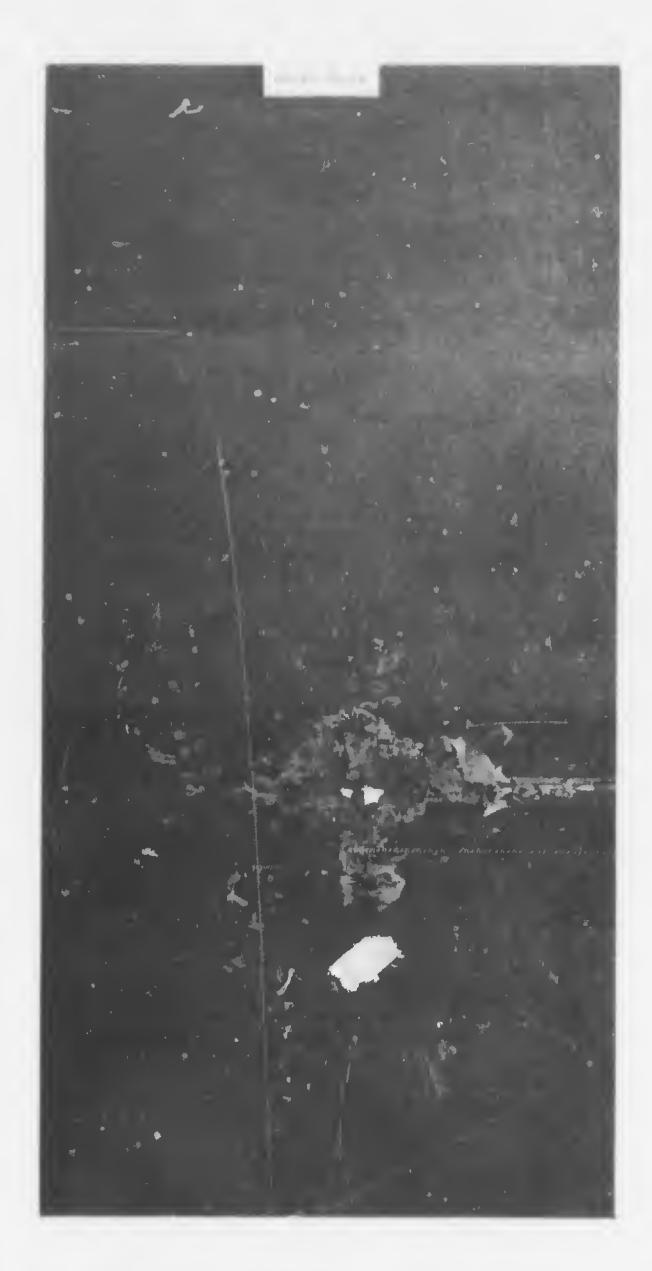
A GD-LS-70-1B (56 kA)

B GD-LS-70-2B (73 kA)

FIGURE 29 - Uncoated Boron Panels After Testing (Front Sides Shown)

The damage to this panel is shown on Figure 29B. As indicated, the damage consists of a spalled region in which the boron composite material was blown away from the panel. In this way it is very similar to the kind of damage one observes if a high voltage simulated lightning arc strikes a piece of concrete and punctures the concrete to a conductive reinforcing bar inside the concrete. The concrete blown away leaves a shallow conical depression of width several times its depth.

As was the pattern previously, the damage to the boron panel was much more severe than to the most nearly comparable graphite sample (Figure 12). There is a definite effect of the plies in spreading the damage at the arc impingement point out toward the edges of the panel. Damage was also observed all the way down the panel from the arc impingement point to the ground electrode.

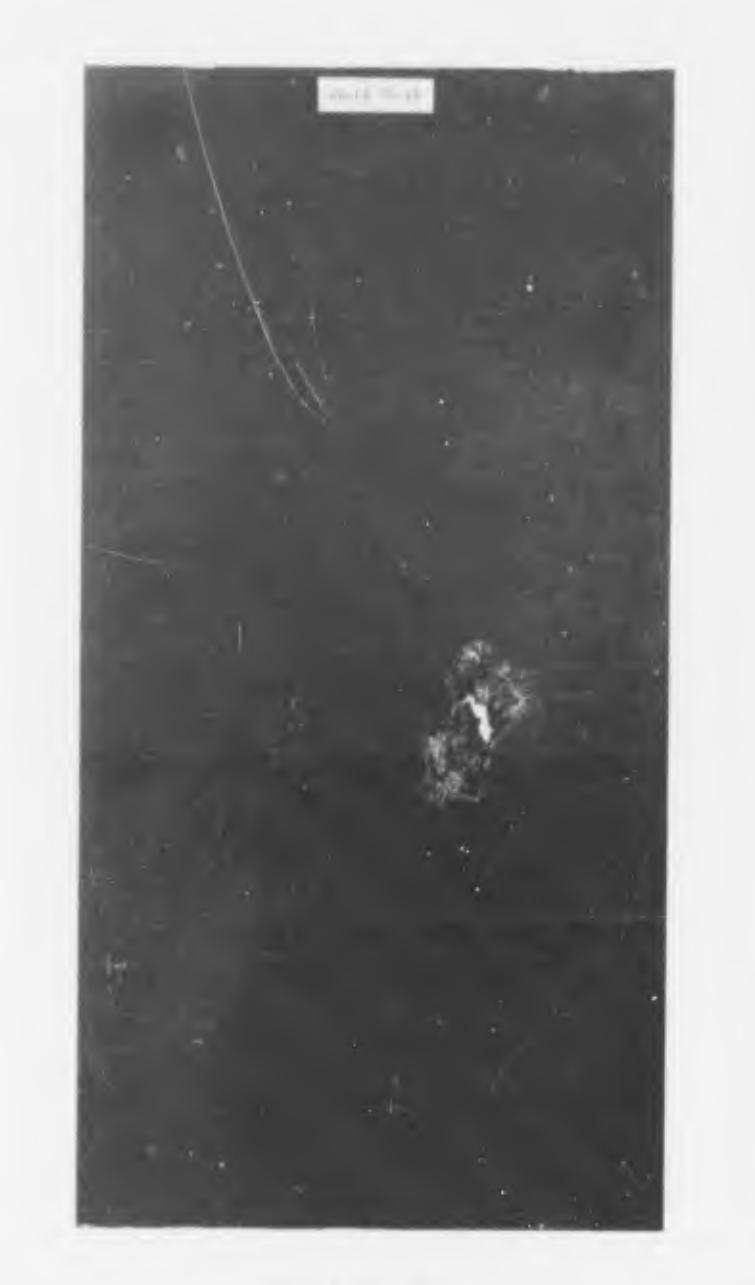
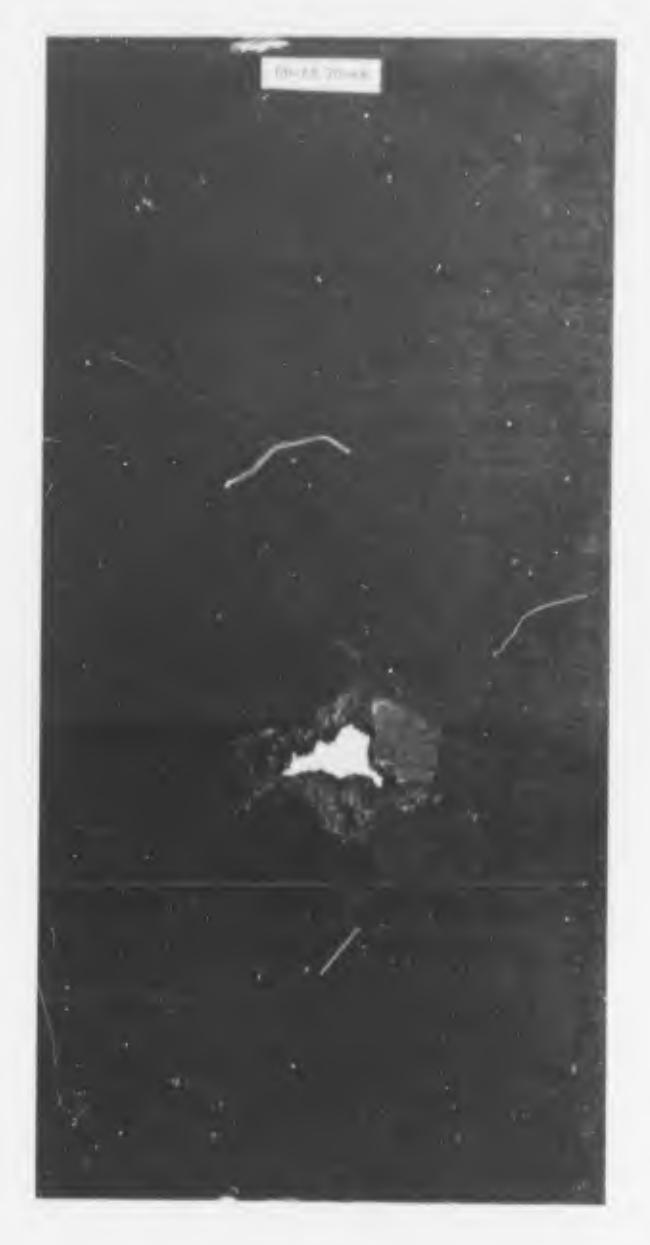
A GD-LS-70-3B (88 kA)

B GD-LS-70-4B (168 kA)

FIGURE 31 - Uncoated Boron Panels After Testing (Back Sides Shown)

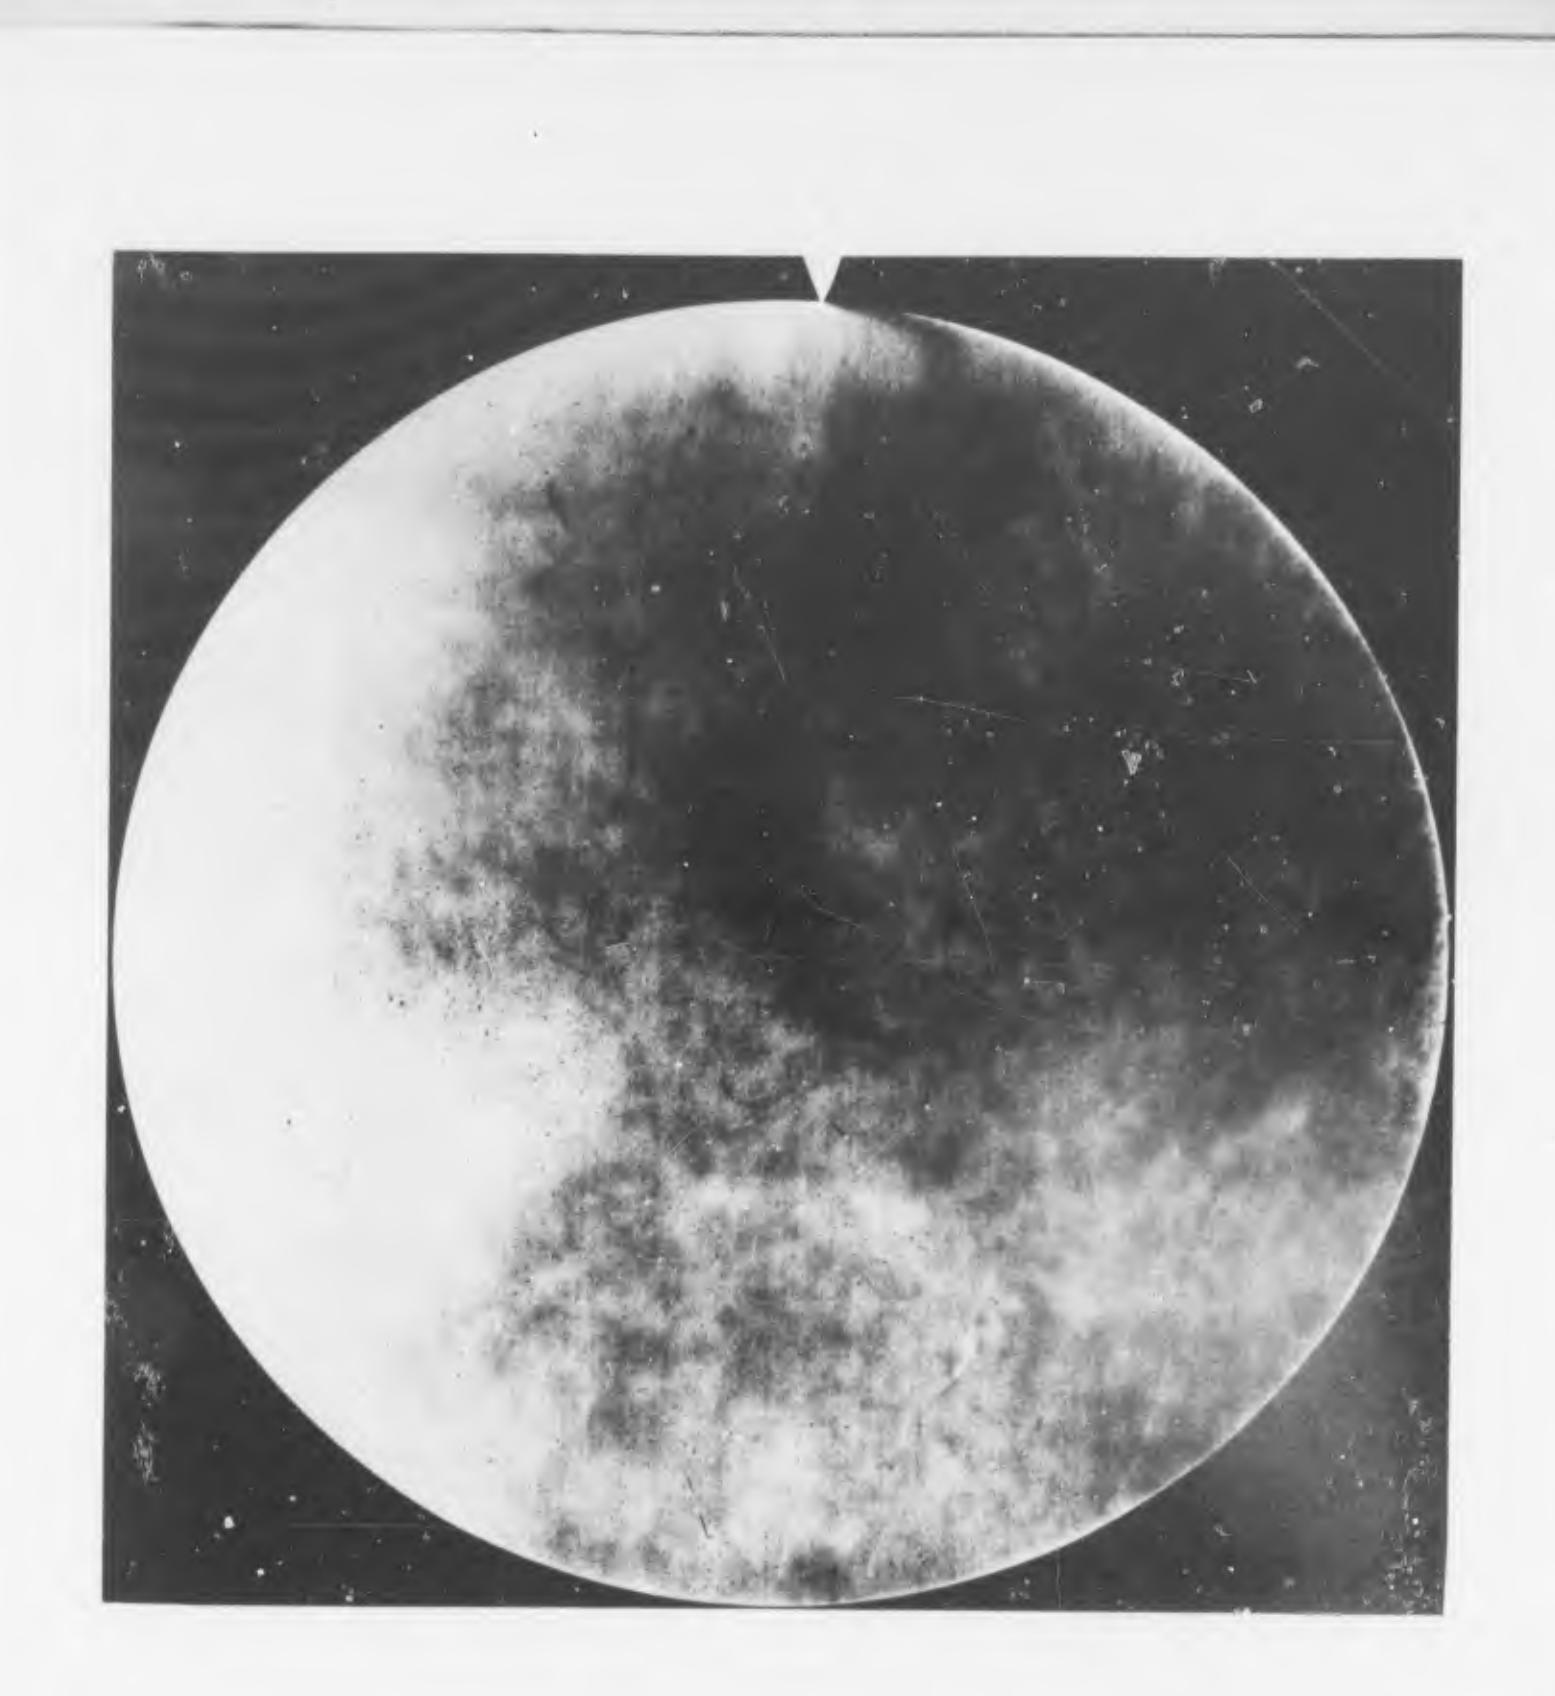
Figure 52 is typical of a 0° and 90° layup of high modulus graphite. The fibers appear uniformly spaced and straight on LS-70-1.

FIGURE 52 - Extracted X-Ray Radiograph of Thornel-50/Epoxy Panel LS-70-1 Before Simulated Lightning Test

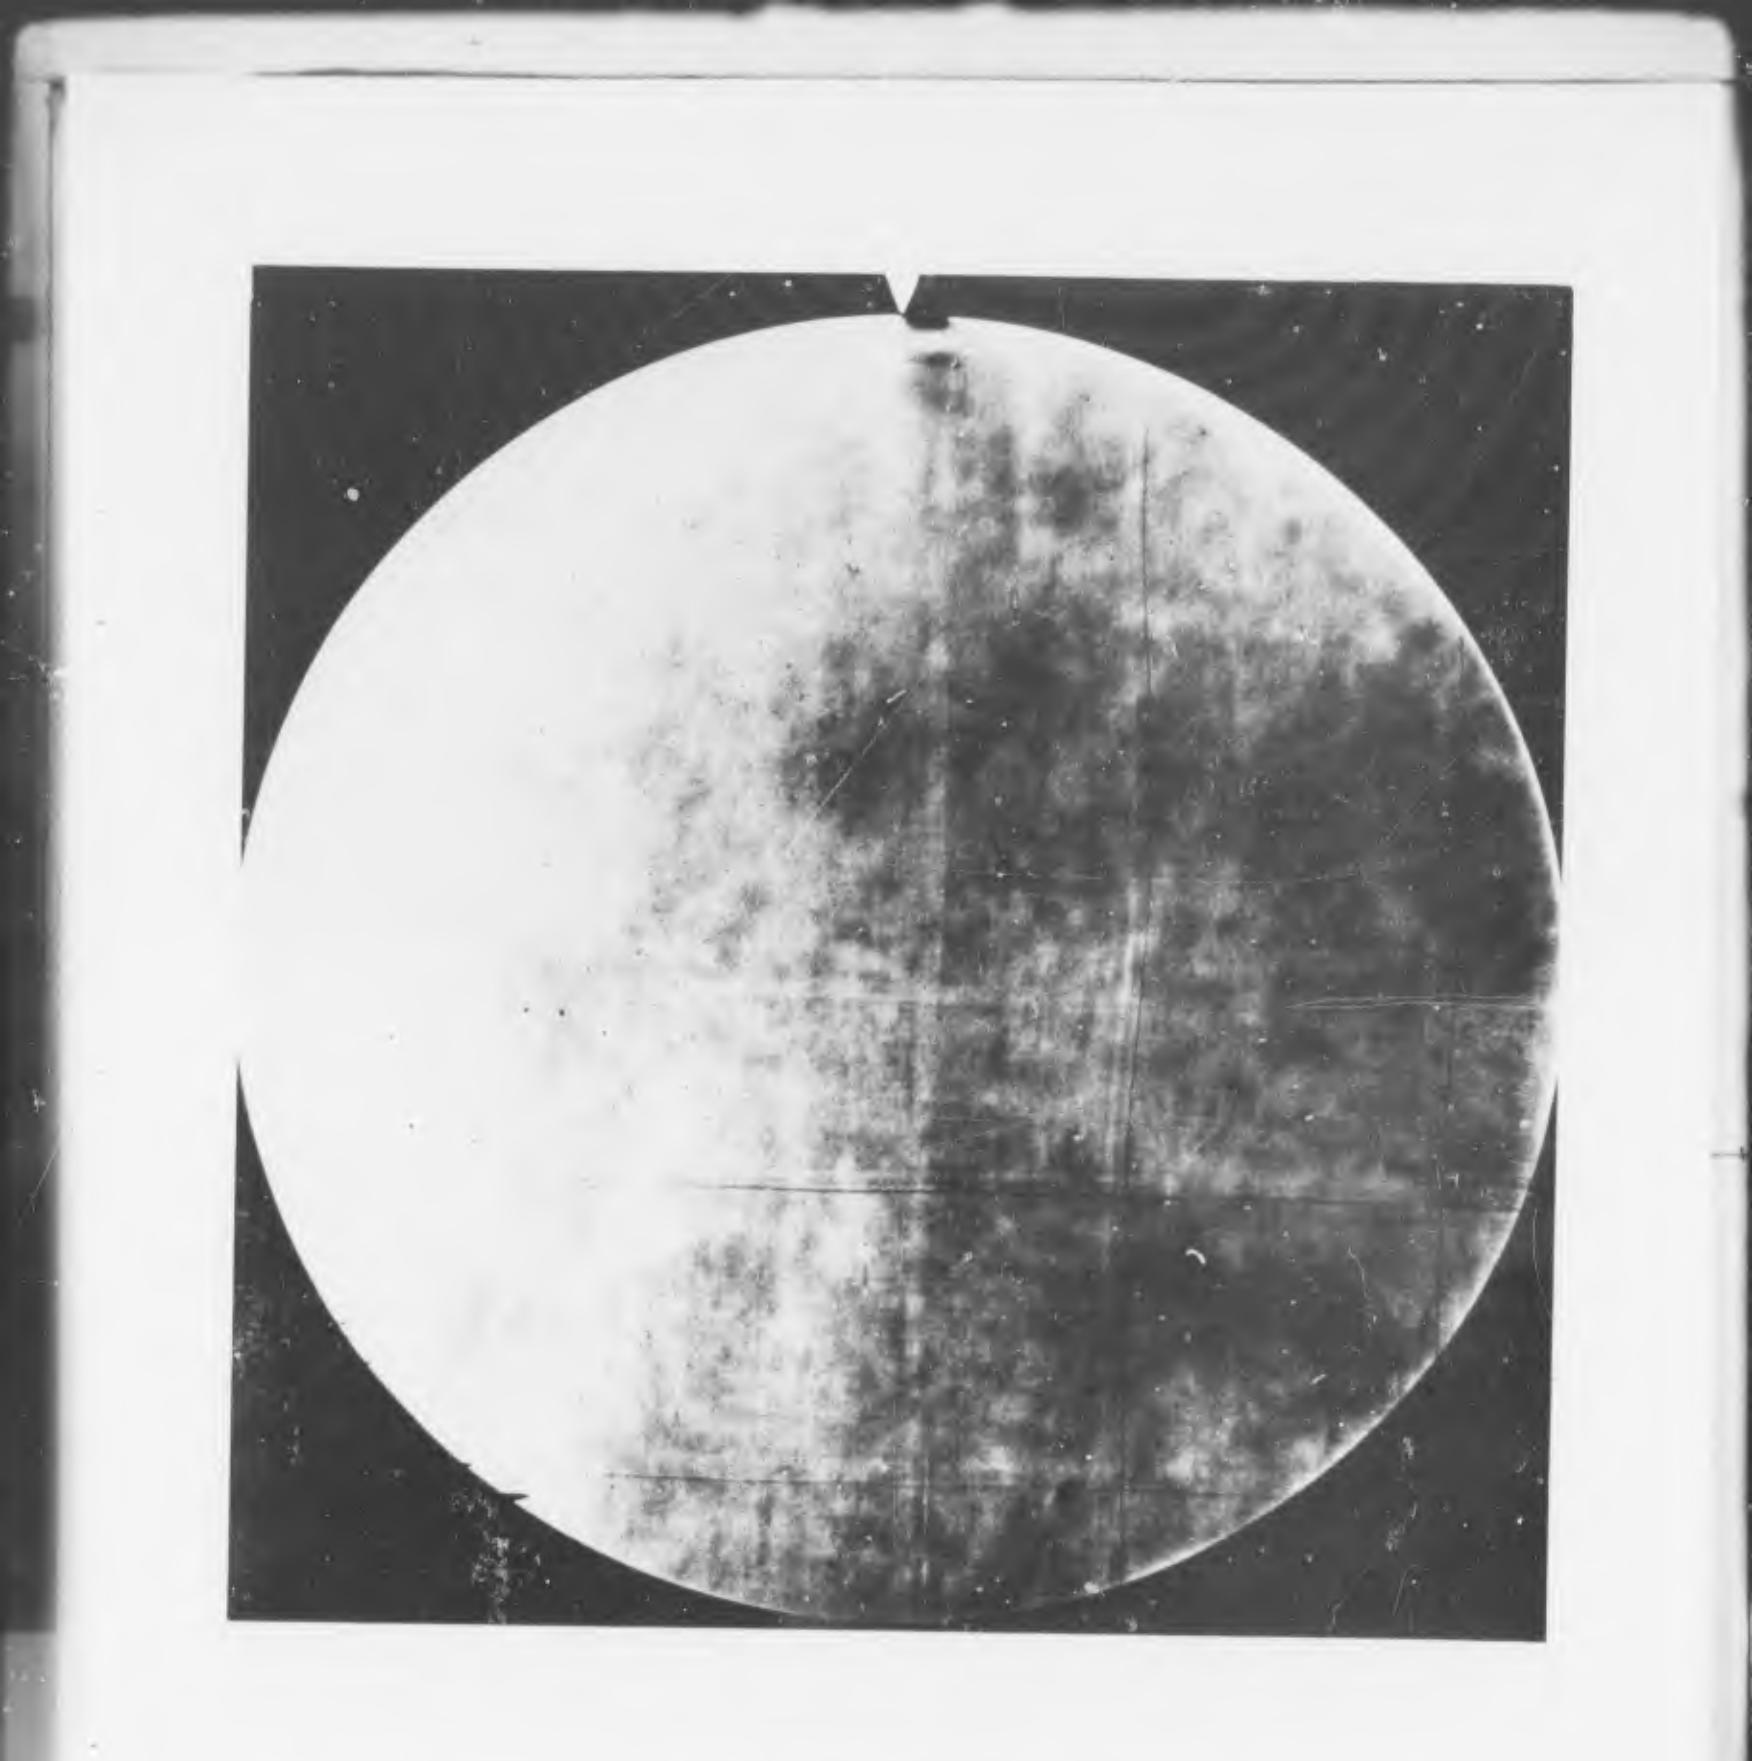
Figure 53 of Panel LS-70-2 contains a number of dark lines generally parallel, and waviness of the plies in one direction is easily observed. Panel LS-70-3 appears reasonably uniform. Specimen LS-70-4 shows strong irregularities

FIGURE 53 - Extracted X-Ray Radiograph of Thornel-50/Epoxy Panel LS-70-2 Before Simulated Lightning Test

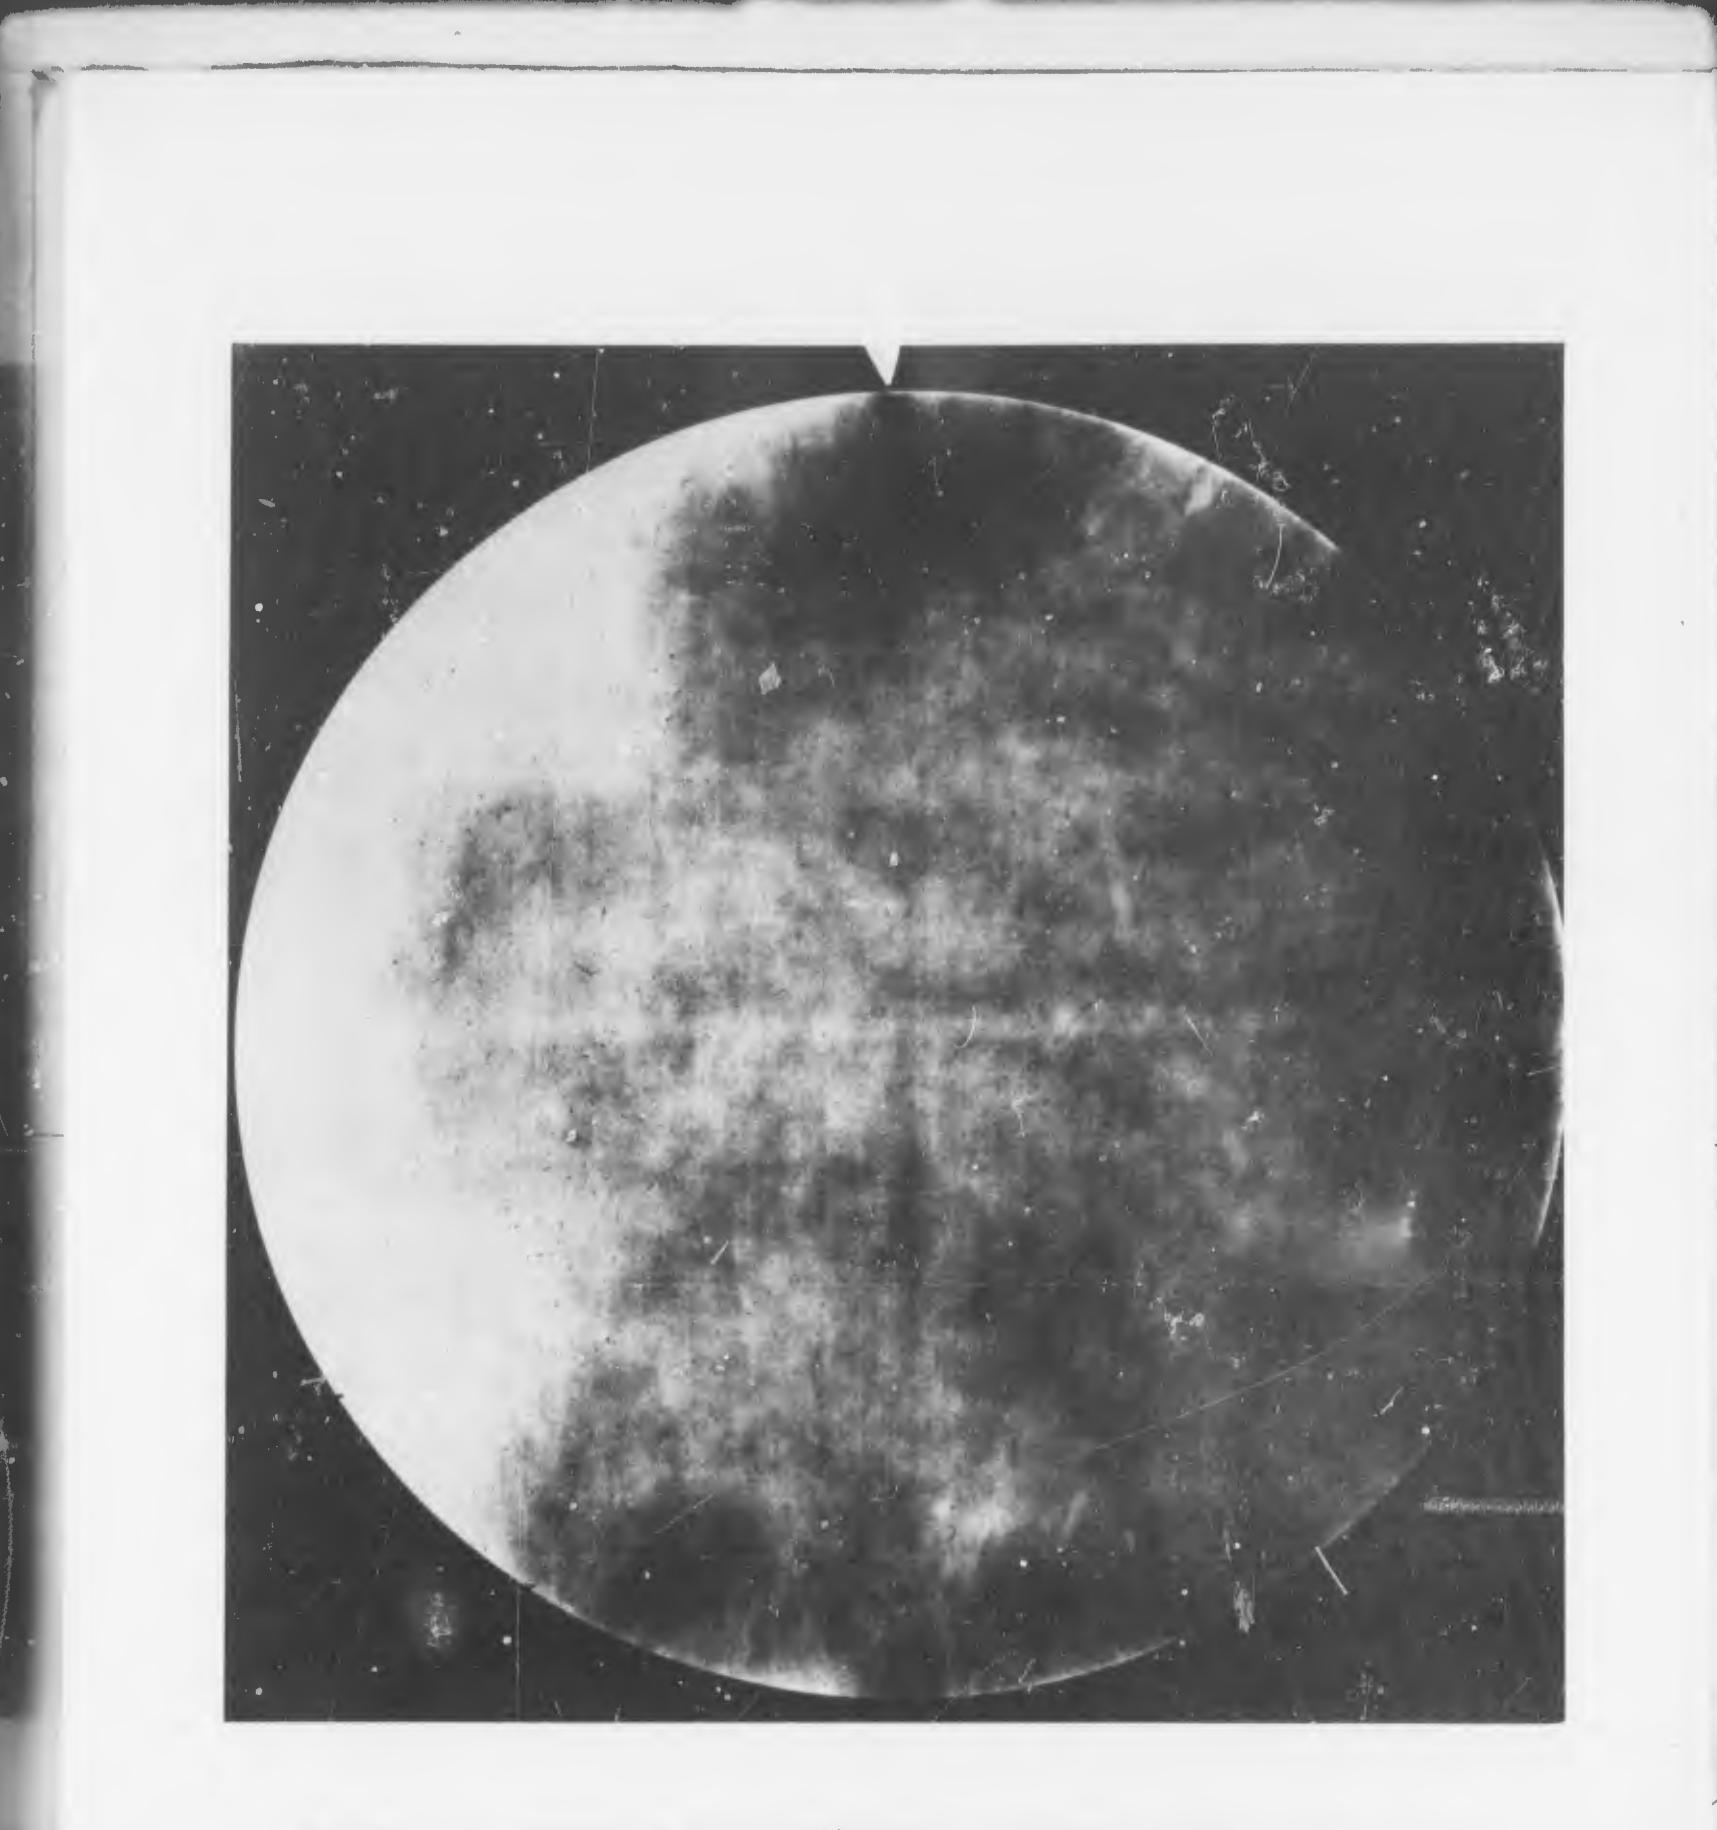
FIGURE 54 - Extracted X-Ray Radiograph of Thornel-50/Epoxy Panel LS-70-3 Before Simulated Lightning Test

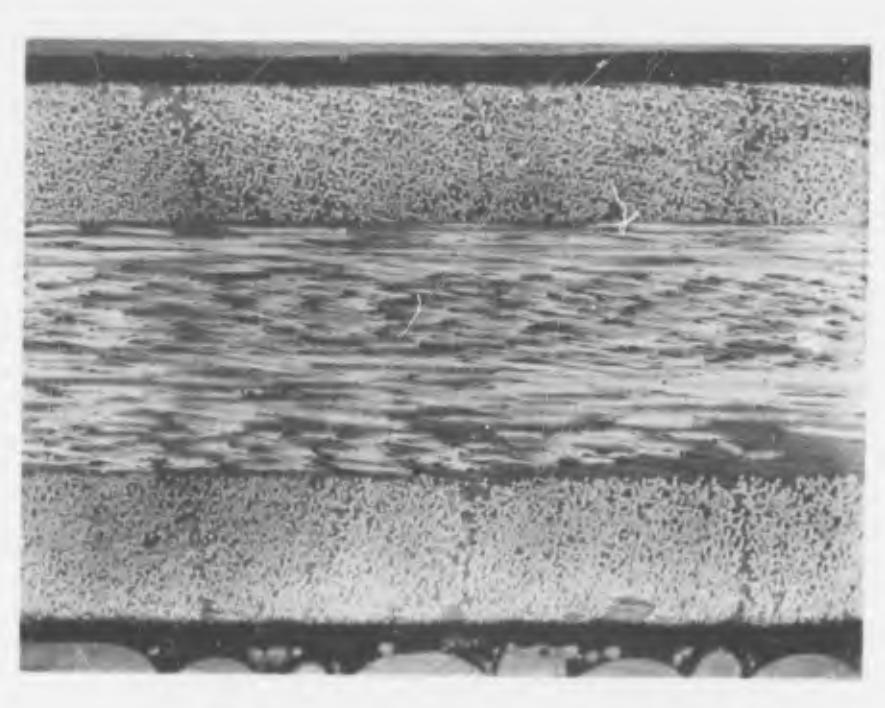
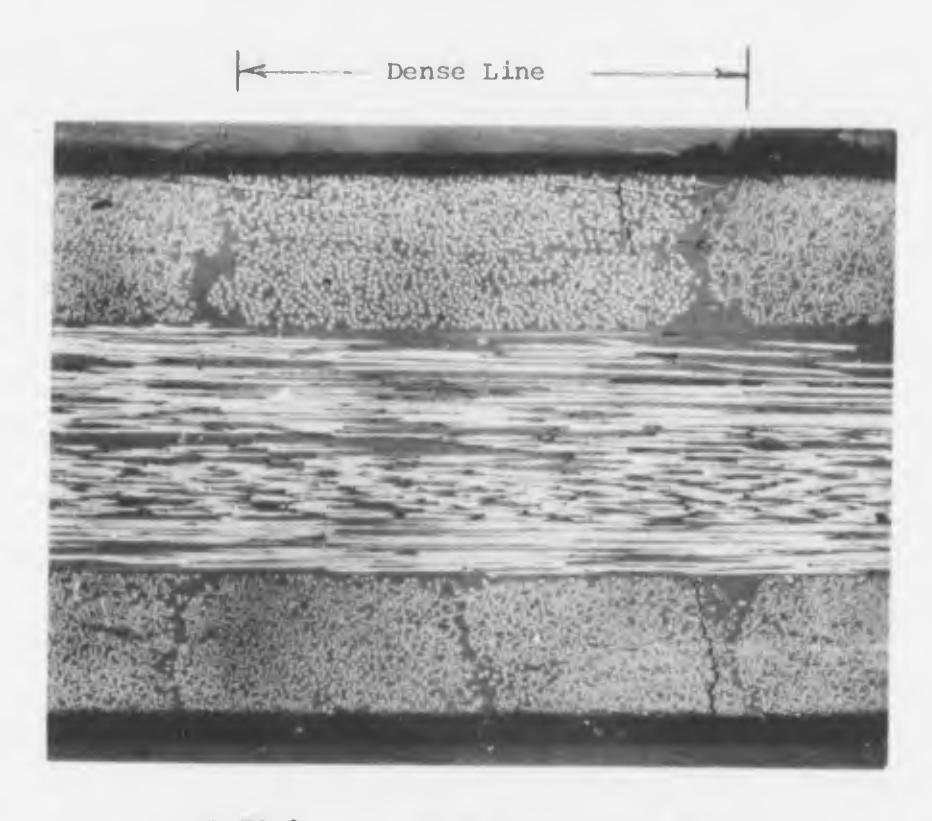
Overall appearances of the chosen areas had no drastic or obvious physical differences in material appearance under plain and polarized reflected light. Sample LS-70-2 and LS-70-4 contained less dense (black) lines. Examination of these lines showed that the dark (lower density) lines of both samples are caused by the presence of bundles of fibers with individual fiber diameters measuring 8 to 10 microns, or twice that of the surrounding matrix graphite. The various photomicrographs are shown on Figures 56 through 58. It can be noted in the photomicrographs of LS-70-2 and LS-70-4 at 200X that packing densities for the bundles of larger diameter fibers are strikingly less than the adjacent bundles made of smaller diameter filaments. One bundle photographed at 100X shows a cross-section diameter of 0.7 millimeter. Measurements of the same line on the X-ray print shows that line to be somewhat less than 1 millimeter (estimated to be 0.75 millimeter using a millimeter scale). Two such areas in

LS-70-2 100X Denser Line

LS-70-2 100X Black Line

FIGURE 57 - Photomicrographs Showing the Differences Between a Dense Area and the Dark Line of Panel LS-70-2

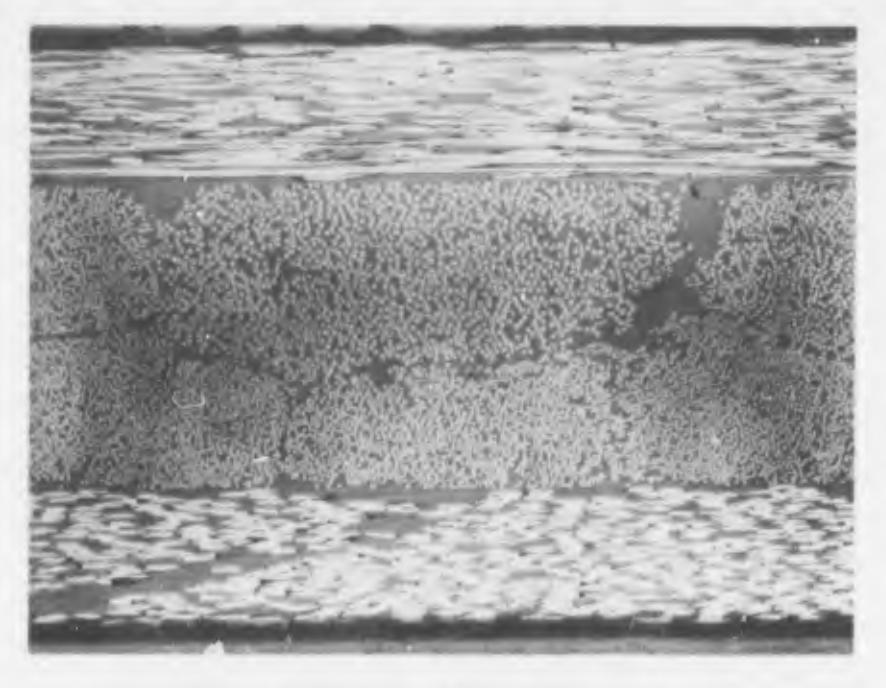
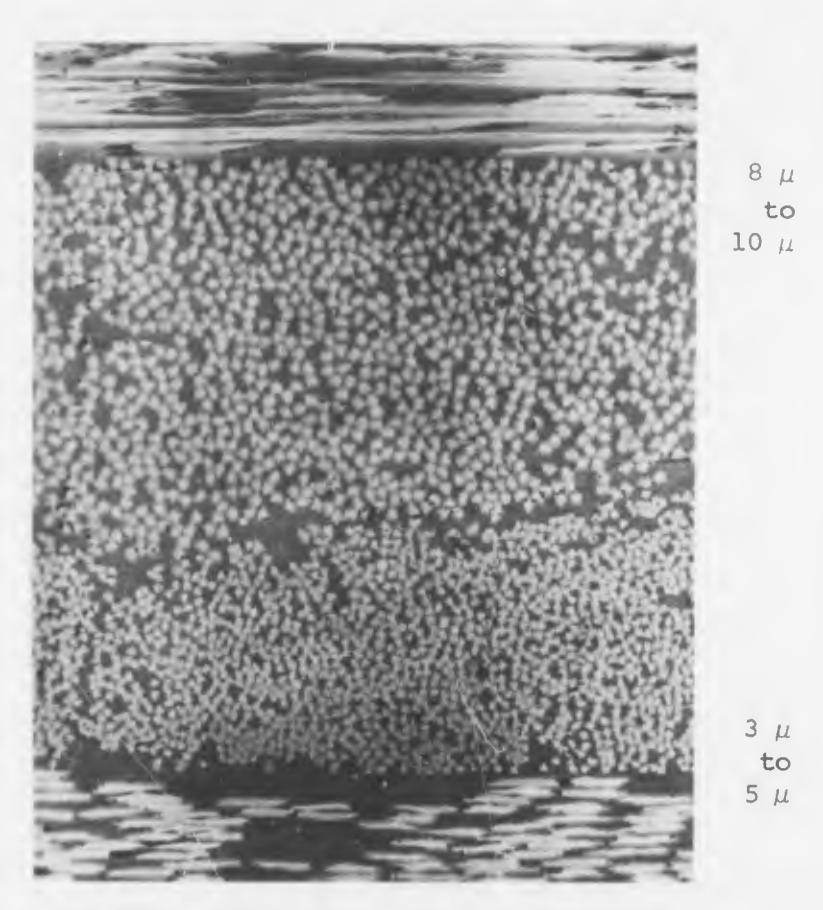
LS-70-4 100X 1 of 2 Dark Lines

LS-70-4 200 X Dark Line (Low Density)

the LS-70-4 sample correspond to lines marked on the sample surface; one bundle occurs in Sample LS-70-2 closely adjacent to a mark made on the surface prior to examination.

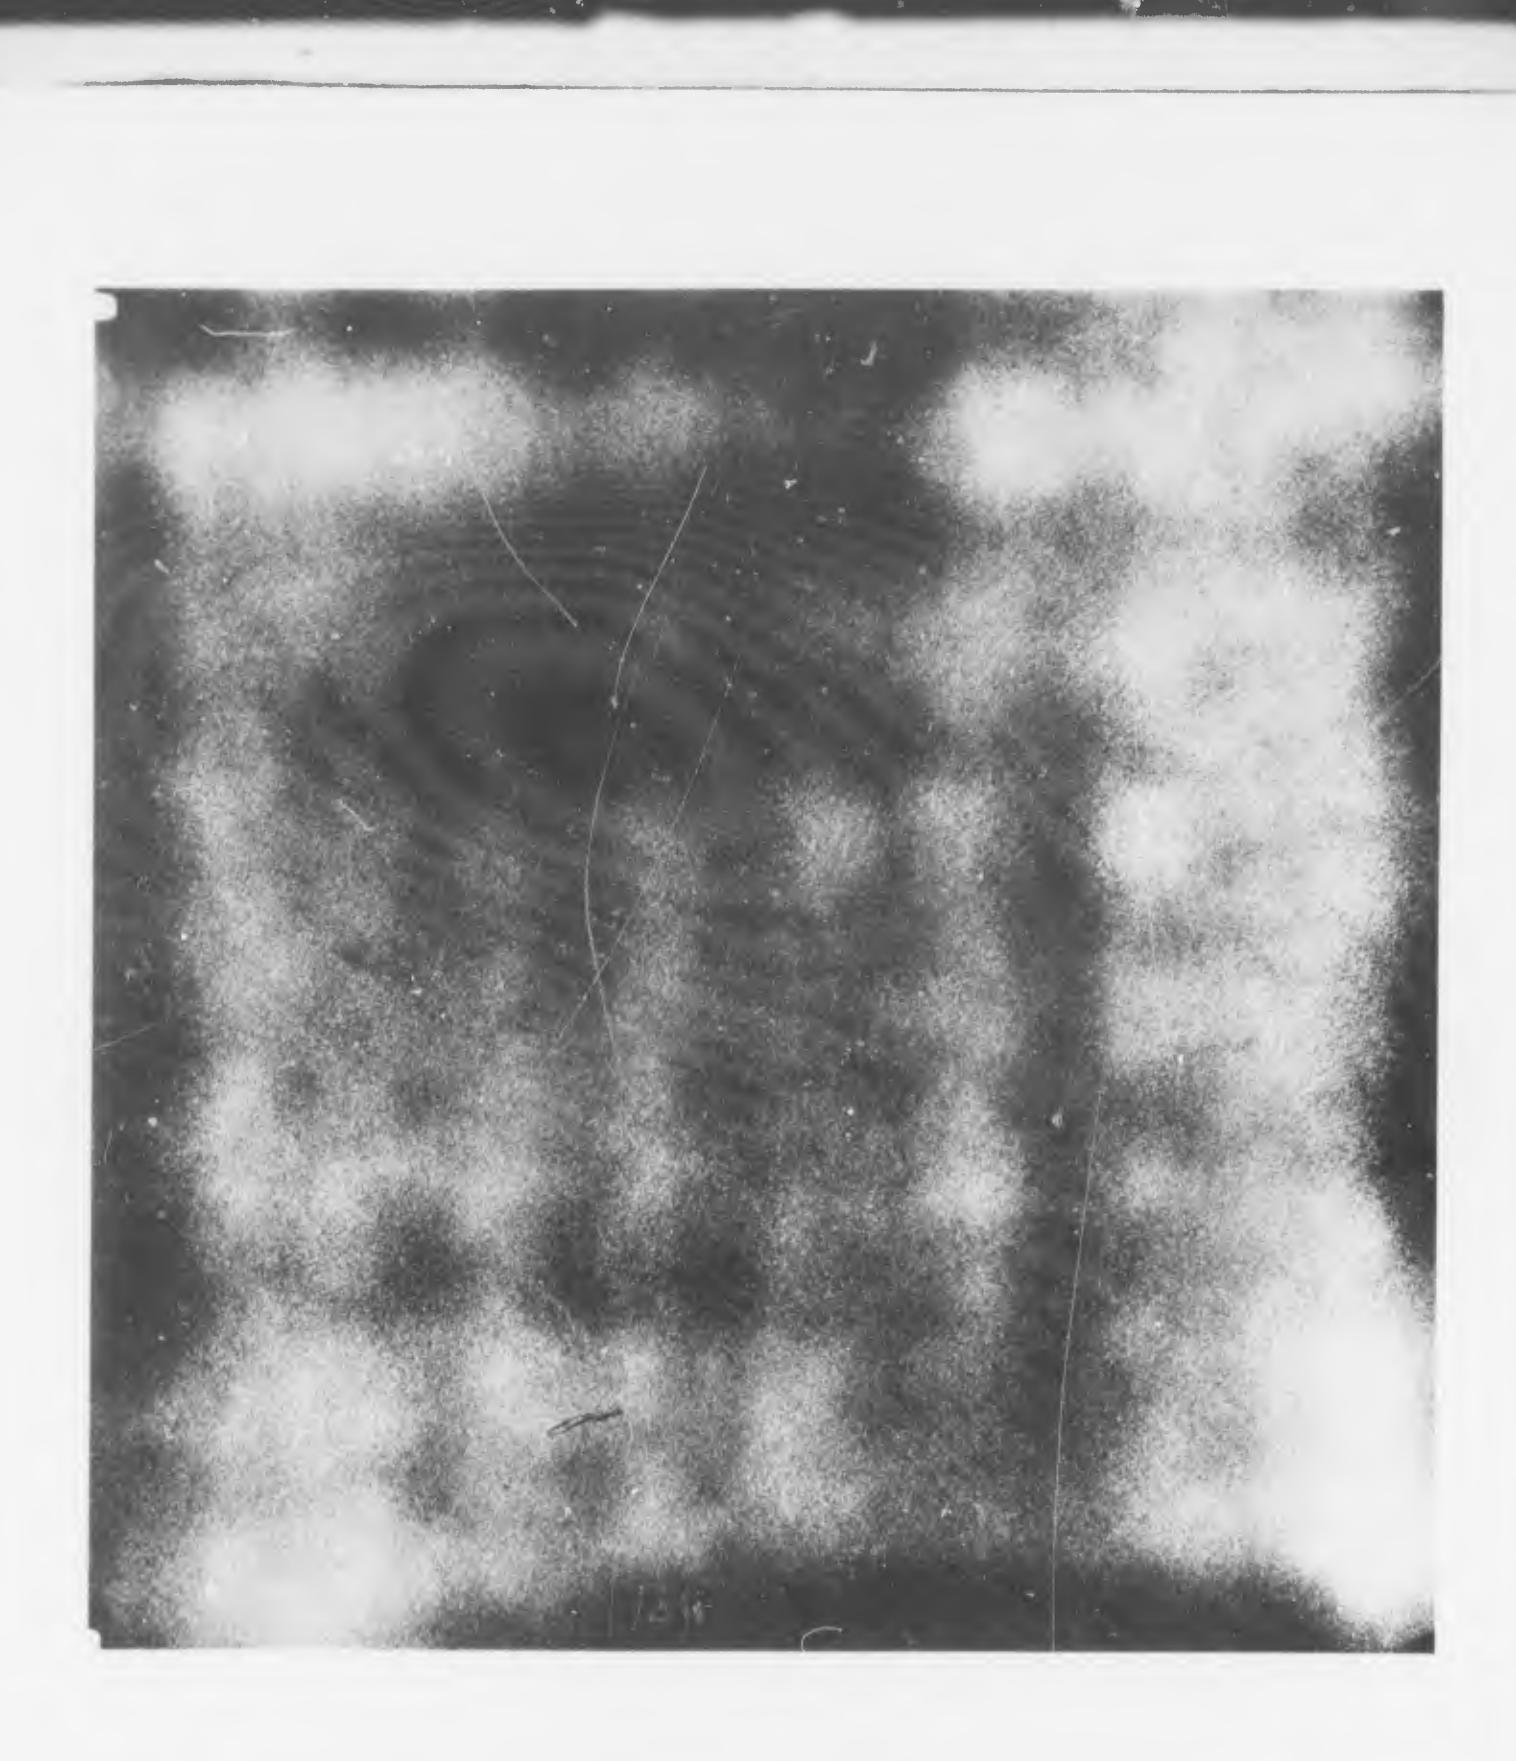
Reference X-ray radiographs were also made of the silver-paint coated panels. The very large difference in atomic numbers between silver and the graphite-epoxy makes it impossible to determine structural details of the graphite either on the original radiograph or on the separation negative. The variation of the paint film was clearly shown on each sample. Figure 59 is a typical print made from a separation negative to enhance the contrast of the original radiograph. The lighter bands represent increased thickness. Apparently the panels were spray-painted with two coats, with the gun travel at 90° on successive coats. The white specks correspond to "pimples" on the painted surface.

FIGURE 59 - Photo Extraction Showing Variations of Silver-Paint Coating Thickness - Typical for Panels LS-70-5 through LS-70-8

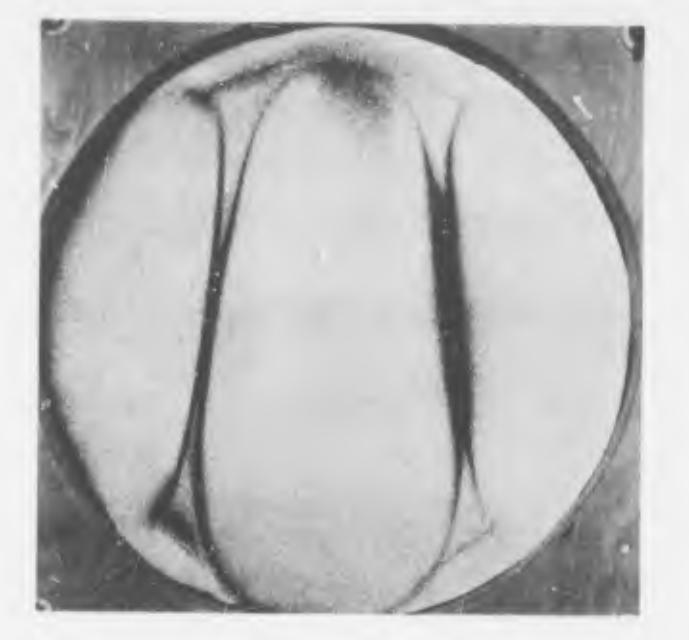
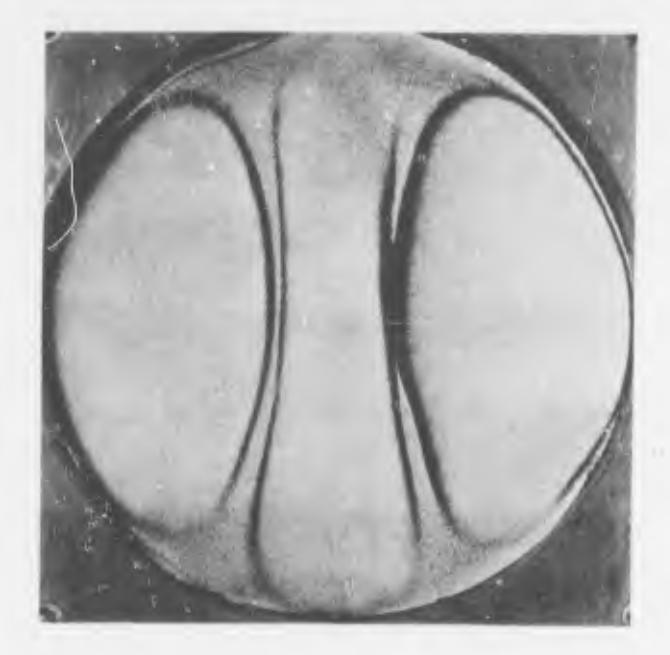
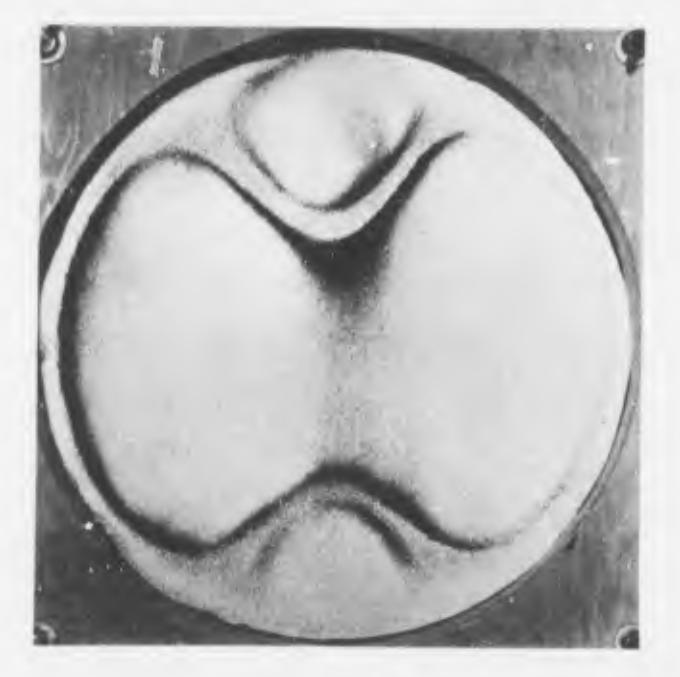
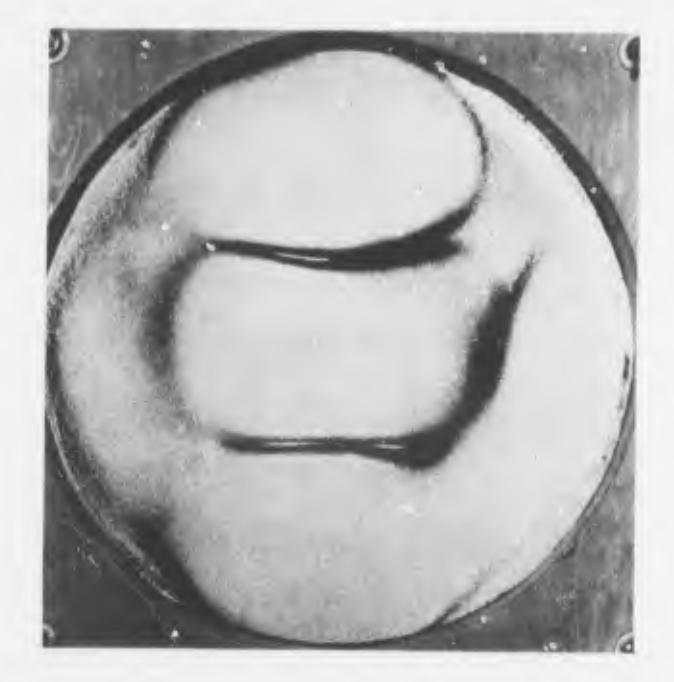
None of the patterns examined show any pronounced asymmetry indicative of serious panel defects. This is not surprising since careful visual examination, X-ray radiographs, and ultrasonic "C"-scan examination of the panels likewise indicated that none had any particular defects. Figures 60, 61 and 62 show the vibration patterns obtained with silver-painted panels at various frequencies. Panel LS-70-6, Figure 61 showed perhaps the greatest amount of pattern asymmetry, but this could not be correlated with any other panel properties or defects. The pattern for panel LS-70-7 (not included with this report) showed a place where the silver coating was debonded at one edge of the panel. The silver-paint coating was chipped along this edge and the chipping could be seen visually.

FIGURE 60 - Characteristic Vibration Patterns of a 0.040" Silver-Paint Coated Panel

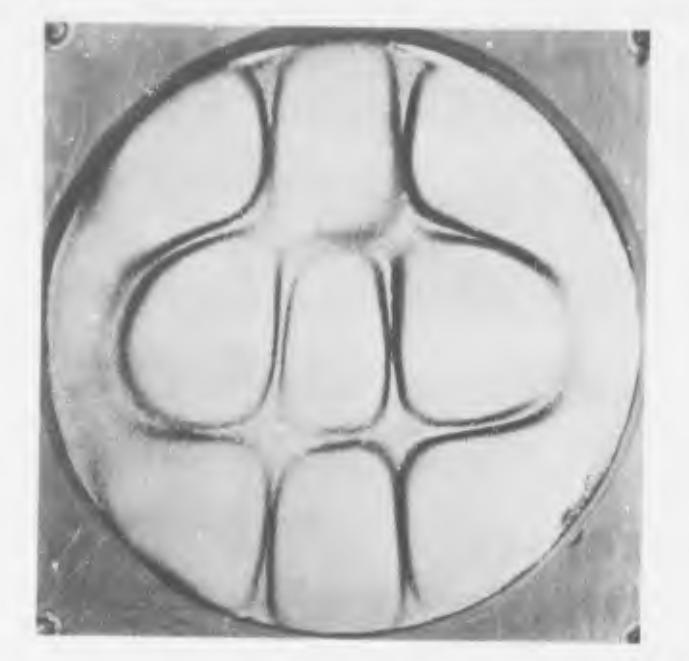
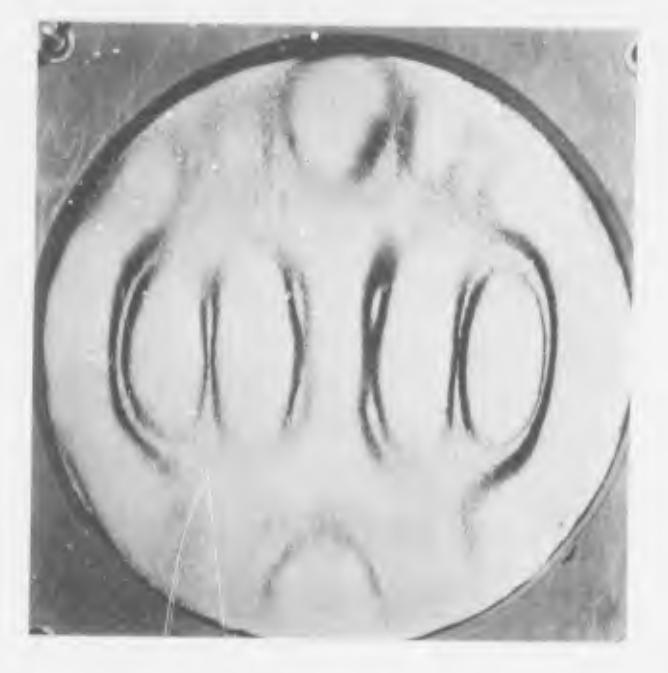
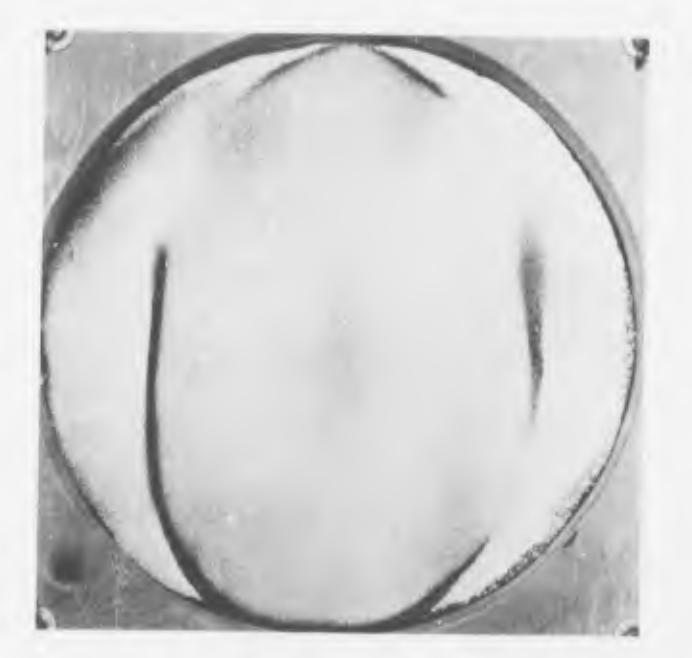
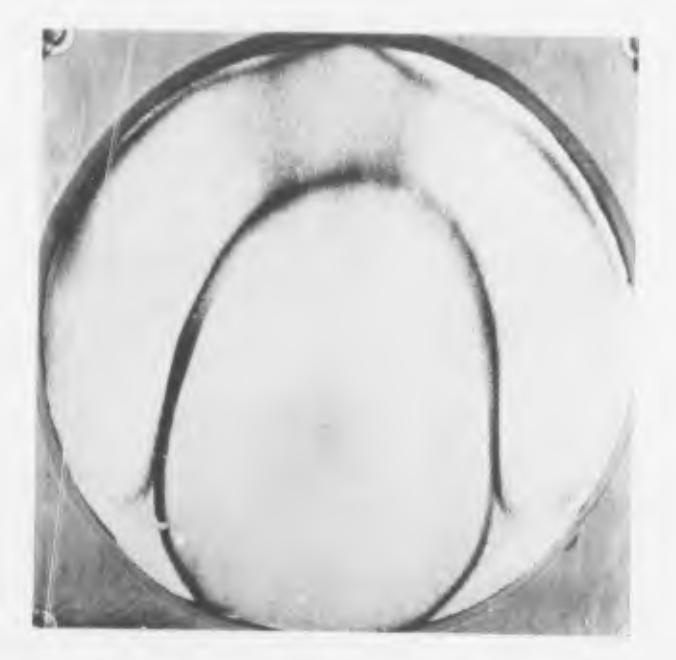
FIGURE 61 - Characteristic Vibration Patterns of 0.040" Silver-Paint Coated Panel
