# LIGHTNING EFFECTS RELATING TO AIRCRAFT PART I - LIGHTNING EFFECTS ON AND ELECTROMAGNETIC SHIELDING PROPERTIES OF BORON AND GRAPHITE REINFORCED COMPOSITE MATERIALS

F.A. Fisher High Voltage Laboratory General Electric Company

W.M. Fassell Materials and Processes Laboratory Aeronutronic Division Philco-Ford Corporation

Technical Report AFAL-TR-72-5

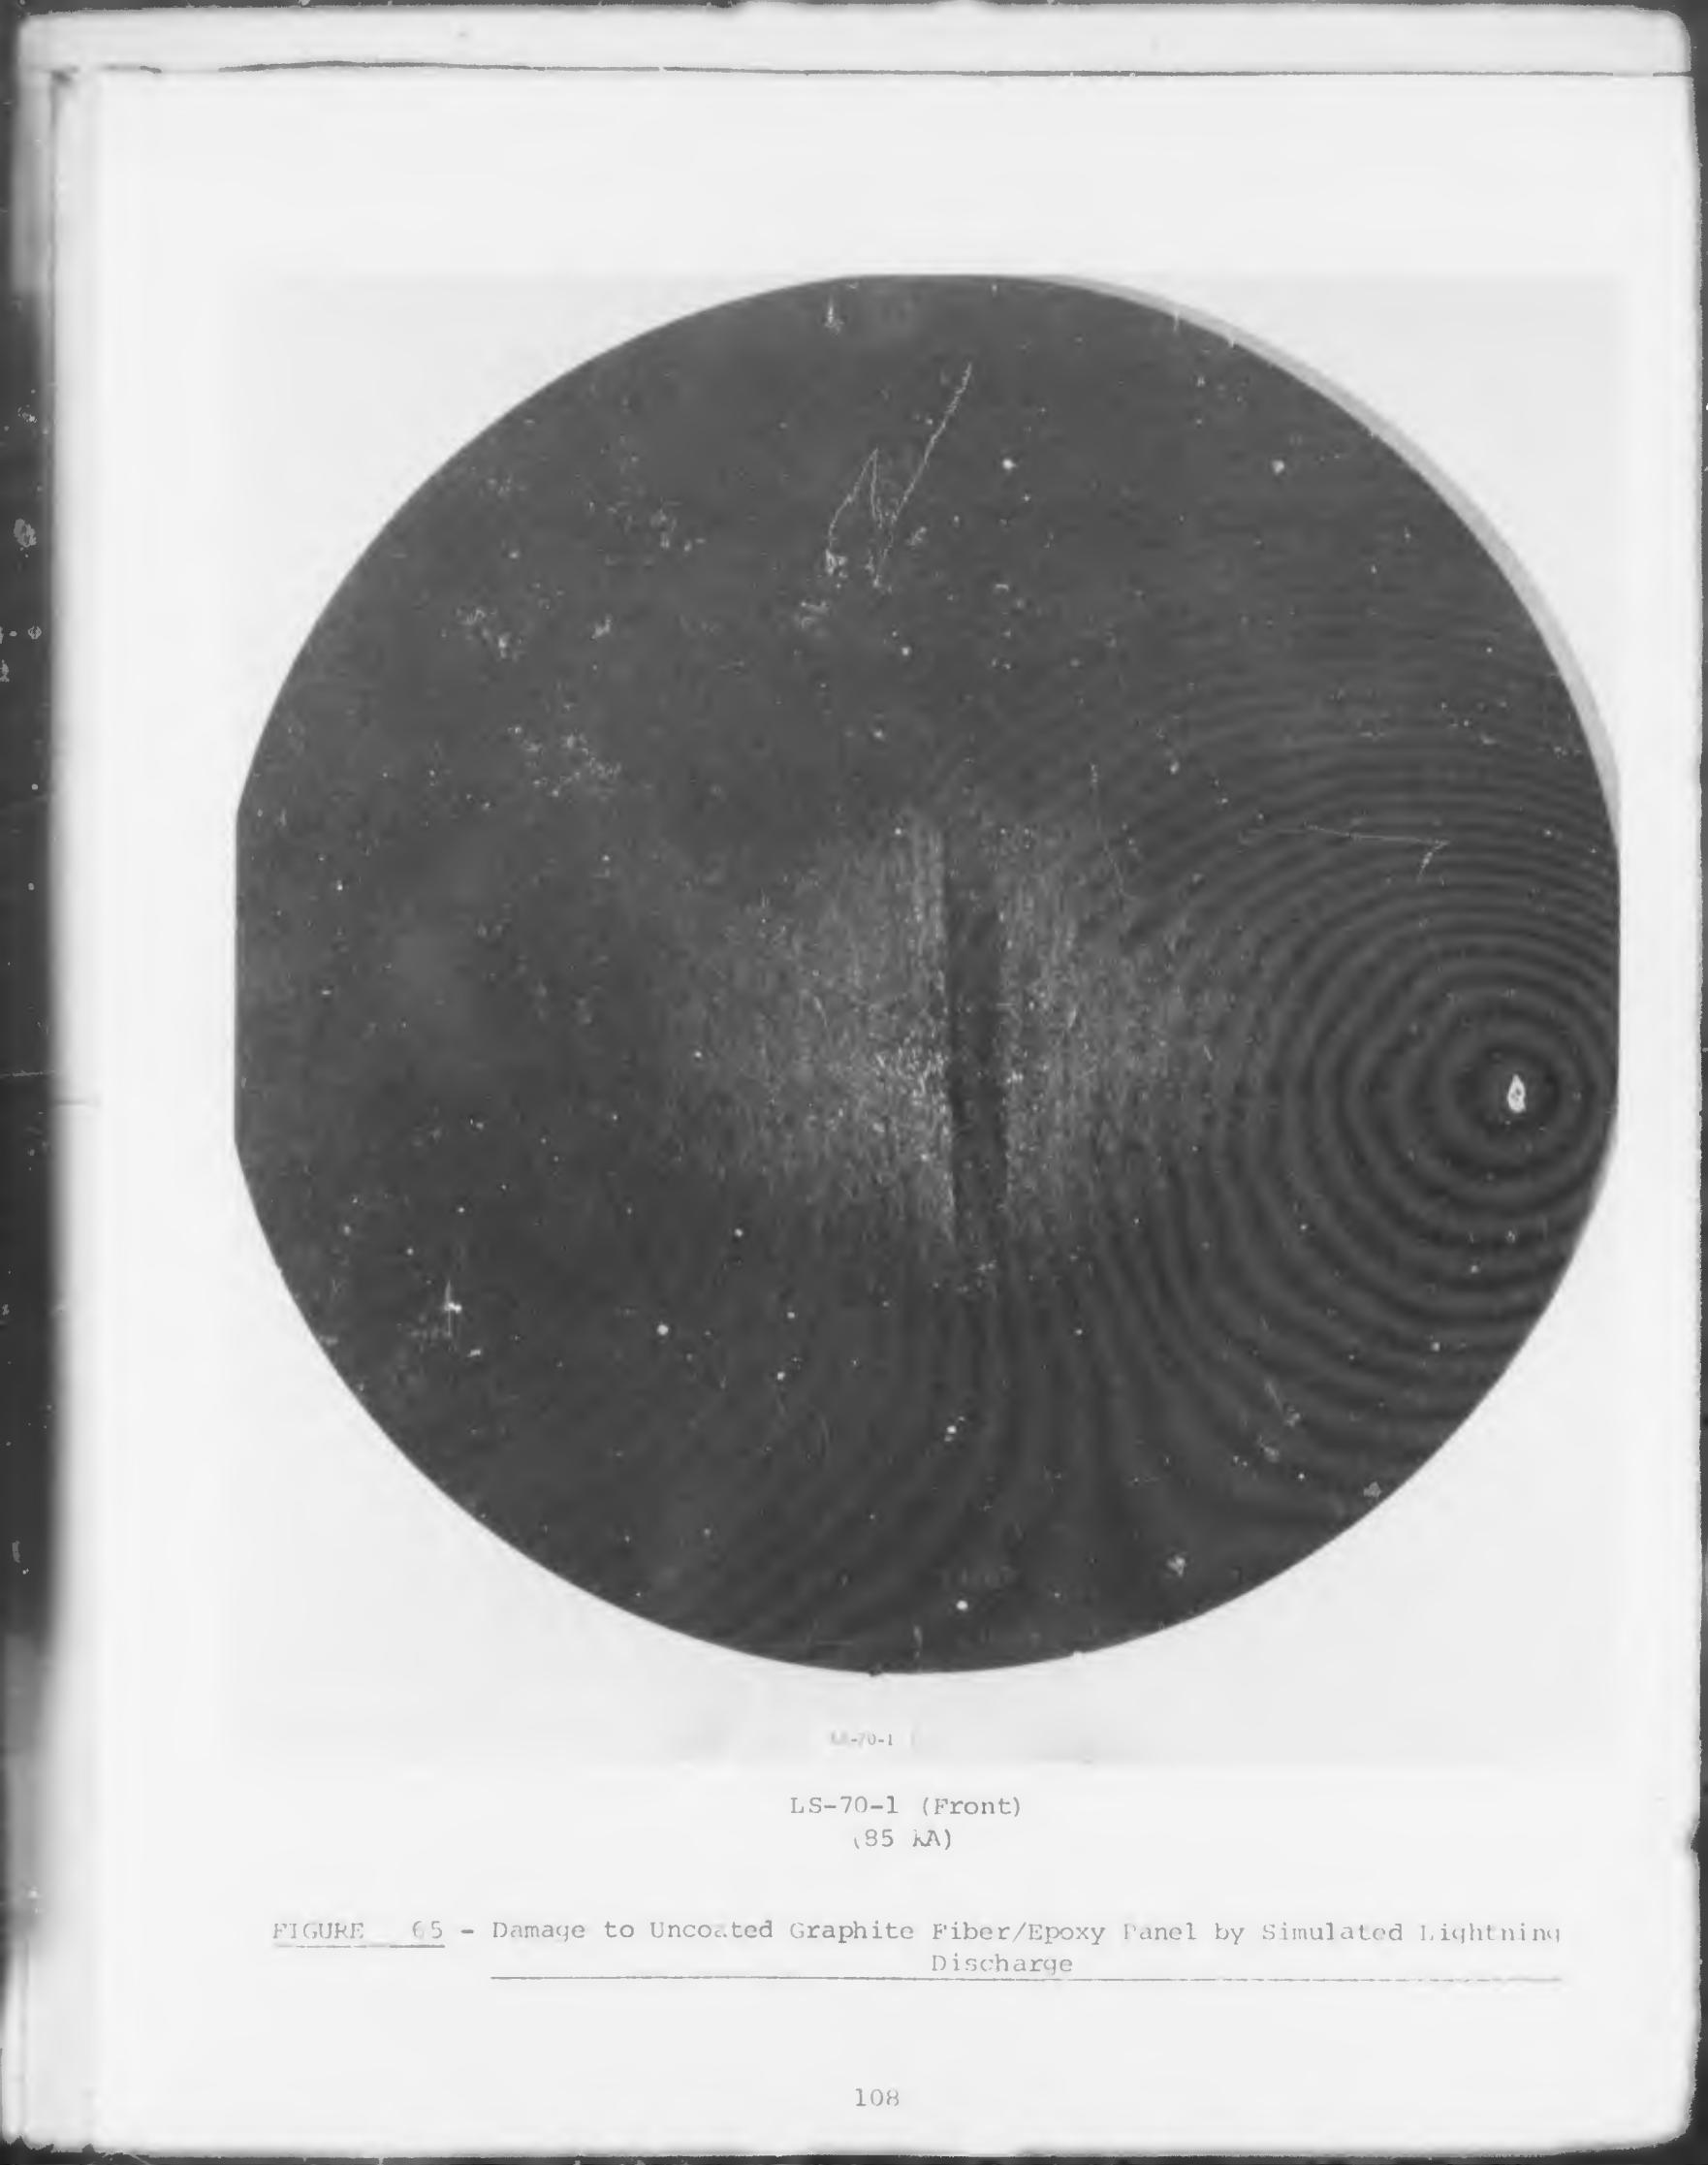
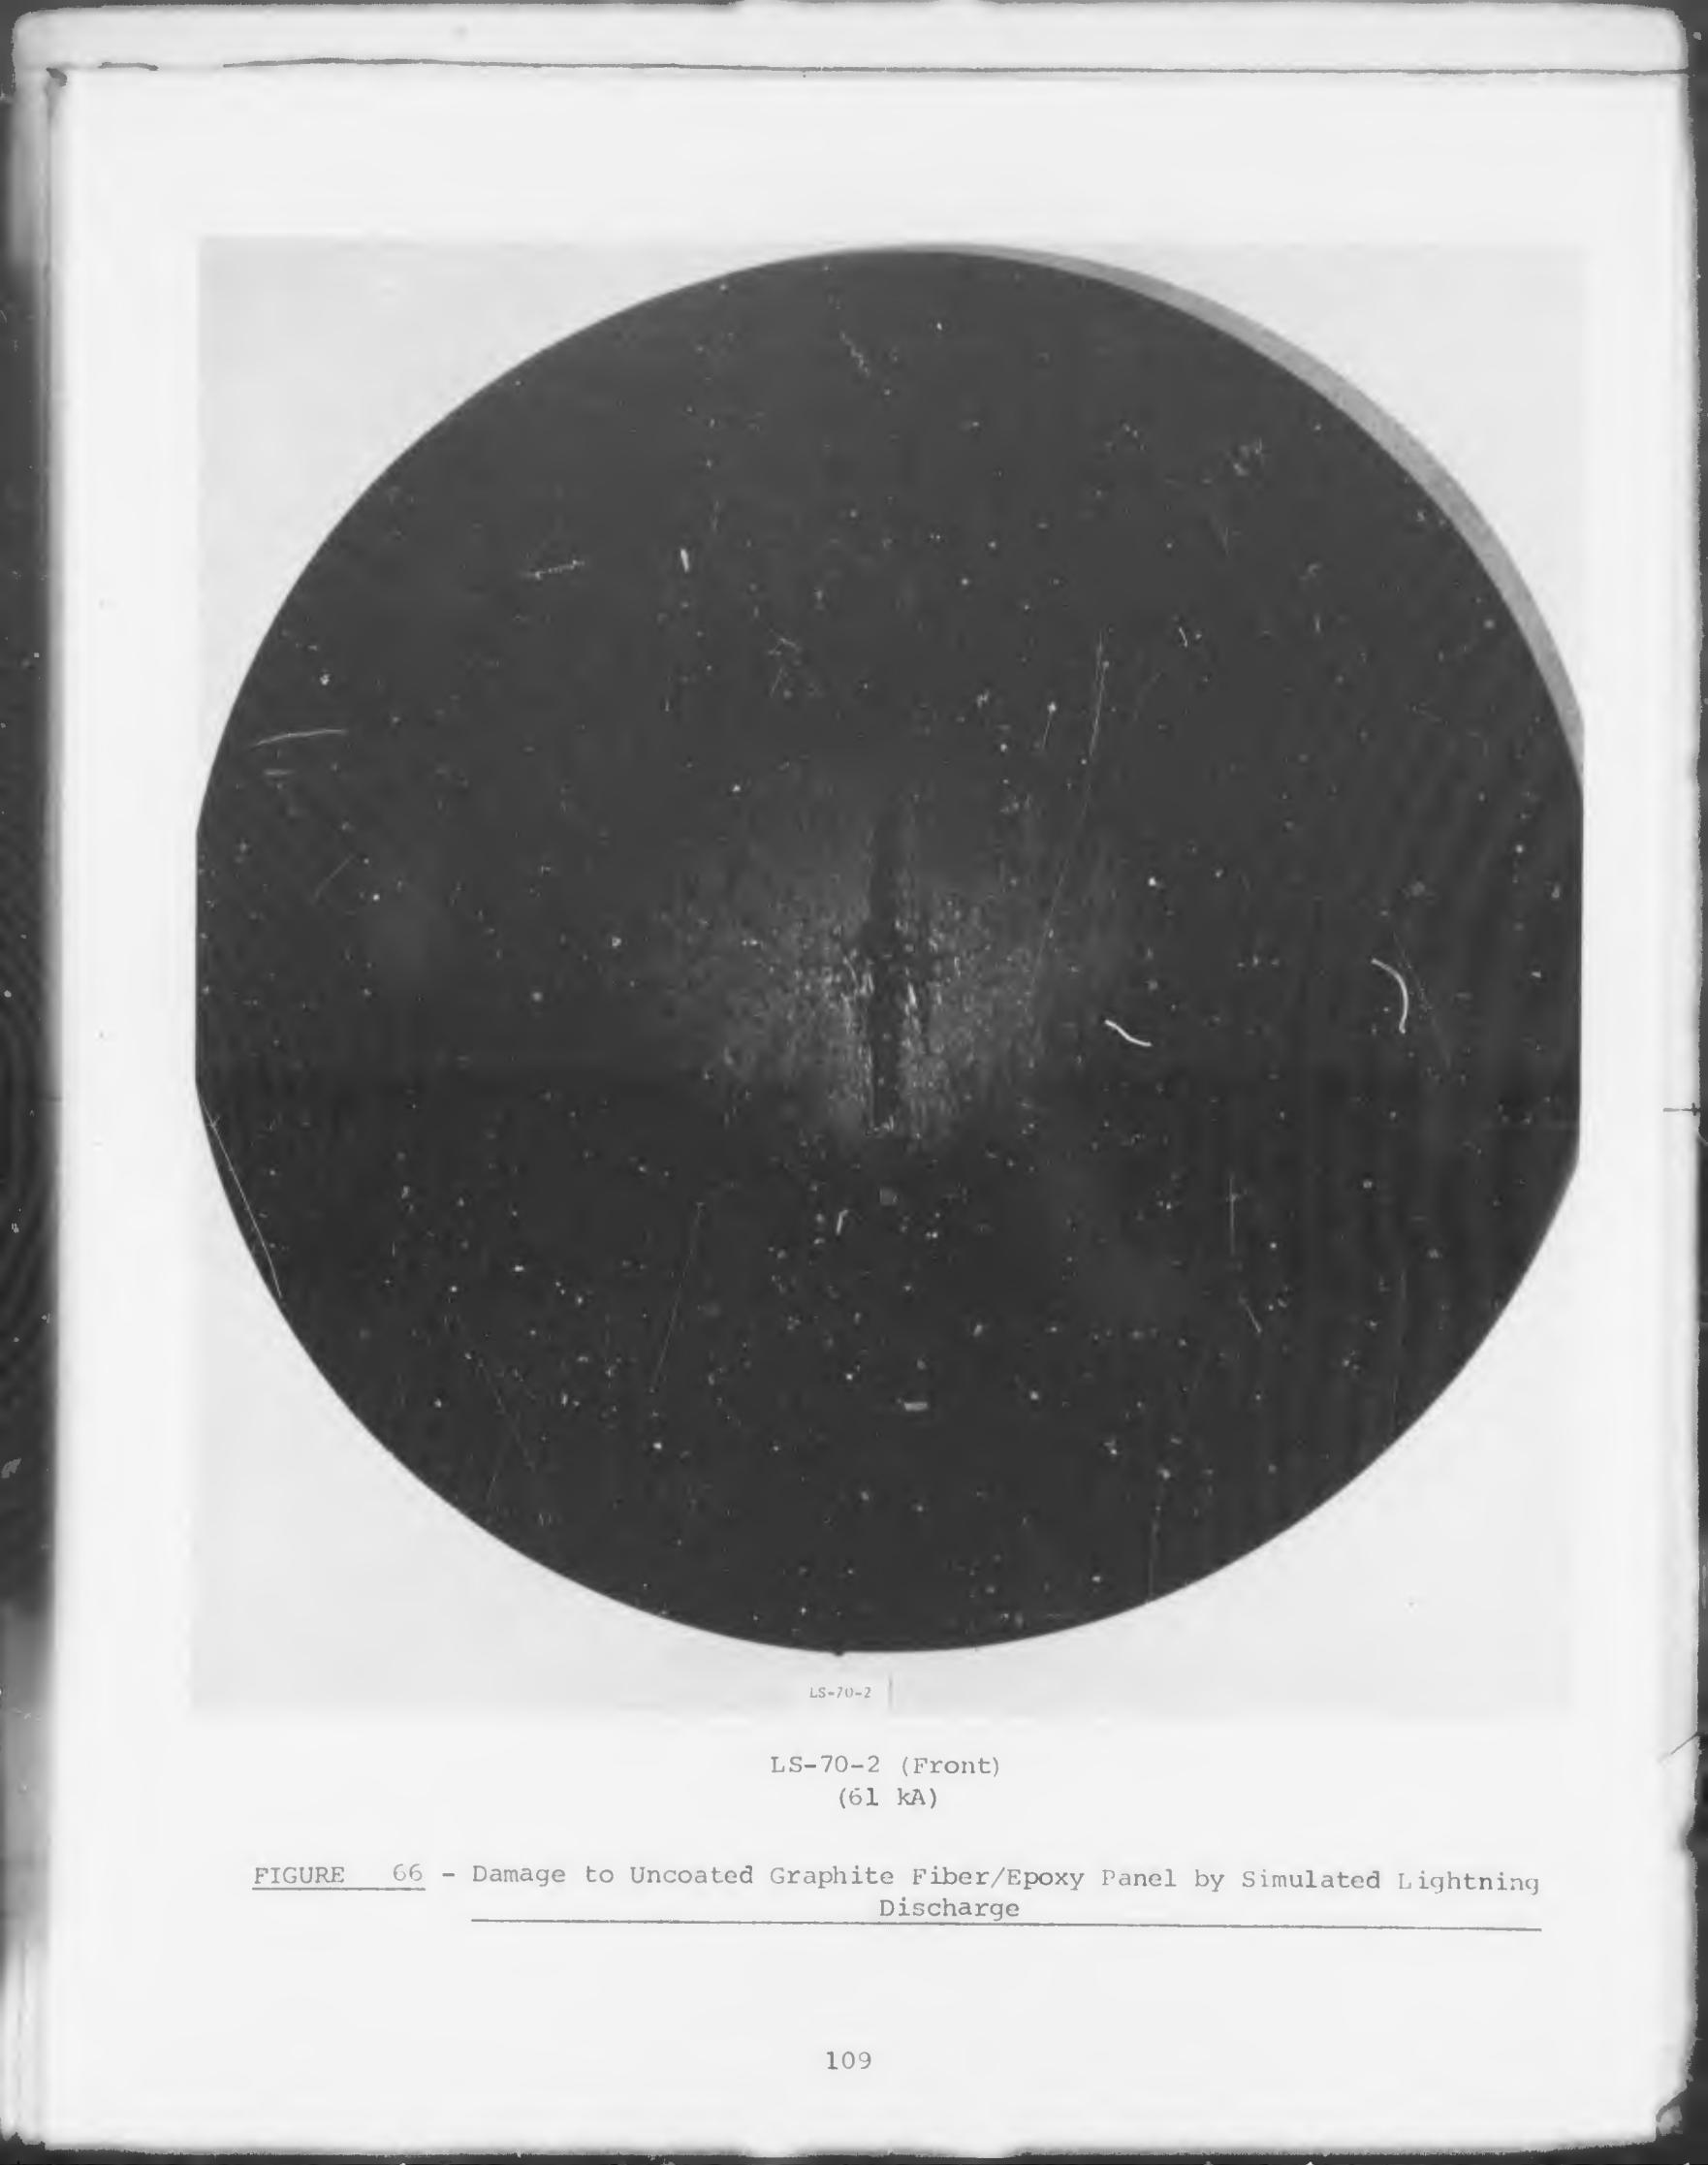
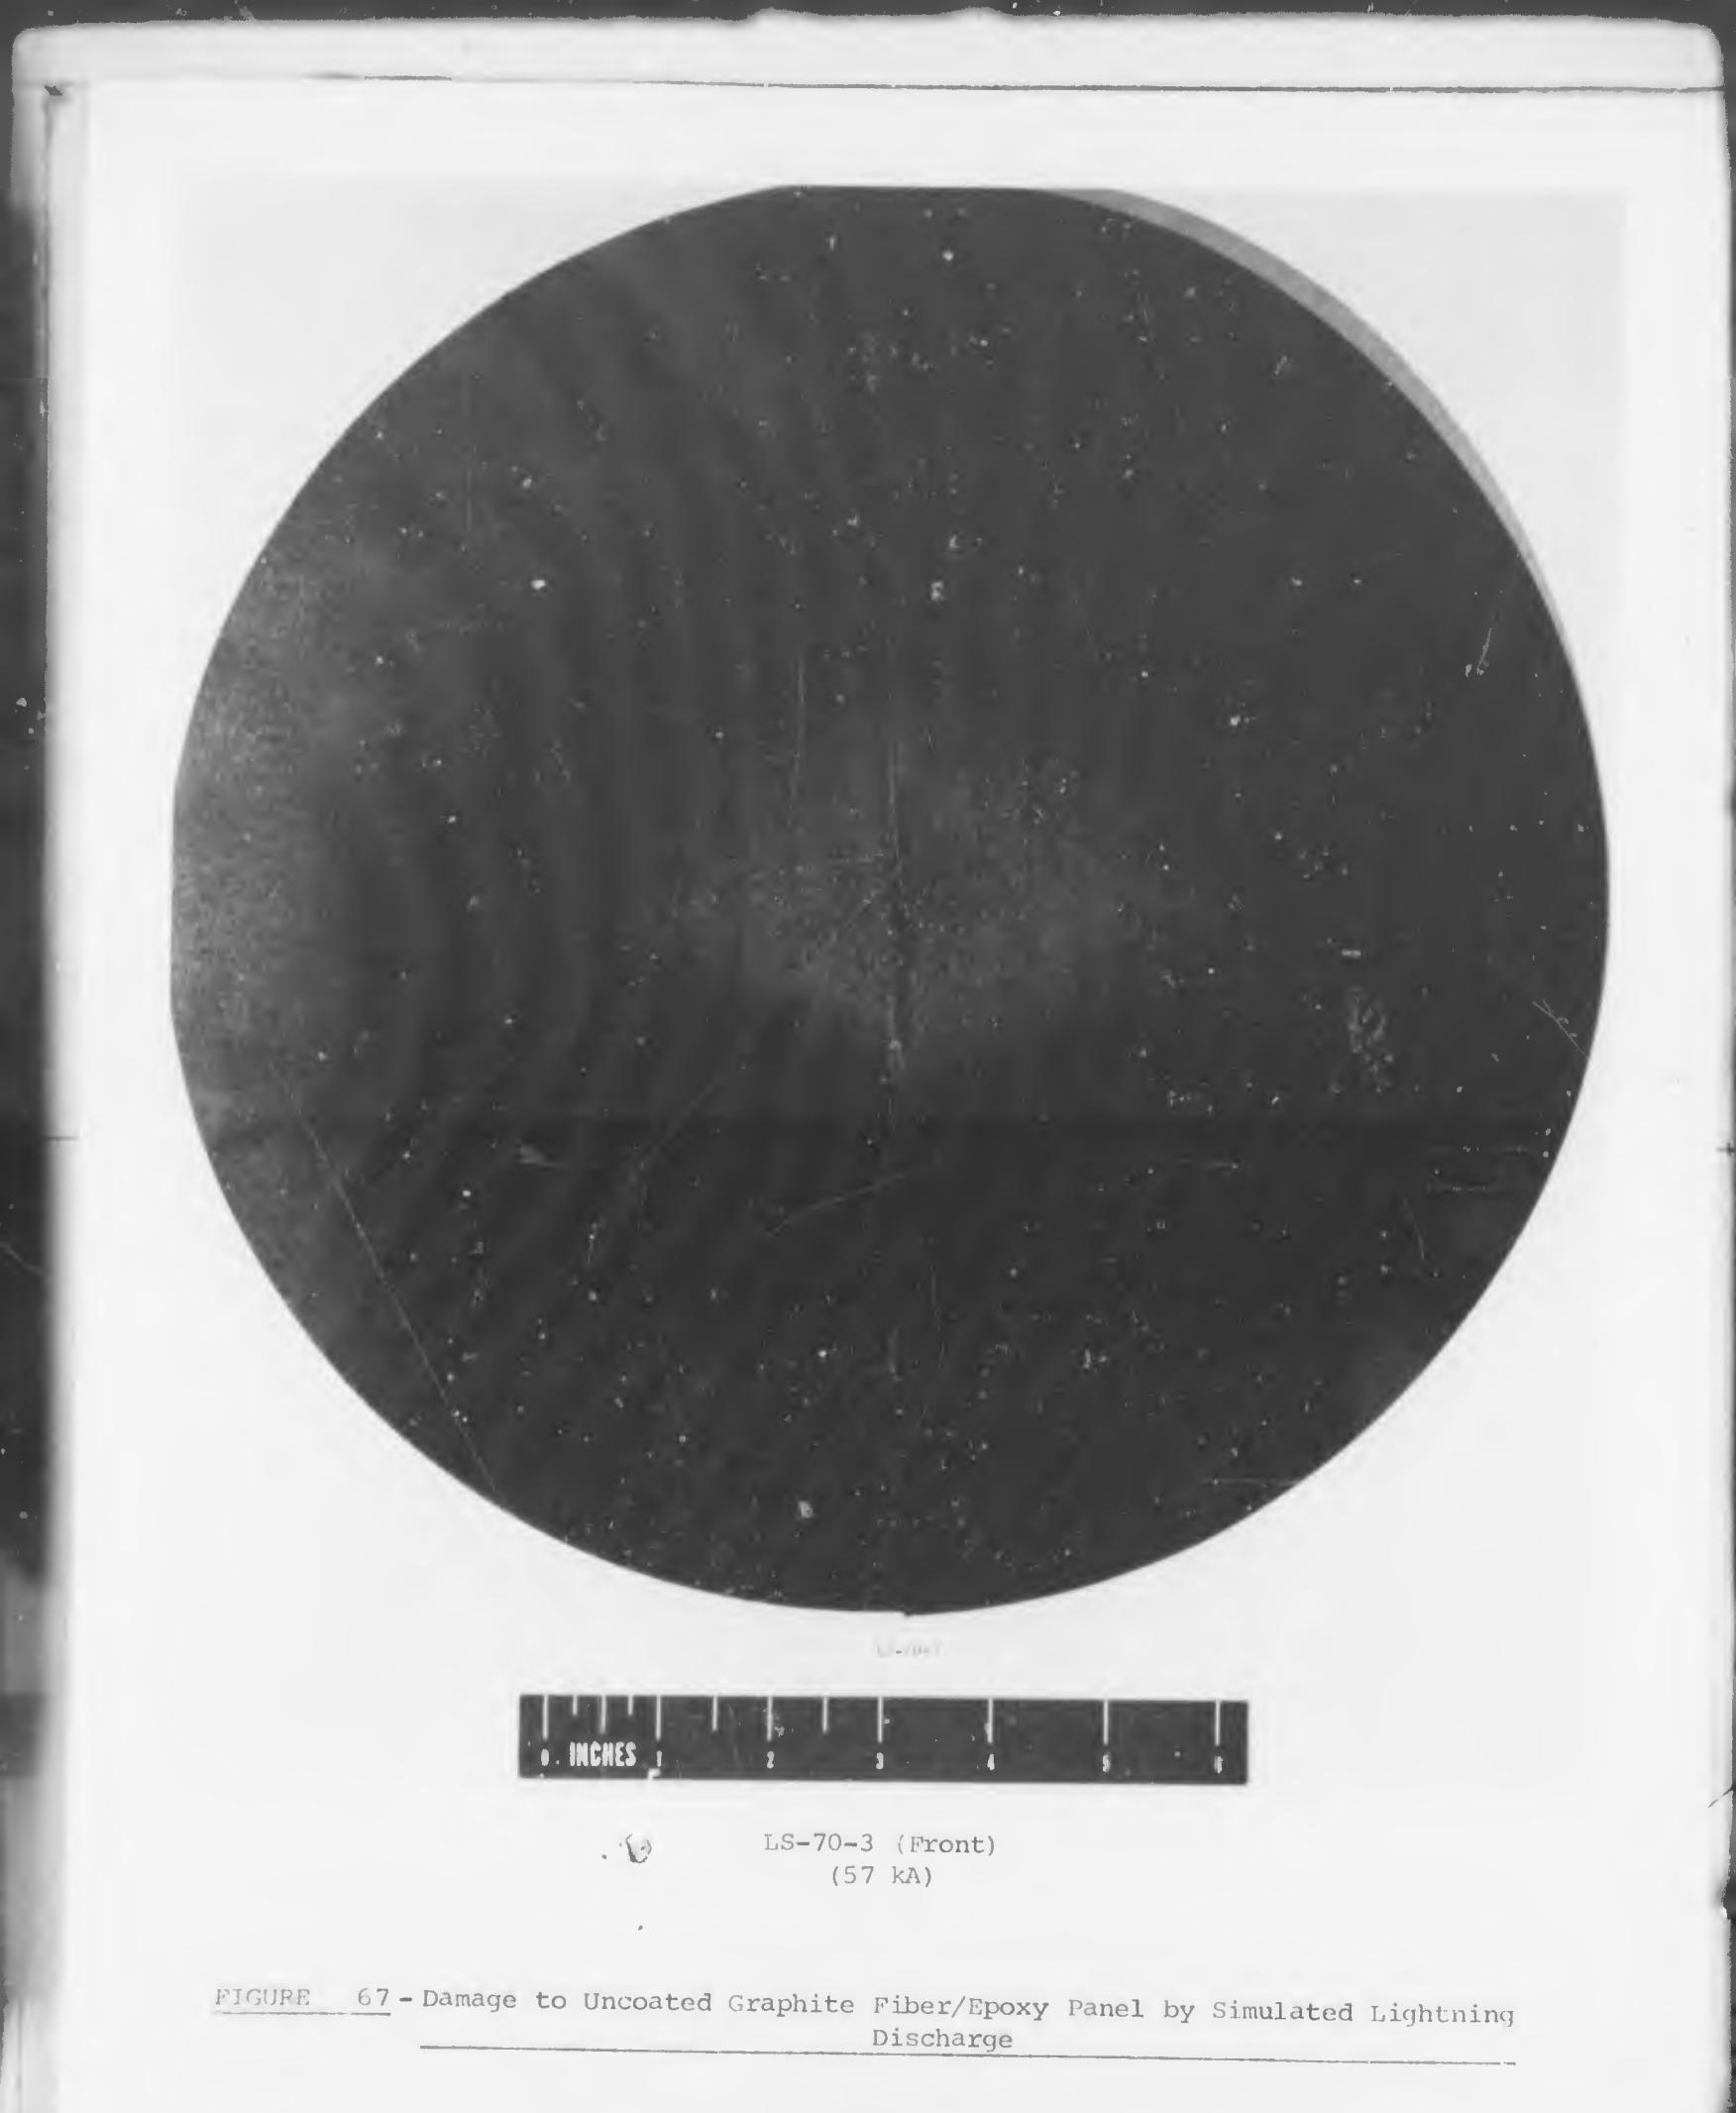
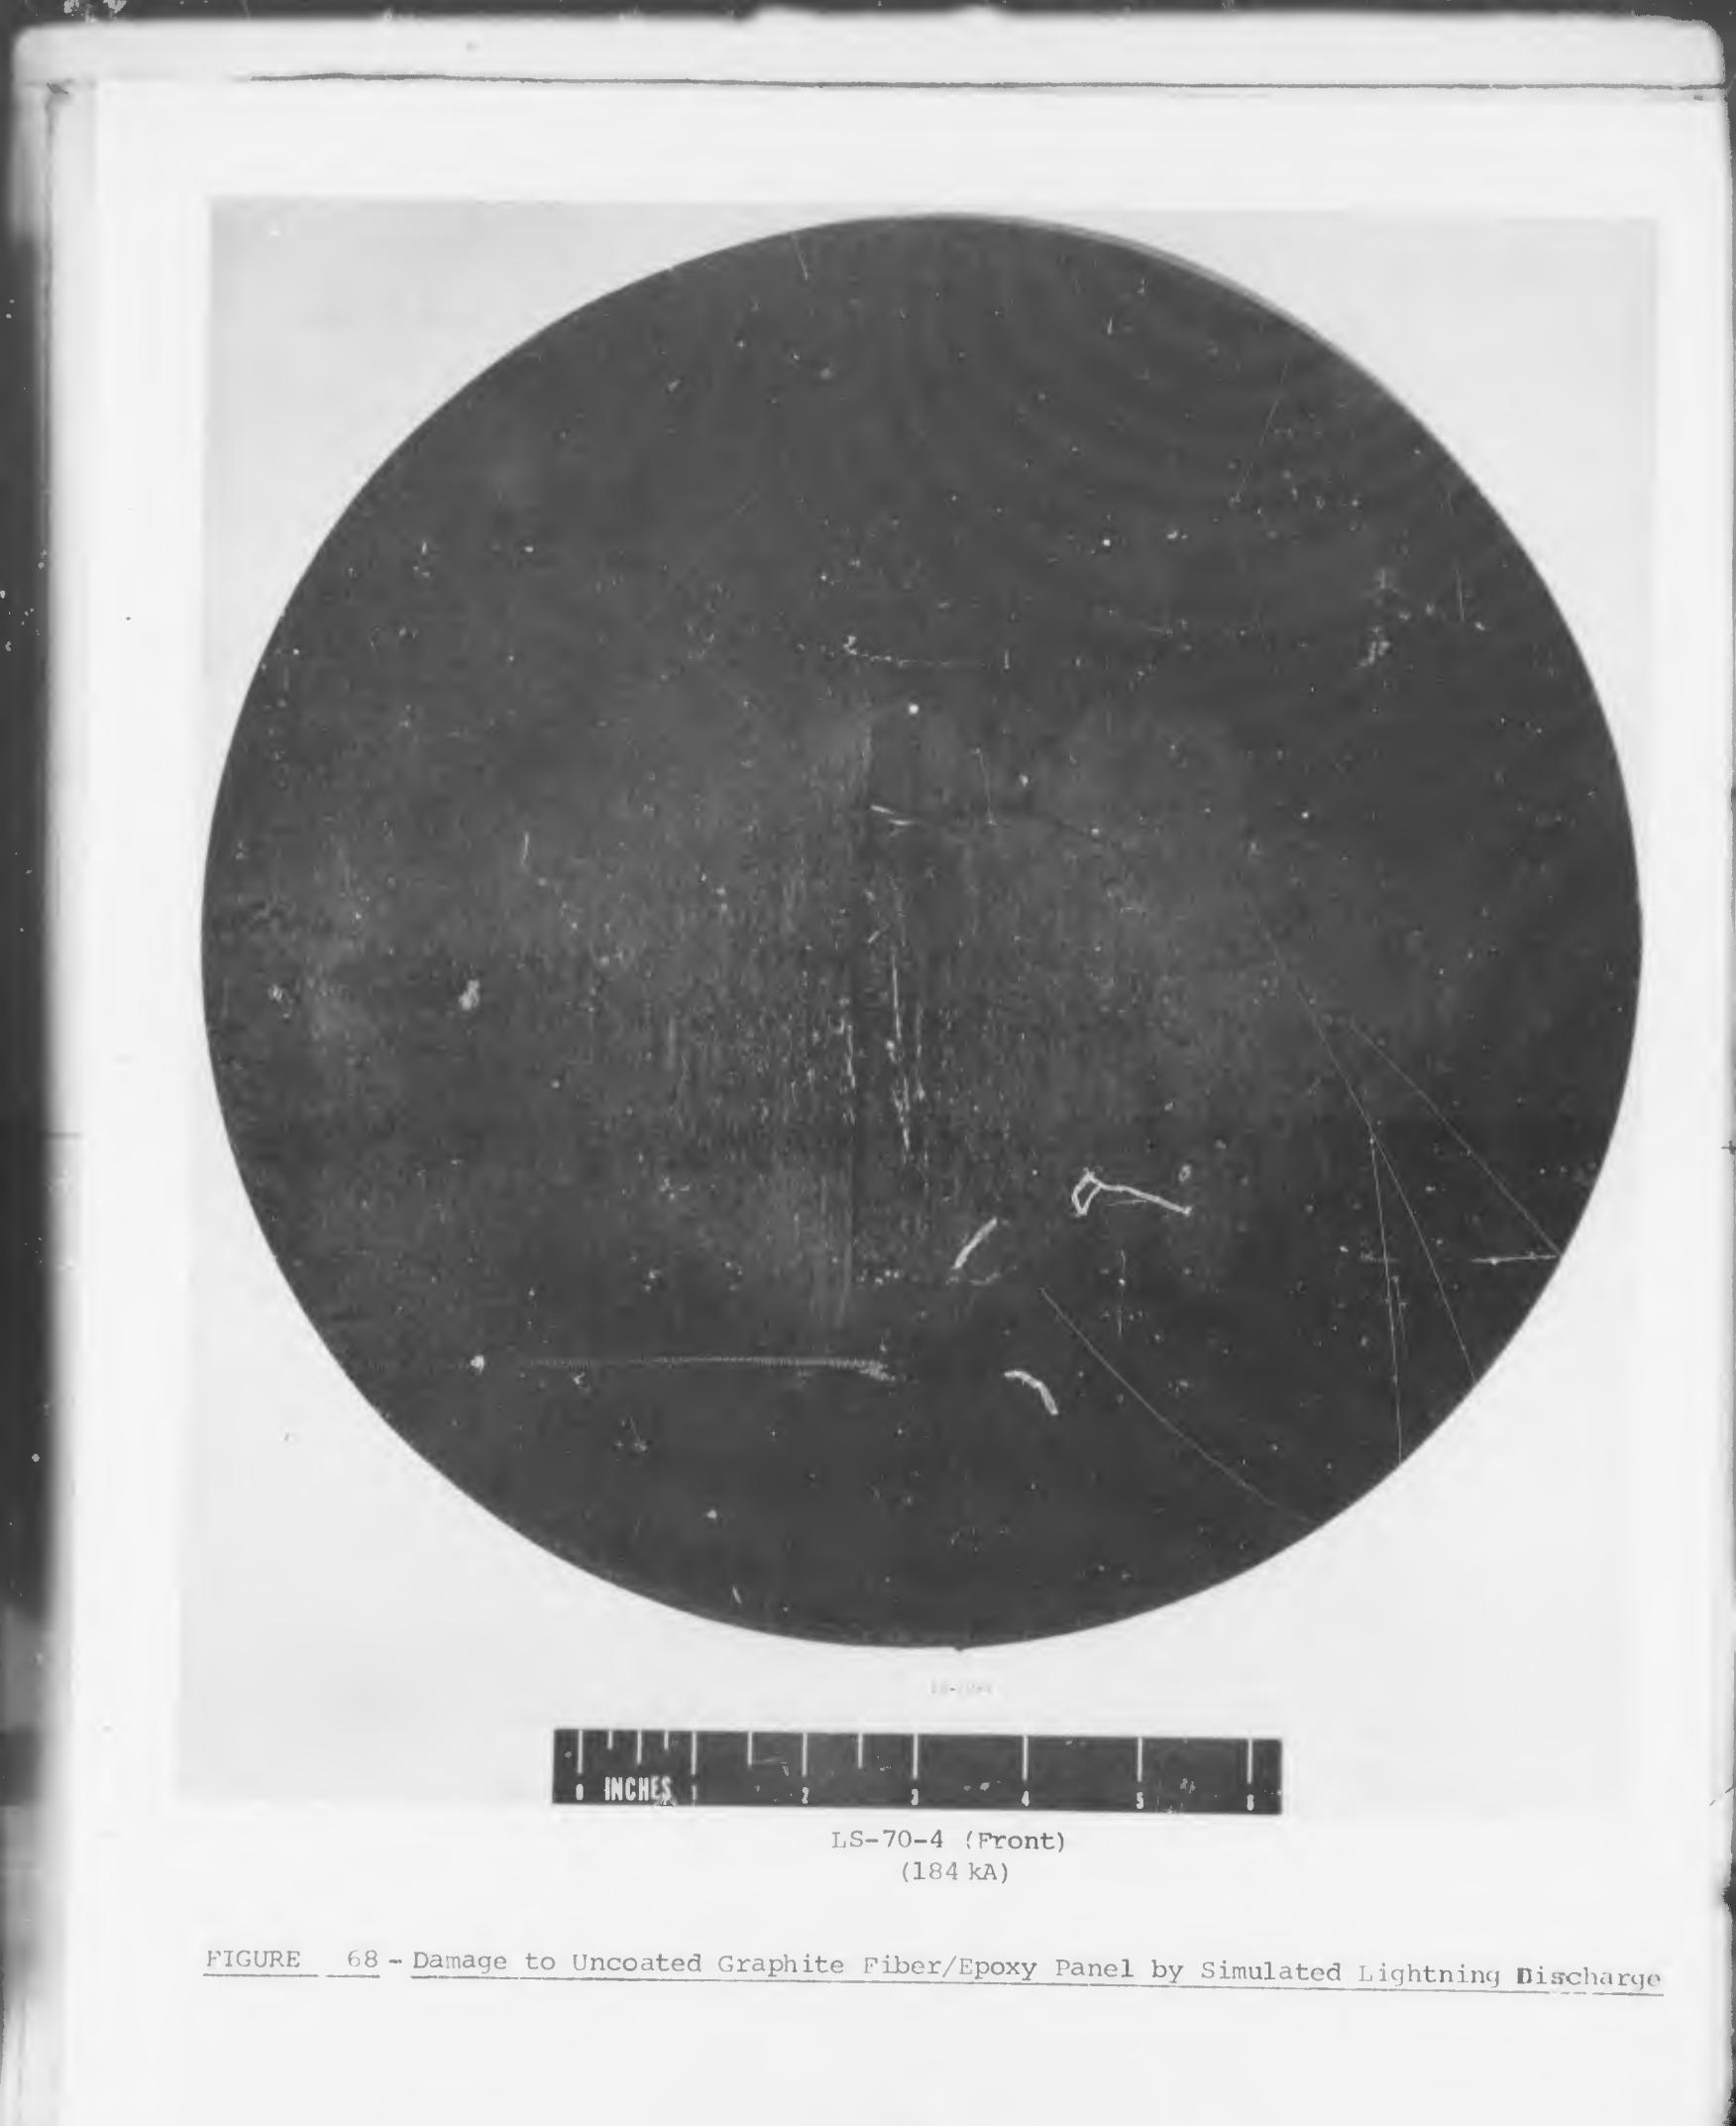
Photographs of the damage caused by the simulated lightning discharge to the four uncoated panels (LS-70-1 through LS-70-4) of 0.040" thickness is shown on Figure 65 through Figure 68 respectively.

The panels displayed nearly identical damage to the coatings. Both front surfaces were discolored to nearly identical shape and size. On panel LS-70-3 the top plies were blown off over a region of dimensions  $1/8" \times 2-1/2"$ . Around the perimeter of the panel there was disruption of the laminate due to the contact of the panel at this point with the aluminum top of the test tank and the aluminum retaining ring, where the lightning current followed a path to ground. Similar discoloration had been noted on the 6"  $\times 12"$  panels at the grounded end. Both of these panels were punctured through to the back of the surface. About the same amount of material was blown off of the back surface of each of these panels.

The panel was punctured with a small portion  $(3/8" \times 2")$  of the back ply being broken by the high-current arc.

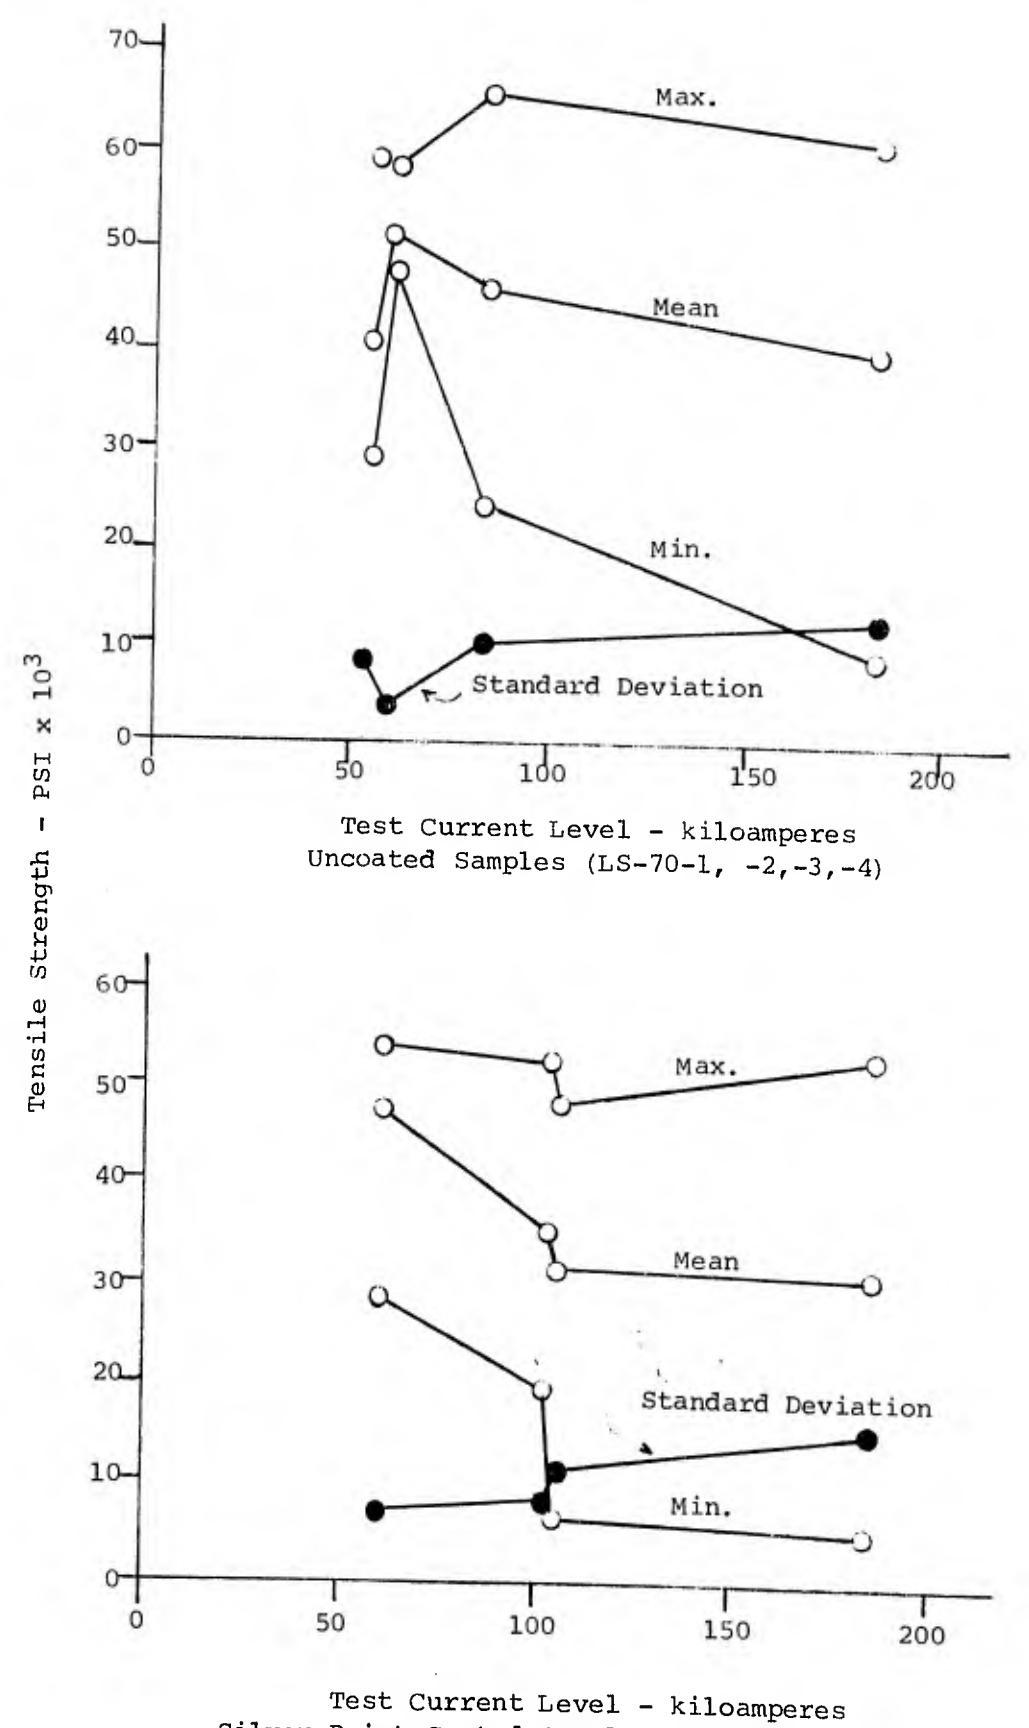
shown on Table XIV and plotted on Figures 76 through 78. On Figure 76 (for either coated or silver painted panels) the tensile strengths of all the specimens, near to and removed from the arc attachment point are grouped. There is a large spread between maximum and minimum tensile strengths since specimens near the arc at attachment point were more severely damaged than those farther away from the arc attachment point.

FIGURE 76 - Tensile Strengths of All Specimens Cut From 0.040" Thick Graphite Fiber/Epoxy Panels

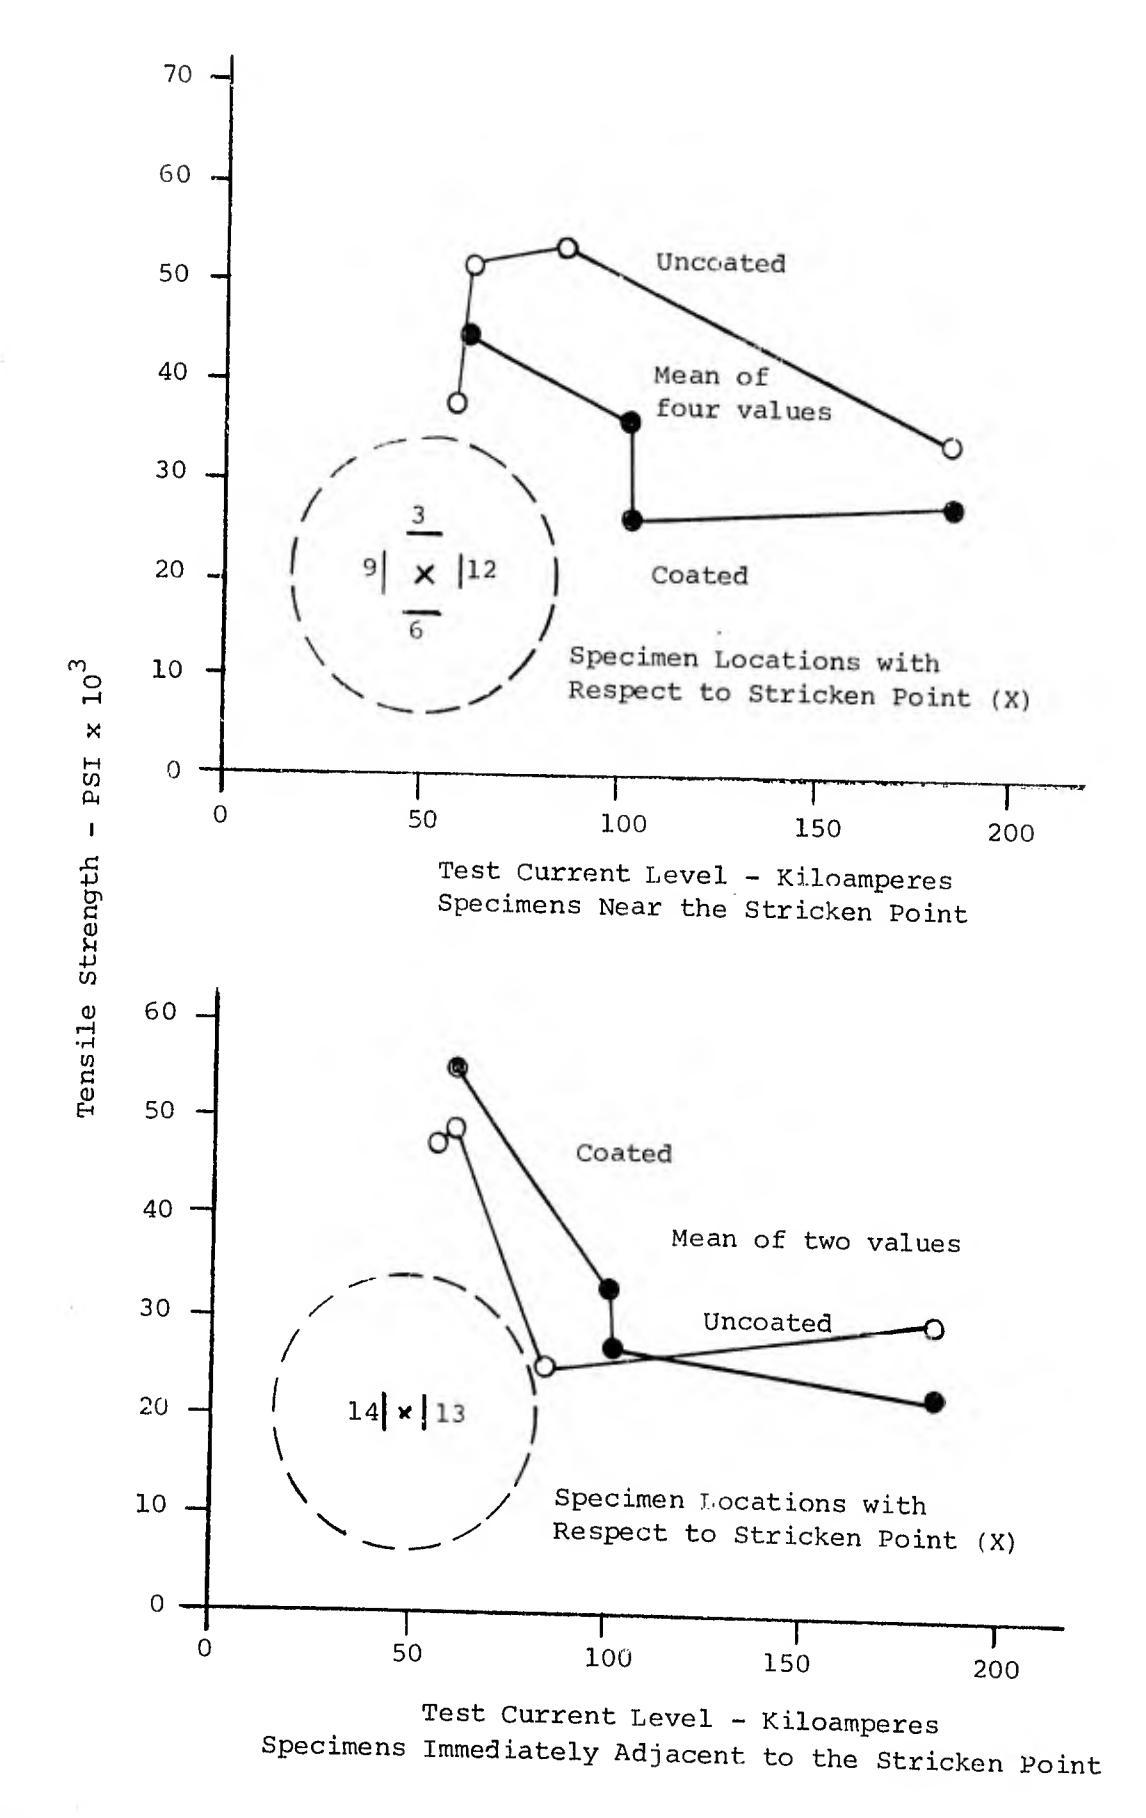
FIGURE 78 - Tensile Strengths of 0.040" Thick Graphite Fiber/Epoxy Panels at Different Distances from the Stricken Point
Panel 70-8

Specimens 2, 3, 6, 7, 13, and 14 showed low tensile values. Specimens 2 and 7 were beyond the "C"-scan damaged area.

The samples for tensile strength measurements were cut in a pattern that allows one to compare the strength of the panel at different distances from the stricken point. Figures 77 and 78 show the tensile strength at various contours around the stricken point. No significant difference in mean values was noted at the different locations, at least as regards test current levels around 50 - 75 kA. At the highest test current levels (or immediately adjacent to the stricken point) the mean tensile strengths were low, but visual observation of the surface of the panel at those points would indicate that the strength should be low. The fact that the specimens from the panels "protected" with silver paint were lower than those from the unprotected panels should not be overlooked.

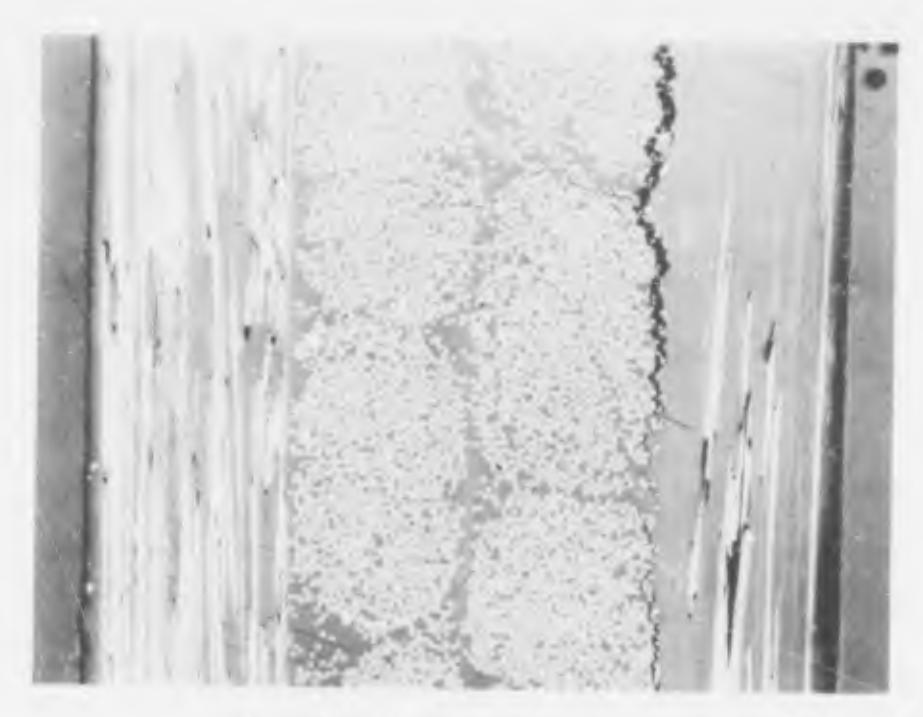
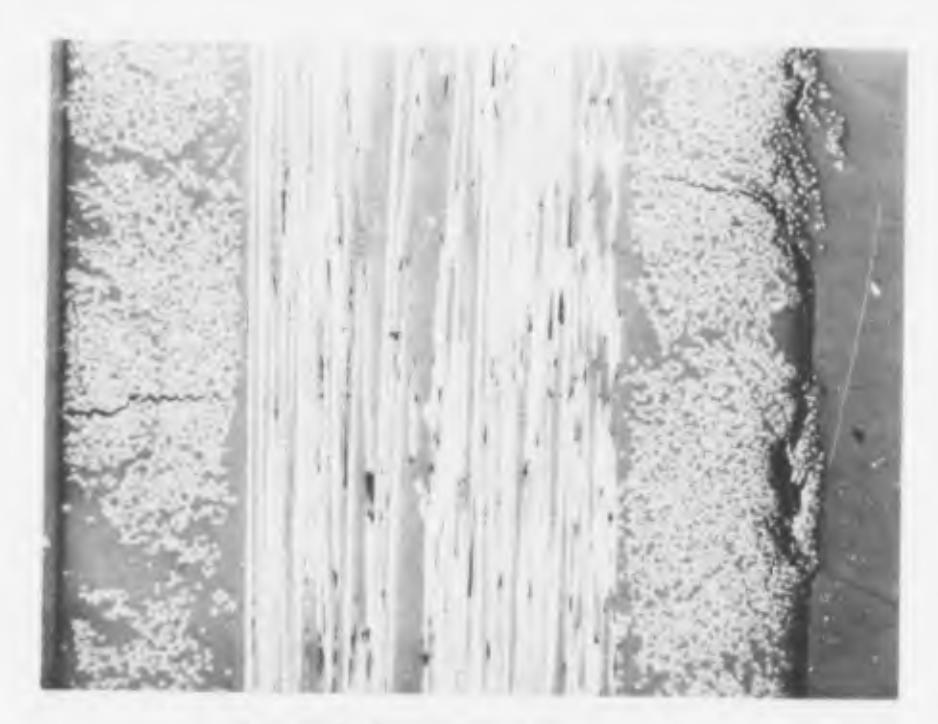
FIGURE 8

Most of the damage observable on these photomicrographs appeared to be mechanical in nature, and not due to thermal degradation of the fibers. Particularly as regards panel LS-70-3, the characteristic damage observed consisted of a series of cracks running parallel to the individual fibers. Some cracks were noted on the photomicrographs taken before the lightning withstand tests; see Figure 58 for example. None of those cracks were as large as these however. The panels would split easily in a direction parallel to the fiber reinforcements because the only strength of the panel lies in the resin binder. These cracks do not seem to have degraded the tensile strength particularly. Tensile specimens 1 and 2 of panel LS-70-3 both showed average tensile strength, while specimen 3 showed a significantly lowered tensile strength. Specimen 3 had the largest cracks of any of these three, which one might expect, since it was closest to the arc-attachment point. Tensile specimen 8 again showed a lowered strength, but the photomicrographs of it did not reveal cracking any worse than that observed on specimens 1 and 2. Specimens 9 and 14, even closer to the stroke-attachment point, showed reasonably high tensile strengths, even though specimen 14 on the photomicrographs began to show a good amount of physical tearing and lifting of the fibers on the top ply.

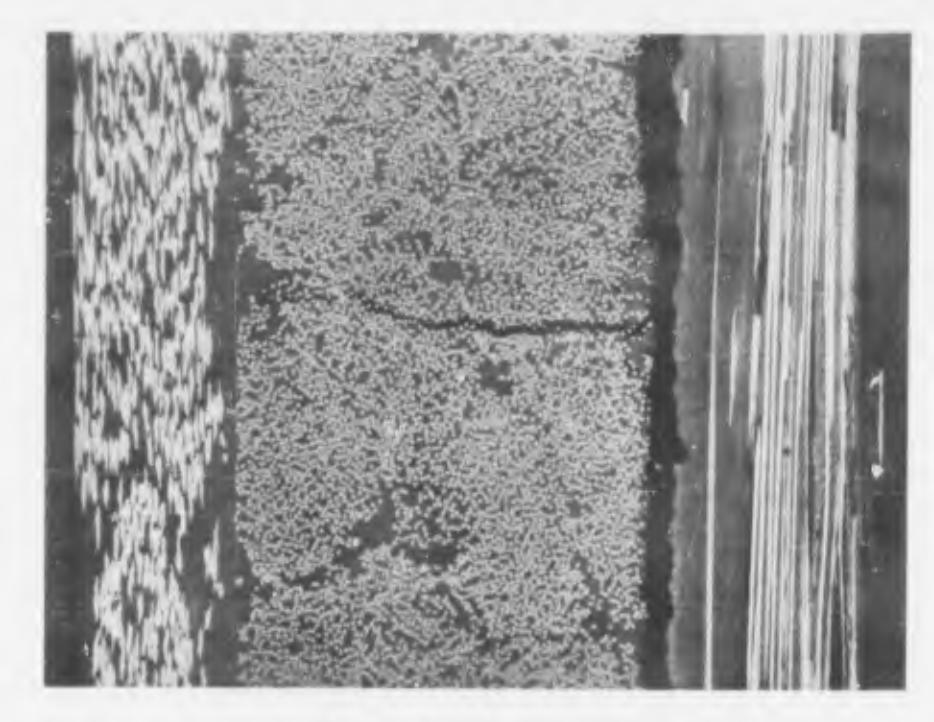
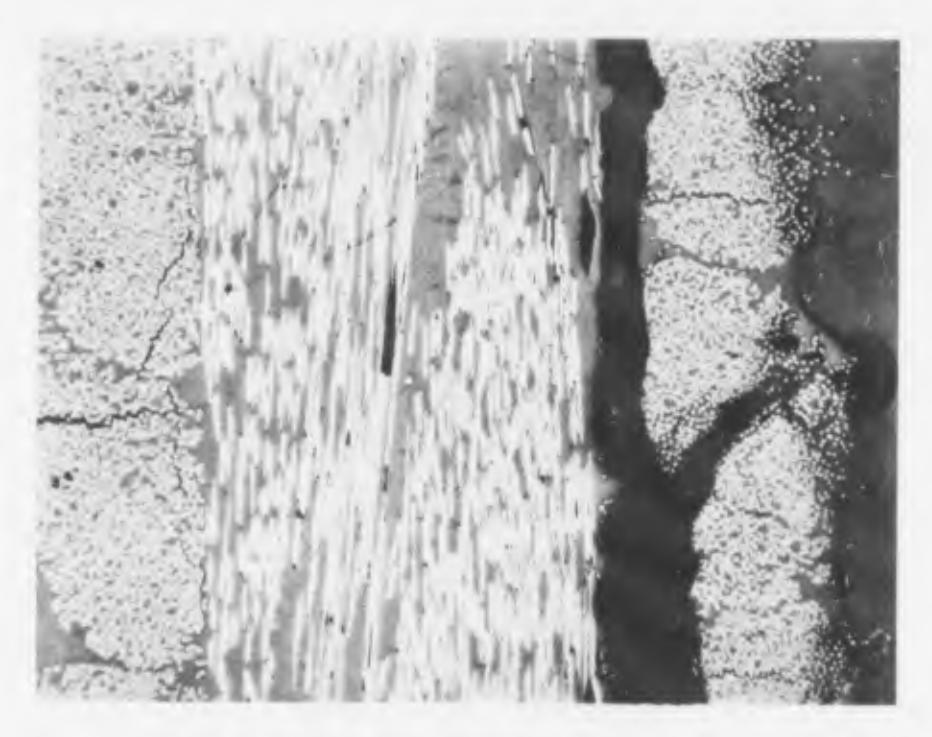
FIGURE 90 - 100X Photomicrograph of a Damaged Area of Graphite Fiber/ Epoxy Panel After Exposure to Simulated Lightning Discharge ing of the resin around the fibers in the top ply. Presumably this would represent pyrolyzed resin surrounding these fibers that should carry the most current and should get the hottest. A little of this same blackening of the resin is noted on the inner ply at the left of the picture, but only around the isolated fibers and around the one small crack shown. Specimen 2 also shows a few isolated fibers having this blackening of the resin around the fibers. The pyrolysis of the resin, if indeed that is what it is, appears on both the outer and inner plies. Specimen 8 does not show any of this. Specimen 9 shows a few isolated fibers having what are believed to be burned spots around them. Specimen 14 shows the top ply split away from the remaining plies and shows the lifting and physical tearing of the fibers that was also observed visually.

In summary, the photomicrographs would indicate that most of the damage to the graphite panels is due to mechanical shock caused by vaporization of the resin leading to breaking of plies and splitting of bundles. This is in considerable contrast to the patterns observed on the  $6" \ge 12"$  boron panels in which the photomicrographs clearly showed thermal degradation of the individual boron fibers.
