# LIGHTNING EFFECTS RELATING TO AIRCRAFT PART I - LIGHTNING EFFECTS ON AND ELECTROMAGNETIC SHIELDING PROPERTIES OF BORON AND GRAPHITE REINFORCED COMPOSITE MATERIALS

F.A. Fisher High Voltage Laboratory General Electric Company

W.M. Fassell Materials and Processes Laboratory Aeronutronic Division Philco-Ford Corporation

Technical Report AFAL-TR-72-5

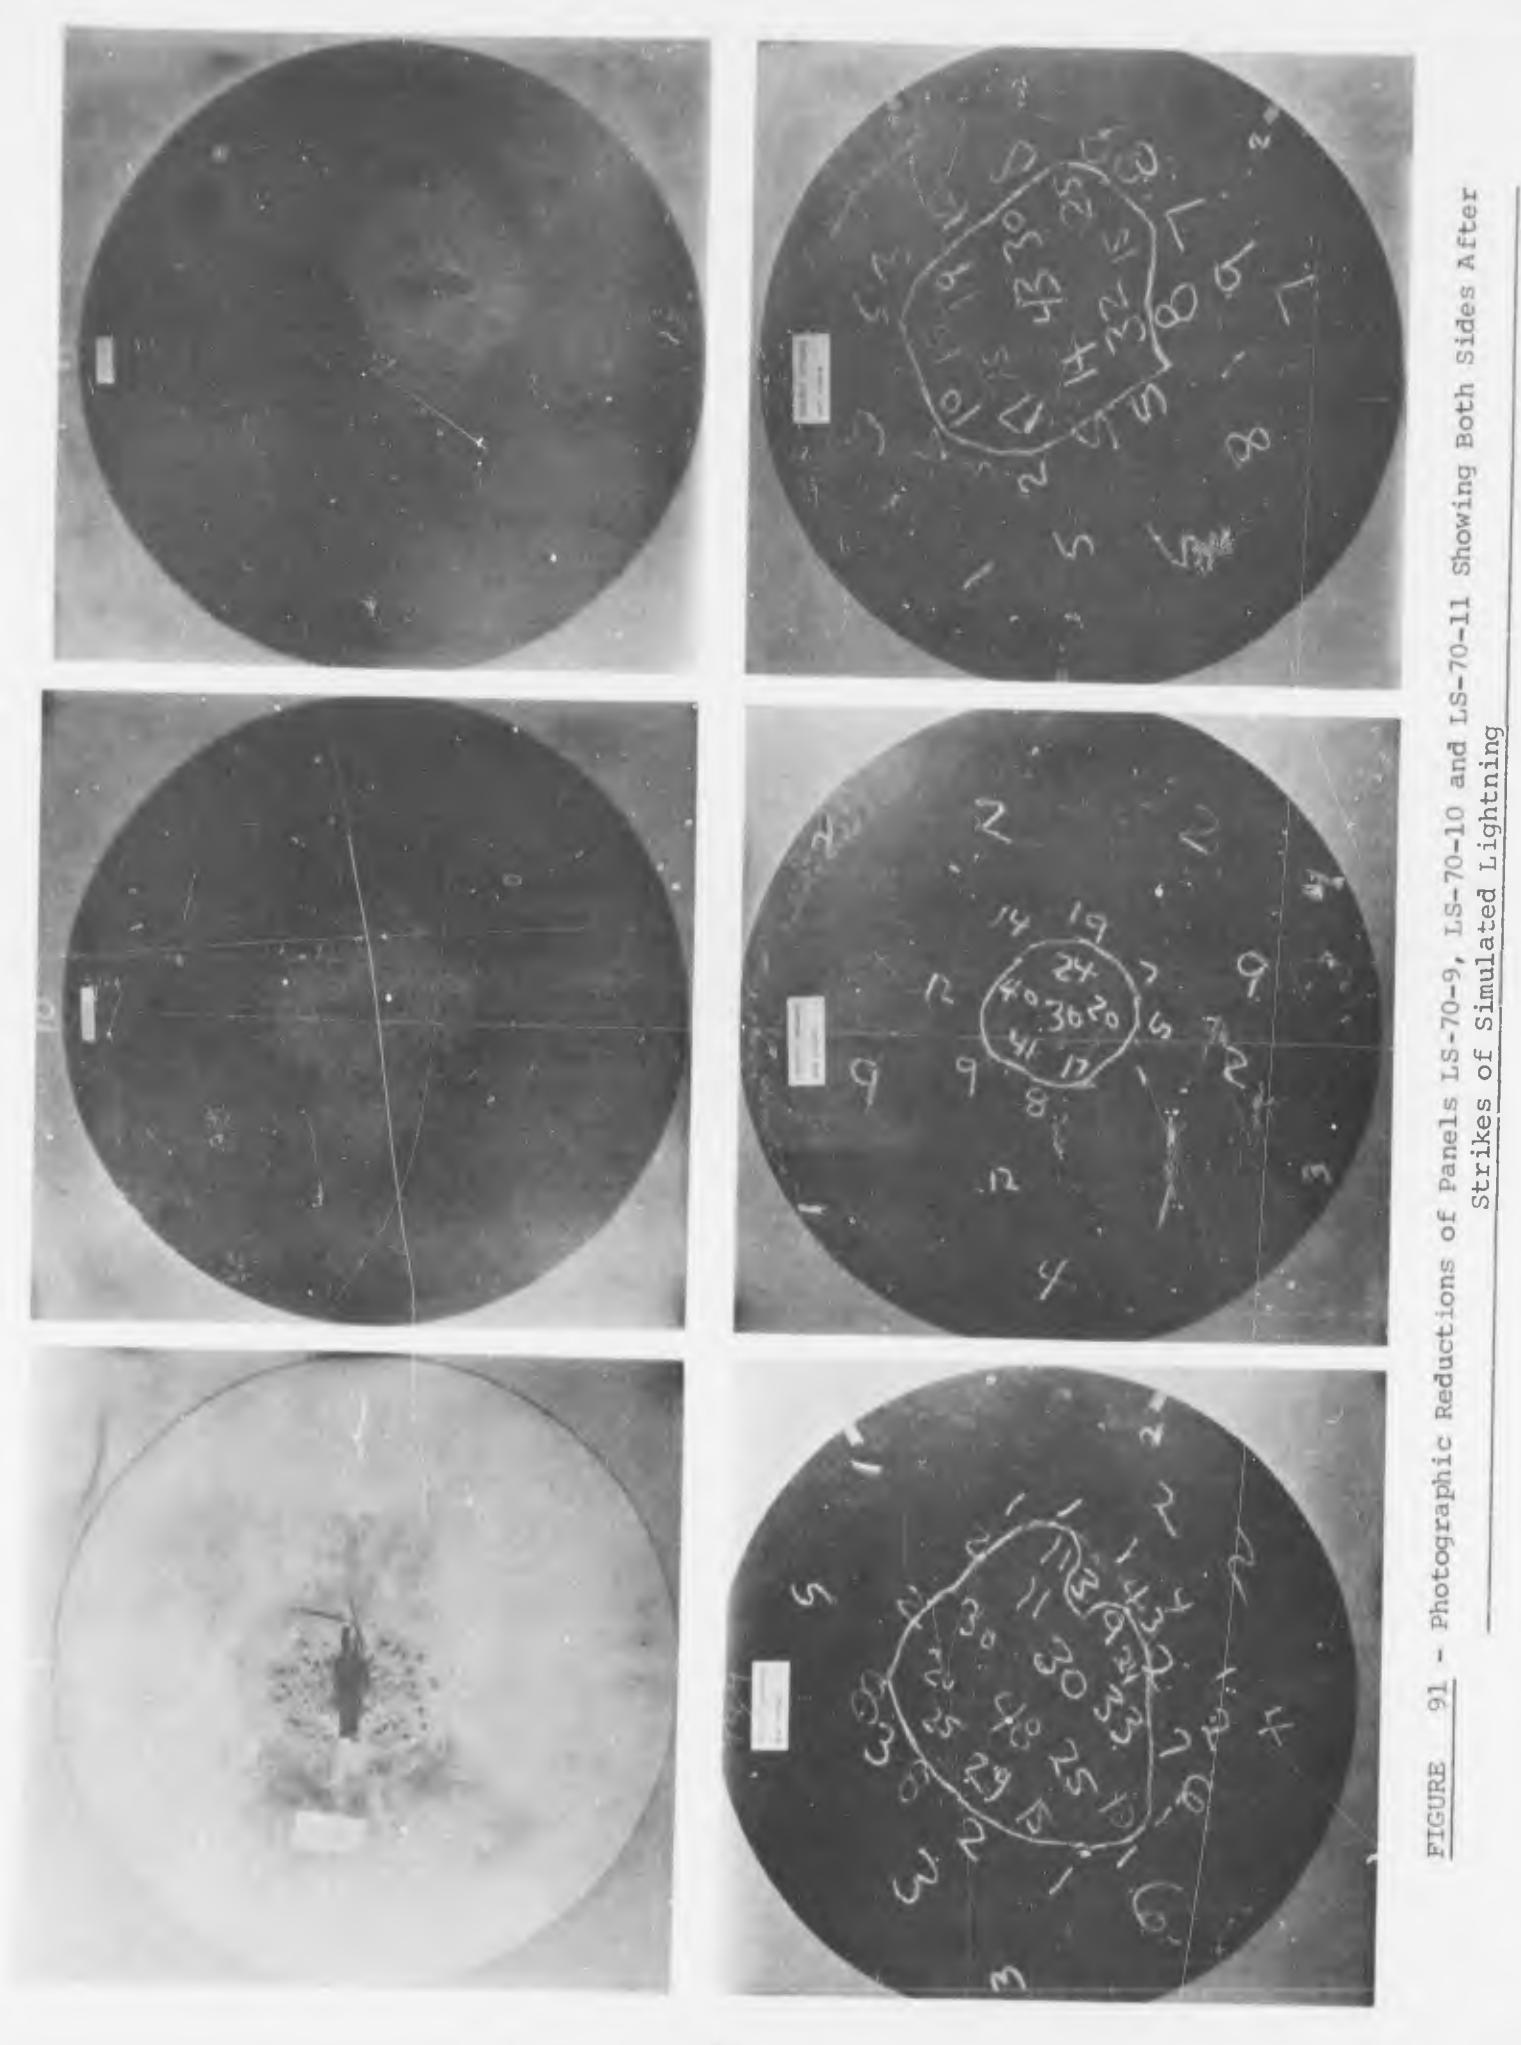
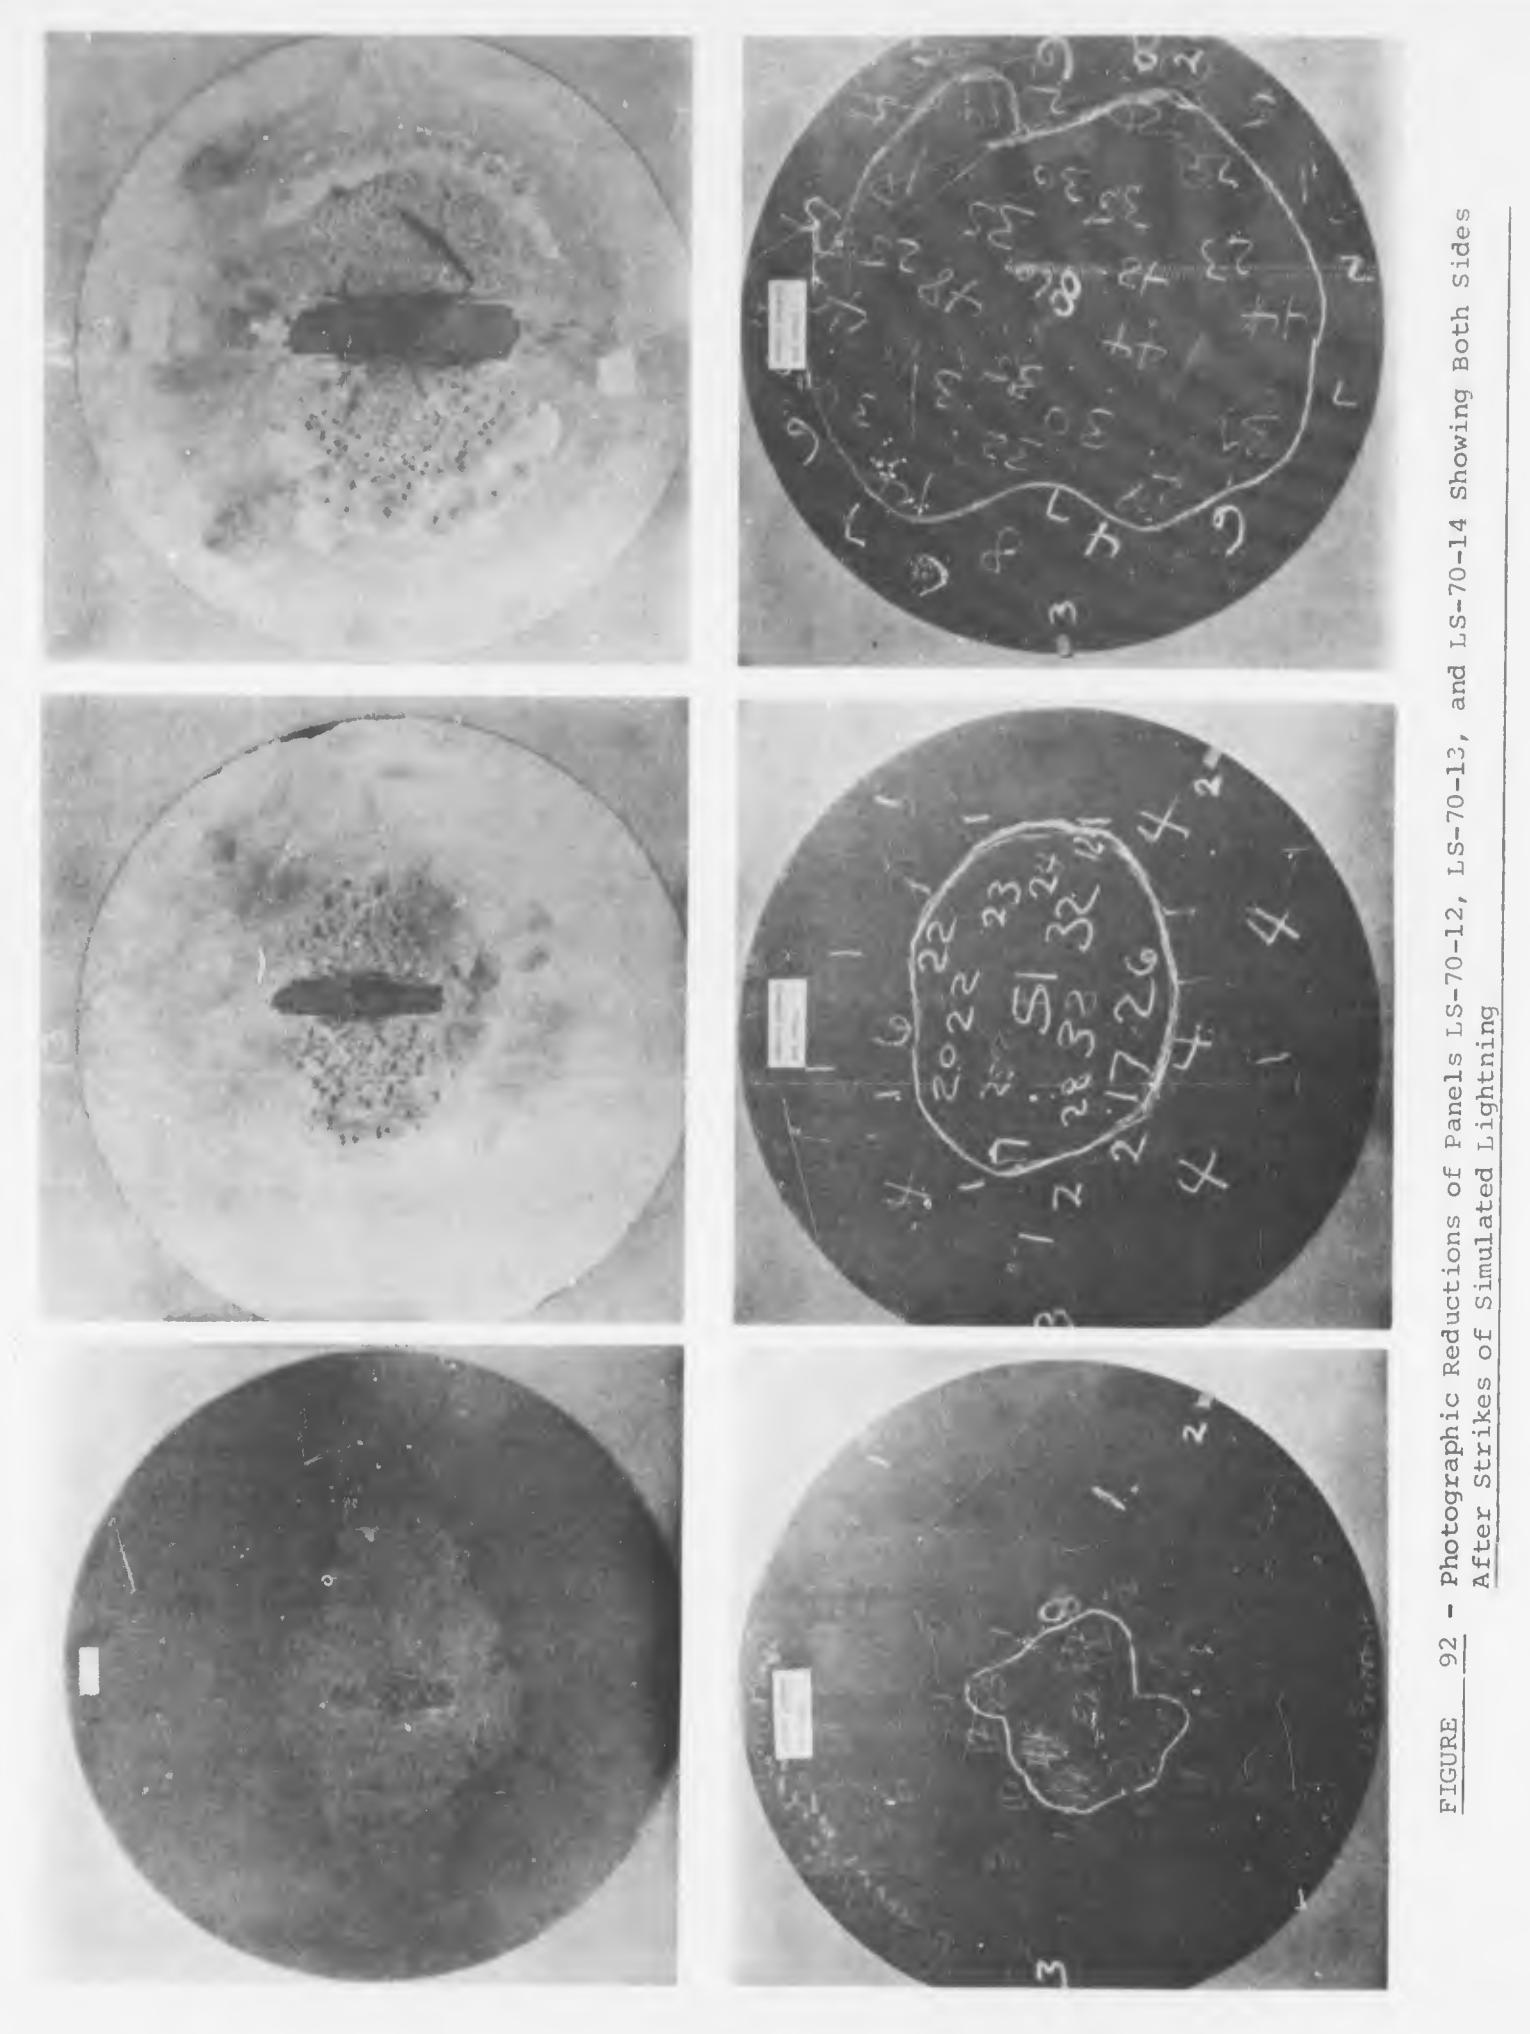
The test made on the thicker graphite panels of nominal thickness 0.120" will not be described. Photographs of the damage to panels LS-70-9 through LS-70-14 are shown on Figures 91 and 92. Also shown on these figures are data pertaining to an acoustic impedance test. The significance of this latter will be described later.

This was an uncoated, 0-90° layup panel of 0.120" thickness. It was tested at a current level intermediate between the 0.040" panels LS-70-2 (61 kA), LS-70-3 (57 kA), and panel LS-70-1 (85 kA). The area of disruption of the panel surface, or the discolored area, was about the same on

this thick panel as on the thinner 0.040" panels, but the physical lifting or destruction of the first layer of fibers was less on this thick panel. The arc did not blow a hole through this panel as it did on the thinner panels. The back surface was undamaged, at least visually; however, tapping the back surface with a coin showed a dead area in the center. At the outer edges the panel rang clearly as though the fibers were undamaged.

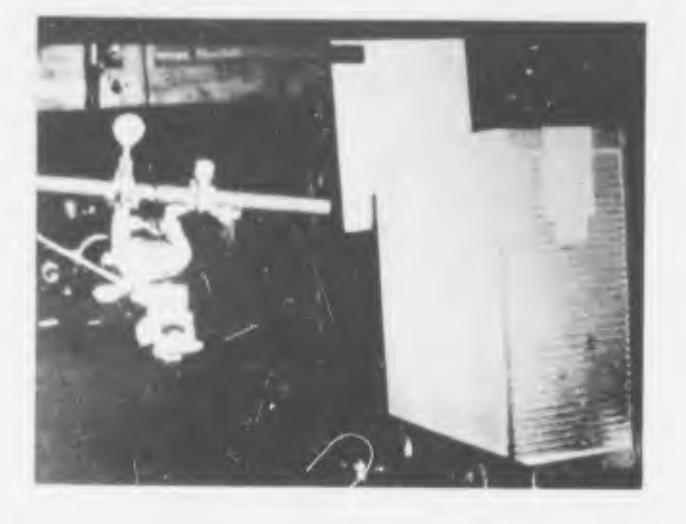
A. Before Test

This was a rectangular honeycomb panel that received four test shots on one side and one on the other. Photos taken before and after the tests are shown on Figure 108. The first shot was at a current level of 4.85 kA peak. This shot did little more than discolor the coating over a 3.5" diameter circle around the contact point. No other visual damage to the honeycomb material was noted. The test did, however, increase the resistance of the silver coating. Before the test, resistance had been measured diagonally across the panel, and between the two sets of edges. The measurements of resistance before and after are given in Table XVIII.

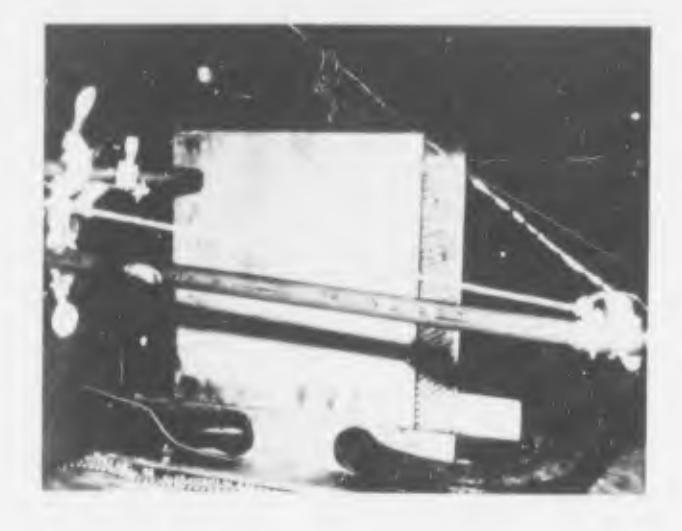
Side 2, After 72.7 kA Discharge

The second shot was to a different point on the panel, but on the same side. At a current level of 72.7 kA, there again was only discoloration of the surface coating, with no damage to the panel itself (Figure 108B).

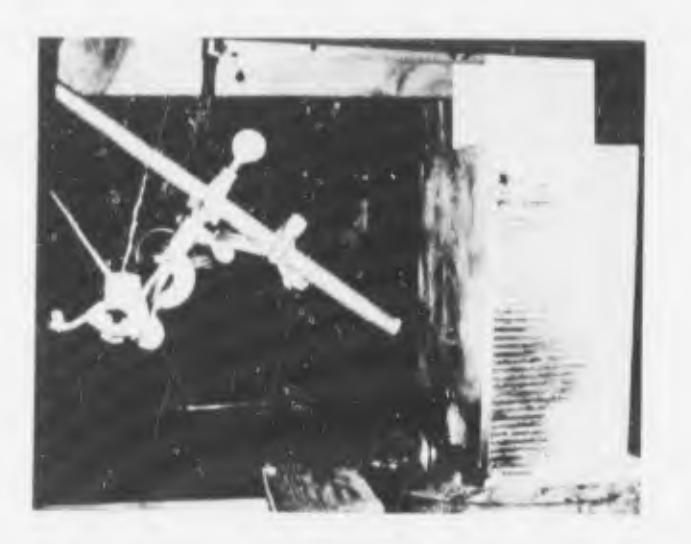
Side 2, After

The third shot, at 111 kA, again resulted in a discoloration over about a 3.5" diameter circle, and produced pitting of the coating at the point of stoke contact. It did not, however, result in any apparent damage to the panel itself (Figure 108C).

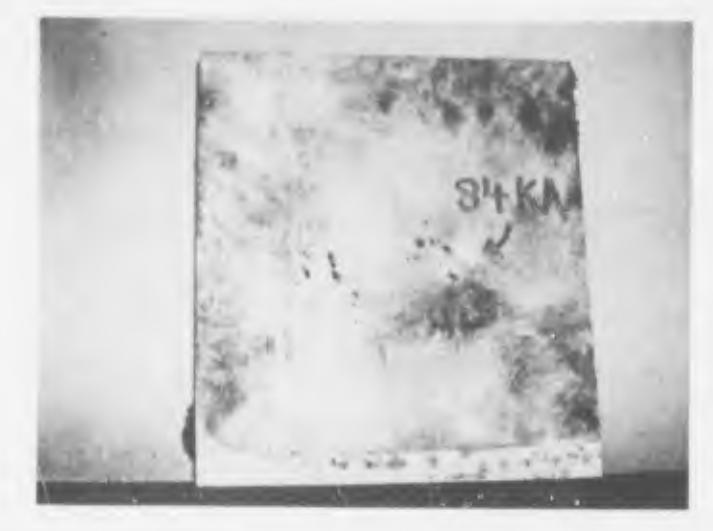
Figure 109-A shows the damage on the second side of this panel.

A. Sample BR-109-1 Side 2 After 84 kA and 111 kA Discharges

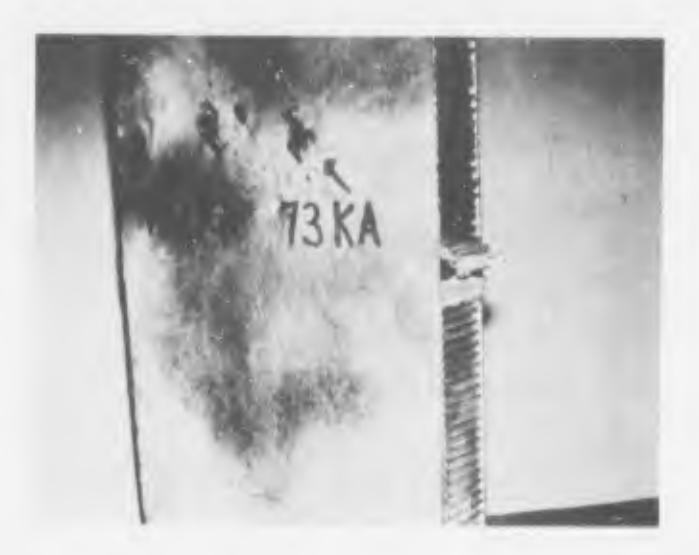
The second shot was at a level of 72.7 kA. It blew a 1"  $\times$  0.5" hole in the panel and blew a piece of honeycomb (1" square) loose from the edge of the panel at the point nearest to the arc. A photograph of the resultant damage is shown on Figure 109-B.

B. Sample BR-103-3 Side 2 After 73 kA and 107 kA Discharges

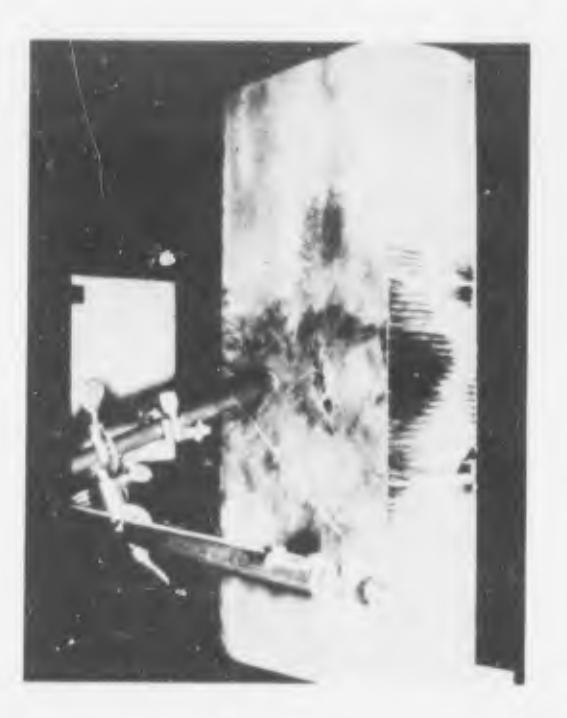
The second shot was at 87 kA on side one and caused approximately the same damage as observed on the other side of the 107 kA level. See Figure 109-C.

C. Sample BR-108-1 Side 1 After 87 kA Discharge
