SIO Shipyard Representative Bi-Weekly Progress Report

Project: AGOR 28	Contract No.: N00014-12-C-0305	Shipyard: Dakota Creek Industries
Prepared by: Paul D. Bueren Scripps Institution of Oceanography (SIO) 297 Rosecrans St. San Diego, CA 98106	Date: 1 March 2016	Program Officer: Robert (Tim) Schnoor Office of Naval Research 875 Randolph St ONR 321 Arlington, VA 22203-1995
Distribution Statement A: Approved for public release; distribution unlimited.		Report No. A002.095

Weekly Report 29 Feb 2016

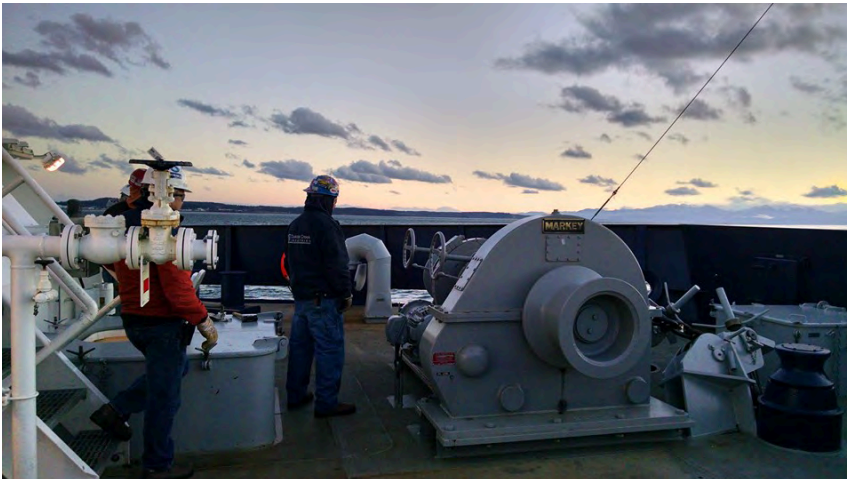
- Starboard Drive Failure – The drive has been fully tested under full load with no issue to report. A new DC breaker is to be installed and the current breaker will be placed into spares. PME 325 is exploring options to add a spare AIM, ALM and Motor Drive Module to the shore based spares.
- Ballast Tank Coatings – Monitoring GDR's for coating issues on Armstrong. WTA for pre delivery ballast tank inspection on Ride is in the works.
- **Anchor Windlass** – Mock INSURV anchor demo was performed with good results. One shot of chain was walked out, port and starboard, with no skipping. The chain did skip multiple times on both sides with the wildcat declutched and in free fall. The chain stopped using the hand brake with no issues at the end of each shot.

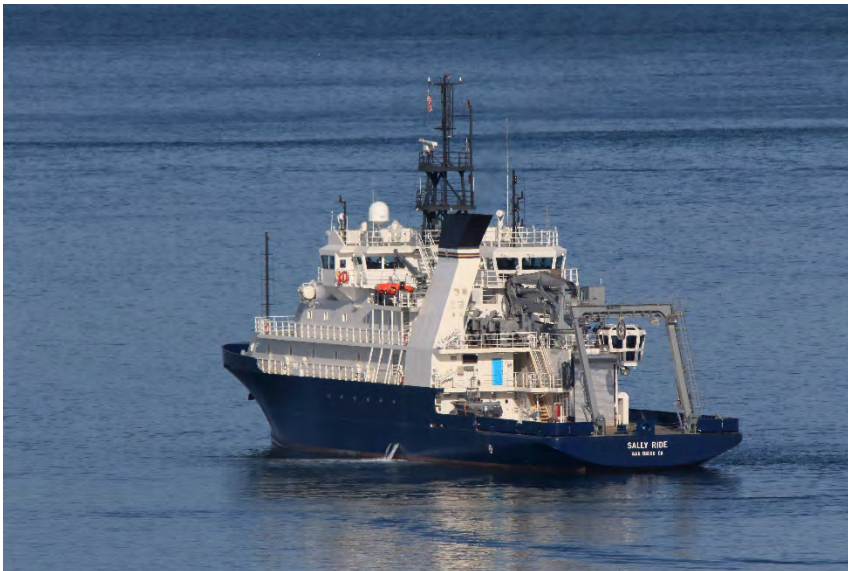
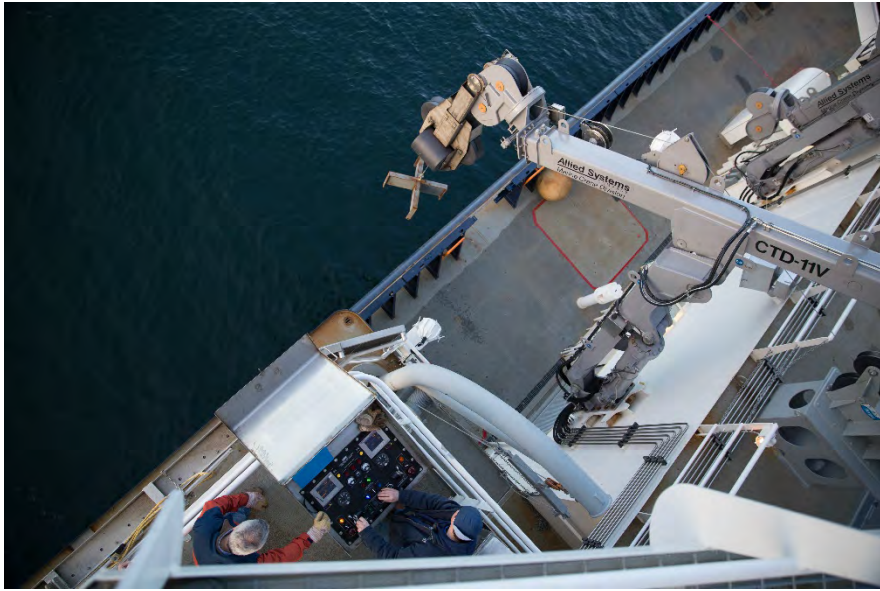
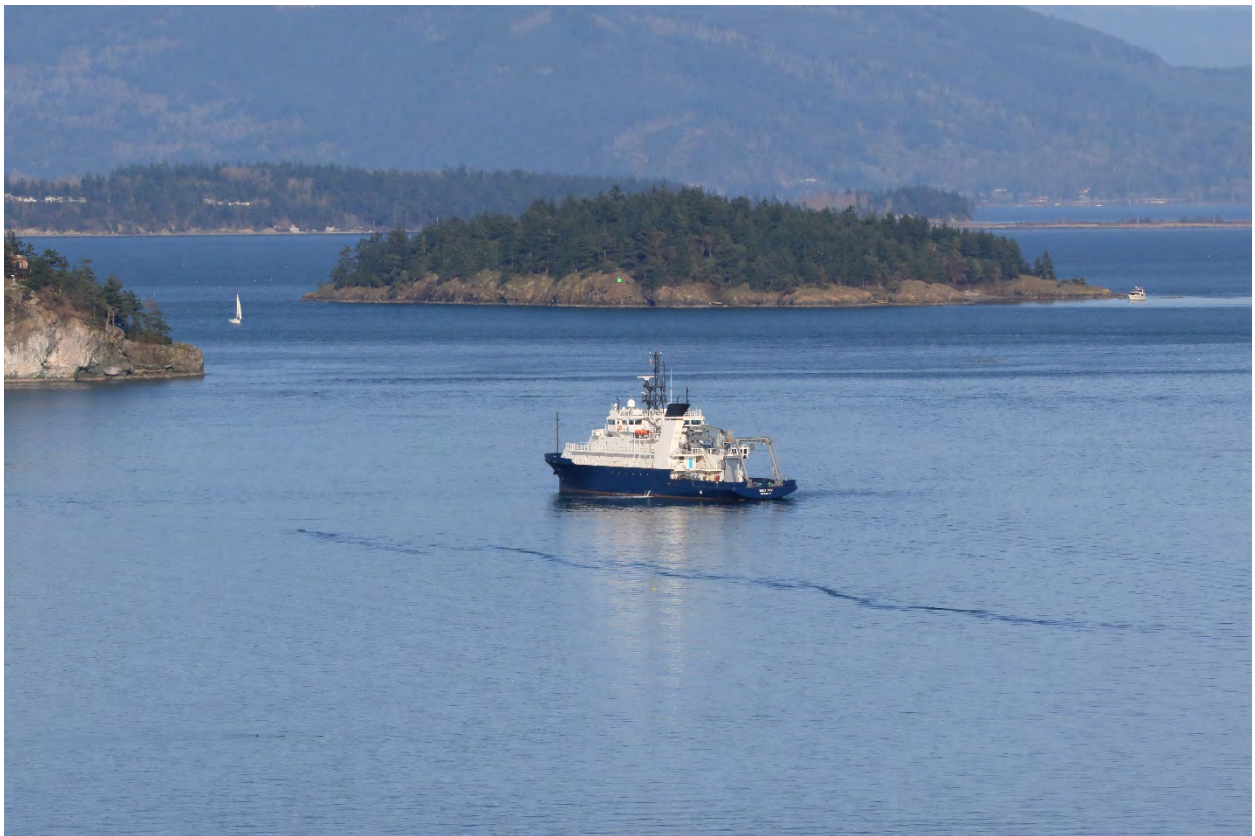
- Starboard Blue Drive – Repairs and testing completed.
- Crew Fam – On schedule.
- Mock INSURV – Completed last Sunday with a successful weekend of sea trials.
- Lab Spaces – Finish work continues in the labs.
- DPS Trial – DPS groomed and tested. USCG and ABS witnessed final testing on Thursday.
- Depth Sounder – The depth sounder display shows interference when the Oily Water Separator heaters are on. The yard is investigating the issue.
- DC Ground Detection – DCI and Siemens have corrected the ground detection issues. A final report/drawing explaining the corrective actions should be forthcoming.
- AT – Scheduled to begin 0400 Day Zero March 6.
- DC Locker – Provided additional SIO purchased firefighting gear to yard for installation prior to INSURV. Carpenters mounting SCBA's and shelving in 1st Plat DC location. Ship's crew to assist with the location and stowage the gear.
