AFCEC-CX-TY-TP-2013-0006

**EXPERIMENTAL INVESTIGATION OF
WIDESPREAD DELAMINATION DAMAGE TO
COMPOSITE MATERIALS CAUSED BY
RADIANT HEATING**

Contract No. FA4819-09-C-0030

June 2013

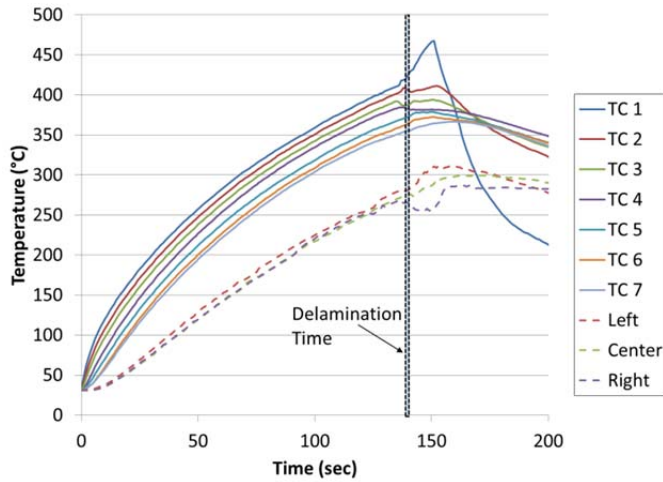
The approximate delamination time was estimated from the embedded TC and backface TC readings, as shown in Figure 11. These times corresponded well with the time of global plate buckling observed during testing. Deviations in the measured embedded TC temperatures are seen during delamination as plies separate from one another. If the TC remains bonded to the ply on the heat-exposed side of the plate, for example, a short-term increase in the rate of temperature increase is seen. A short-term reduction in the rate of temperature increase, and sometimes a temperature drop, is seen if the TC remains bonded to the ply away from the heating. Deviations in the backface TC temperatures, which are originally in contact with the insulated side of the plate, are seen when the surface of the plate is moved away from the TC, such as when global buckling occurs.

Two criteria were used to determine the time of global plate delamination. The first criterion was the time when three of the embedded TCs showed deviations in the temperature loading rate. Indication from a single TC was not considered definitive because it could indicate when a small crack occurred around an individual TC and not be a good indicator of plate-wide delamination. The second criterion used was when all three backface TC readings (left, center and right) showed a deviation, as discussed above. The time and temperatures reported here are the averages of these two methods.

Figure 11. Temperature history data from embedded and backface TCs.

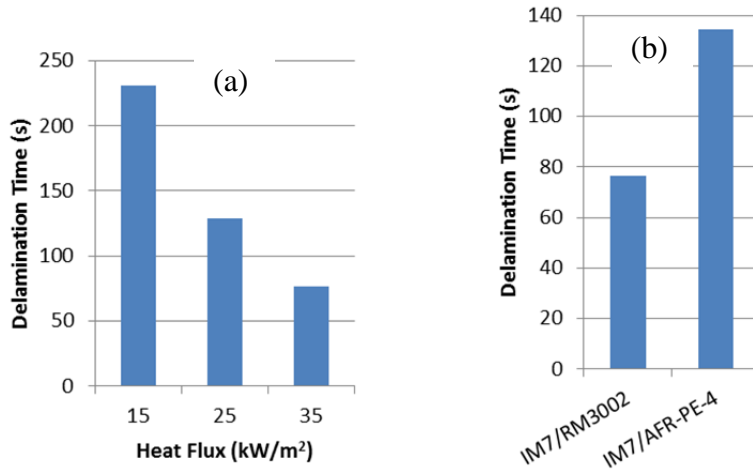
Delamination times for plates tested dry are shown in Figure 12 as a function of heat flux for IM7/RM3002 in Figure 12(a) and comparing IM7/RM3002 to IM7/AFR-PE-4 in Figure 12(b). Results from these two materials can be compared because the plates had nominally the same thickness. As would be expected, the time to delamination decreases rapidly with increasing heat flux as shown in Figure 12(a). Limited testing was performed on IM7/977-3 and IM7/AFR-PE-4 composites at a single heat flux intensity, so the variation with heat flux is unknown. Comparison between materials in Figure 12(b) shows that material having the higher dry T_g , IM7/AFR-PE-4, took longer to delaminate.

Figure 12. Delamination times in (a) dry IM7/RM3002 plates at three heat flux magnitudes and (b) in dry plates tested at 35 kW/m².

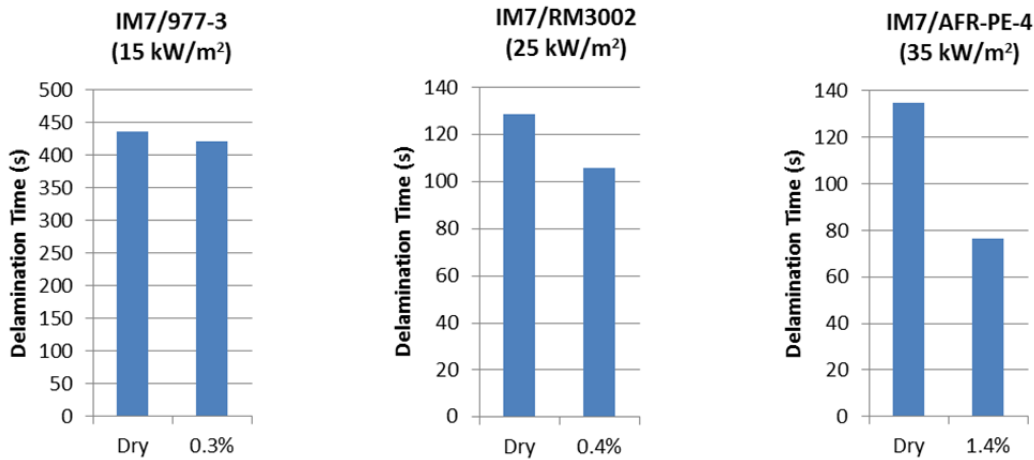
Figure 13. Effect of moisture content on the time to delamination at fixed heat flux magnitudes.

When moisture was added to the plates IM7/AFR-PE-4 had the greatest reduction in the time to delamination, as shown in Figure 13. Note that it also had the highest moisture content. The time to delamination at 35 kW/m² was actually reduced to the same time (77 s) as the lower T_g material, IM7/RM3002, tested dry at this heat flux. No conclusion can be made about the relative sensitivity to moisture for all materials tested since each was at a different moisture content at the time of testing. The lowest T_g material, IM7/977-3, showed the least reduction in time to delamination tested wet and dry. It is not clear from the limited data what effect the greater specimen thickness, lower heat flux, and smaller temperature gradient had on these samples with regard to the elevated moisture content. Additional testing is needed to examine all of these effects.

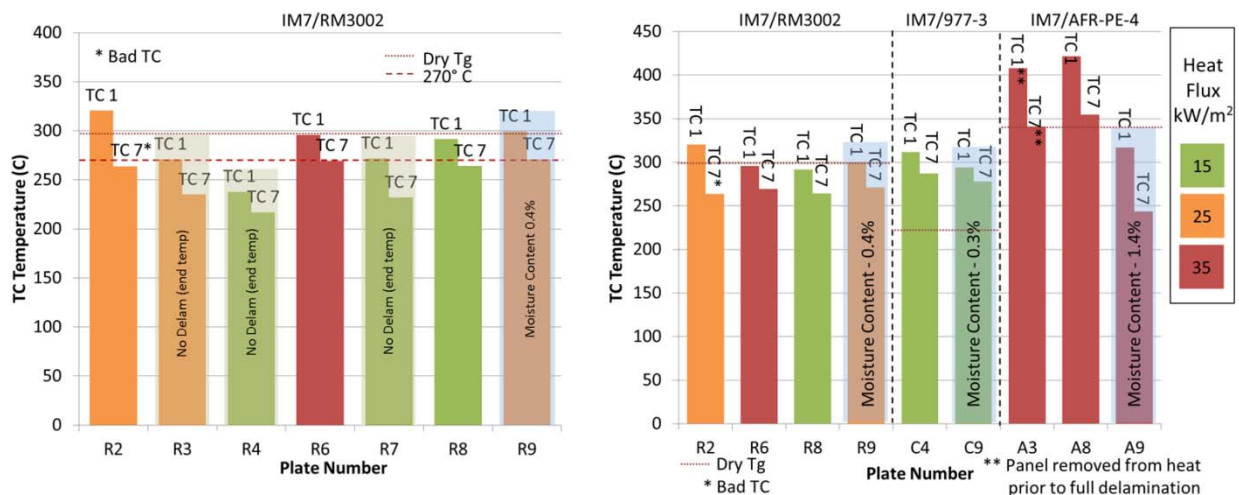
Direct comparisons of the three different composite materials cannot be made because of differences in material thickness and in the heat flux intensities to which each material was exposed. However, the plate temperatures at which delamination occurred can be compared, as shown in Figure 14 for all three materials. Ply temperatures on front (exposed to heat) and back (insulated) of the laminate plate (TC 1 and 7) were recorded at the time of apparent delamination. Results for IM7/RM3002 in Figure 14 also show the temperatures at the time a plate was removed from heat for plates that did not delaminate. Since IM7/RM3002 was tested at three heat flux intensities, some observation can be made regarding the temperature at which delamination occurred independent of the heat flux applied. Delamination did not occur until the TC 7 temperatures reached approximately 270 °C for all IM7/RM3002 plates tested. Plates that did not reach this temperature at any ply in the samples did not delaminate.

The material with the highest T_g, IM7/AFR-PE-4, showed the largest reduction in the temperature at which delamination occurs due to the presence of moisture. As shown in Figure 14, temperatures varied between 341 °C on the back faces and 422 °C on the front faces of the dry material at the time of delamination. When delamination occurred, the entire plate was above the dry T_g for this material, cited by the manufacturer as 340 °C. Water in general acts as a plasticizer, lowering the T_g, but its effect on this condensation polyimide resin is not known. The temperatures in the plate with 1.4-percent moisture content varied from 244 °C to 317 °C at the time of delamination, well below the dry T_g.

Figure 14. Front (TC 1) and back (TC 7) temperatures at the time of delamination.

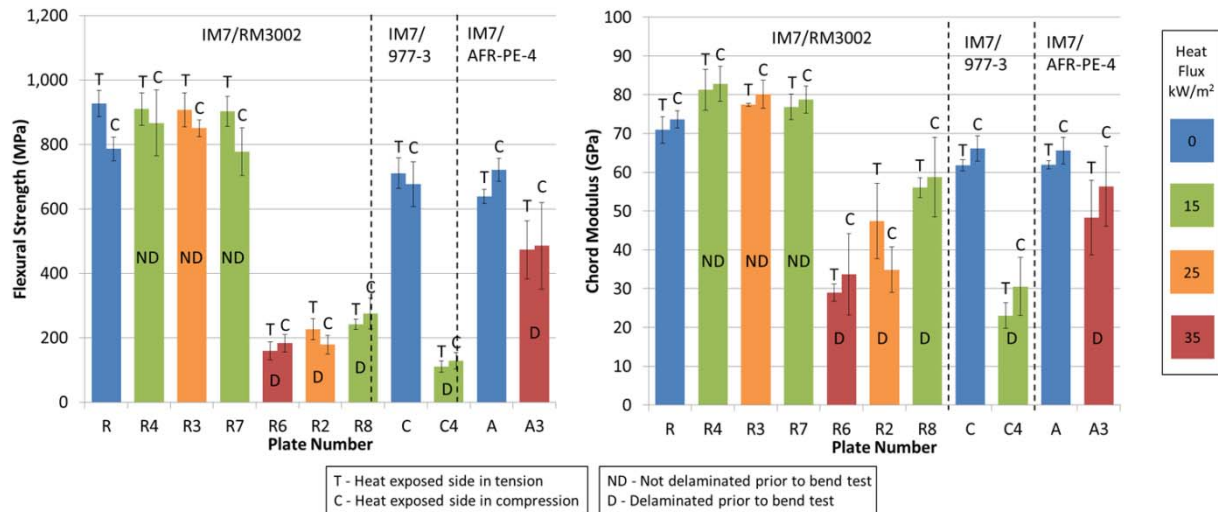
Four-point bend testing was performed on unexposed and heat-exposed samples with the heat-exposed side in both compression and tension. The flexural strength and chord modulus are shown in Figure 15. The standard deviation of typically four tests with the heat exposed side in tension (T) and five in compression (C) are shown with the error bars in the figures. Note that plates that did not delaminate from heat exposure are marked with ‘ND’ and those that did with ‘D’.

The IM7/977-3 and IM7/AFR-PE-4 materials also had a large drop in flexural strength once delamination occurred. The highest T_g material, IM7/AFR-PE-4, demonstrated the smallest drop in strength with delamination in the one plate tested (approximately 30 percent). It is important to note, however, that plate A3 was removed from heat just as delamination started. So it is not clear if reduction in flexural strength is less severe in this material or if similar reductions would be seen if allowed to complete delamination.

The overall effect on material chord modulus is similar to that for the strength. Here, the effect on modulus was a decrease of 23 percent at the lowest heat flux and a decrease of 60 percent at the highest heat flux. The apparent increase in modulus of the IM7/RM3002 plates without delamination (cf. plates R, R3, R4, and R7 in Figure 15) is likely due to plate-to-plate variation or post-curing.

Figure 15. Average flexural strength and chord modulus at varied degrees of heat exposure.

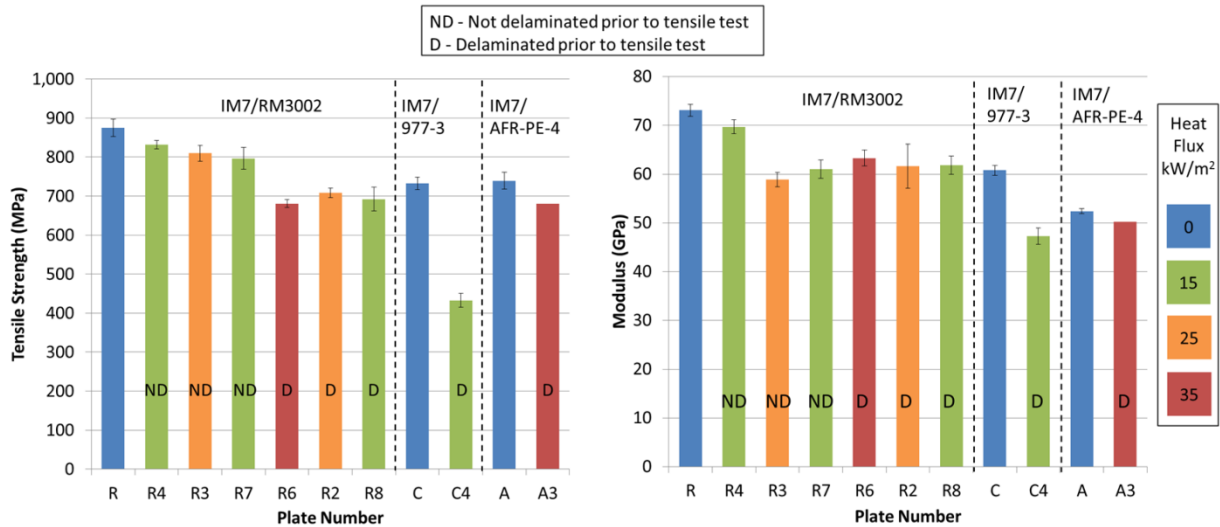
Tensile testing was performed on unexposed and heat-exposed samples. The tensile strength and tensile chord modulus of elasticity are shown in Figure 16. The standard deviation of six samples are shown with the error bars in the figures. Only three samples were tested for plates A, C, C4, R and R6. Data for A3 is from a single sample so no standard deviation is shown. In general, the heat-exposed plates that delaminated showed less degradation in the tensile properties than the flexural properties, as would be expected by the dominant damage mode of delamination.

All materials showed a reduction in tensile strength for samples with delaminations from heat exposure. This reduction was only large for IM7/977-3, which had a 40-percent drop in tensile strength between the two plates tested. Tensile modulus was also reduced for this material. IM7/AFR-PE-4 showed a similar trend, but the magnitude of the reduction in properties was much smaller. The material IM7/RM3002, with the largest number of exposures, showed some mixed results.

The tensile strength of IM7/RM3002 samples with delaminations from heat exposure was lower than samples with no delaminations, even with heat exposure. This is consistent with the other materials. The chord modulus is also lower for samples with delaminations than material with no heat exposure (plate R). However, plates R3 and R7 with no delaminations also have a lower chord modulus similar to the delaminated plates. Plate variation may be responsible for the differences in chord modulus rather than the effect of delamination. Future testing should ensure tight control on consistency between plates to avoid this uncertainty.

Figure 16. Average tensile strength and modulus at varied degrees of heat exposure.
