# **ACES-II Seat Roller Study: Findings of Detrimental Friction under High Windblast or Adverse Flight Conditions**

*Analytical findings of an intrinsic, restraining, high-friction response from the ACES-II Ejection Seat's legacy "seat roller" (a dry metal wheel on a shaft), when subjected to high loads (such as ejections at high speeds or with an aircraft yaw angle). Recommendations are made for improvement.*

12 Aug 2015

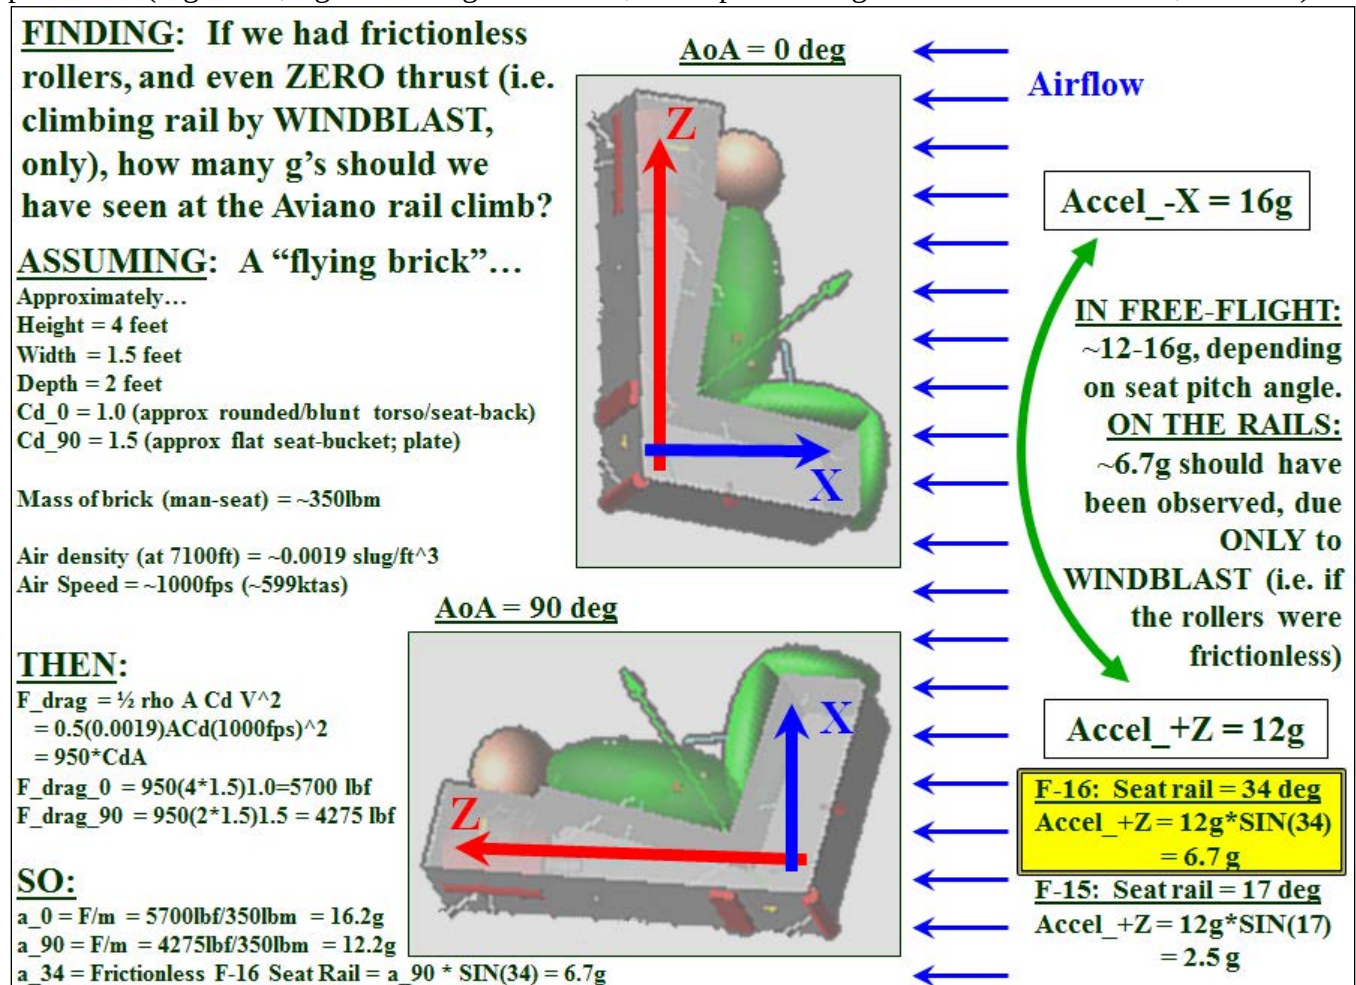
Figure 2 – Hand-Calculations of Aerodynamics on a Man-Seat Emerging at 7100ft-msl & 600kt

Note that this simplified relation ( $F_{\text{friction}} = ma - PA$ ) excludes what may have been an additional “wind assist” ascending the rails. As shown in Figure 2, a frictionless seat roller should allow additional man-seat acceleration due only to vectored wind forces “getting under the man-seat” on a 34-deg reclined F-16 aircraft rail.

However, as noted: This measured friction was simultaneously overcoming what is presumably up to ~6.7g (see Figure 2) in additional wind-assist; acceleration which should have been measured as a “negative friction” (acceleration exceeding the  $F=PA$  value), had roller friction been zero. Therefore, the actual seat roller friction may have been thousands of pounds higher than this  $F=ma-PA$  measurement, in order to have finally been measured as a “restraint” on the man-seat (or on the CKU-5 ROCAT).

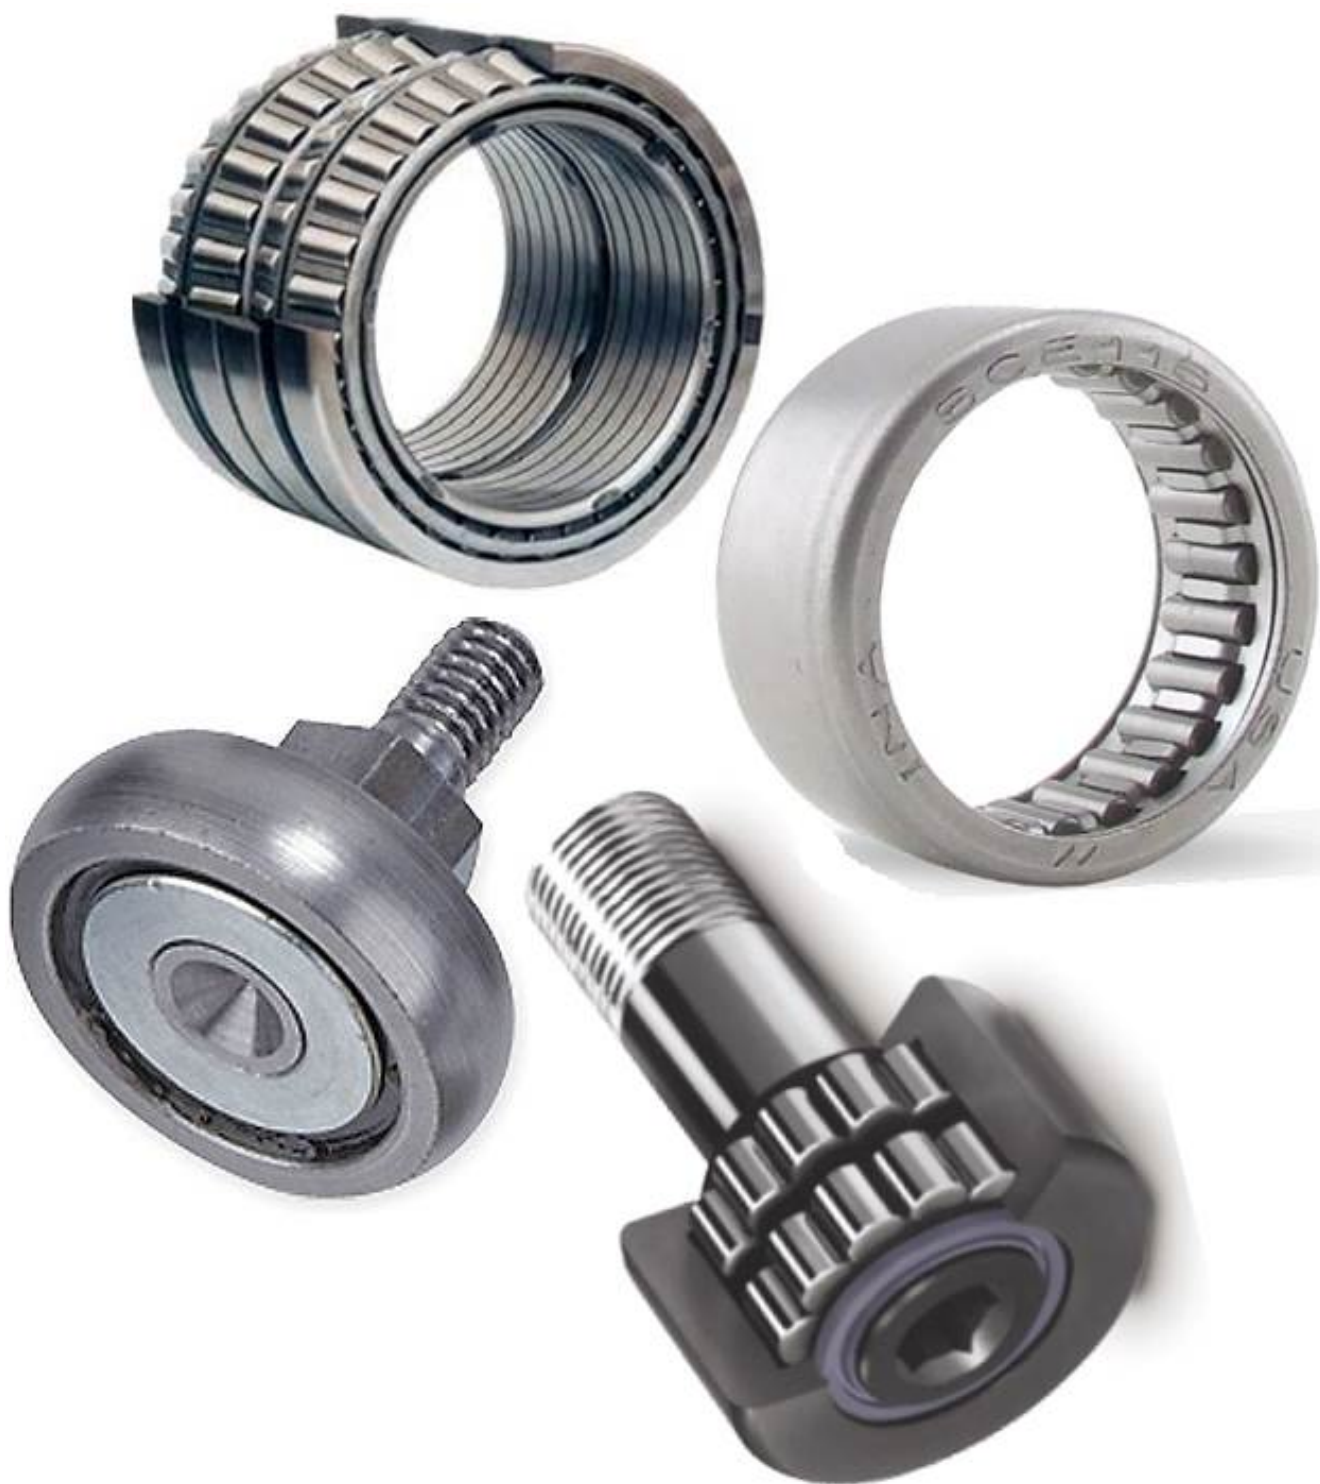
Figure 7 – Images of some Typical Cam Rollers and Bearings

Figure 7 provides some images from the myriad of hundreds of COTS cam rollers which are currently available, and which would approximate the “zero friction” ( $\mu=0.0$  to  $\sim 0.01$ ) behavior analyzed as the first simulation in the ADAMS design study.

The proposed correction is a rapid retrofit program to replace the current ACES-II’s “dry metal wheel on a shaft” design with a modern “cam roller” (lifetime-sealed, high-duty, lateral-thrust tolerant roller bearings). An insightful team may find roller integrations which exploit existing seat hardware (holes, shafts, brackets, etc.), require no machining modifications to the ACES-II seat (only removal of the old wheel, shaft, etc), and minimal additional fittings and tools, such that the retrofit can be performed during routine seat maintenance in fewer than two man-hours per seat, with less than \$1,000 per seat in hardware costs, and adding less than 10 pounds of mass per seat.

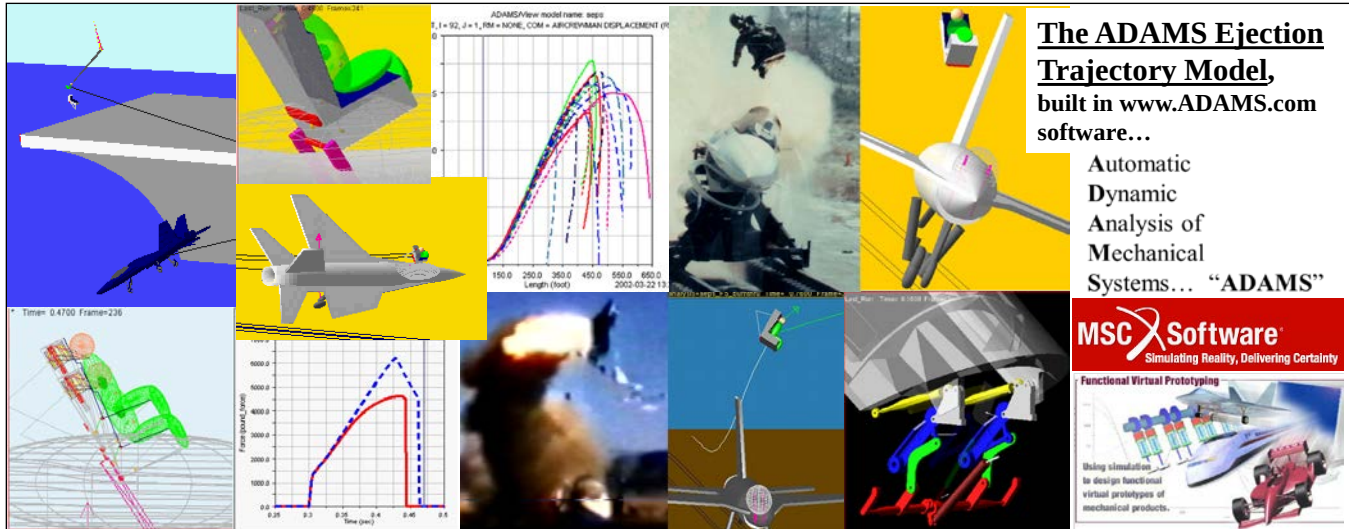
**Figure 8 – Joint AF/Navy ADAMS Ejection Trajectory Model (Developed/Maintained since 1995)**

The 6-DOF ADAMS Ejection Trajectory Model (Figure 8) includes all six (6) rollers of the ACES-II seat, with interaction (stiffness, damping, and friction) against the aircraft rail, and incorporates most major aircraft and ejection dynamics, mechanics, and aerodynamics (dozens of objects with dozens of parametric variables; multiple seat thrusts, emergence into windblast, aircraft roll/yaw/altitude/etc, parachute inflation rates, headbox deployment, etc. – with optional internal propellant ballistics and aircraft features; landing gear, arresting hooks, lift and drag forces, center of gravity, etc.).

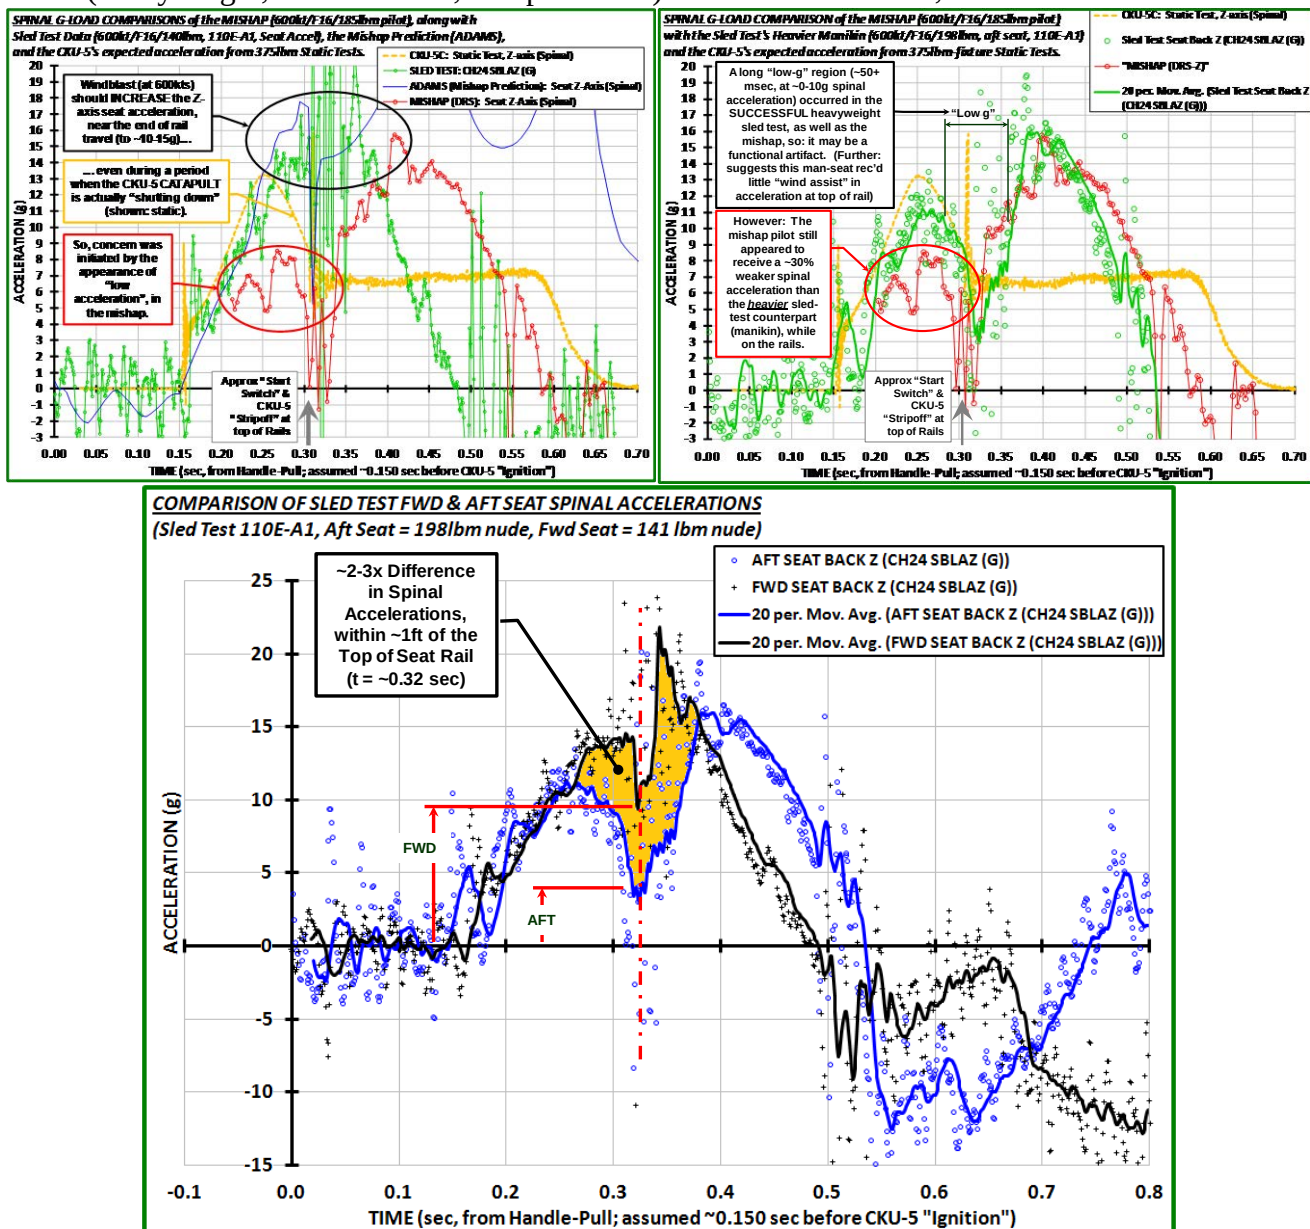
*“A low-g (~0-10g) spinal (Z) reading on the DRS of an ejecting ACES-II seat, any time during the CKU-5 catapult/rail travel, and within ~1-2 feet from departure of the top of rail, at F-16 airspeeds approaching 600 keas.”*

This behavior is indicated below [repeating Ref-1 figures], by the DRS of the subject mishap, and by the aft seat (heavyweight; 198 lbm nude, 95<sup>th</sup> percentile) of sled test 110E-A1, of 2012.

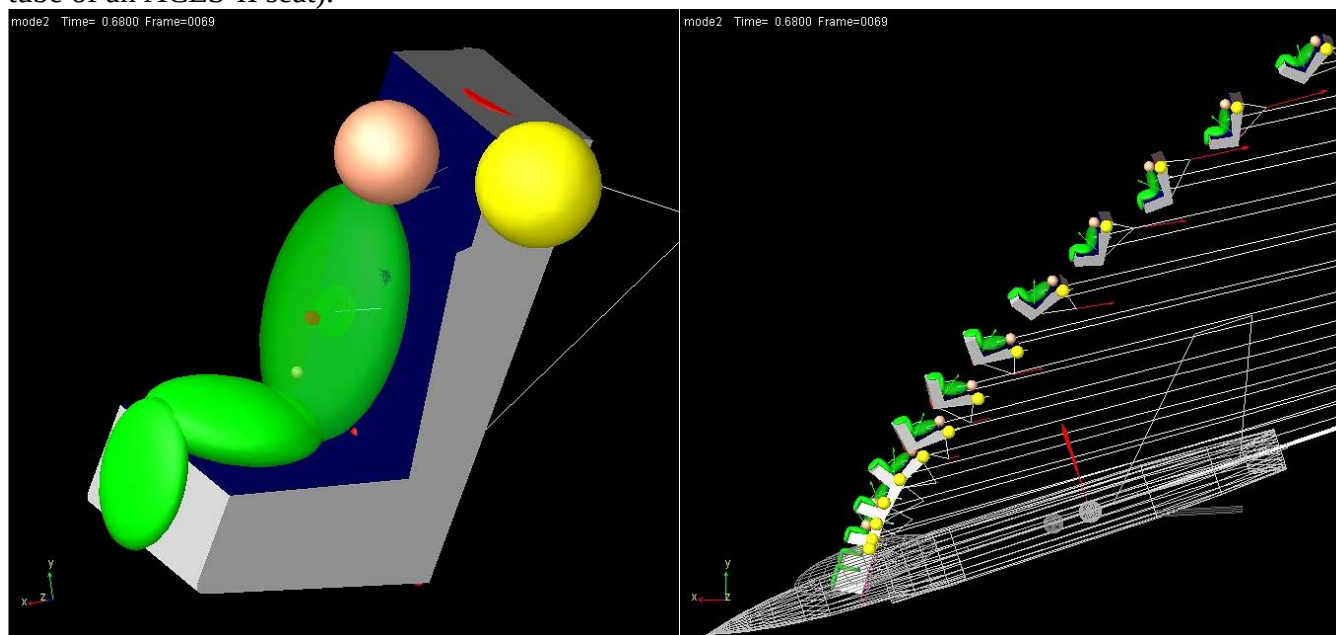
**Figure 17 – Example of a Deviation Analysis; Aerodynamic Helmet on Pitot Tube (from ADAMS)**

Approximately two-dozen ADAMS model studies (experimental scenarios) were exercised, to explore the sensitivity of the DRS’s recorded accelerations to various anomalies, such as pilot Cg shifts (“up and back” from Air Force defaults, for tall/thin body shapes), boot flail aerodynamics, arm flail mass and aerodynamic effects, drogue chute inflation delays, CKU-5 ROCAT performance variations, aircraft pitch and roll (and rate) effects, atmosphere effects (wind, density altitude based on colder weather), seat rail structural failure and early release at top of rails (including asymmetry), etc. No conclusive match was found, to explain “artifact #1”. As an example of these analyses: Figure 17 shows the flyout predicted for this incident, if the aerodynamics are altered by the snagging of a helmet on the port pitot tube of an ACES-II seat).

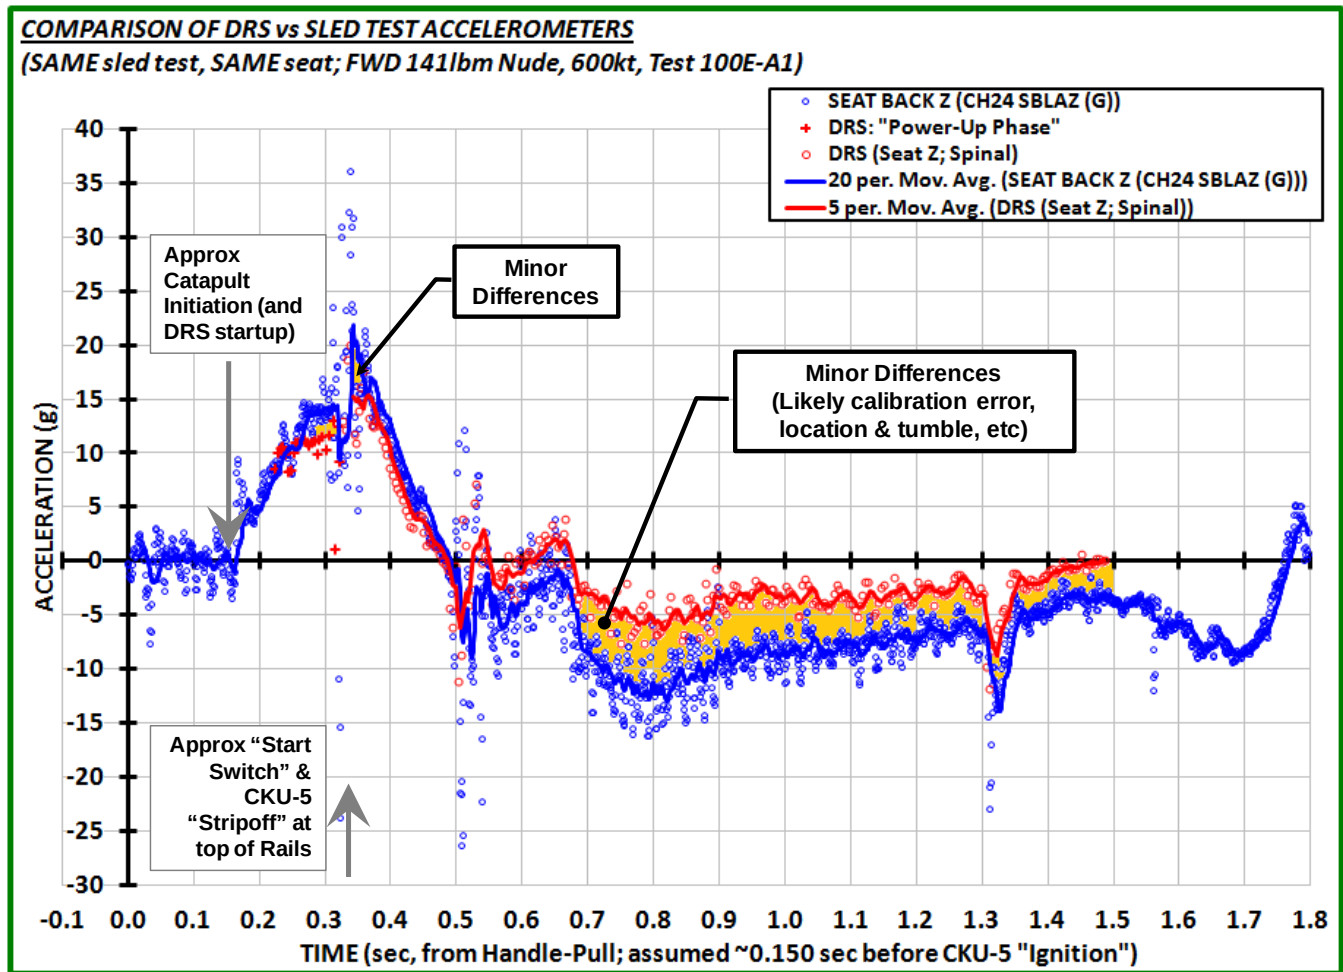
Figure 18 – Proof of DRS Accuracy; Mostly Complies w/ Lightweight Sled Test Instrumentation

Confirmation was achieved (via review of sled test data, containing both “high-fidelity” accelerometers and onboard DRS) that the DRS appears to be capable of accurate readings; tracking well in both time & magnitude with the “high fidelity” accelerometers onboard the sled test seats. Figures 18 and 19 show this good match, between onboard DRS readings (on back starboard of seat) and their comparable sled test instrumentation measurements from additional high fidelity accelerometers (mounted on the back port of the same seat), for the same ejection event. This finding provides good confidence in the DRS design and concept (and suggests DRS errors were NOT the cause of Artifact #1).

Figure 18 also captures the "good" (expected) performance of the catapult and 600kt-emerged sustainer phases; exhibiting 10+g spinal accelerations, throughout the regime of being "at the top of rail, +/- 1ft". Figure 18 also confirms the good timing-alignment achieved (aligning spinal acceleration timing marks from the headbox initiation at  $t = 1.3$  sec, and earlier at top-of-rail "stripoff"). This finding confirms two things; the need to use a ~0.060sec delay (battery warm-up period) to start considering as the DRS's time of "first data", and that this "first data" is the initial "Power-On Phase" data (not the subsequent "Ejection Phase" data, which begins at the "Start Switch"; near the top of the rails). Further, this finding shows two more things; that the DRS's "Power On Phase" data (marked as red "+" signs, vice the "Ejection Phase" DRS data, marked as red circles) is largely capturing the majority of the CKU-5 catapult phase, and that the Power On Phase is measuring this catapult performance fairly accurately.

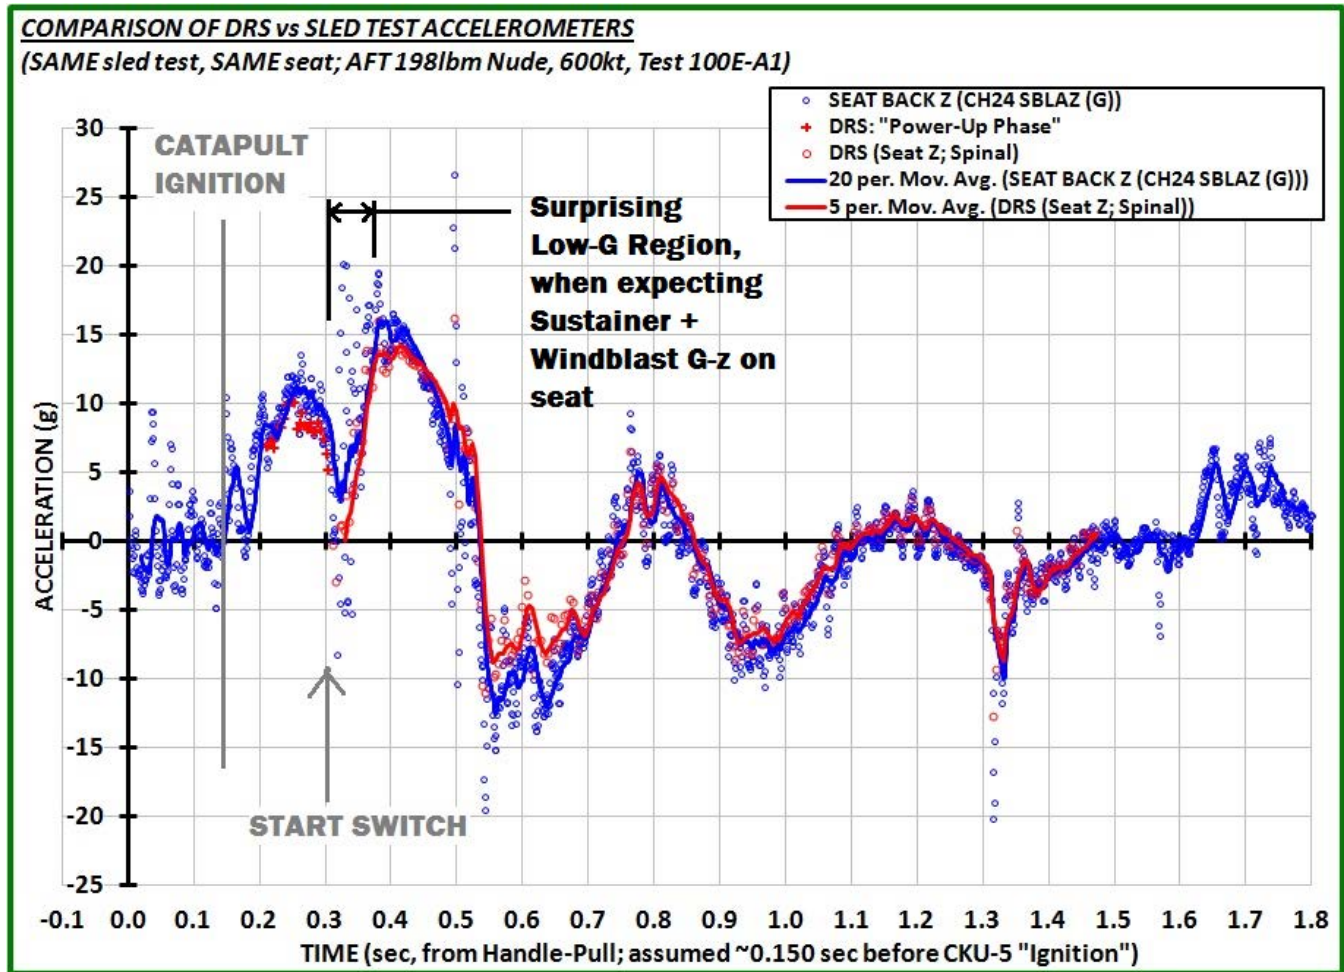
Figure 19 – Proof of DRS Accuracy; Mostly Complies w/ Heavyweight Sled Test Instrumentation

Figure 19 captures this same successful instrumentation as Figure 18, but also appears to have captured an "artifact #1" event of the spinal g-load dropping out to near-zero values within a foot or two of the top of rails (near the end of the catapult, and the beginning of sustainer phases of the CKU-5).

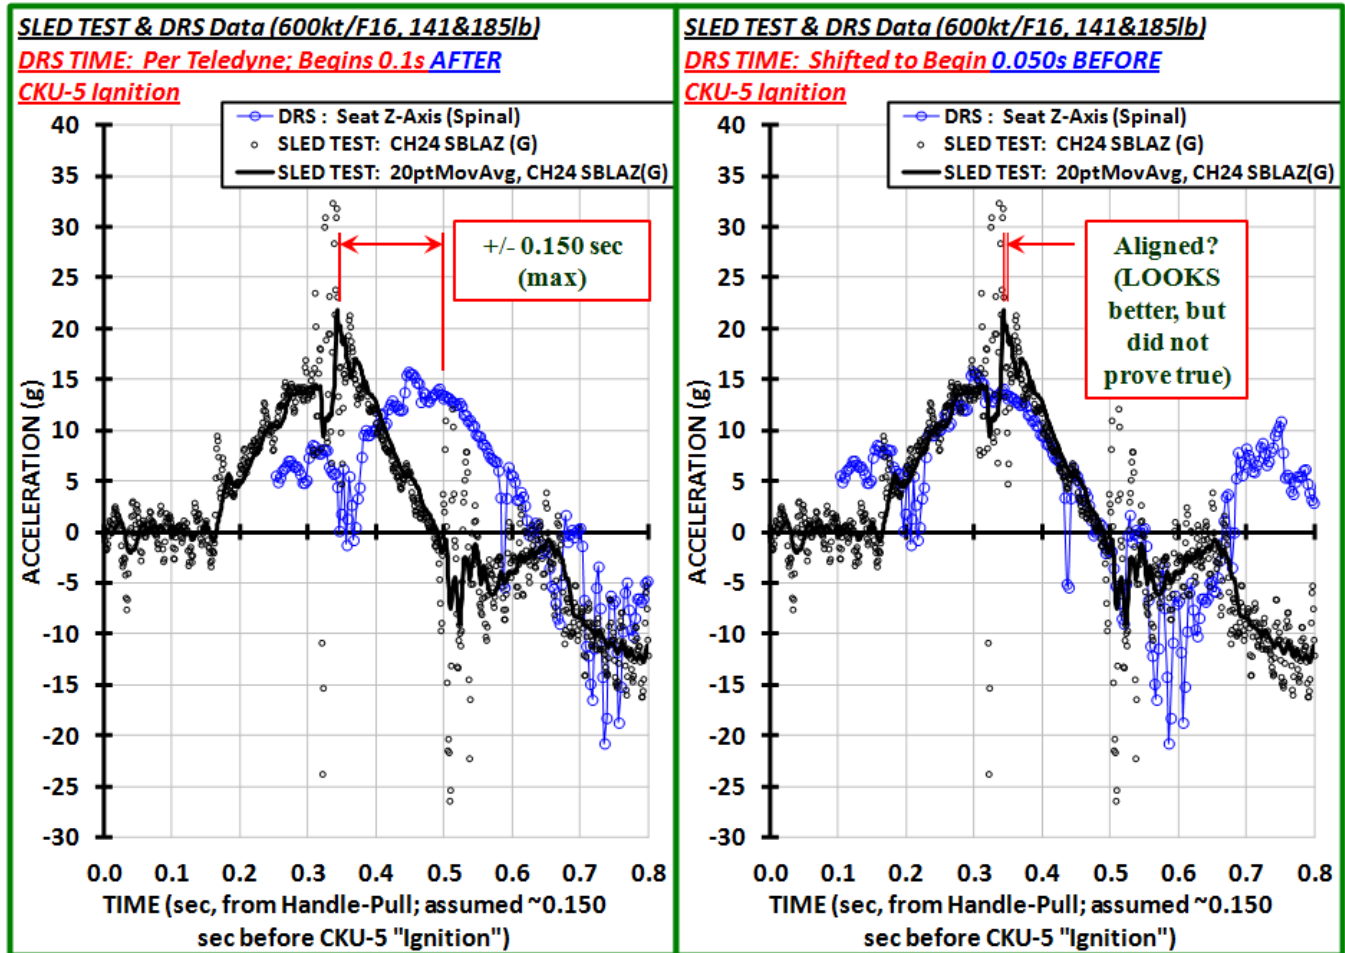
Figure 20 – Illustration of the Discussed “Time Shift”, Cosmetically Fixes Artifact #1 & #2

| 1.5 | "Time Shift" error of DRS data: Misalignment of (properly-performing) high and low acceleration regions creates the FALSE appearance of low g's during the catapult phase (when the early data should actually be deleted) | Reportedly not the case. Teledyne assures that proper time-alignment is: ~0.060sec after CKU-5 signal, the DRS's 0.090sec "Power On Phase" data begins (confirming: that aligns CKU-5 stripoff and headbox time indicators, and matches sled test successes). Conversely: DELETING the "Power ON Phase" and starting the "Ejection Phase" DRS data at the same 0.060sec after CKU-5 signal causes the catapult & sustainer performance to appear normal. (Apparently a cosmetic coincidence. See Fig. 23) |

Previously, as shown in Figure 20: Multiple discussions had occurred, ranging from +0.100 sec delays (spec max), to -0.050 sec delays (if sneak paths or data recordings or phases were misunderstood), and – the latter (shifting time ~150msec earlier than the “max spec”) did make the period of the CKU-5’s operation appear “nominal”, rather than “anomalous”. However, these further studies of the sled test accelerometers and DRS data – complete with time-datums of CKU-5 stripoff, and later headbox launch

- confirmed that the nominal delay of  $\sim 0.060$  sec (from CKU-5 initiation) is the proper alignment. The appearance of “nominal CKU-5 function”, when shifting the DRS data to begin  $\sim 0.050$  seconds BEFORE the CKU-5 (reportedly impossible), or deleting the  $\sim 0.090$  second “Power Up Phase” data, appears to be only a cosmetic coincidence.

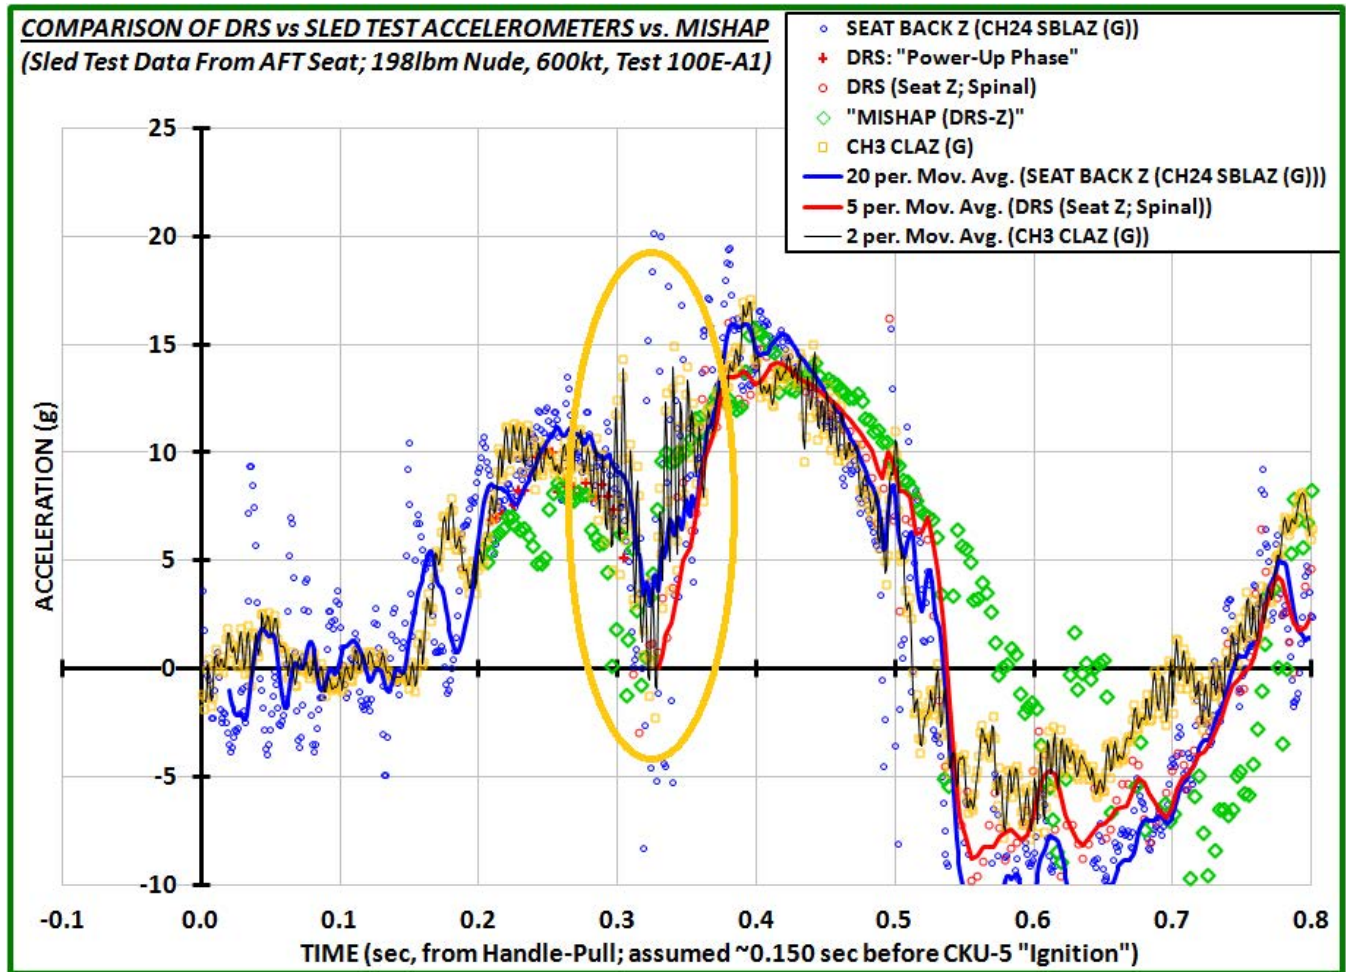
Figure 21 – Proof that Seat Flexure Didn't Cause Artifact #1 (Manikin Chest Accel Agrees w/ DRS)

| 1.1 | DRS out of calibration, mis-designed, non-responsive, or otherwise inaccurate. | Not causal; DRS tracks sled test seat-back acceleration, manikin chest, and post-sustainer g's appear reasonable. (See Fig. 21) |

As shown in Figure 21, confirmation was achieved that the “torso” of the pilot accelerates reasonably well with the seat-back (suggesting Artifact #1 was not caused by modal frequencies of flexure in the ACES-II seat’s structure). The sled test’s aft seat-back accelerometer (Channel 24, SBLAZ), manikin torso (Channel 3, CLAZ), and DRS-Z all three agree, showing that the cause of the “low-g dropout” is NOT merely an instrumentation accident, or a localized “slump” or structural flexure artifact in the manikin or seat, but rather (apparently) a true, macro, seat-motion artifact. Additionally, the mishap’s DRS-Z exhibited this same artifact; spinal acceleration largely “zeroed” for  $\sim 0.030$  to  $0.050$  seconds, near the top of the rail.

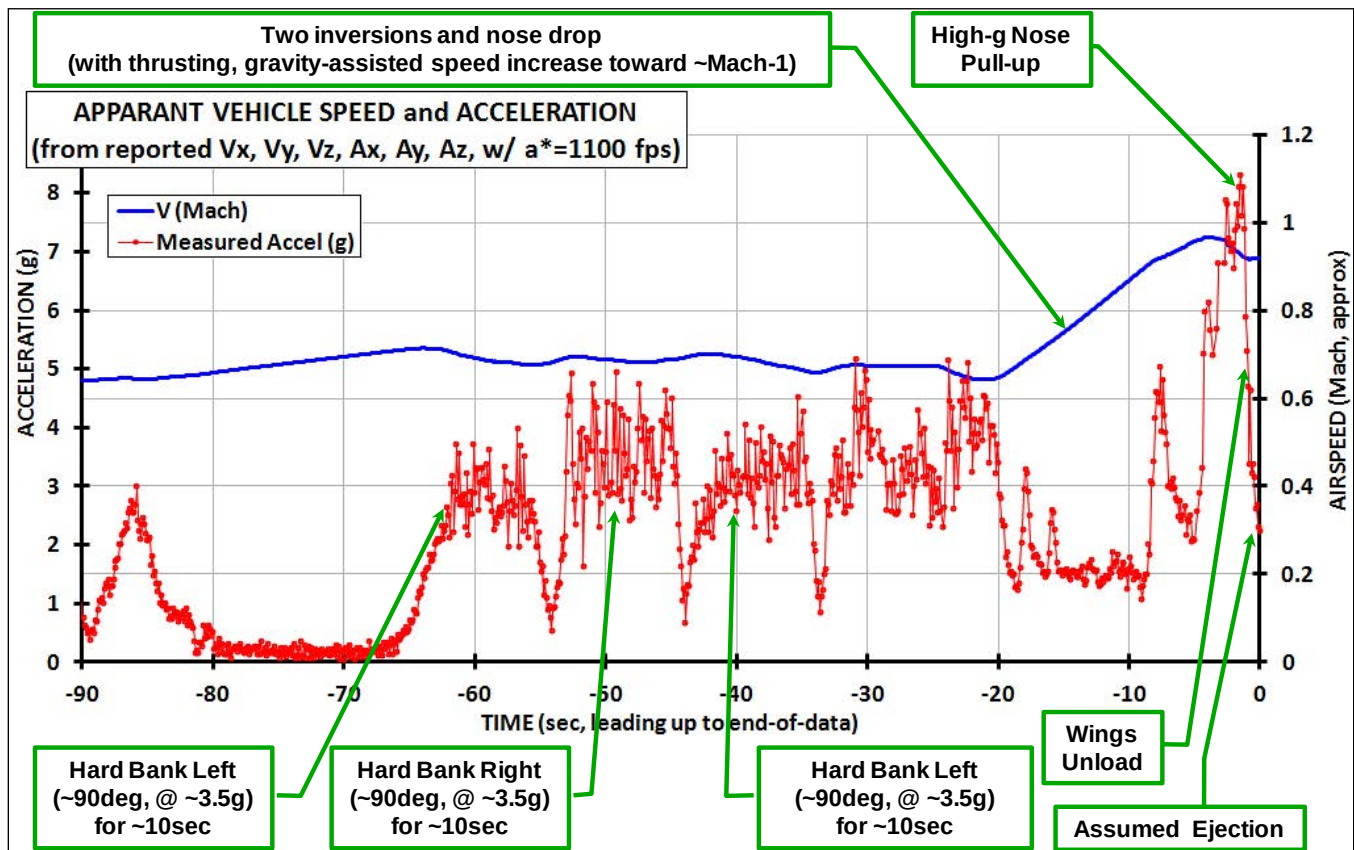
Figure 22 – Acceleration Report of Aircraft for 90sec Prior To Ejection (at ~2.3g)

Consideration was given that the ongoing "ambient" aircraft acceleration (about 2 g's) at the time of catapult firing could have "decreased" the CKU-5's catapult performance. The acceleration profile for the 90 seconds prior to the assumed ejection is shown in Figure 22, along with approximate Mach number. However, logical examination disproves this aircraft g-load from explaining artifact #1 ("low-g", including during catapult phase). First, while the aircraft was "bellying out" (positive AoA) as a high-g (~8-9g) "nose pull-up" maneuver, and retained approximately ~2-2.5g of this positive AoA at the time of ejection, "subtraction" of this ~2g from catapult performance would not explain the regions of catapult-phase acceleration which appear ~5-10g below the expected 10-15g performance, particularly during the "mid-catapult" g-load dropout of several g's, as shown in Figure 21, at approximately 0.25 seconds. Second, a contained solid propellant ("catapult") performance generally "self-compensates" against restraint, by increasing burn rate at higher pressures, so a superimposed "2g" aircraft environment would generally be expected to have a "less than 2g" reduction on the catapult's thrust acceleration. Third, since the seat's DRS is mounted to measure inertial acceleration of the seat (not acceleration *from* the aircraft, or "infer" seat acceleration from thrust measurement), the aircraft's acceleration would be INCLUDED (i.e. somewhat "added") to the measurement of the CKU-5 driving performance on the seat. So, if the DRS measures "+5g" of spinal acceleration during the catapult phase, during a time when the aircraft is itself "pulling +2g" of spinal acceleration, then that

measurement indicates a net acceleration of the seat (departing the aircraft; catapult-driven) of only +3g (i.e. LESS than the DRS measurement of +5g).

Therefore, it would not be a reasonable attempt to explain a “low 5g catapult-phase acceleration” by suggesting the “aircraft g’s inhibited this measurement”, or that the ambient 2g aircraft acceleration should be “added” to this DRS reading, to report that the “actual ejection g-load was 7g”. Conversely, the superposition of accelerations works the opposite; a 2g aircraft acceleration superimposed would suggest the CKU-5 catapult only added ~3g additional, to be measured as +5g by the DRS.

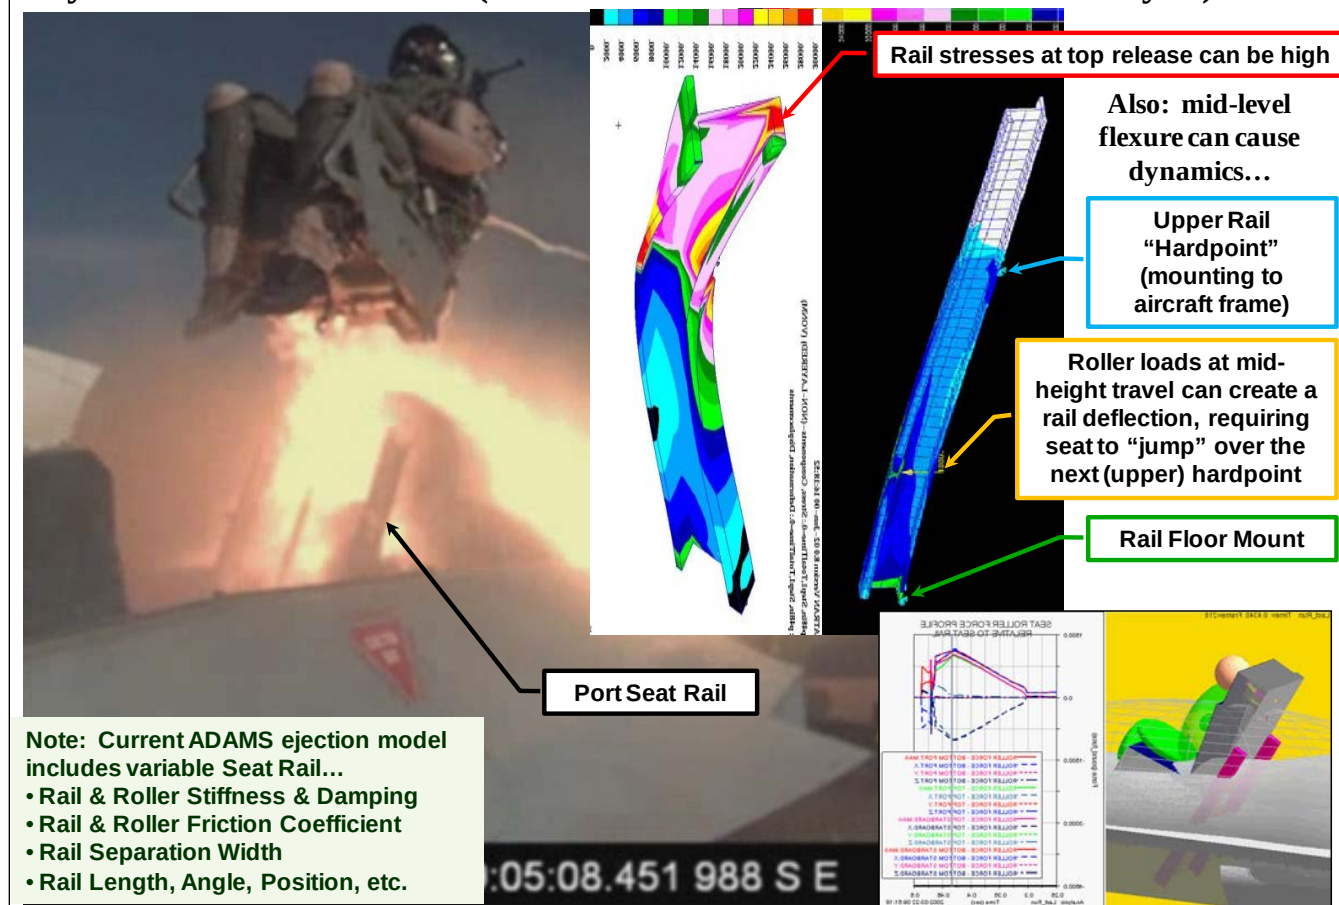
Figure 23 – Example of Potential Seat/Rail Mechanical Dynamics Analysis

While no analysis has been repeated for this particular scenario (high speeds, F-16 recline, heavyweight pilot, CKU-5C booster profile), Figure 23 shows an example of historical – and potential future - analysis of the man-seat-rail-roller interactions which could be re-analyzed, to check for motion restrictions caused by flexure or dynamics.
