Corrosion Control of Central Vehicle Wash Facility Pump Components Using Alternative Alloy Coatings

Final Report on Project F09-AR14

Michael K. McInerney and Robert B. Mason, Jr.

July 2016

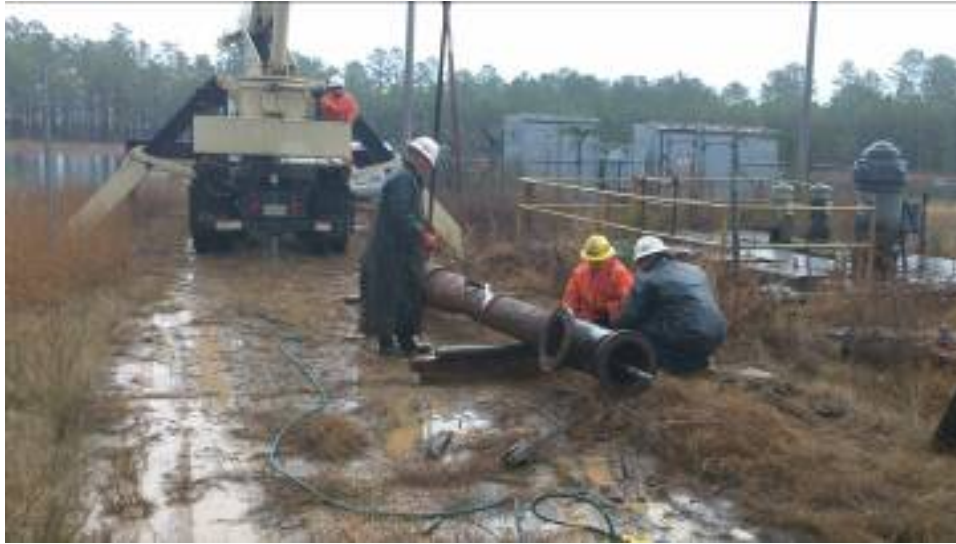
Figure 7. Old (inoperable) Unit 2 pump disassembly.

The installation took place at the Fort Polk CVWF North Station in January 2011. Before installing the new pumps, Fort Polk “outside” electricians (electricians who work with outdoor high voltage equipment) were called to disconnect the primary power to the pump station. The north-side pump (hereinafter referred to as Unit 2) was disconnected and removed first. The old Unit 2 pump was placed on the ground, and the existing header was removed to be reused with the new pump. The disassembly of the old Unit 2 pump is shown in Figure 7.

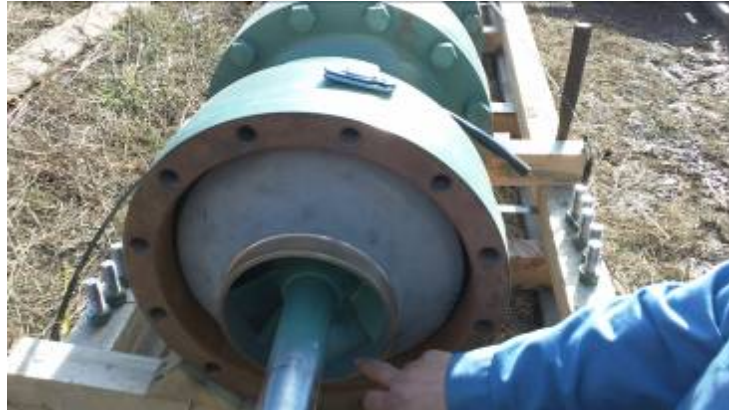
Figure 9. New Unit 1 first-stage impeller coating configuration.

The bottom cap of the new south-side pump (hereinafter referred to as Unit 1) was removed to verify what type of coating was on the impeller prior to installation, as seen in Figure 9.

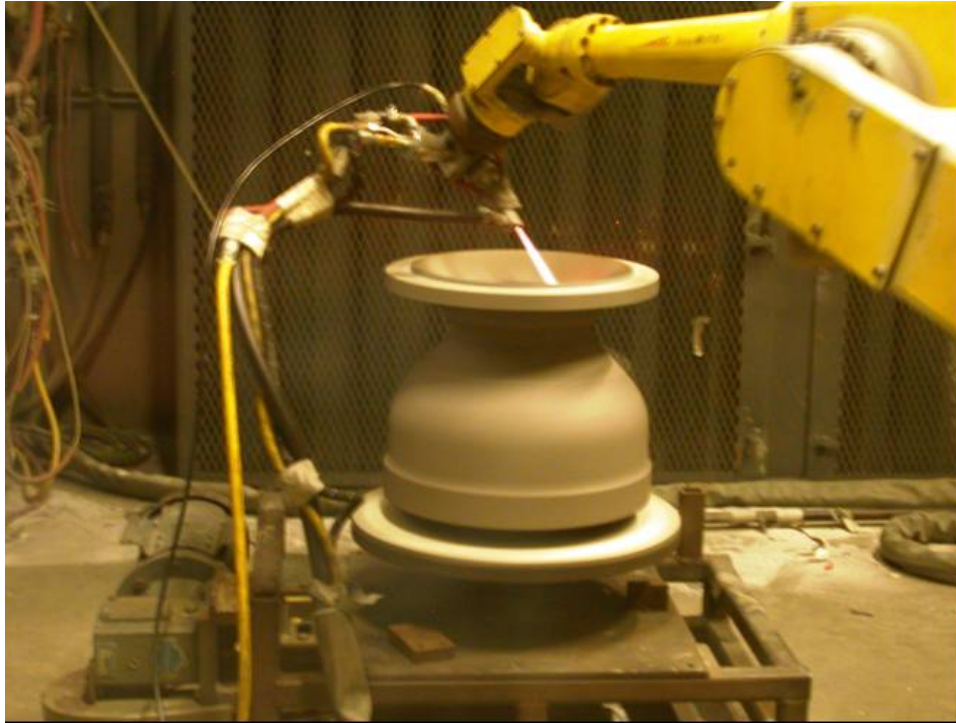
Figure 19. Stellite 6 coating being thermally sprayed on underside of pump bowl.

The new pump components were sent to two different facilities for coating. At one facility Stellite 6 coatings were applied to the pump components. Upon arriving at the site, the pump components were found to have a small amount of superficial surface corrosion. Prior to coating, the parts were grit blasted to provide a clean surface to promote coating adhesion. The parts were then coated using the HVOF thermal-spray process. HVOF is one of the most commonly used thermal-spray processes because it can be used to deposit a wide variety of materials as dense, well-bonded coatings. In the HVOF process, powdered material is fed into a gun, where it is combined with oxygen and fuel. The process of coating the underside of a pump bowl is shown in Figure 19.

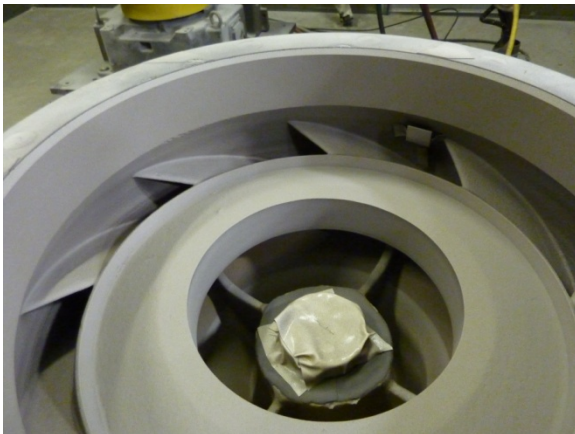
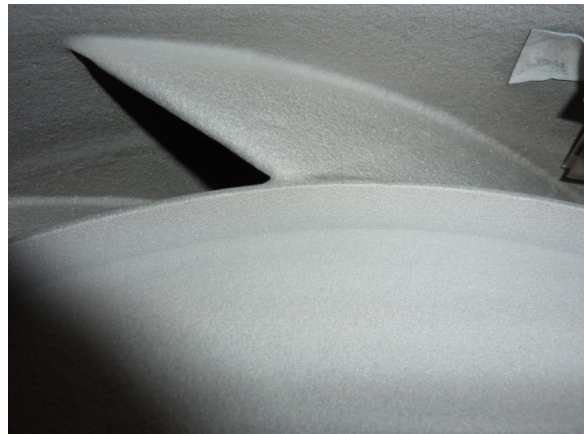
Figure 20. Condition of pump components after application of the Stellite 6 coating.

the time of processing. The appearance was found to be acceptable by the coater. The pristine condition of the coated pump components corresponds to an overall rating of 10 in accordance with ASTM B537 – Appearance; ASTM B537 – Protection; and ASTM D2809.

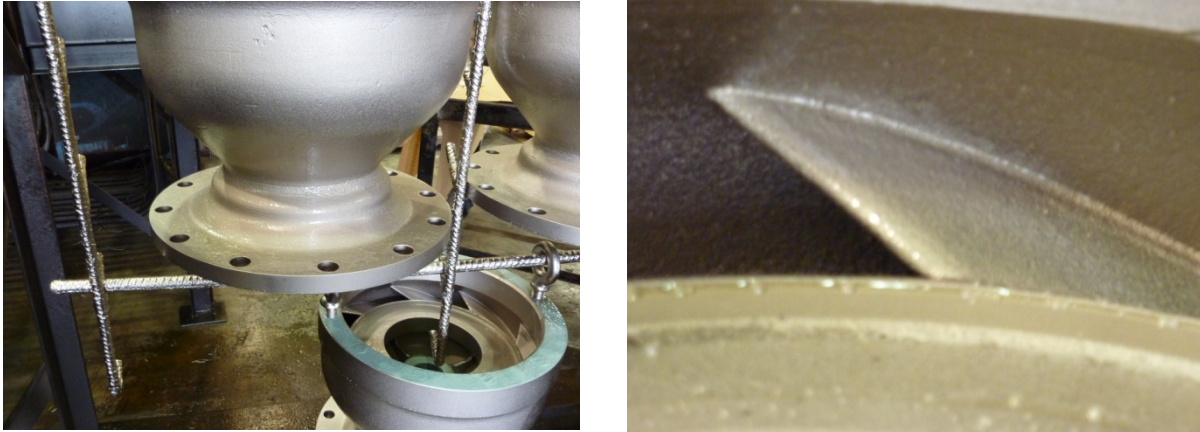
Figure 22. Condition of pump components after EN plating.

The pristine condition of the coated pump components corresponds to an overall rating of 10 in accordance with ASTM B537 – Appearance; ASTM B537 – Protection; and ASTM D2809. Coating thickness and adhesion were confirmed with witness coupons. The EN-coated parts were then heat treated for optimum wear and erosion resistance.

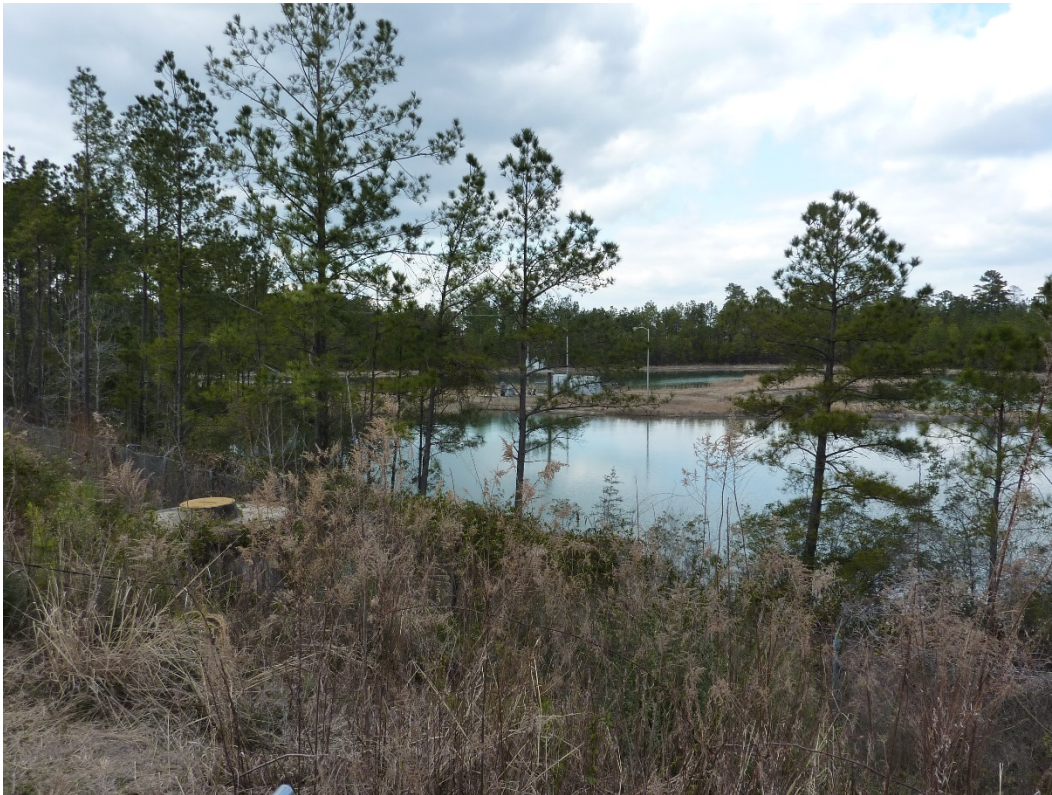
Figure A1. Photograph of CVWF water sources, with facility in background.

Note that two of the samples have a very high Ryznar index indicating mild steel is expected to experience intolerable corrosion. The third has a high Ryznar index indicating mild steel is expected to experience heavy corrosion.
