**AFRL-RQ-WP-TM-2016-0155**

# **OPERATION OF A T63 TURBINE ENGINE USING F24 CONTAMINATED SKYDROL 5 HYDRAULIC FLUID**

**SEPTEMBER 2016**

**Interim Report**

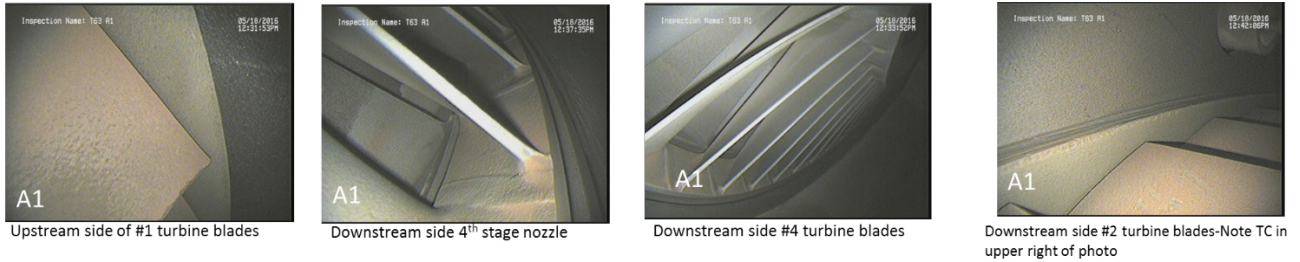
The engine was reassembled with a plastic media blasted clean combustor liner, first stage heat shield, and ultrasonically cleaned fuel nozzle depicted in Figure 2. The inspection included photo documentation of the first stage nozzle and #1 turbine condition from the rear of the engine with the combustion liner removed shown in Figure 3. Additional inspections of the second stage nozzle, #2 turbine, and third stage nozzle were carried out by removing combustor thermocouple and using a borescope depicted in Figures 4 and 5. The #4 turbine and fourth stage nozzle were accessed through the exhaust ports of the engine with the borescope Figures 4 and 5. SEM results indicated the first stage nozzle was comprised of 49.2% (wt.) cobalt.

Figure 4. Turbine Section Component Borescope Photos

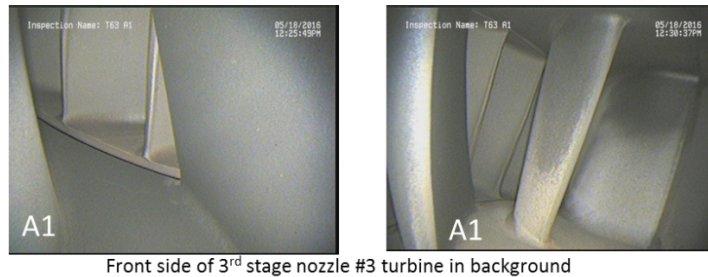
Figure 5. Turbine Section Component Borescope Photos
