Petrographic Analysis of Cores from Plant 42

E. Rae Reed-Gore, Kyle Klaus, and Robert D. Moser

October 2016

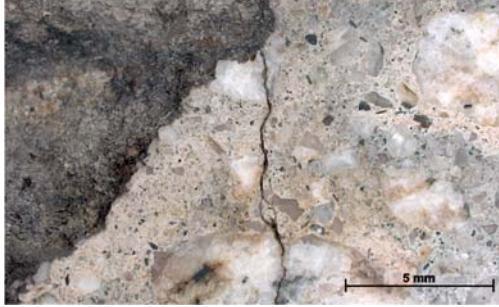
Figure 5. Low and High magnifications of 160143-2 (04T). (a) carbination sataining at the surface, (b) carbination stainging, crack at the surface, and large void most likely due to aggregate pop out, (c) carbination staining around cracked aggregate, (d) high magnifiction to see fine aggregate and cement, minir cracking.

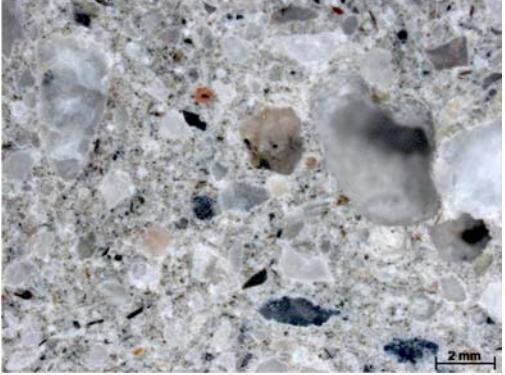
(d) High magnification photomicrograph

Figure 7. Low and High magnifications of 160143-3 (05T). (a) minor carbination sataining at the surface, (b) carbination stainging at the surface, (c) carbination staining around cracked aggregate, (d) high magnification to see fine aggregate and cement.
