INSPECTOR GENERAL

SEPTEMBER 30, 2016

Military Housing Inspection - Camp Buehring, Kuwait

SUBJECT: Military Housing Inspection - Camp Buehring, Kuwait (Report No. DODIG-2016-139)

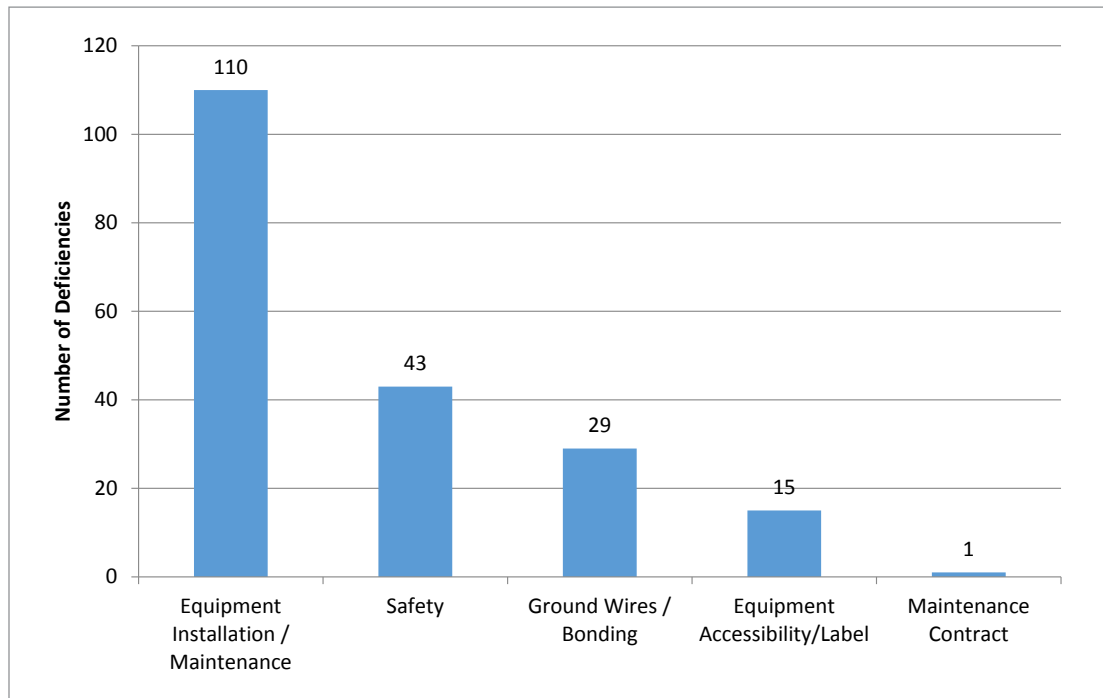
Figure 1. Camp Buehring Electrical Deficiencies by Category

We documented 198 deficiencies related to electrical systems (see Figure 1). The deficiencies were related to equipment installation and maintenance, safety, ground wires and bonding, equipment accessibility and label, and maintenance contract. Maintenance contract is a deficiency related to electrical systems, and it will be discussed in Finding C. All of these deficiencies pose a risk of shock, electrocution, or fire.

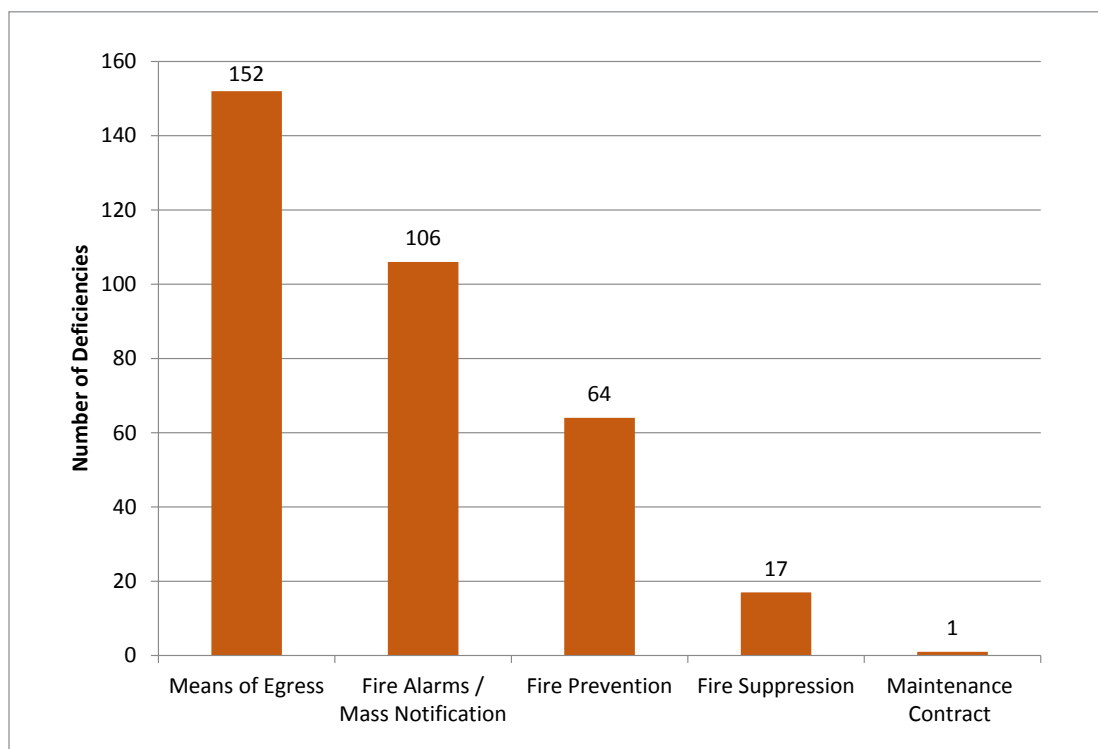
Figure 7. Camp Buehring Electrical Deficiencies by Category

We documented 340 deficiencies related to fire protection systems (Figure 7). The deficiencies related to means of egress, fire alarm and mass notification, fire prevention, fire suppression, and maintenance contract. Maintenance contract is a deficiency related to fire protection systems that will be discussed in Finding C. These deficiencies increase the risk of fire, injury, or death.
