## **Demonstration and Validation of Reactive Vitreous Coatings to Prevent Corrosion of Steel Fixtures Attached to Masonry Walls**

Final Report on Project F10-AR12

Under Project F10-AR12, "Use of Reactive Vitreous Coatings on Steel Fixtures for  
Masonry Wall to Prevent Corrosion at Fort Stewart, GA"

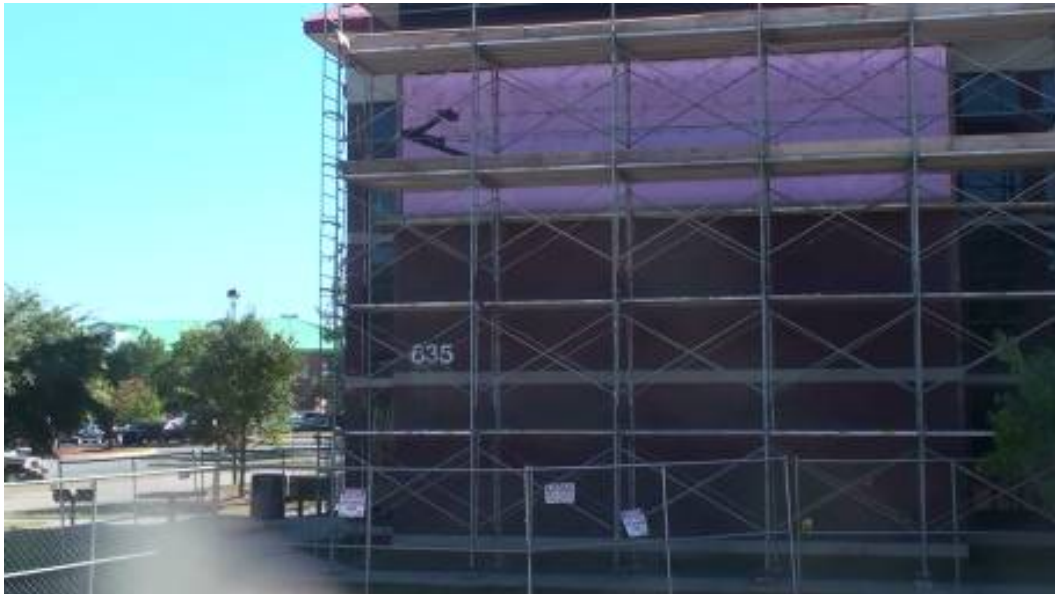
Figure 4. Scaffolding erected for project.

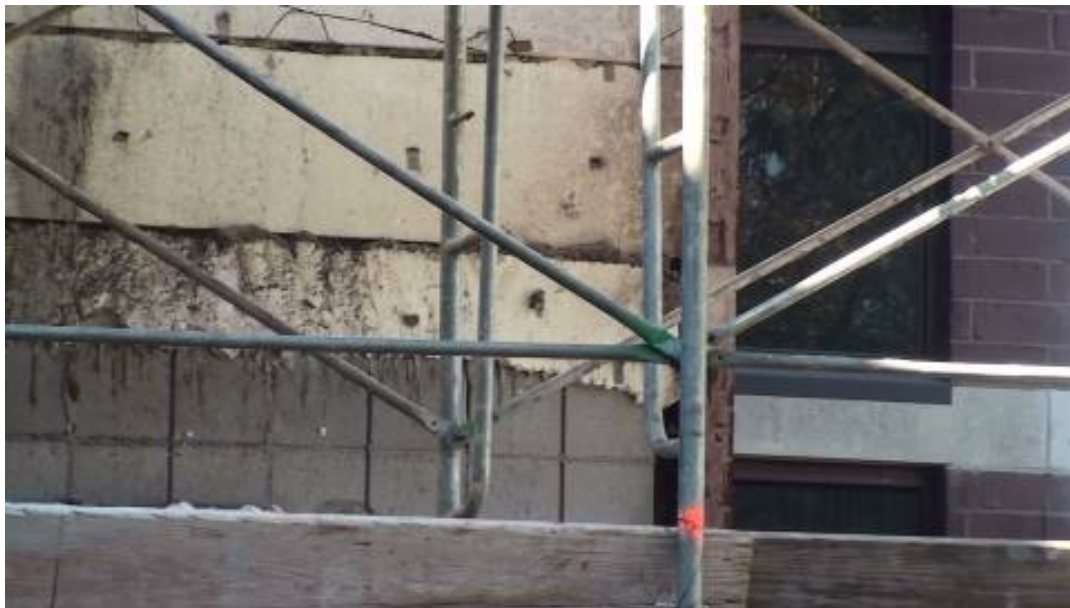
Figure 5. Selected panels stripped to bare walls.

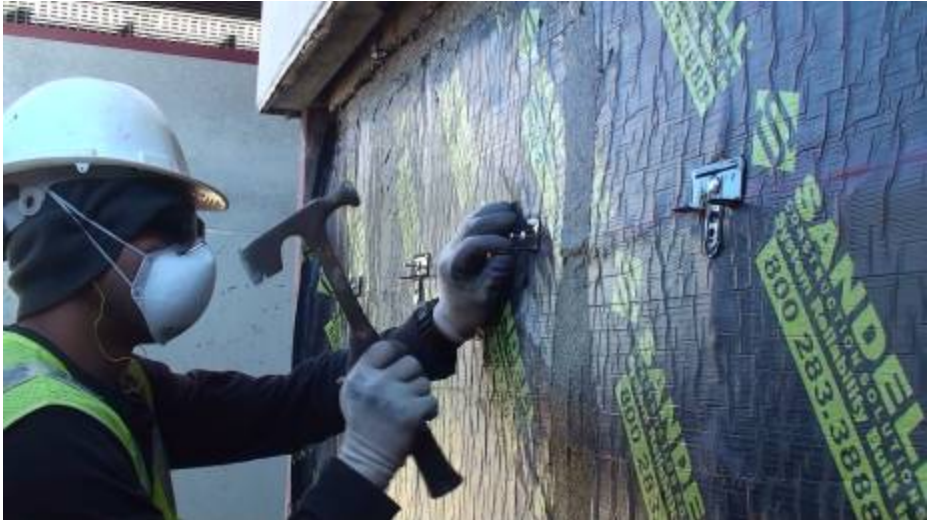
Figure 10. Installation of a double-eye wall tie component.

Inspection results indicate that the demonstrated coating is very brittle, like a typical ceramic or glass material. Therefore, the coating is vulnerable to fracture when the treated hardware is bent or subject to sharp impact. Although conventional steel ties and pintles tolerate bending adjustments and impacts related to shipping, handling, and installation, the coating on the demonstrated enameled hardware is subject to damage from such stresses. The wall ties in particular are subject to sharp impacts associated with the installation process, which uses hammer-driven pin anchors as described in section 2.2, Figure 10; the impact of hammering can potentially cause damage to the coating.

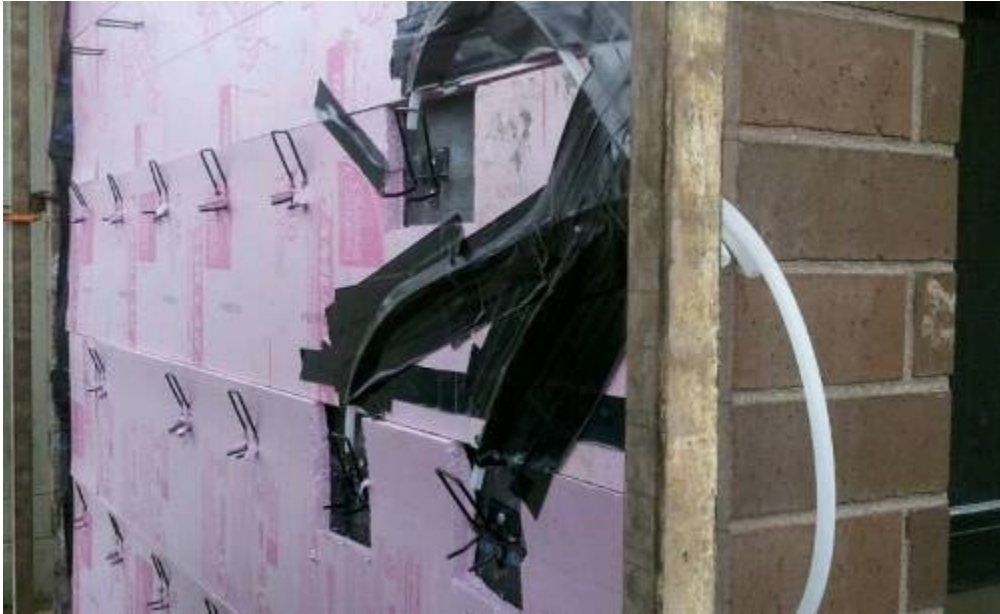
Figure 14. Plastic tubing for borescope inspection.

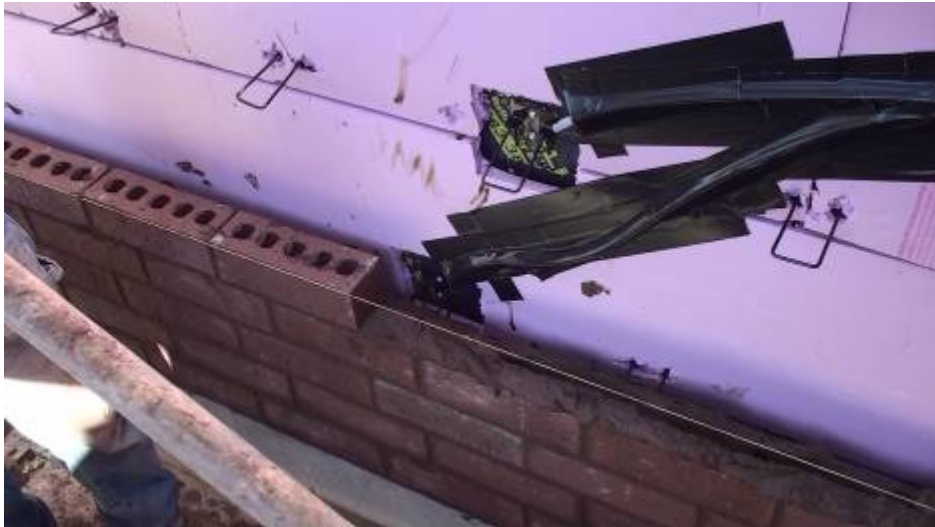
Figure 15. View showing brickwork and mortar adjacent to tubes and tie.
