# High Frequency Shock During Random Vibration Testing

# Overview

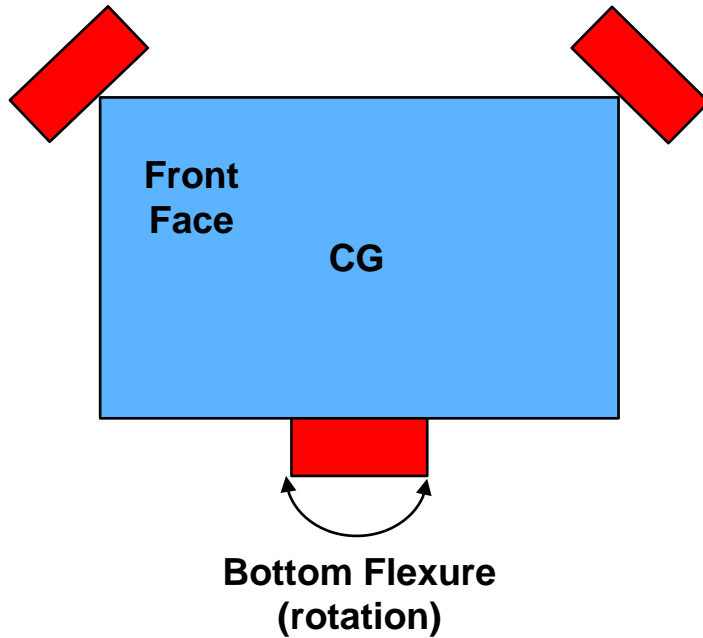
# Geometry

- **Experienced high frequency shock during random vibration testing**
- **Geometry is a ball and gothic arch mount**
- **Incorrect stiffness of flexures in finite element model led to much higher reaction forces at interface**
- **What if this was not an audible event? Occurred above 2kHz, therefore outside of normal monitored range**

- **System already in final configuration**
- **Not realistic to replace flexures, but needed to fix rotational stiffness**
- **Reduced shock down to acceptable levels by stiffening flexures using Constrained Damping Layer**
