## **Investigation of Hydrophobic Concrete Additive for Seawall Replacement at Pililaau Army Recreation Center, Hawaii**

Final Report on Project F09-AR05A

May 2017

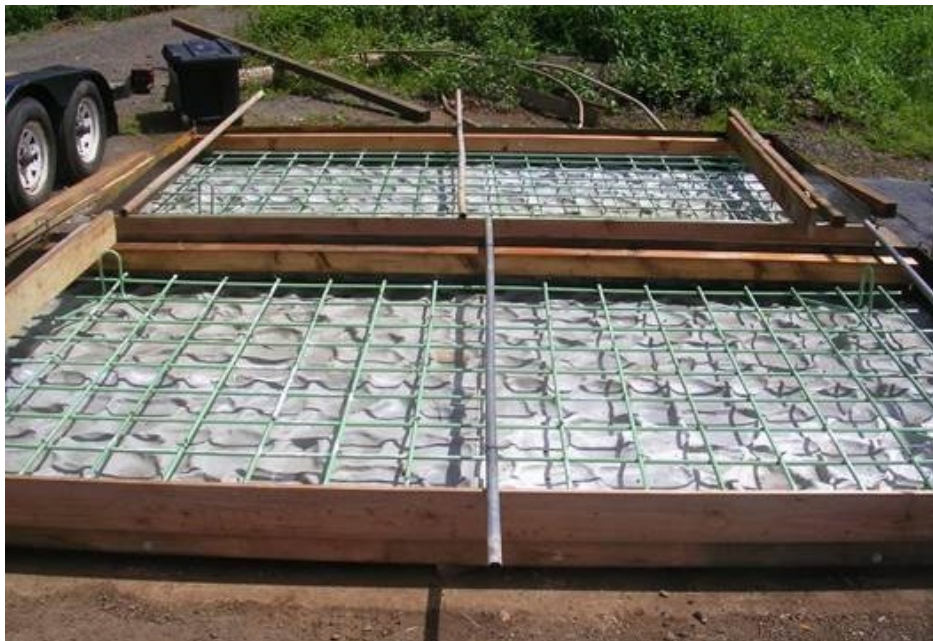
Figure 5. Formed 144" x 72" x 8" panels with #4 epoxy-coated rebar reinforcement.

At an offsite location, production of the panels for the seawall repair was started. Each precast panel measured 72" x 144" x 8" and included a 3-inch lap joint. The panels were reinforced with #4 epoxy-coated rebar arranged in a grid pattern on 8-inch centers and suspended a minimum of 3 inches from all surfaces, as shown in Figure 5. The panels were poured with concrete mixed with the ultrahydrophobic admixture. A representative from

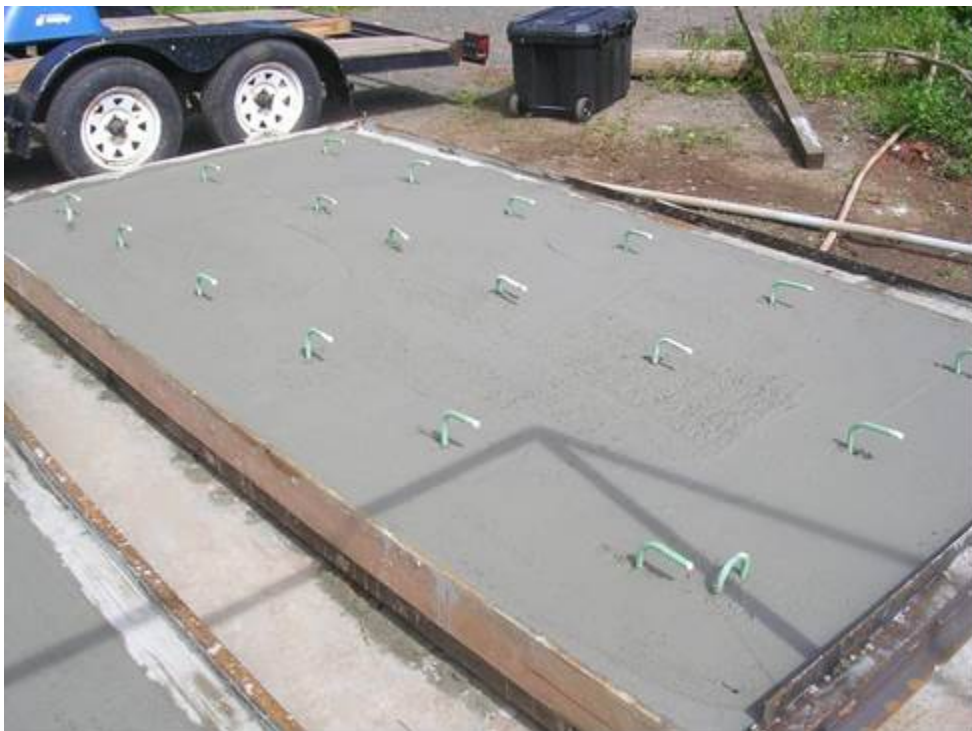
Figure 7. Rebar dowels inserted in the precast panels.

Once the concrete was poured, vibrated, and leveled, #4 epoxy-coated rebar dowels were inserted every 12 inches on center (Figure 7); the rebar would later be used to anchor to the front of the existing seawall, as shown in Figure 3. The panels were allowed to cure for a minimum of 24 hours before the forms were removed, and an additional 3 days were allowed before they were relocated for staining. Each panel was given a faux finish by using an acid to produce colors similar to those of the adjacent seawall (Figure 8).

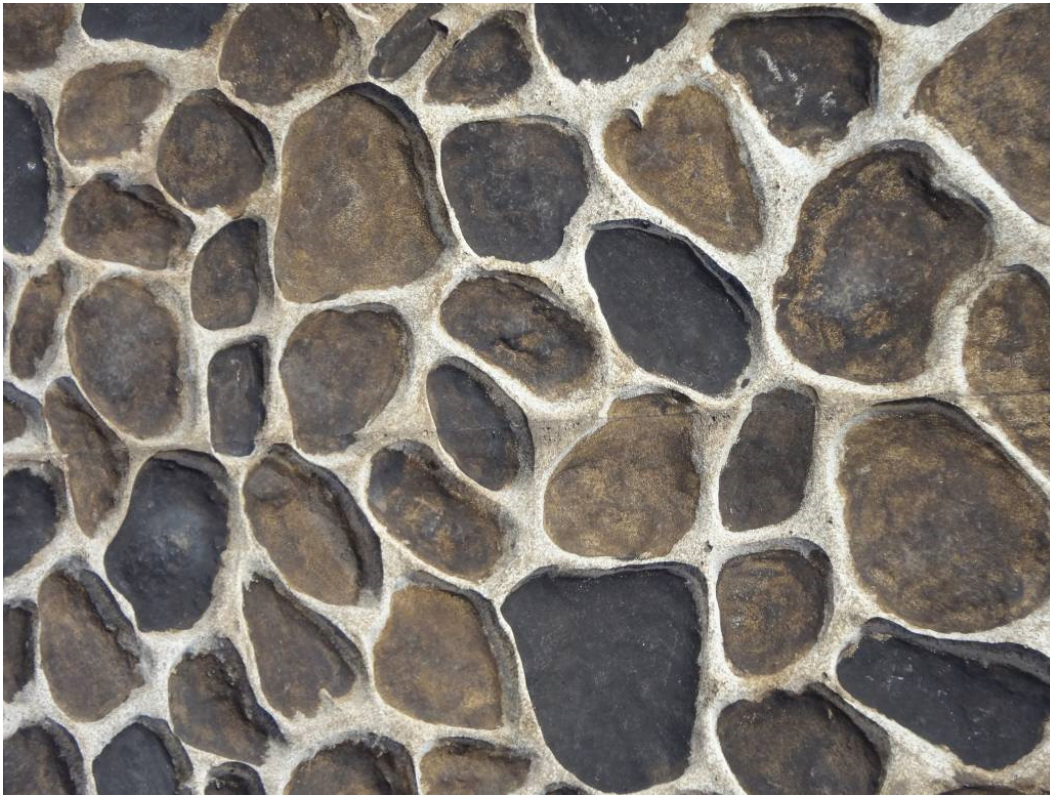
Figure 8. Stained panel.

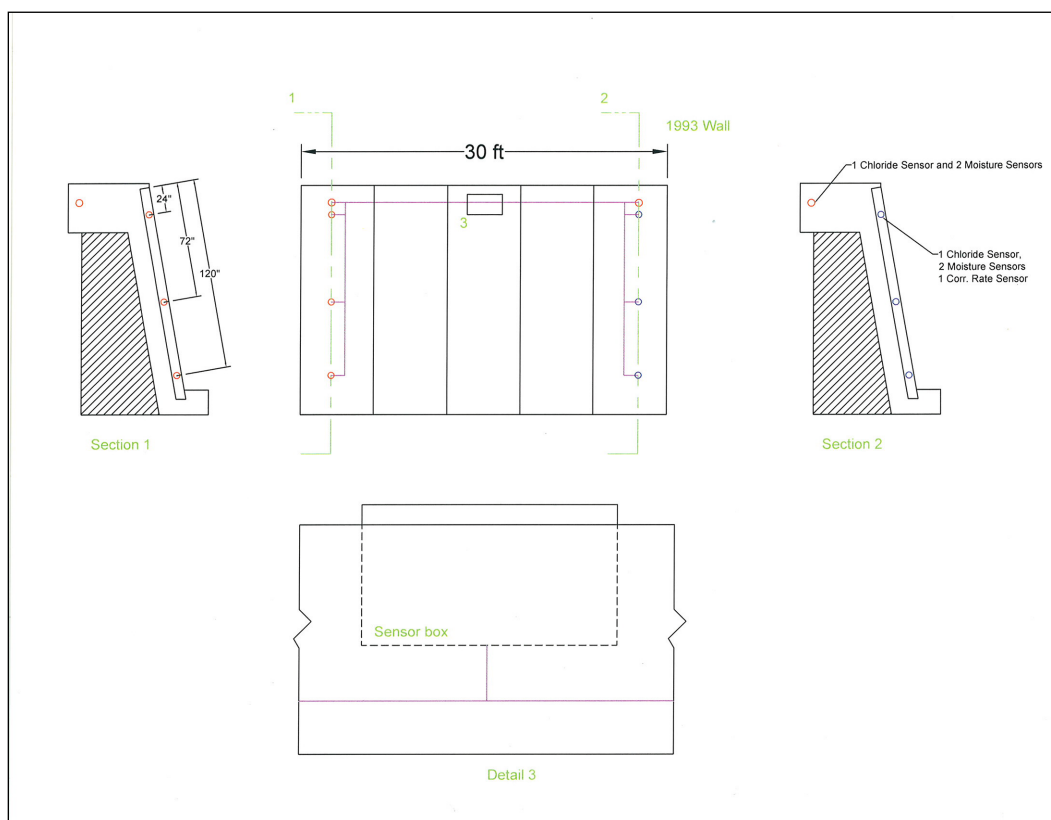
Figure 9. Sensor layout.

To assess the performance of the ultrahydrophobic admixture, three types of sensors were employed: a chloride ladder sensor, a humidity sensor, and a corrosion sensor. These sensors were placed into two panels during their construction. The sensors would measure moisture content in the concrete, chloride depth penetration, and the corrosion rate relative to the rebar. The Omega HX 71 relative humidity sensor was inserted into a PVC tube and capped with a known volume, providing a method to measure the amount of moisture entering the concrete. Two moisture sensors were installed at each sensor location at 1 and 2 inches from the surface. The Cosasco 900 chloride ladder sensor contains four stainless steel and four standard steel electrodes that measure impedance and correlate to chloride penetration. The chloride ladder sensors were arranged 30 degrees from the surface, to provide 1-inch increments in relation to the surface. The Cosasco 800 Corratel is a linear polarization resistance (LPR) sensor that is fitted with two standard steel electrodes. The probes measure and calculate a corrosion current that can be related to the corrosion rate. Typical installation of a set of sensors can be seen in Figure 9. A set of these sensors were installed above the splash-zone area of the panel when placed

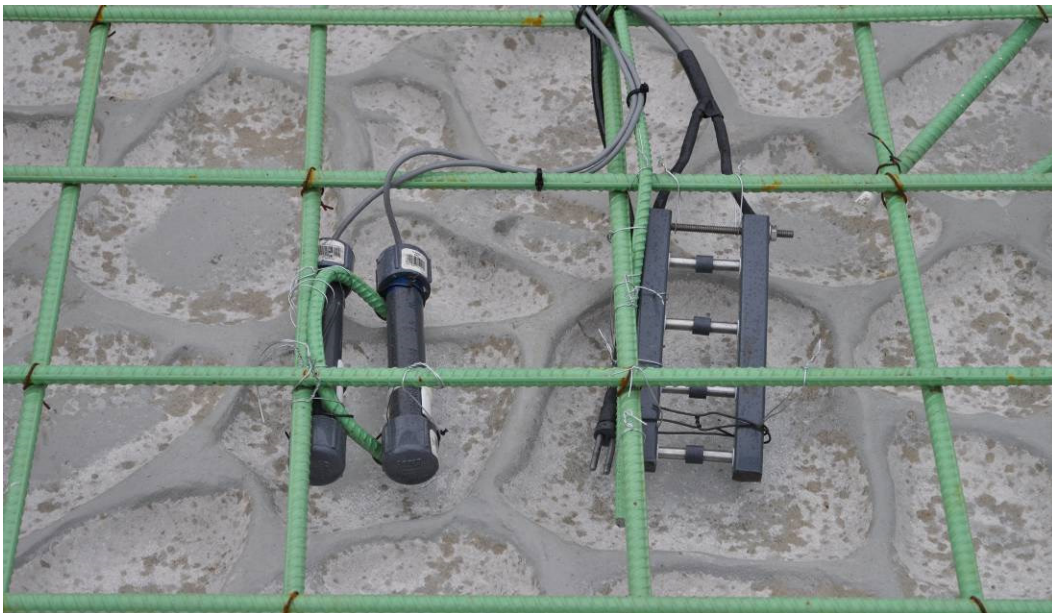
on the seawall, in the average splash-zone area, and below the splash-zone area in one precast panel. A second panel was similarly constructed but without the Cosasco 800 Corraters sensors. The sensor sets' locations in each of the precast panels are shown in Figure 10 and Figure 11.

Figure 11. Installation of one set of sensors in a precast panel.

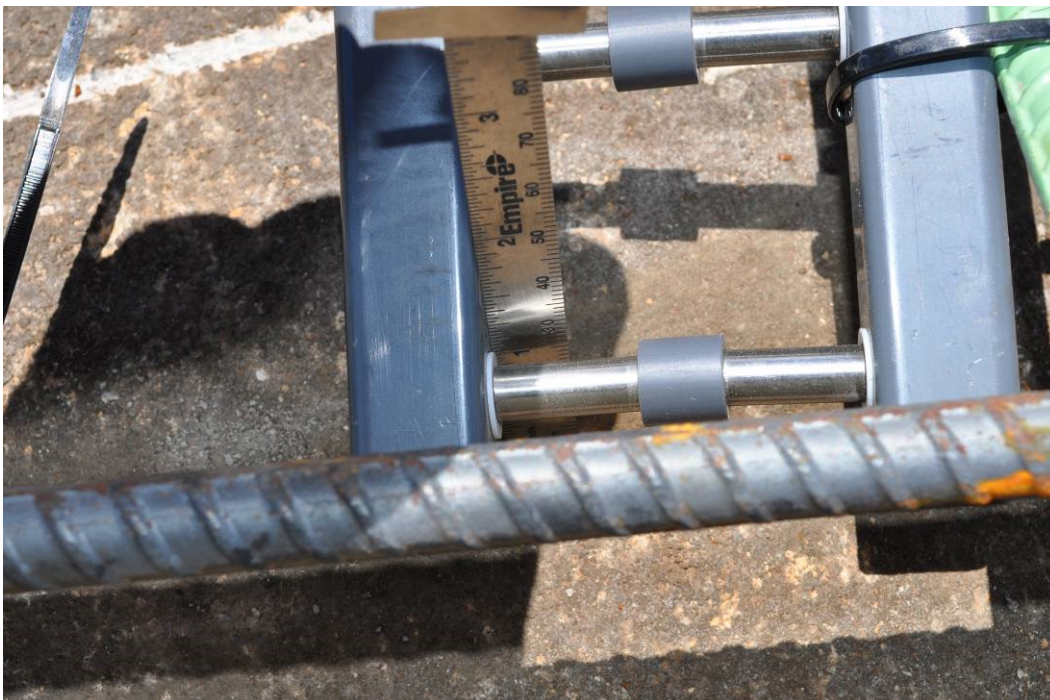
be mounted vertically approximately halfway up the south end of the sea-wall veneer. PVC conduit was to be used to route the sensor wires to the control box. Typical sensor installation is depicted in Figure 12 and Figure 13.

Figure 13. Installation of the Cosasco 900 chloride ladder sensor at 1-inch increments from the surface.
