CONTRACT NUMBER: FA8532-17-C-0008 (CDRL A002)

Evaluation of the Aircraft Ground Equipment (AGE) at Pacific Air Force (PACAF) Locations

Prepared by:
Battelle
505 King Avenue
Columbus, Ohio 43201

Date: 16 January 2018

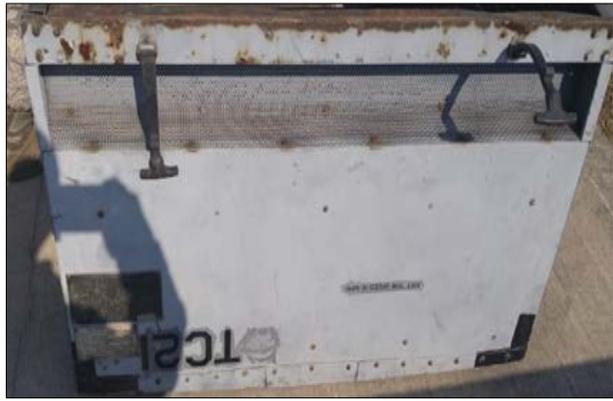
Figure 14 UV degradation over time of AGE coatings at the three PACAF Locations

Figure 14 presents the trend observed on the inspected AGE in gloss reduction through pictures of the AGE at the three PACAF locations.

TC21 Kunsan 192 months Gloss = 1.53

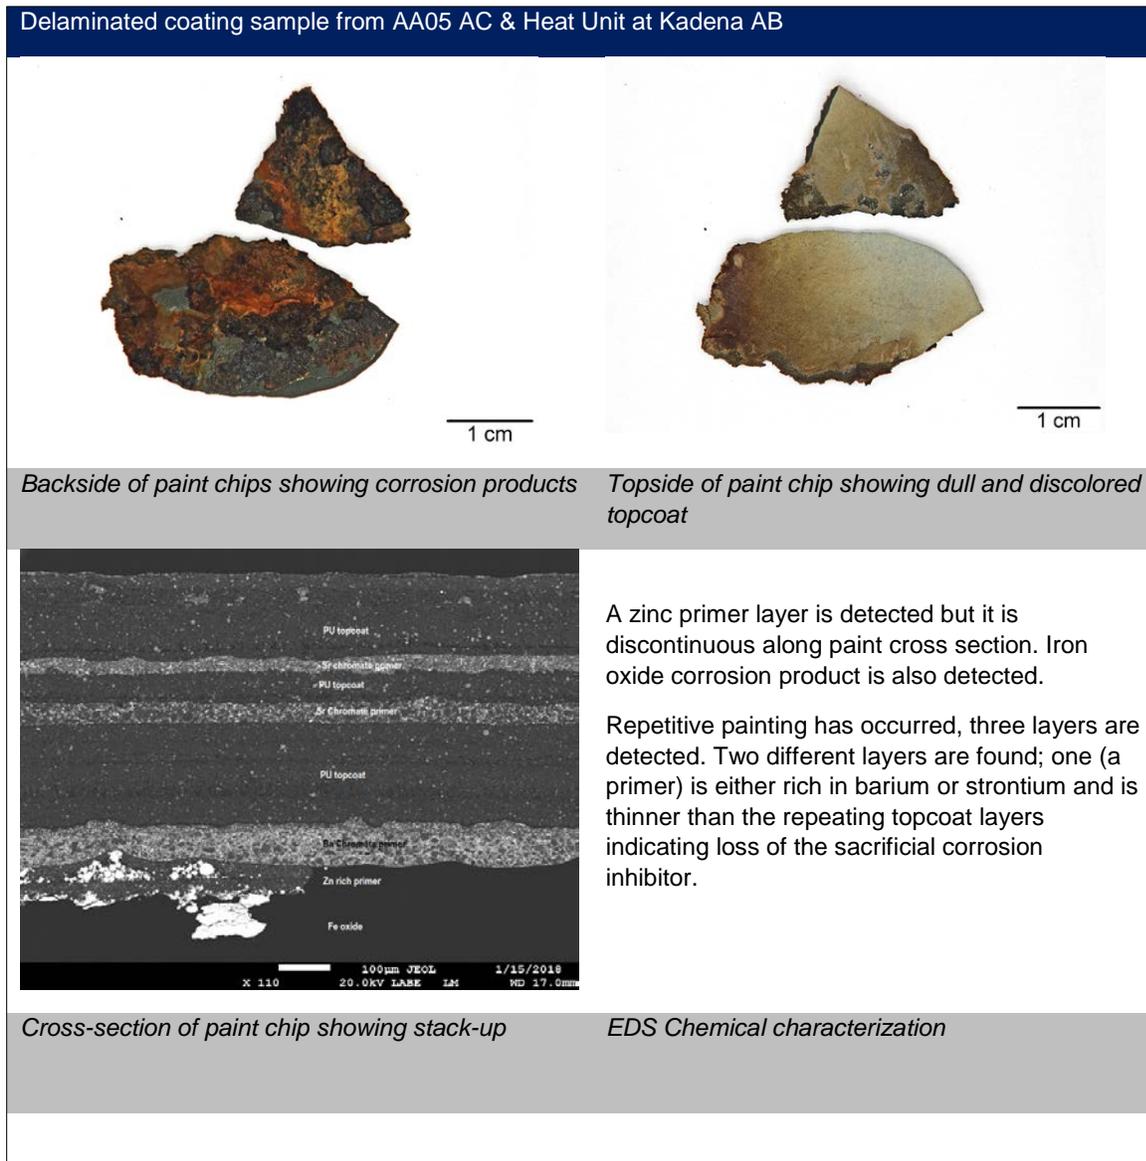
Figure 17. Evaluation of Corroded Coatings Sample from Kadena AB

Many film thickness measurements were taken on the various AGE assets at various locations with a DeFelsko Positector 6000 coating thickness gage. The results of these film thickness readings can be found in Appendix B. The film thicknesses varied significantly because during the corrosion repair process the AGE is only sanded down to the base metal in areas showing corrosion, and over time the film build can be quite significant. Where the coating stack-up was peeling away from the assets substrate, samples of the coating were removed and were characterized optically to determine primer and topcoat thicknesses within the stack-up. Energy-dispersive X-ray spectroscopy (EDS), is an analytical technique used for the elemental analysis or chemical characterization of a sample. EDS was used to determine the elements in each film layer so it could be identified. Figure 17, Figure 18, and Figure 19 present the evaluation of the corroded samples from the three PACAF locations.

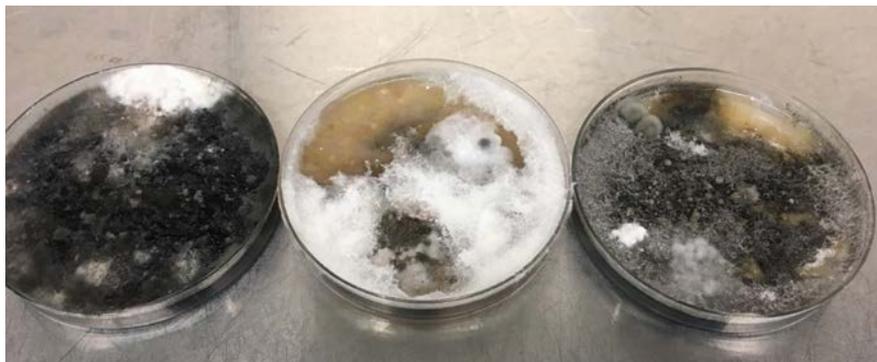
Figure 23. J-AA05_C PDA plates

Table 9 describes the fungal morphologies observed on the plates. No isolations were performed on PDA since sequencing was performed also (Section 4.4.1). See Figure 23 for an example of fungal growth observed. Fungal growth was especially prevalent on sample J-AA05_C, the sample from Kadena AB that was a piece of chipped corroded coating (Figure 24) and was presented in Figure 17 under section 4.3.
