Rapid-Setting Flowable Fill Performance in Cold Weather for Airfield Damage Repair

August 2018

Final report

Prepared for U.S. Air Force Civil Engineer Center 139 Barnes Drive, Suite 1 Tyndall AFB, FL 32403

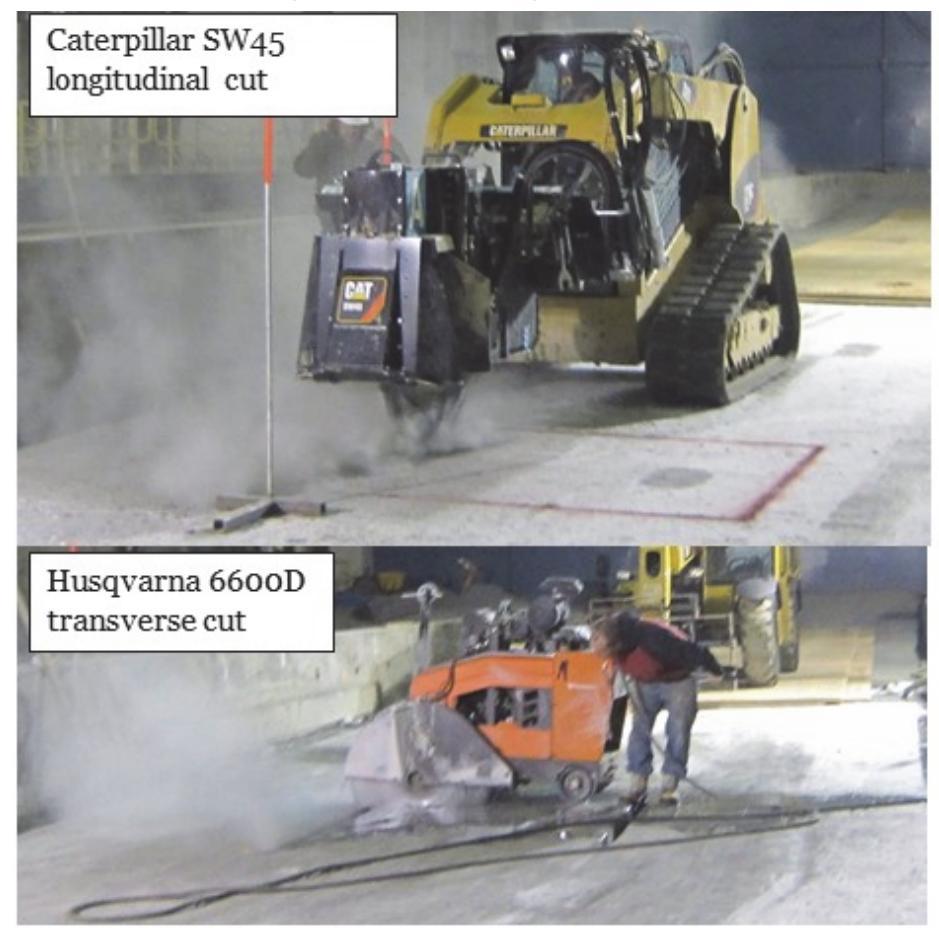
Figure 14. Saw-cutting of Crater 1.

Boundary lines were first painted for saw cutting. Figure 14 provides photos of the saw-cutting process, while Figure 15 shows a completed saw cut. Saw-cutting provided the crater's boundary lines. Table 3 provides approximate information about the saw-cut crater boundary lines. Note that saw-cut lengths would generally be larger than actual crater dimensions.

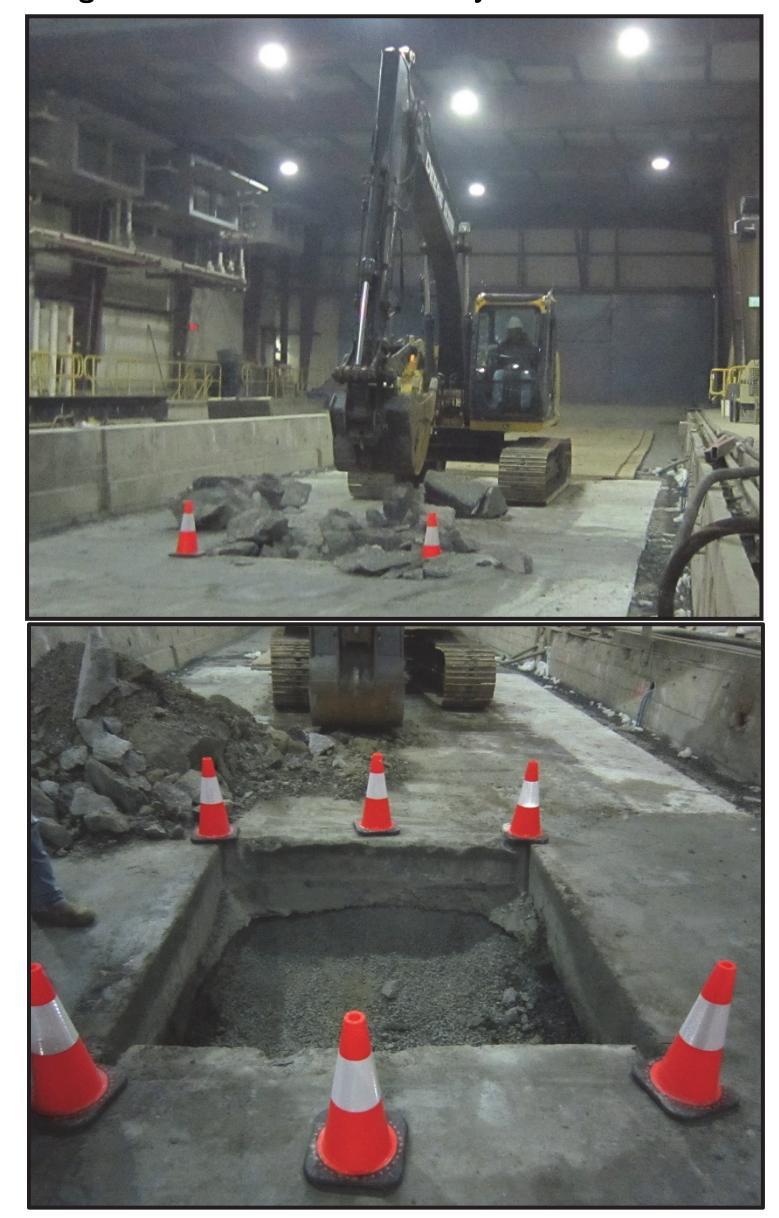
Figure 17. Debris removal and fully excavated Crater 1.

Initial attempts were made in Crater 1 to break out the sawn crater with a Bobcat S250 wheeled skid steer (Figure 3) with a pavement breaker attachment. After approximately 20 min, this approach was deemed minimally effective; the slab had been broken 11 times on the north edge at this point. Thereafter, a John Deere 135D excavator (Figure 5) with a hammer attachment was used; the slab was broken 14 times with this approach. Visually, the slab seemed harder than normal to break and also seemed very flaky near the top (broke into several small pieces). The crater was then excavated to a depth of approximately 32 in. with a John Deere 135D with a 36-in.-wide bucket and 7-in.-long teeth. Figure 16 summarizes the breaking process ultimately used for Crater 1, and Figure 17 shows debris removal and the completed Crater 1.

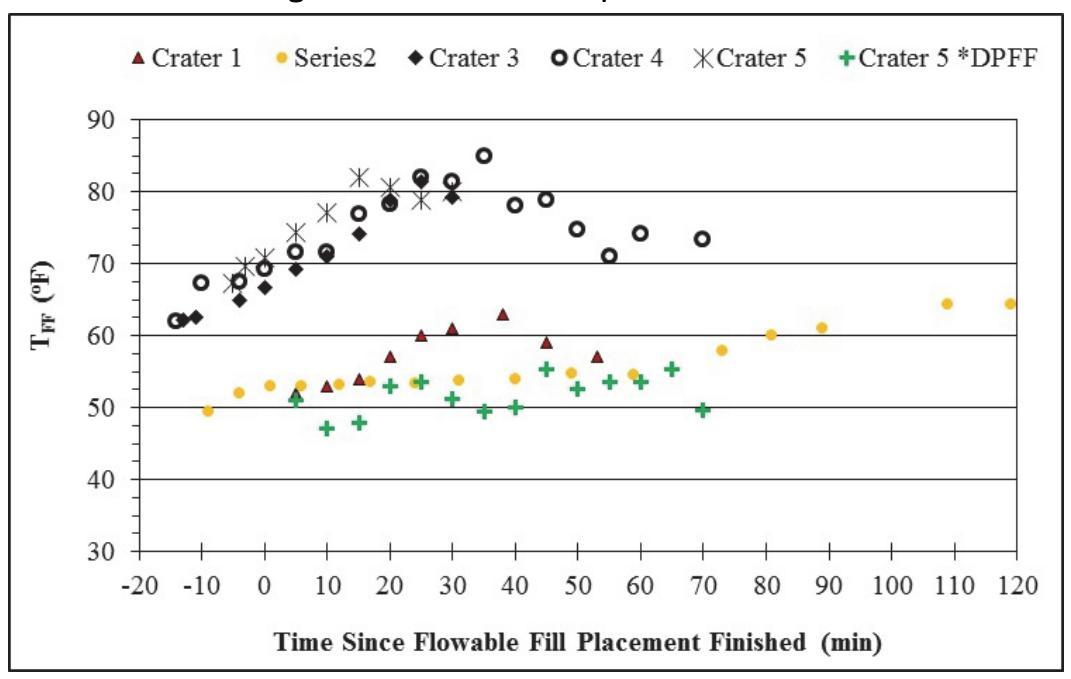
Figure 30. Flowable fill temperature results.

Compressive strength measurements on molded cylinders collected during backfill placement (Figure 24) were not productive. UCS strength from the cylinders averaged approximately 20 psi after 4 hr of cold curing, with no measurement exceeding 50 psi. FERF temperatures where the cold region repairs were performed ranged from 29 to 32° F, and temperatures in the adjacent MEF facility were 20 to 22° F. When these values are compared to the Figure 30 T_{FF} temperatures measured in the repairs themselves (Figure 23), differences are apparent. Figure 30 shows the temperatures measured during and after the flowable fill placement. Negative time values indicate temperature measurements taken during placement, and the positive time values indicate time lapsed after the flowable fill placement was finished.

Craters 1 and 2 did not use heated water, and their temperatures were 50 to 64°F (Figure 30). Craters 3 to 5 did use heated water, and their temperatures were 62 to 85°F. When these values are compared to the MEF/FERF temperatures of 20 to 33°F and the small size of the molded cylinders are considered, it is apparent that the temperature condition of the molded cylinders is not representative of the conditions of the larger repairs. The larger repairs benefit from exothermic heat generation from cement hydration. Therefore, measuring properties on small molded specimens in order to represent properties present in the actual repair need to consider exothermic heat generation in the curing protocol for very early-age testing (e.g., 1 to 4 hr). Obtaining core samples directly from the crater repair could be a more effective way of measuring early-age properties of RSFF or RSC in sub-freezing temperatures. When viewing Figure 30, it should be noted that these temperatures were in the upper portion of the crater (a noticeable distance from an edge). Temperatures closer to the middle of the crater would be expected to be higher than those in Figure 30; DCP measurements presented later in this section show CBR values increasing with depth.

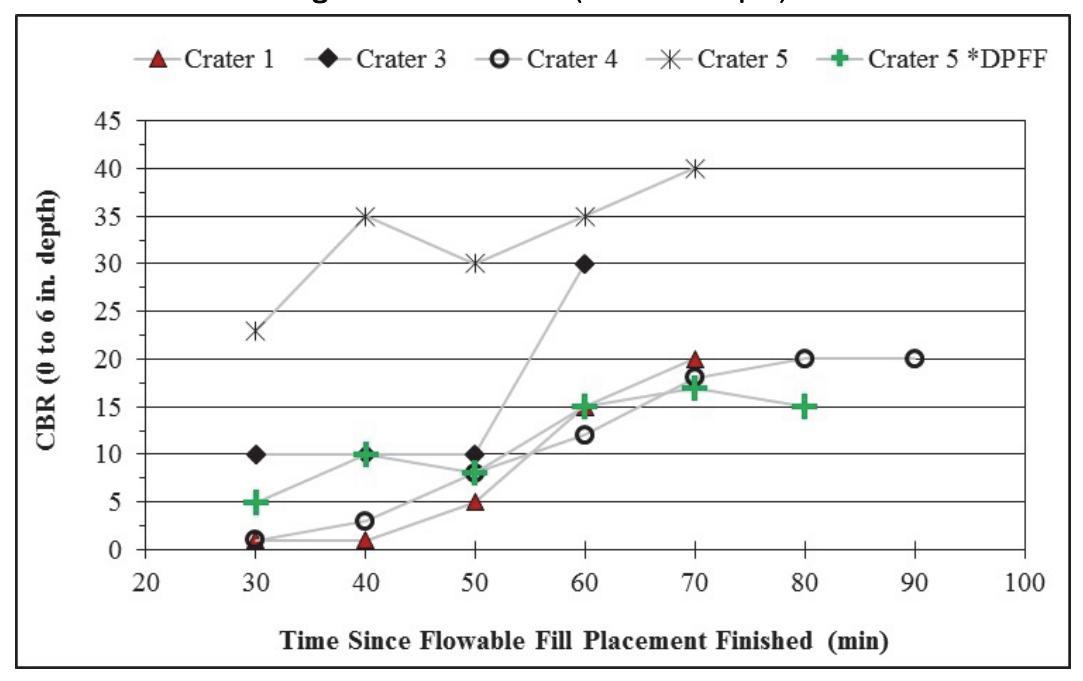
The CBR values for all repairs are plotted as a function of time and are shown in Figures 31, 32, and 33 for 0- to 6-in. depth, 6- to 12-in. depth, and 12- to 18-in. depth, respectively. CBR values for Craters 1, 3, and 4 clearly show that heating mix water was more useful than use of AlSO₄. All three craters were tested at 30 and 60 min with a DCP, and those readings show that heated mix water made considerable improvements at 30 min, noticeable but lessened improvements at 60 min, and that AlSO₄ hindered strength gain even in the presence of heated mix water. Crater 1 was the control section and did not use heated mix water or AlSO₄. At 30 min, Crater 3 (heated mix water only) had a composite CBR value over 3 times that of Crater 1, while Crater 4 (heated mix water and AlSO₄) had half the CBR value of the control. At 60 min, Crater 3 had a composite CBR roughly 1.4 times the control, while Crater 4 had a composite CBR value roughly one-third of the control. By 90 min of cure time, Crater 4 was comparable to Crater 1 after only 60 min of cure time, i.e., there is evidence that AlSO4 hindered set time. All testing documented in this report showed AlSO4 reducing the performance of crater repairs in cold regions and Crater 3 (heated mix water only) being the best performing option evaluated.
