## **Demonstration of an In Situ Pipe-Lining Technology for a Fire Suppression Deluge System at Fort Drum, NY**

Final Report on Project F07-AR17

May 2018

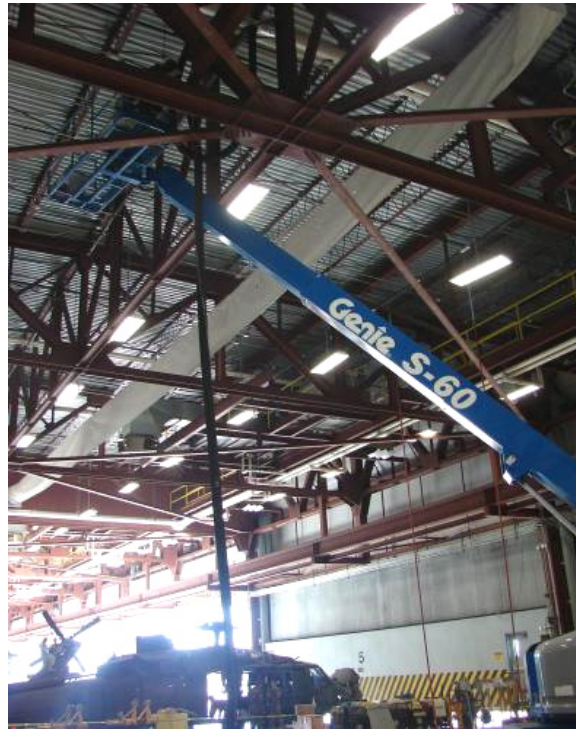
Figure 4. Manlifts were used to reach the connections near the ceiling.

The deluge system is the portion of the fire-protection system that manifolds along the ceiling and contains the sprinkler heads. In this case, the deluge system was approximately 45 feet above the hangar floor. To reach that height, 60-foot manlifts were used, as shown in Figure 4.
