Guided Wave Testing of Trunnion Rods at West Point Dam, Georgia

by Jason D. Ray, Richard W. Haskins, and James A. Evans

PURPOSE: This Coastal and Hydraulics Engineering Technical Note (CHETN) describes trunnion rod crack detection testing using the portable guided wave test system on a sample of the trunnion rods located at West Point Dam, Georgia, in January 2016. It is also intended to be used as a guide for test efforts at other sites.

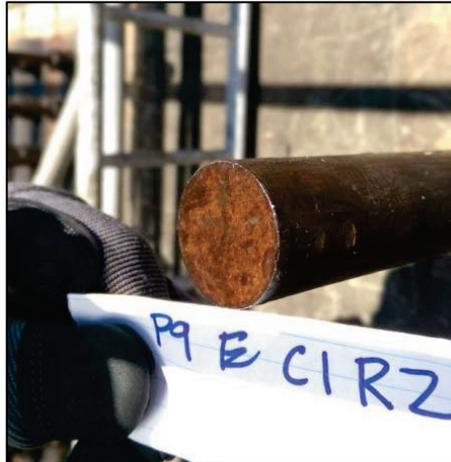
TEST PLAN: Safety concerns at this dam dictated that no grinding or unnecessary contact with the rods would be allowed. It was known before testing that the rod ends were, for the most part, in good shape and would not require any work to prepare the surfaces. A few rods exhibited surface anomalies (Figure 4). Other rods were very flat and were quite responsive to the test (Figure 5).

Figure 5. Typical rod without corrosion.

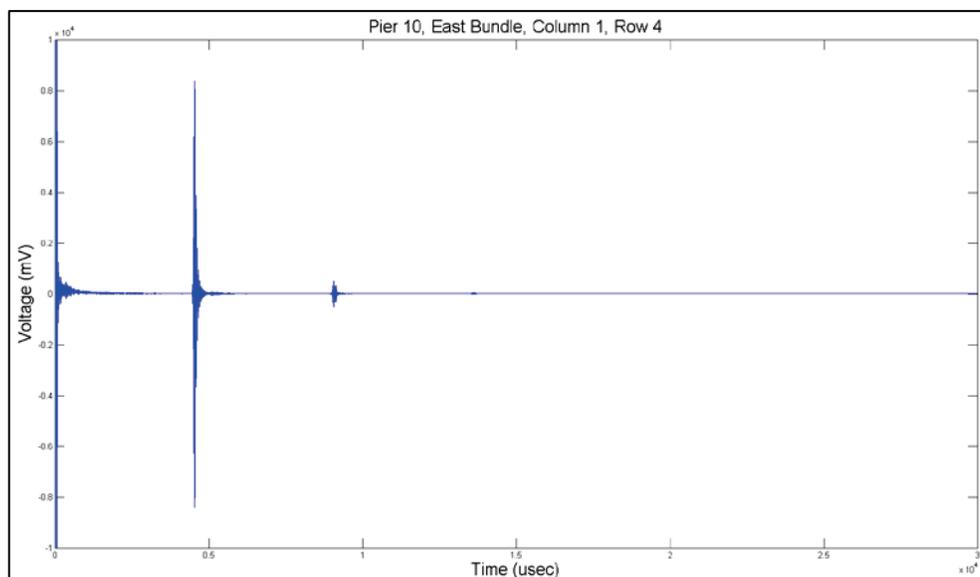
Figure 10. Typical acoustical guided waves response from rods.

Though the rods were of similar length, diameter, and visible condition, the level of the output varied from rod to rod. These results can be contributed to several factors, including the angle and the condition of the fixed end of the trunnion. All of the rods tested, with the exception of one (Figure 11), displayed a variation of the typical response shown in Figure 10.
