## **Rock Demolition and Hazardous Debris Removal for Ecosystem Restoration on the Elwha River**

Charles W. Ertle, M. Jason Roth, John S. Judson, and  
George H. Vankirk

May 2019

Final report

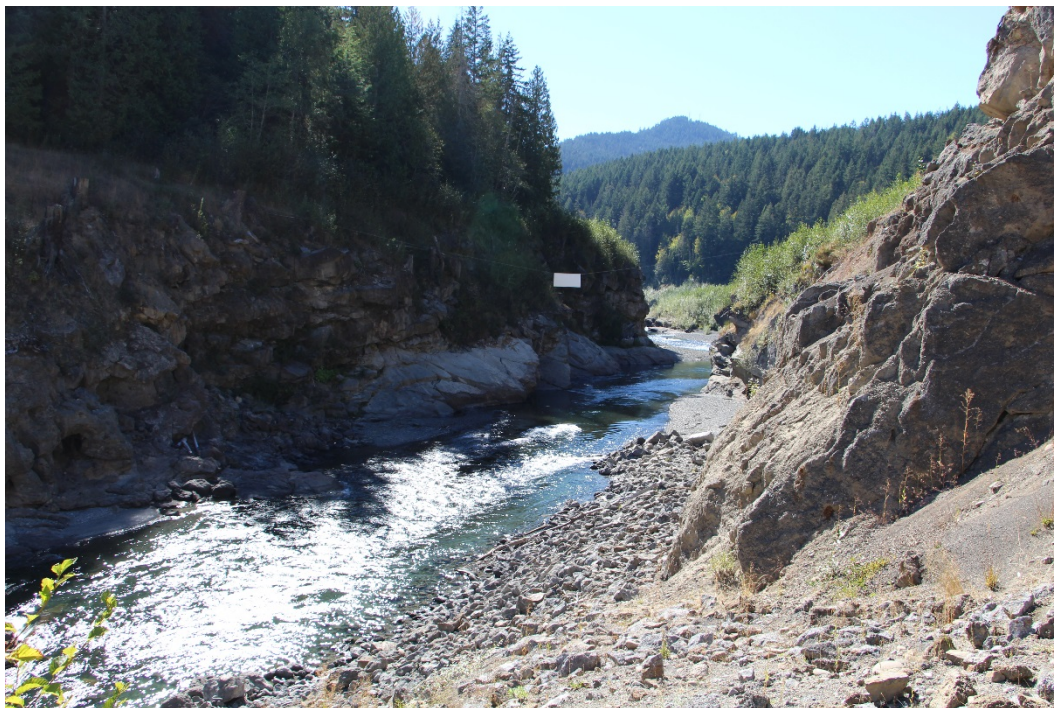
Figure 10. Upstream view at Elwha Dam site, September 2016.

After the 2012 demolition, remnants of the dam that remained in the channel included a part of the foundation and the 20-ft by 50-ft concrete-filled caisson. It is assumed that some or all of the sheet piling curtain walls (reference Figure 8) are still in place, although this was not confirmed by ERDC. From a historical article (Anonymous 1912), it was reported that the dam base was approximately 100 ft thick by 40 ft wide. This is consistent with dimensions measured by ERDC while on site. A panoramic view of the dam site area in 2015 is shown in Figure 9; the dam and caisson locations are noted in the picture. A picture looking upstream from the dam site is shown in Figure 10, and a downstream picture is shown in Figure 11.

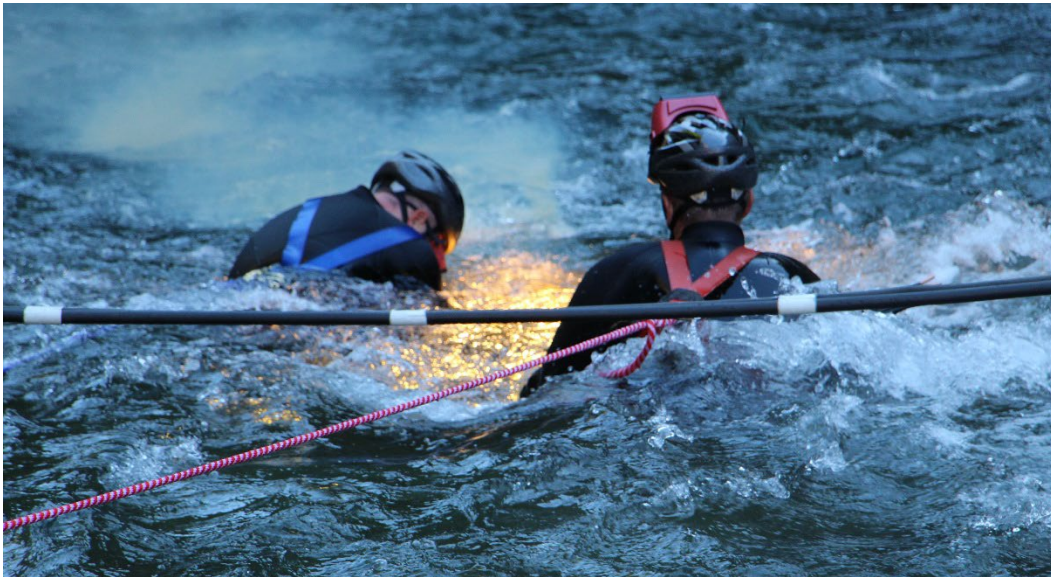
Figure 15. Dive team members removing hazardous debris.

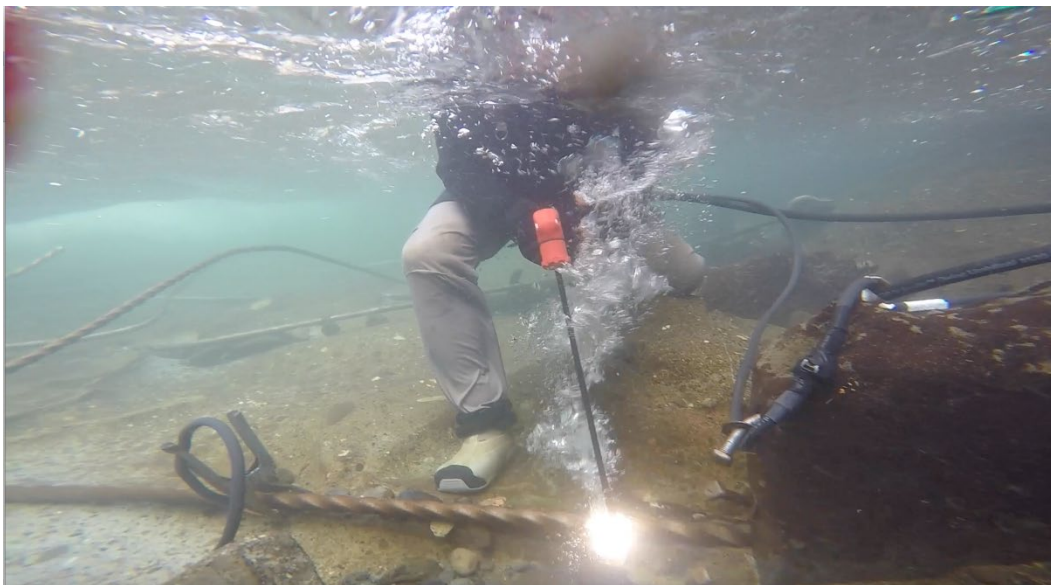
Figure 16. Underwater metal cutting.

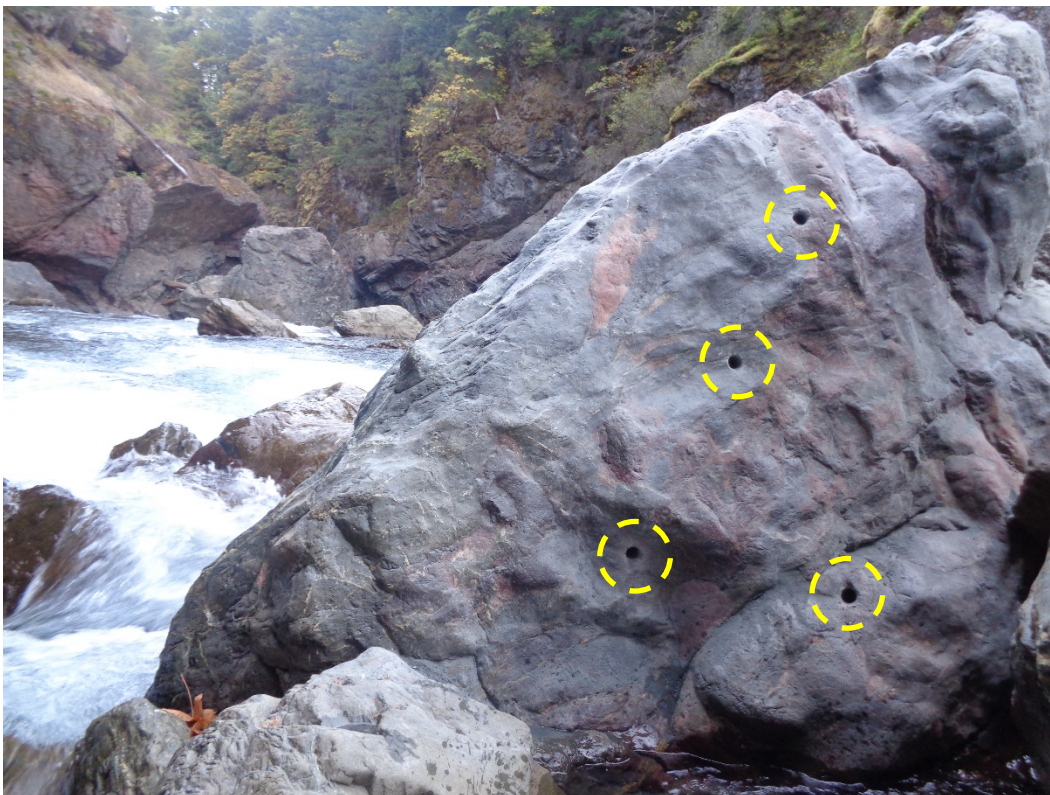
All demolition was conducted using a drilling-and-blasting approach. Explosive charges were 1.5-in.-diam by 16 in. long Dynamax Pro dynamite (1.5-lb net explosive weight); each dynamite stick was initiated with a Dyno Noble Primaline SMS detonator. Multiple charges were simultaneously detonated in a single blast by bringing the Primaline leads together to a single point and initiating with an FS-17/RP-83/non-el firing system configuration. The dynamite was placed into the rock by drilling 1.75-in.-diam holes with an AIRREX Panther S55-B rock drill. This is a pneumatic drill that can be fit with different length shafts and different size bits for drilling. A 1.75-in.-diam button bit was used in this project. Charge depths (measured to bottom of the hole) varied from 2 ft to 4 ft depending on specific rock geometry. Charges were placed on a 2-ft to 4-ft spacing according to geometry and accessibility, which resulted in powder factors between 0.25 lb/cy and 0.4 lb/cy. All charges were placed in the bottom of the drilled holes and were stemmed with small gravel from the river bed. Where 4-ft-deep holes were drilled, two charges were typically stacked in the hole to achieve the desired powder factor. Pictures of the drill and a typical drilled hole pattern are shown in Figure 24 and Figure 25, respectively.

Figure 25. Typical drilled hole pattern (prior to charge placement).

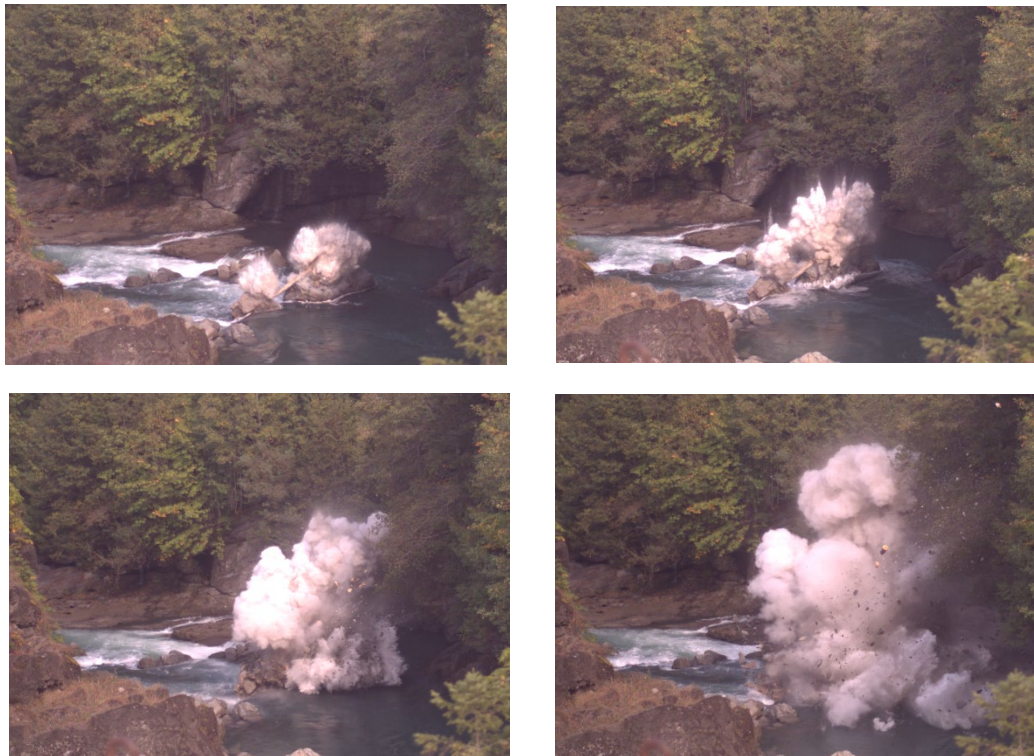
The two large boulders downstream of the caisson were demolished in a single detonation on September 18. The total charge weight was 18 lb. Flow rate at the time of detonation was 350 cfs. The charges were successfully detonated and fractured both of the target boulders to the water line. A picture of the boulders prior to demolition at a river flow rate of 650 cfs is shown in Figure 28. A picture of the boulders after demolition at a river flow rate of 320 cfs is shown in Figure 29. A close-up view of the boulders from river-right bank after demolition is shown in Figure 30. As seen, the boulders were generally reduced to 2-ft to 4-ft rubble, which is expected to be moved downstream during winter and spring flows. The detonation process recorded on high-speed video is shown in Figure 31.

Figure 31. ELD boulder demolition from high-speed video.

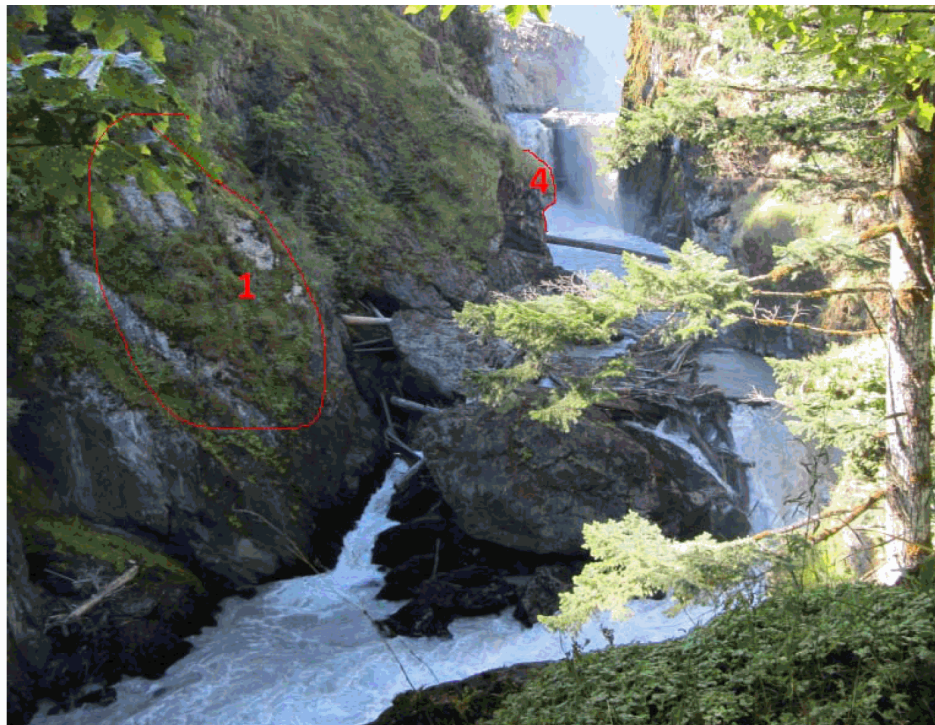
Figure 33. Obstruction downstream of GLI prior to dam demolition (courtesy of A. Ritchie).

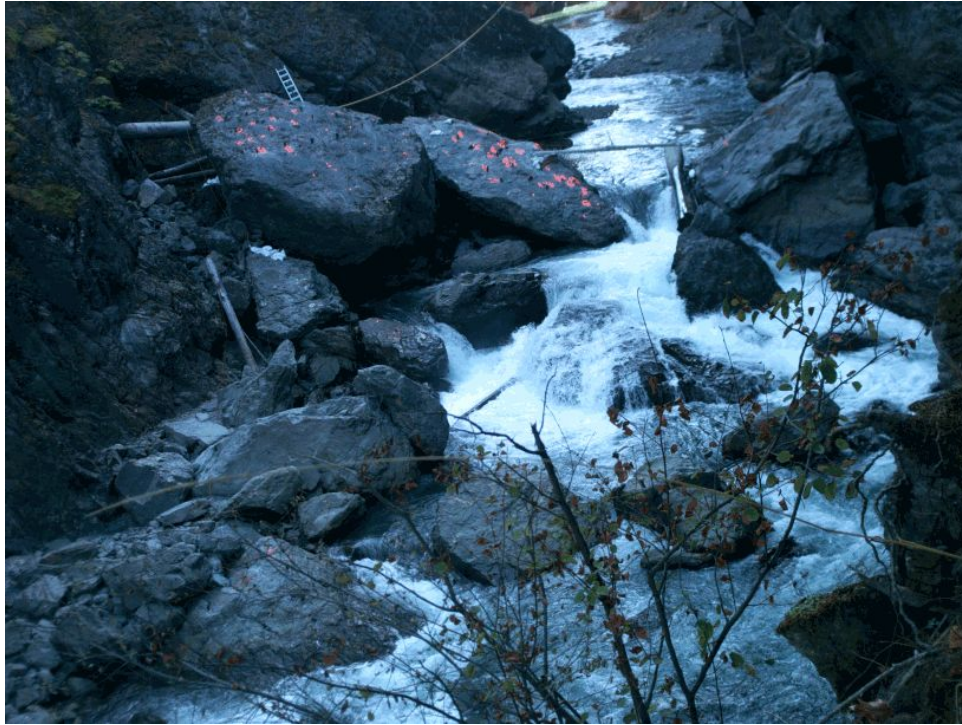
Figure 34. Channel downstream of GLI prior to 2015 blasting (courtesy of A. Ritchie).

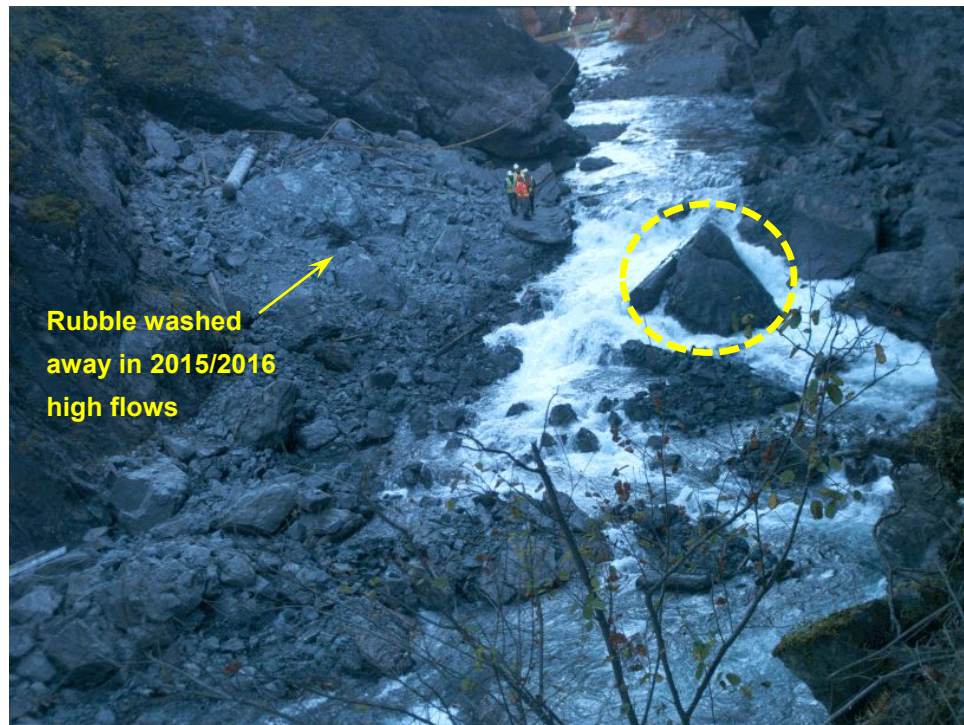
Figure 35. Channel downstream of GLI after 2015 blasting (courtesy of A. Ritchie).

Although a large portion of the channel obstructions were addressed during construction and the follow-on blasting, several large boulders remained that created potential hindrance to fish passage. Channel conditions in July 2016 are shown in Figure 36. Boulders at the river-left bank that are seen in the 2015 photo (Figure 35) are circled in yellow.

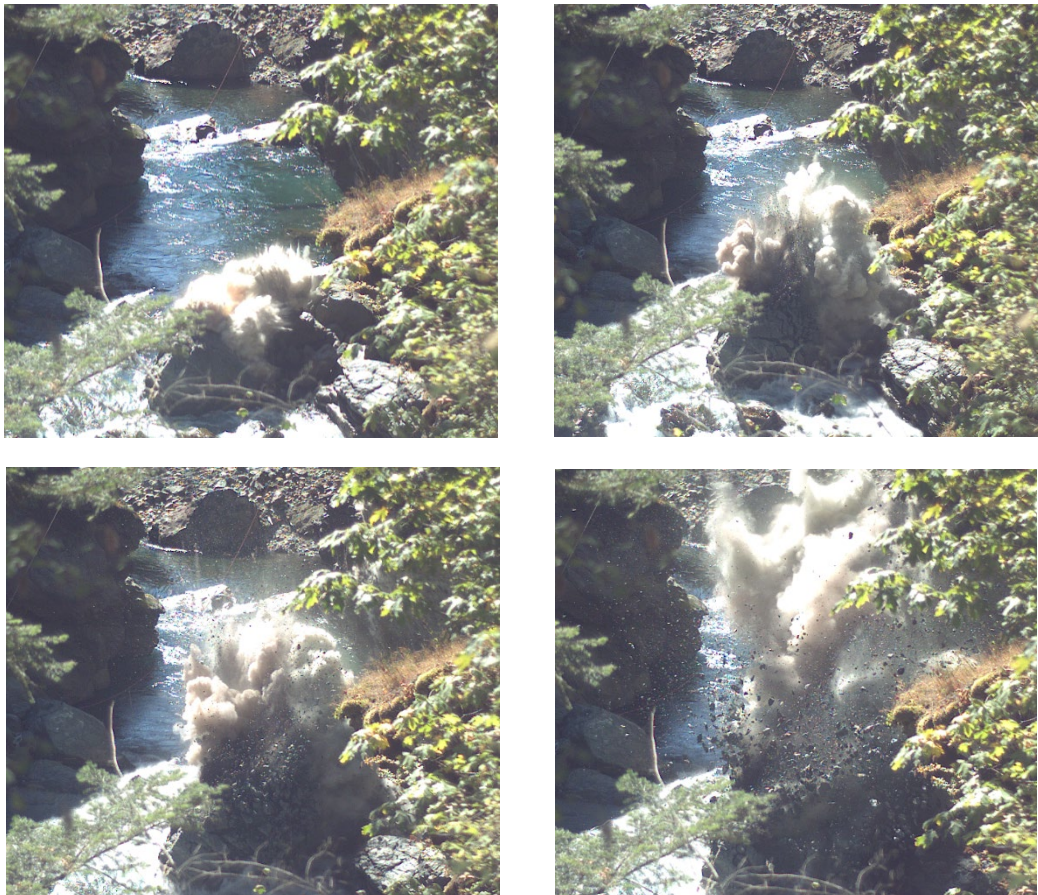
Figure 42. GLI boulder demolition from high-speed video.

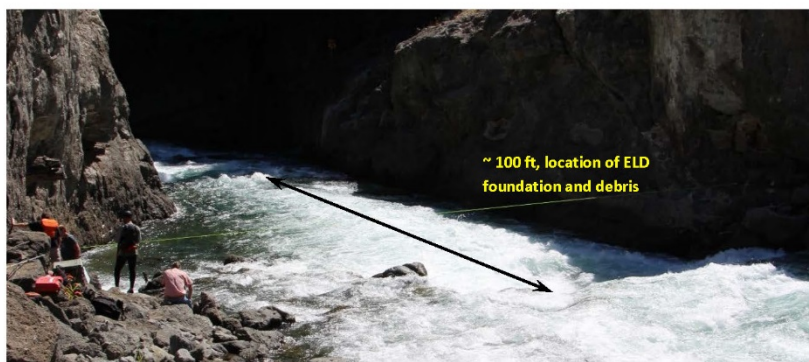
conditions on the right side of the channel significantly restricted visibility conditions. Therefore, the survey coverage was limited to approximately 30-40 percent of the channel at the river-left side. For the purpose of planning debris removal work in Task 3, conditions identified along river-left are assumed representative of the entire channel. Flow conditions in the river at the time of survey are shown in Figure 1. For comparison, flow conditions at 210 cfs on August 27, 2015 are shown in Figure 2.

Figure 1. Flow conditions at ELD site during ERDC metal debris survey (July 2016).

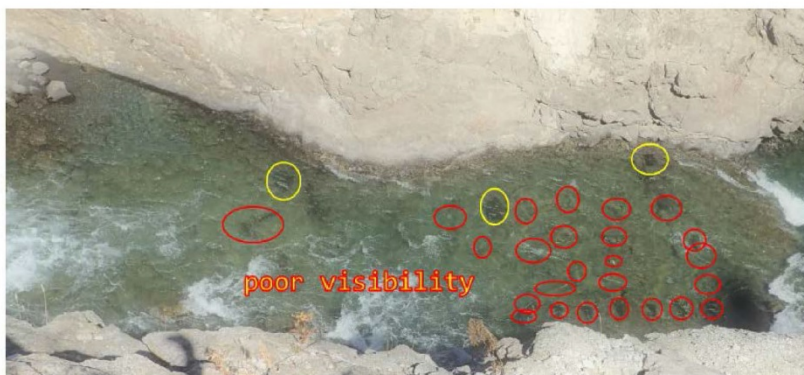
Figure 2. Flow conditions at ELD site during NPS metal debris survey (August 2015)<sup>2</sup>.

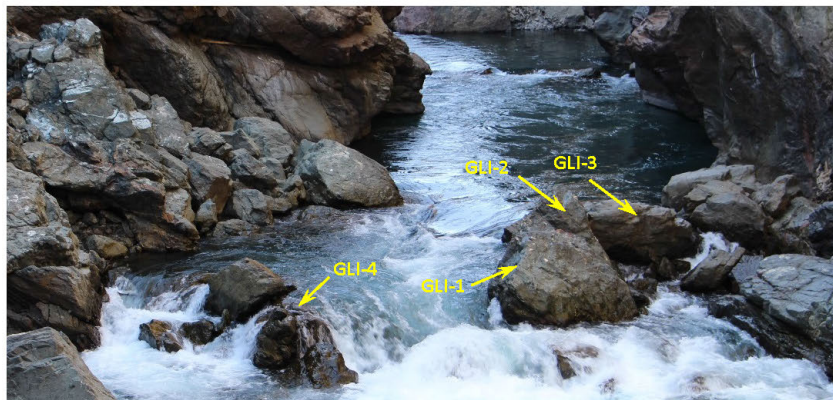
The boulders that are creating potential fish passage restrictions at Glines Canyon and Elwha Dam are shown in Figure 4 and Figure 5, respectively. Four boulders were identified at the GLI site. From visual observation, each of the GLI boulders are 8 ft to 10 ft in largest dimension. Three of the boulders – GLI-1, GLI-2 and GLI-3 – are located on the river-left bank and are constricting 30-50 percent of the channel width. The fourth boulder, GLI-4, is located closer to the river-right bank and is a part of several rocks that are restricting the right side of the flow path. All four of these rocks are positioned in close proximity to each other, so that the channel width is restricted by over 50 percent at flows present during the site visit. A large hydraulic jump is also present between the rock groups, which is expected to diminish with demolition of the four rocks.

Figure 4. Boulders at Glines Canyon site.

The most feasible method of removing the boulder flow restrictions is to reduce their size using explosives. Five large boulders have been identified for possible demolition, as shown in Figure 4 and Figure 5. All blasting will be limited to the locations of these boulders within the GLI and ELD site footprints; NPS has previously indicated that all required permits and right-of-way access to these sites are in place and will be verified by NPS prior to blasting in this project.

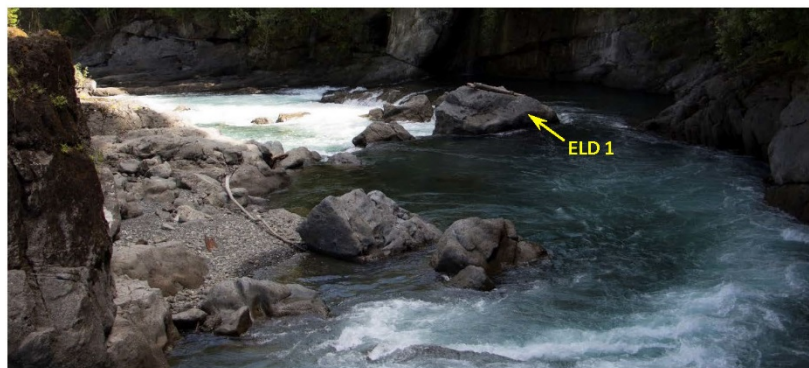
A single boulder was identified as the ELD site for possible demolition to improve fish passage. This rock, labeled ELD-1 in Figure 5, is similar in size to the larger rocks at GLI. ELD-1 appears to be restricting approximately 25 percent of the flow path, so the conditions at this location are not as critical as at Glines Canyon. However, a hydraulic jump is located adjacent to the rock, so demolition is expected to create flow conditions that are more favorable for passage.

Figure 5. Boulder at Elwha Dam site.
