# SITE SPECIFIC REPORT SSR-2410-SHR

## IMPACT LOAD TESTS, STRUCTURAL ANALYSES AND LOAD LIMITATIONS OF THE MARGINAL WHARF

TRIDENT REFIT FACILITY NAVAL SUBMARINE BASE BANGOR, WASHINGTON

September 1998

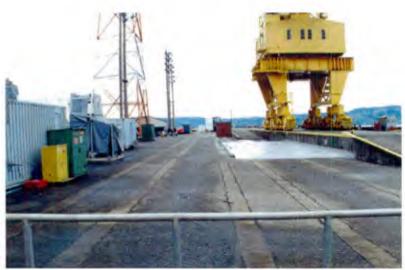
Figure 1. North pier of the Marginal Wharf looking south.

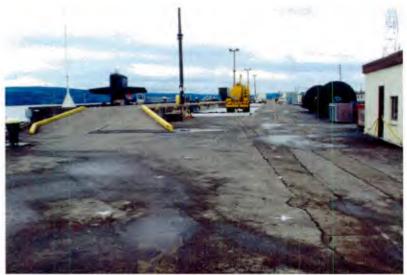
Figure 2. South pier of the Marginal Wharf looking North.

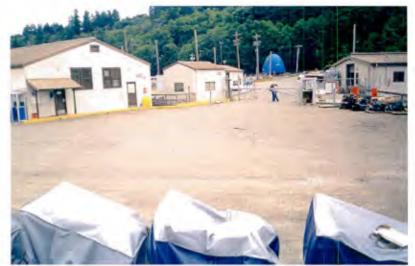
Figure 3. Marginal Wharf approach.

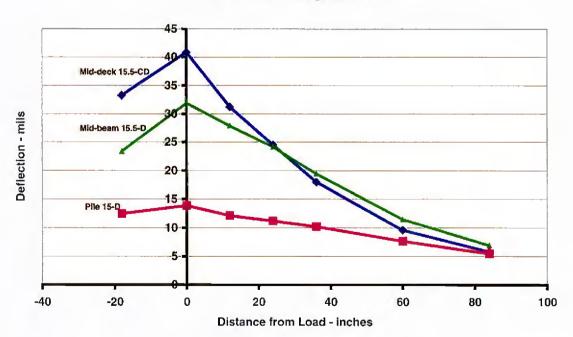
Figure 12. ILM deflection distribution.

Figure 12 shows characteristic ILM deflection shapes for midspan slab, midspan beam, and pile response for the south platform that are typical for sound, undamaged concrete. Peak deflection adjacent to the load was plotted in a surface plot for a graphic summary of pier response to vertical load. These summary surface plots are intended to isolate structural elements. Along the stringers, the midspan load response reflects the structural status of the stringer between pile bents. The midspan response on the slab primarily reveals the status of the slab. The impact load responses on the pile bents provide indications of the status of pile and pile caps. Figures 20 and 21 are surface summary plots for the deck and pile/wall support respectively of the south platform. Figures 22, 23, and 24 are similar response plots for the deck slab, stringers/pilecaps, and piles, respectively, of the wharf approach. Figures 25 through 28 are plots for the apex area of the main deck. Figures 29 through 36 are plots for the South Pier main deck and the area adjacent to the south platform ramp while Figures 37 through 44 are plots of the North Pier main deck. These provide a comparison of all areas to a peak test load of 55 kips. They are compared to like FEA model summary plots to quickly locate soft responses that would indicate loss of materials or loss of strength. The vertical axis of the summary graphic is measured peak deflection. The horizontal axes identify longitudinal test lines (not to scale) and the pile bent designation along each test line. If there were no obstacles (e.g., bollards, cleats, material, and equipment), a load test was conducted at each bent and midspan between bents along each longitudinal line. Nonvalued areas on the plots are locations where load testing was not conducted.

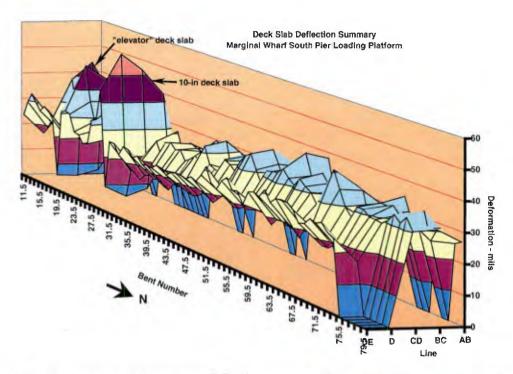
Boundaries between original and the modification slabs on the approach and on the loading platform do not seem to be monolithic. There is a lack of continuity across the construction joints. For example the response is softer than normal in the vicinity of the 10-inch slab addition on the south end of the loading platform and the elevator mod (Figure 20).

Figure 20. Summary of ILM maximum deflection response. Deck and stringers of south platform.

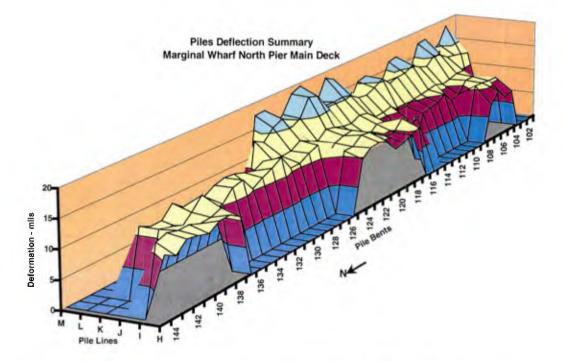
Figure 43. ILM maximum deflection response summary. Piles of wharf north pier.

**Outrigger loads.** Patch loads applied directly above a pile (or vertical pile/batter pile combo) or to a pilecap will be distributed into immediate neighbor piles through the pilecaps and stringers (Figure 43). The effects of a patch load over the midspan of a girder are confined primarily to the girder, adjacent deck slabs, piles, pile caps and stringers within 15 feet in orthogonal directions. The effects of a patch load applied to the middle of a deck slab panel are confined primarily to the panel and the bounding beams and piles. This means we will find little response at the midspan of the rail girder due to the other three outriggers placed on elements outside adjacent spans. Further, we determined early in the analysis that the deck slabs were not able to support outrigger loads larger than 50 kips without exceeding flexural capacity. Therefore, the analyses concentrated on outrigger loads positioned along stringers and pilecaps.

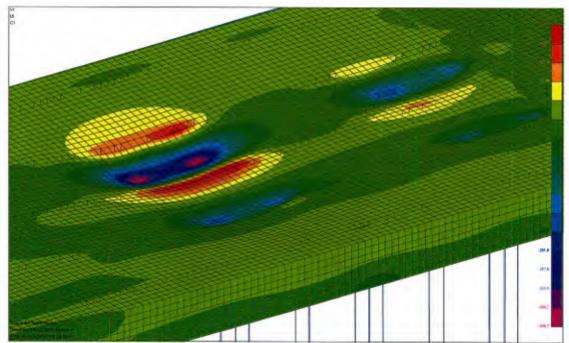
Figure 47. Graphic representing plate bending stress from wheel loads of Grove TM890 traveling left to right on the south platform.

The graphics of Figures 47 and 48 demonstrate the confinement of the patch load response to the deck panel between pilecaps and stringers where the load is applied. This is primarily due to the flexural, torsional and axial stiffness of the pilecaps, longitudinal stringers, and piles. The FEA models also clearly show the wharf deck responds to a patch load with two-way biaxial bending. A patch load at the center of a deck panel produces X- and Y- axis (strong and weak axis, respectively) moments of comparable magnitude at the point of load. The weak axis moment magnitude is approximately 2/3 of the strong axis moment. Conversely, the wharf deck slabs were constructed with one-way flexural reinforcing arranged perpendicular to the longitudinal girders and stringers. The lack of reinforcing is the largest load limiting determinant of the wharf.

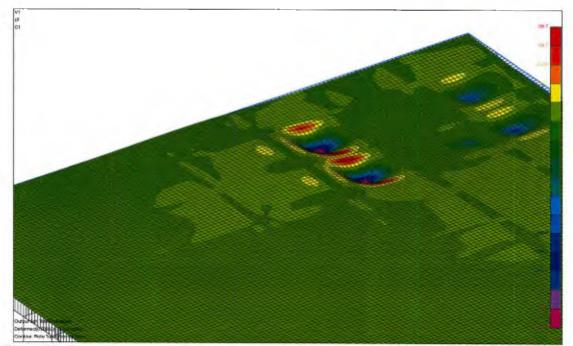
Figure 48. Graphic of main deck slab maximum bending stress from RT890 crane straddling Line L.
