## **Seismic Testing of an Indigenous Material Troop Constructible Building**

James Wilcoski

September 2019

Final Technical Report (TR)

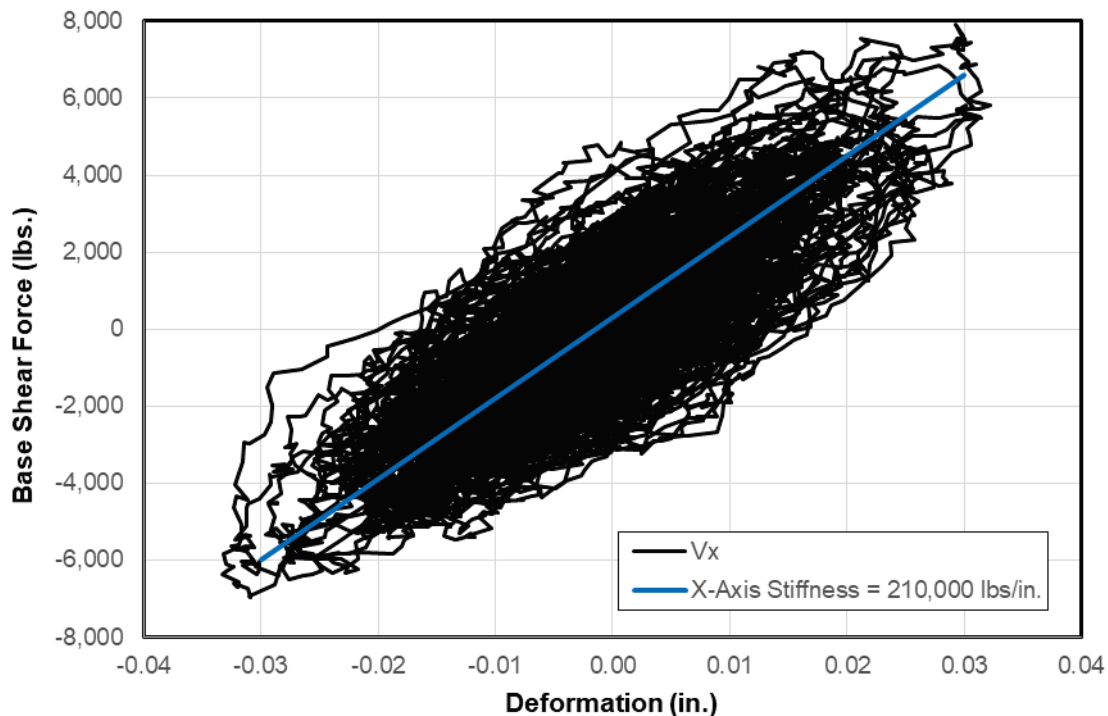
Figure 23. Base shear versus deformation and X-axis stiffness, 10% seismic test.

Figure 23 plots the base shear versus the average deformation in the X-axis. The data plotted here show that the deformations were relatively small, with the maximum averaged deformation reaching only 0.03 in. Figure 23 also plots an estimate of the stiffness of the building in this direction, with a value of 210,000 lbs/in. The decrease of this stiffness in future tests will be one measure of the damage condition, because the building will soften as damage occurs. Figure 24 plots similar data for the Y-axis, showing the building deforms as much as 0.08 in. in one direction. The stiffness in the Y-axis (or short direction of the building) is much less than the X-axis with a value of 55,000 lbs/in. These plots and visual observations show that there was little damage in the 10% seismic test with only minor cracking in the columns near the footings and the short wall panels. There was considerable cracking of concrete where the corner columns connected to their footings. This damage was to the stucco applied over the chicken wire, with almost no damage to the columns themselves.

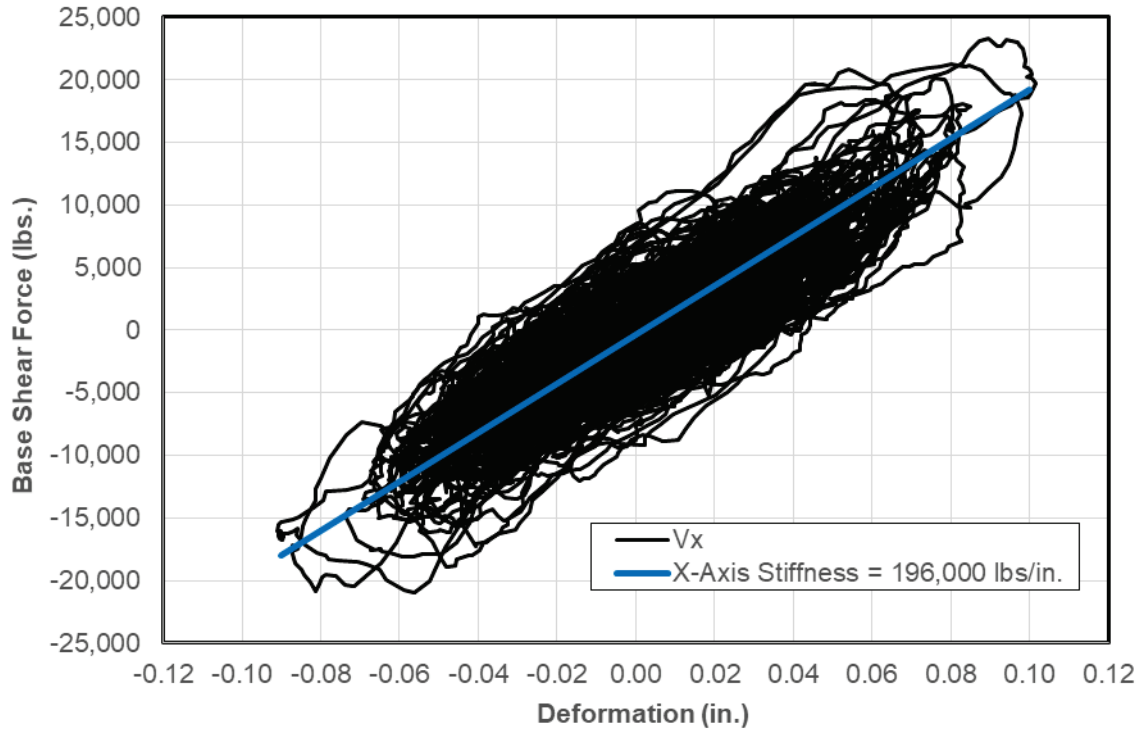
Figure 25. Base shear versus deformation and X-axis stiffness, 25% seismic test.

Figure 25 plots the base shear versus the average deformation in the X-axis. The deformations in the X-axis increased to over 0.10 in. Figure 25 shows that the estimated X-axis building stiffness decreased to 196,000 lbs/in., a 7% decrease, indicating some softening and damage relative to the 10% test. Figure 26 plots the base shear versus deformation for the short direction of the building (Y-axis). This test shows that there was over twice the deformation, and the stiffness decreased to 50,000 lbs/in., a 9% decrease, indicating slightly more damage than in the X-direction.

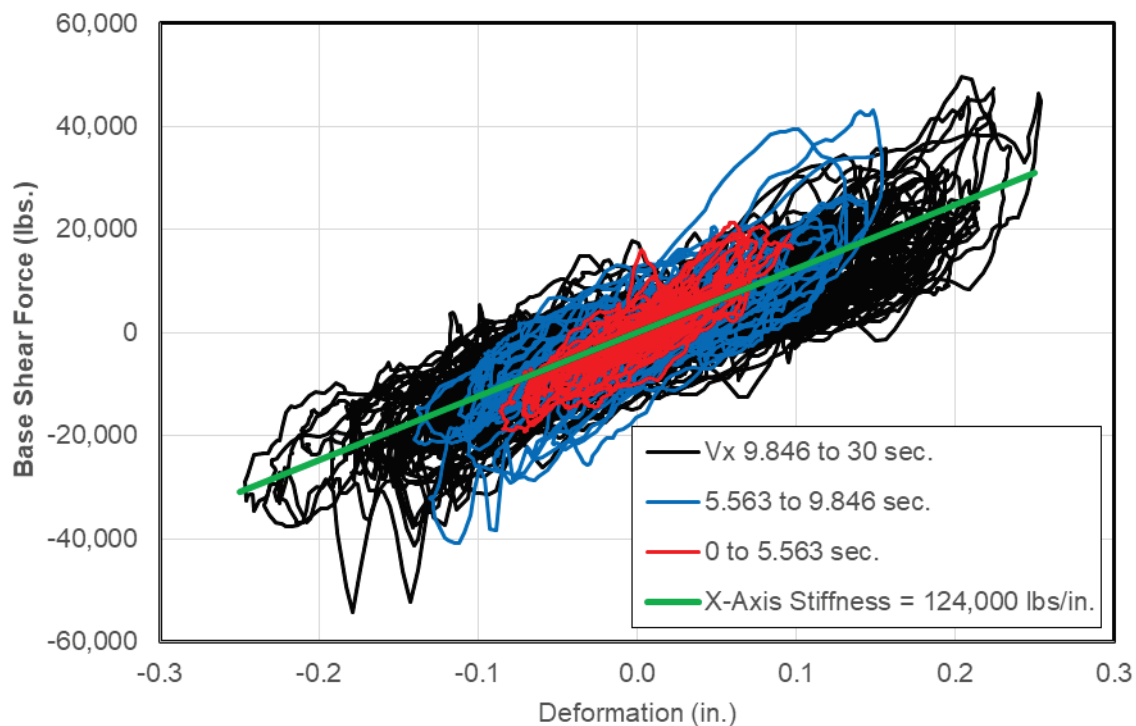
Figure 29. Base shear versus deformation and X-axis stiffness, 50% seismic test.

Figure 29 plots the base shear versus the average deformation in the X-axis. The deformations in the X-axis increased to 0.25 in. Figure 29 shows that the estimated X-axis building stiffness decreased to 124,000 lbs/in., a 37% decrease, indicating significant softening and damage relative to the 25% test. Figure 29 shows a plot of three segments of base shear versus deformation in time showing that the building becomes more flexible after 5.6 seconds and again after 9.8 seconds. Figure 30 shows a plot of the base shear versus deformation for the short direction of the building (Y-axis). This test shows the stiffness decreased to 34,000 lbs/in., a 32% decrease, indicating significant softening and damage. The segments plotted in time do not indicate a dramatic decrease in stiffness as the test progressed.

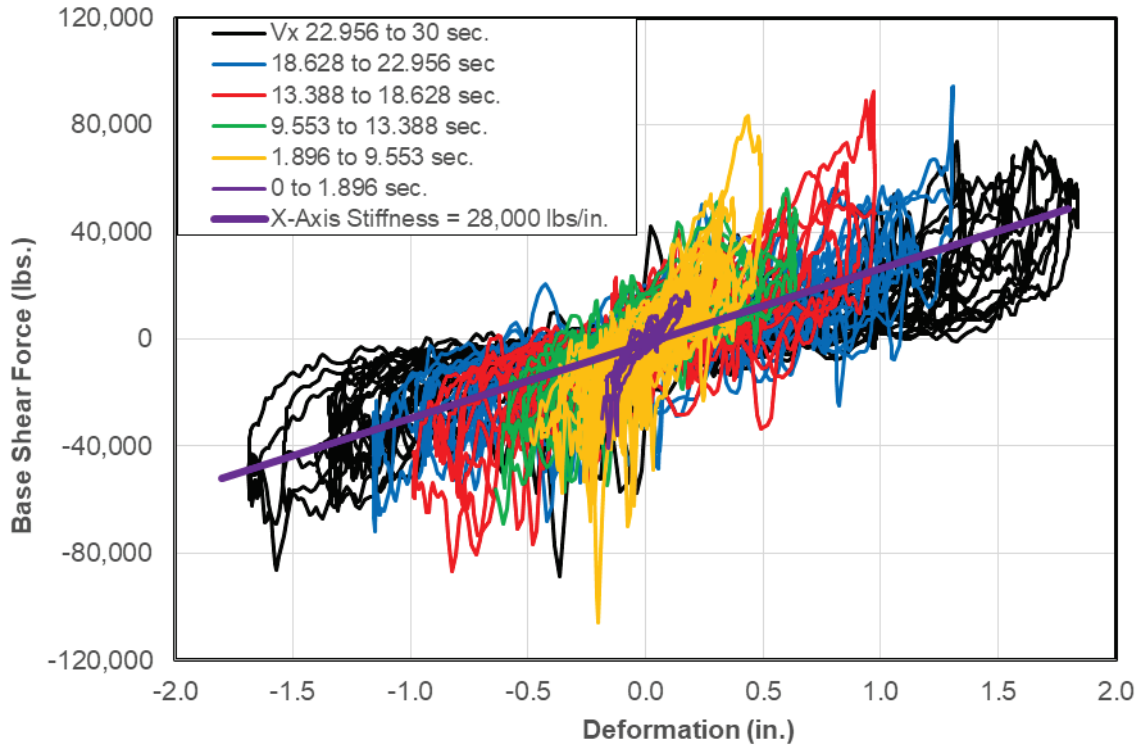
Figure 34. Base shear versus deformation and X-axis stiffness, 100% seismic test.

Figure 34 plots the base shear versus the average deformation in the X-axis. The deformations in the X-axis increased to 1.8 in. Figure 34 shows that the estimated X-axis building stiffness decreased to 28,000 lbs/in., a 77% decrease, indicating very large softening and damage relative to the 50% test. Figure 34 plots six segments of base shear versus deformation in time showing the building became much more flexible after 9.5 seconds and again after 18.6 seconds. Figure 35 plots the base shear versus deformation for the short direction of the building (Y-axis). This test shows the stiffness decreased to 16,000 lbs/in., a 53% decrease, indicating significant softening and damage. The segments plotted in time do not indicate a dramatic decrease in stiffness as the test progressed.

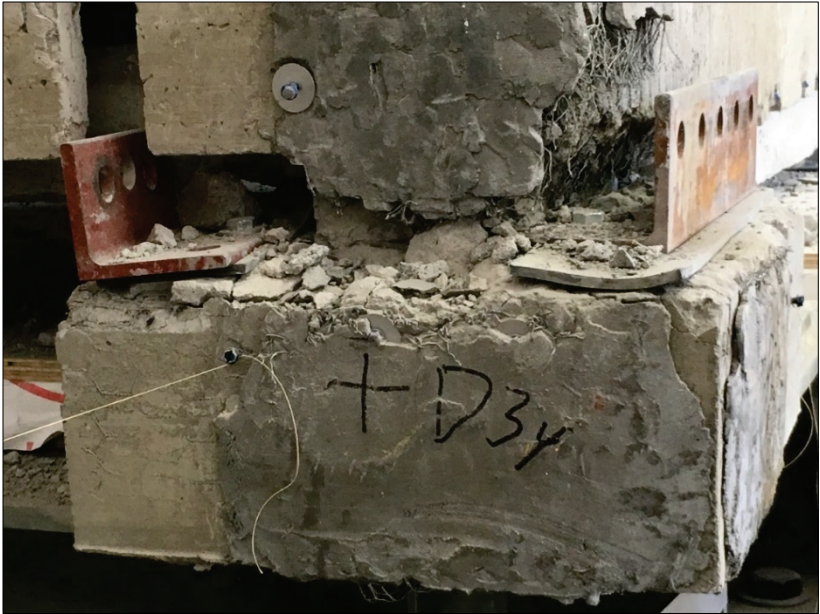
In the 100% seismic test, the four columns at the corners of the building completely failed in shear just above their footings. The corner columns failed in shear in the short direction of the building, where the cracks opened with large offsets in the Y-axis of the building early in this test. The columns 4 ft. to the interior, and almost immediately after all the columns along the long east and west walls failed in shear in the long X-axis of the building. Before the corner columns failed, the interior columns would have been more heavily loaded in the Y-axis of the building, which is the strong or stiffer axis of the frames. Once the corner columns failed and offset, the rigid long walls transferred significant load in shear to these interior columns in the X-axis. This progression of failure and offsets was seen in video files of the test. At the end of this test, the concrete along the top of the footings was crushed into golf ball and smaller sized rubble with a three-dimensional chicken wire mesh holding the rubble together. Many of the wires were also fractured, as seen at the southeast corner in Figure 36, southwest corner in Figure 37, and west face in Figure 38.

Figure 37. Bottom column at southwest corner, 100% test.

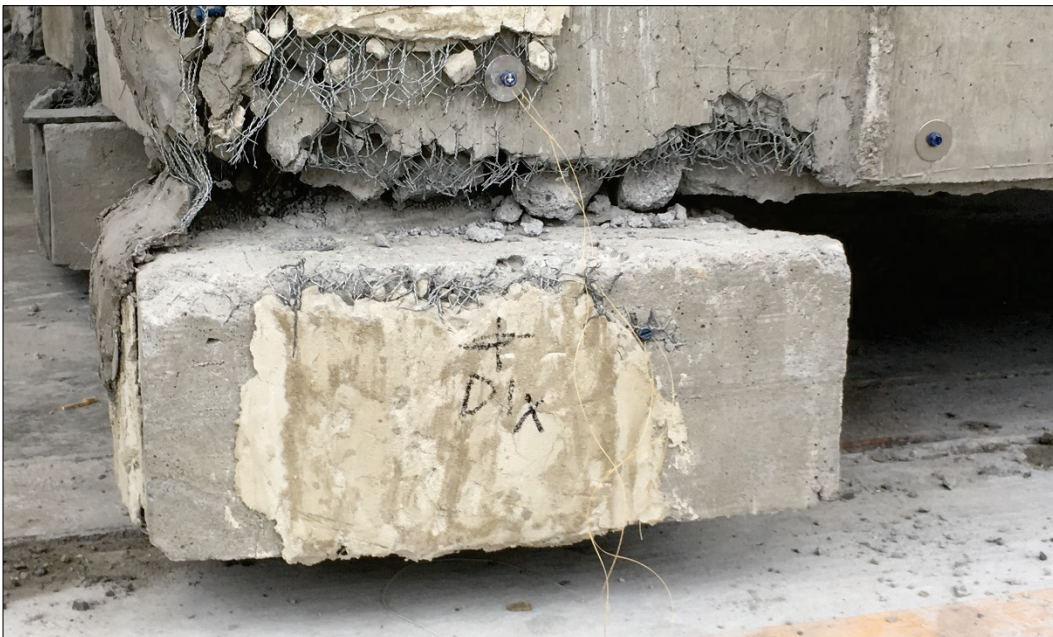
Figures 39, 40, 41, and 42, show severe damage to the stucco and chicken wire mesh at the northeast column and northwest column.

Figure 40. Bottom of northeast column, after removing the building from the test fixture, 100% test.

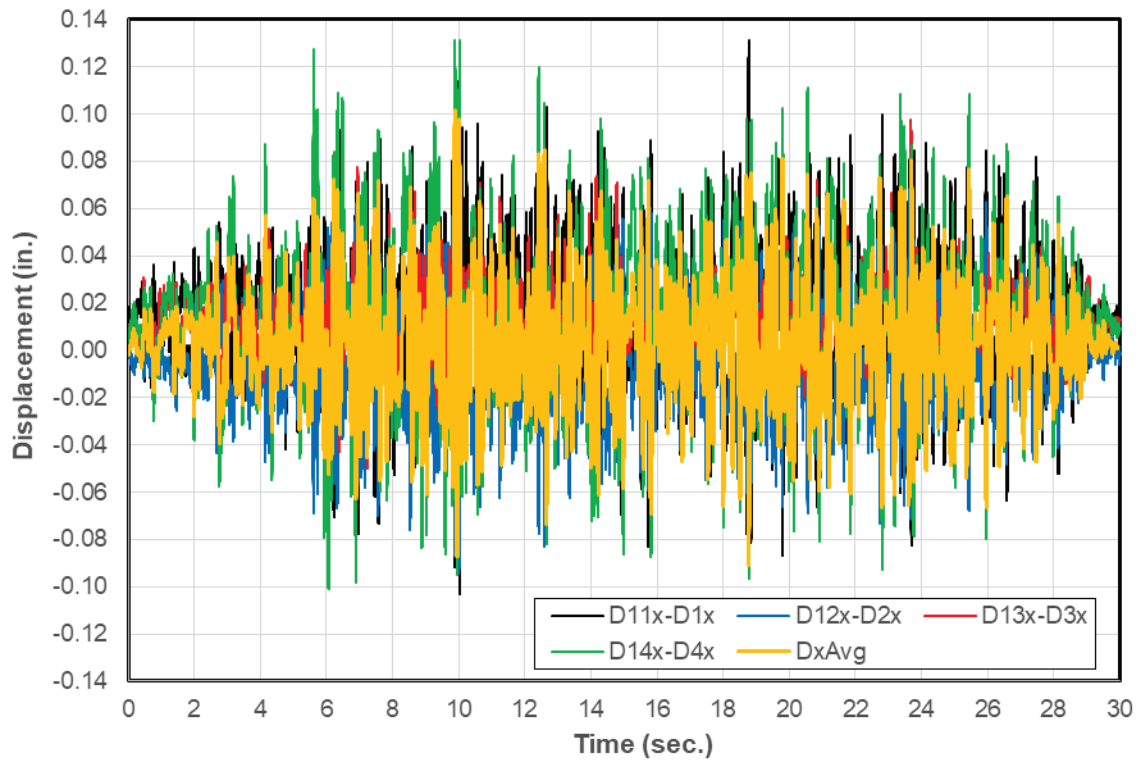
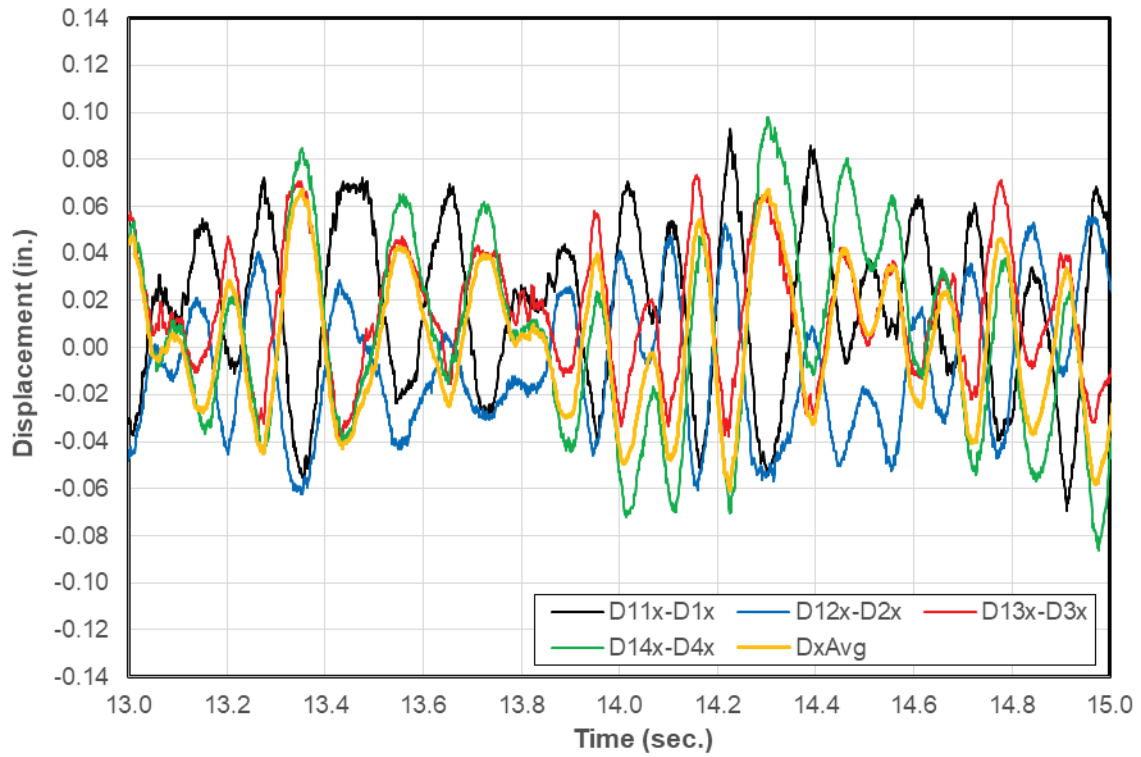
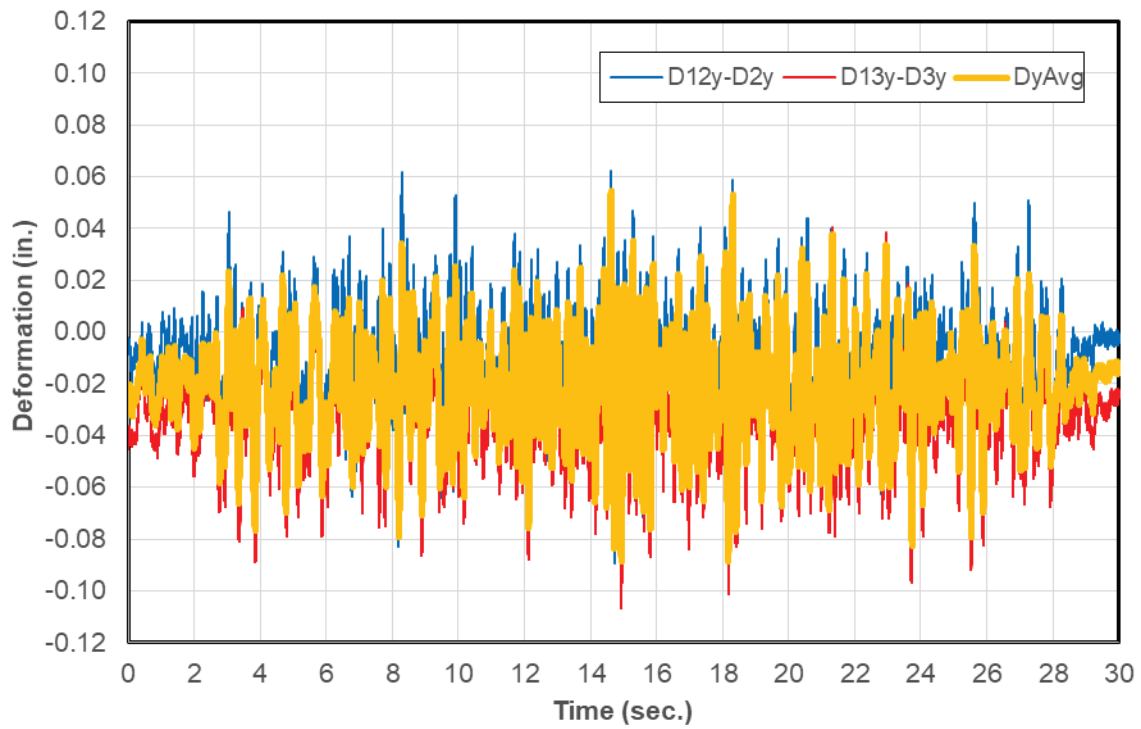
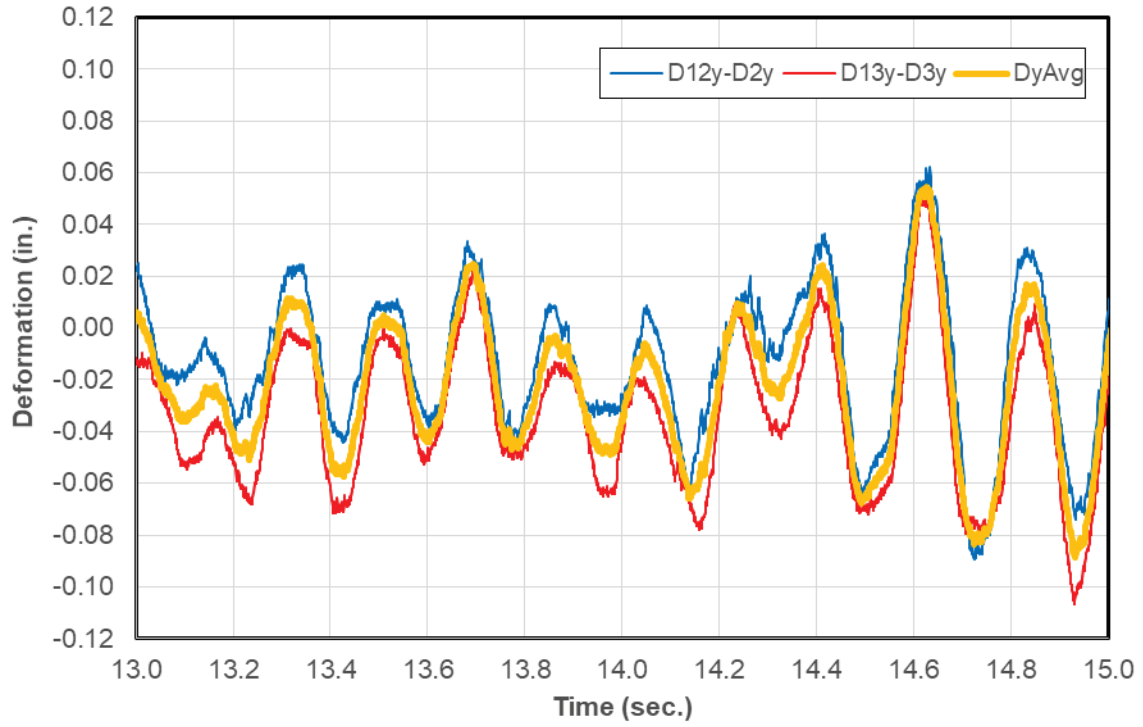
Figure D-14. Deformations in the X-axis during the 25% seismic test.

Figure D-15. Deformations in the X-axis during the 25% seismic test, 13 - 15 seconds.

Figure D-16. Deformations in the Y-axis during the 25% seismic test.

Figure D-17. Deformations in the Y-axis during the 25% seismic test, 13 to 15 seconds.

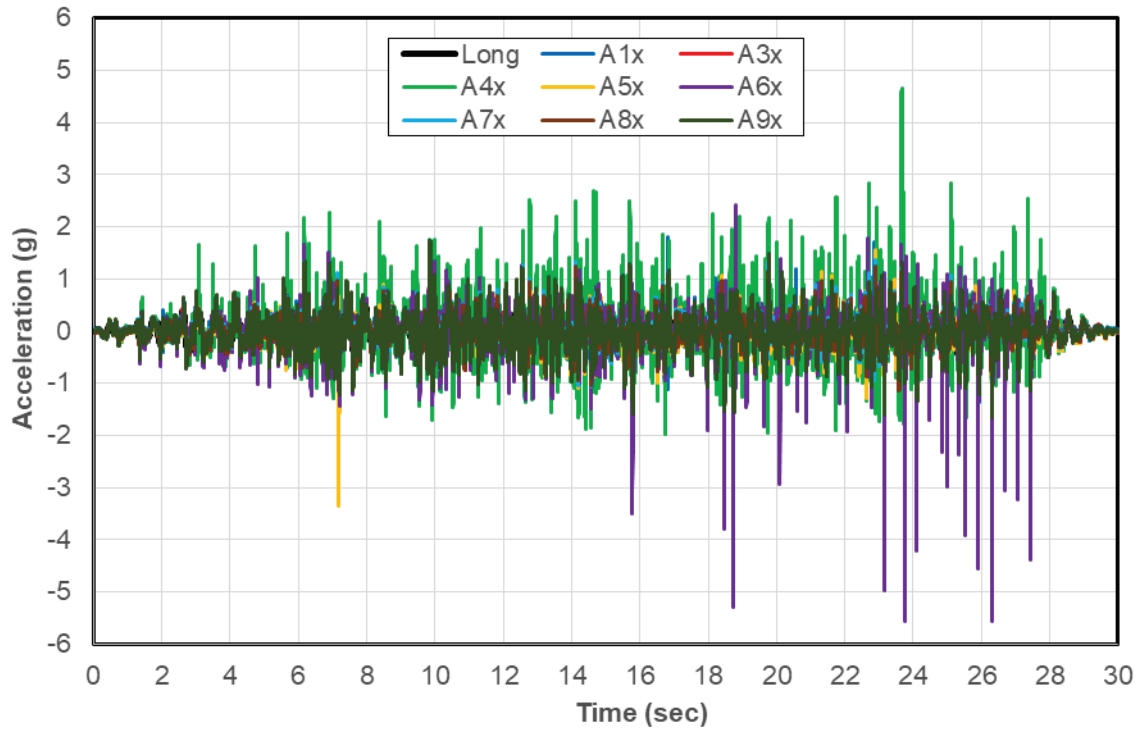
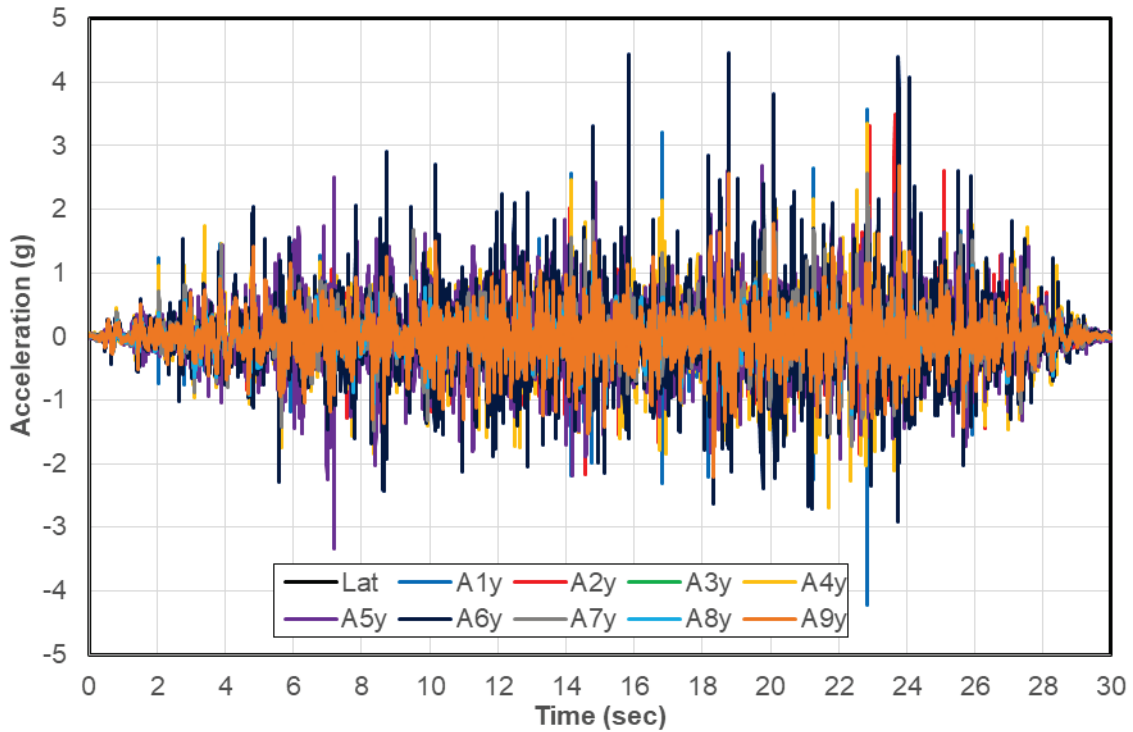
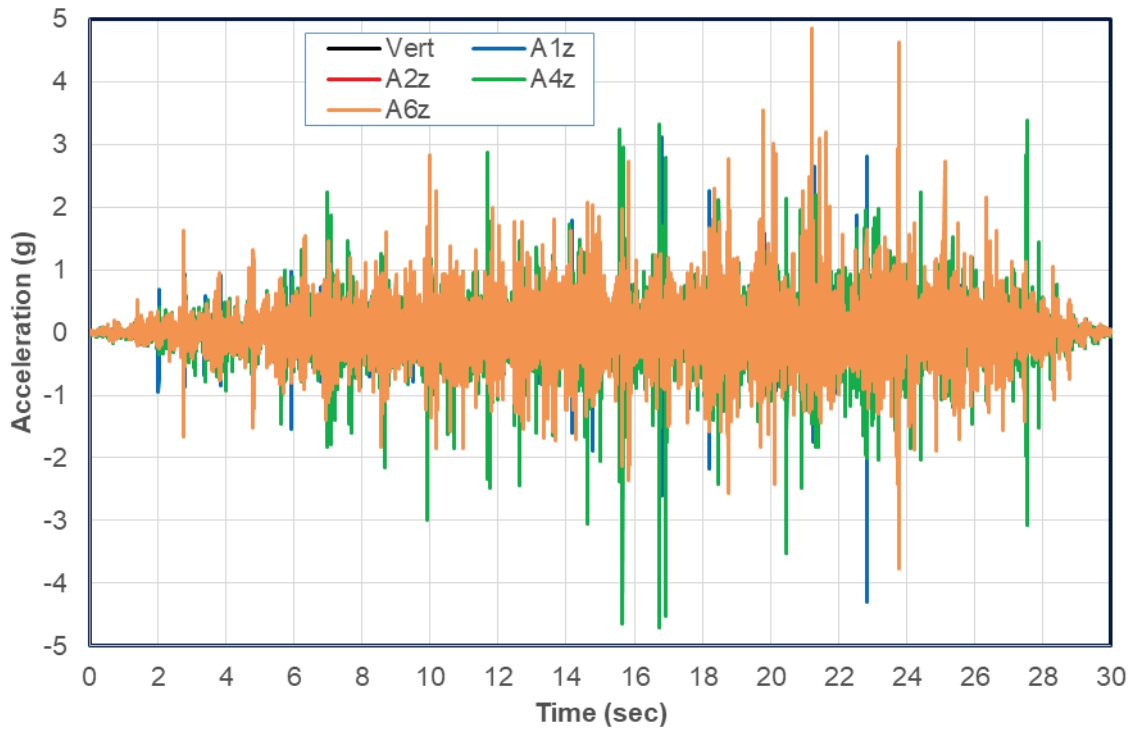
Figures E-1 through E-3 plot all the accelerations measured in the X-axis, Y-axis, and Z-axis of the building for the 50% seismic test. These figures show high frequency spikes that far exceed 1 g even in the vertical direction (Figure E-3). These spikes are more than twice the values seen in the 25% tests, indicating greater impact loading than the 25% test. The spikes are localized and should not engage large portions of the mass of the building. The average accelerations plotted in Figures E-4 through E-7 reduce the high frequency impacts, while still preserving a reasonable portion of this increased loading effect, which does damage the building. The inertial loads and base shear plotted in Figures E-8 through E-11 scale up well from the loading seen in the 25% test, where the amplitudes of the high frequency spike portions of these plots are somewhat greater than twice the values seen in the 25% test. The number of cycles seen in the average acceleration and inertial loading decreased in the X-axis to 7 Hz. The average acceleration and inertial loading at the ceiling both decreased to under 5 Hz. The average acceleration in the Y-axis is greater than at the bottom of the building (Figure E-6) than the ceiling level (Figure E-7). The inertial loads at the ceiling level do oscillate at under 5 Hz (Figure E-11), but the higher frequency, higher amplitude accelerations and inertial loads at the bottom causes the base shear in the Y-axis ( $V_y$ ) to no longer oscillate at the building natural frequency.

Figure E-1. Accelerations recorded in the X-axis during the 50% seismic test.

Figure E-2. Accelerations recorded in the Y-axis during the 50% seismic test.

Figure E-3. Accelerations recorded in the Z-axis during the 50% seismic test.

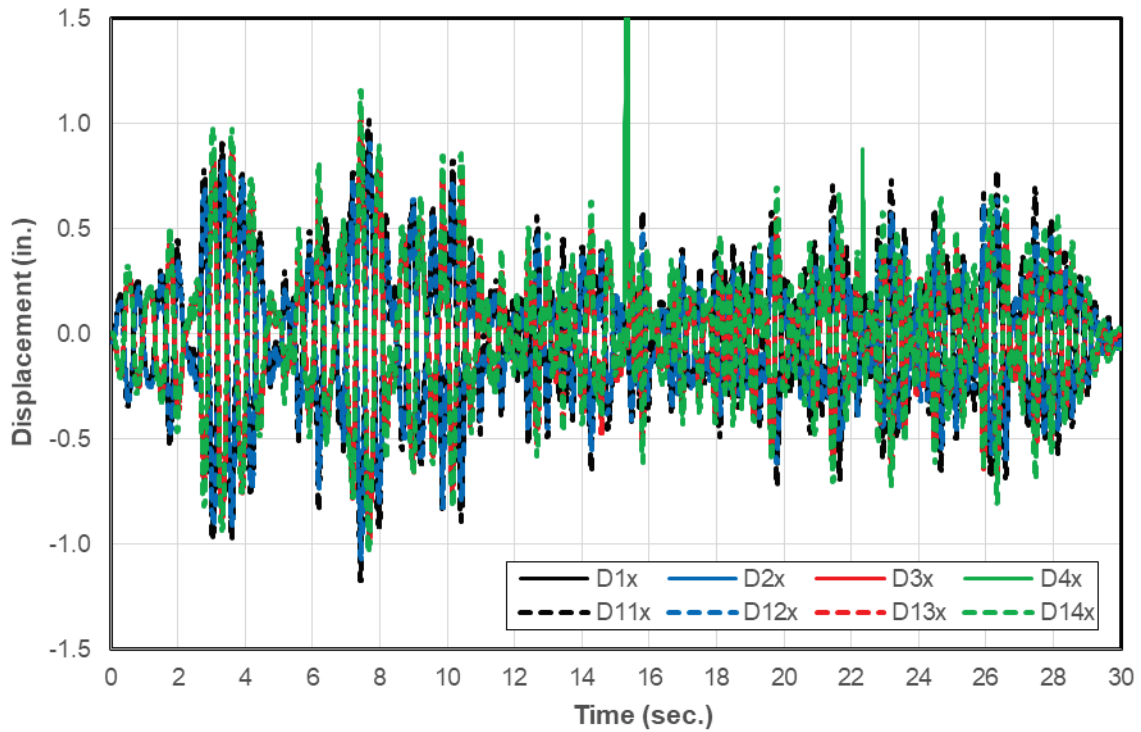
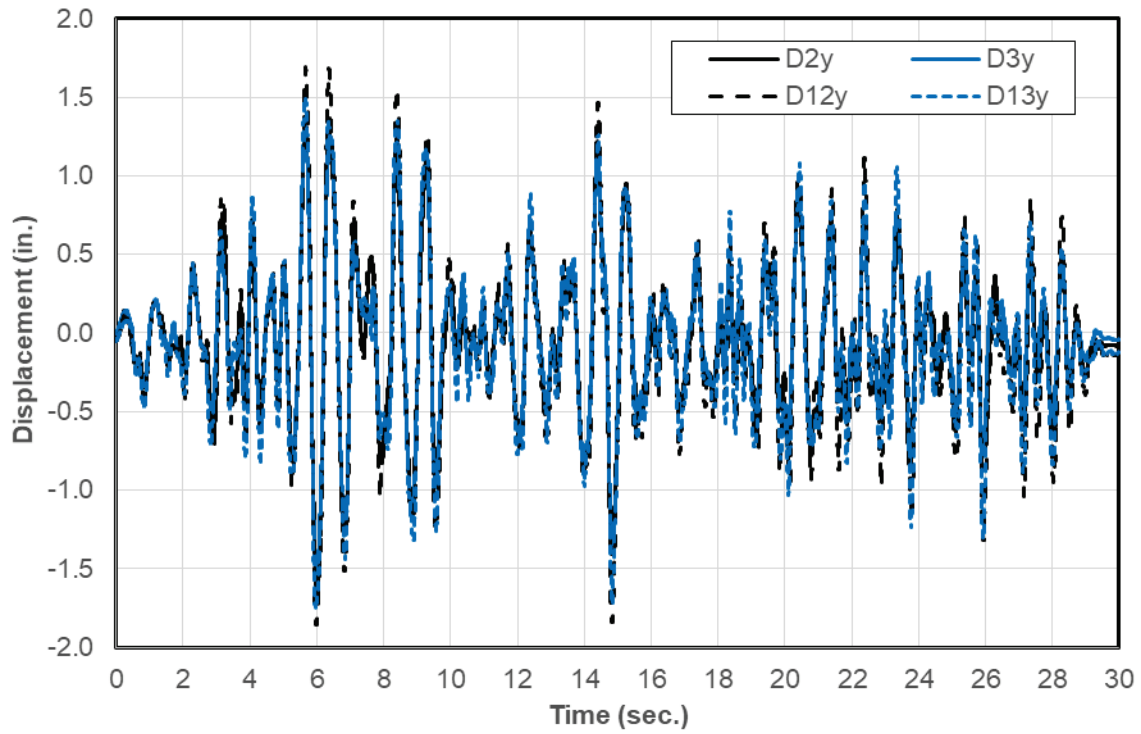
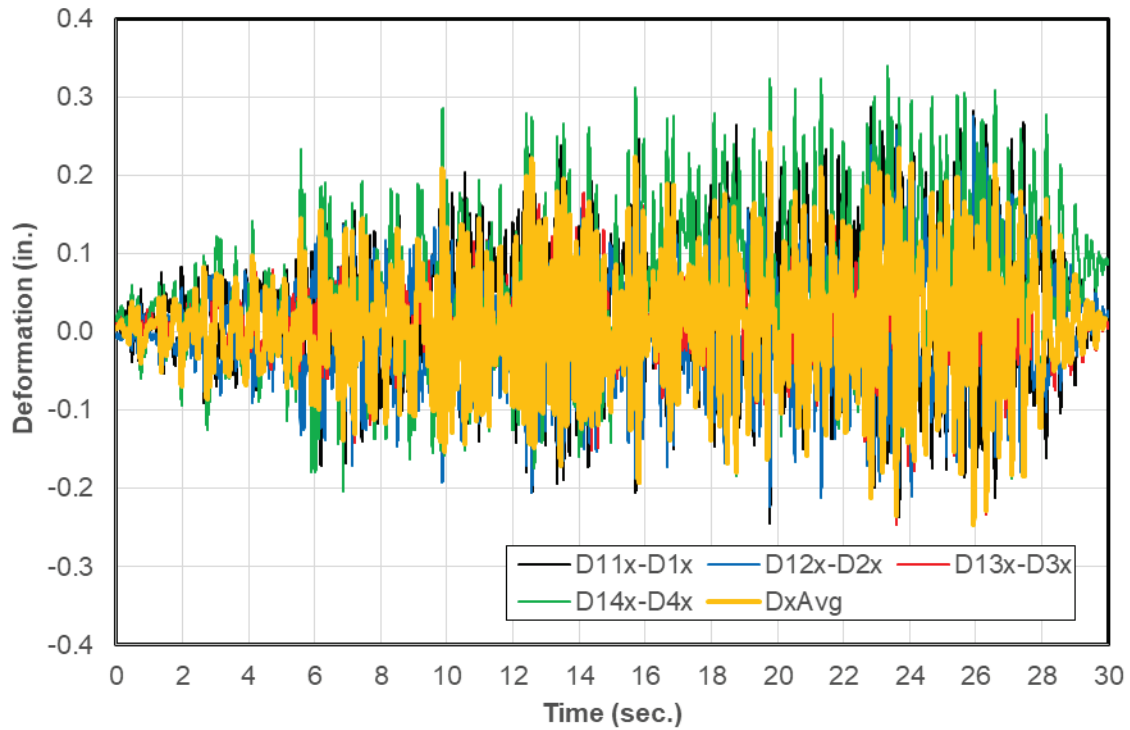
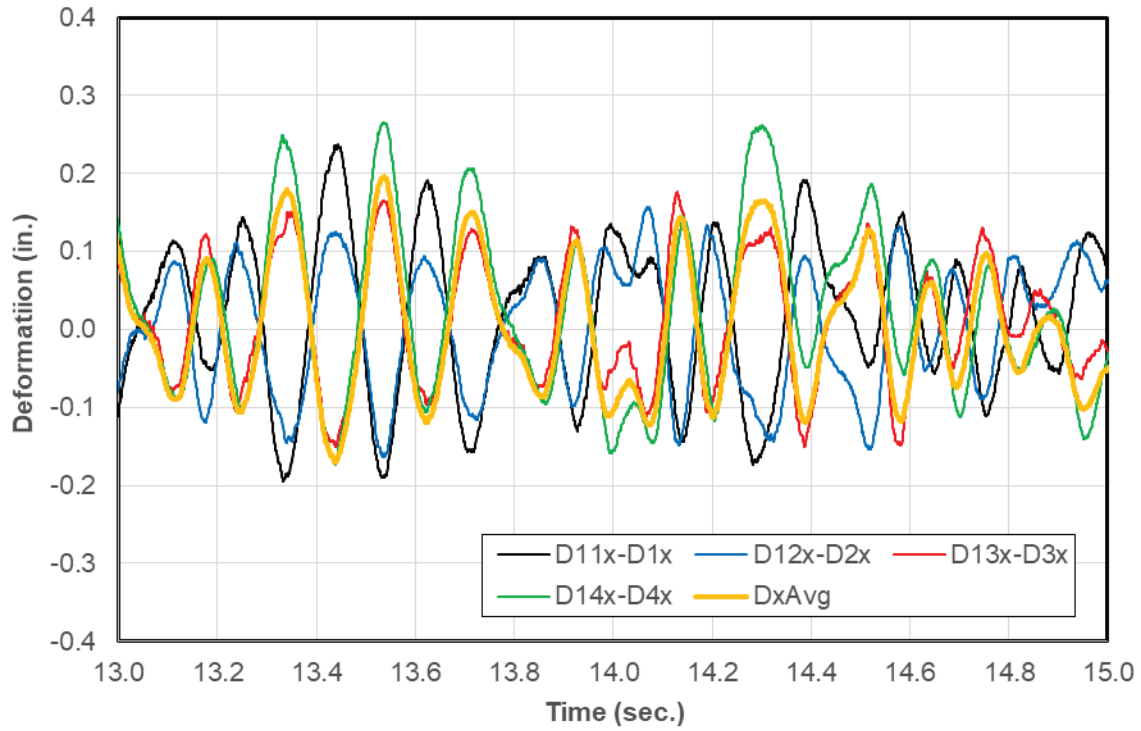
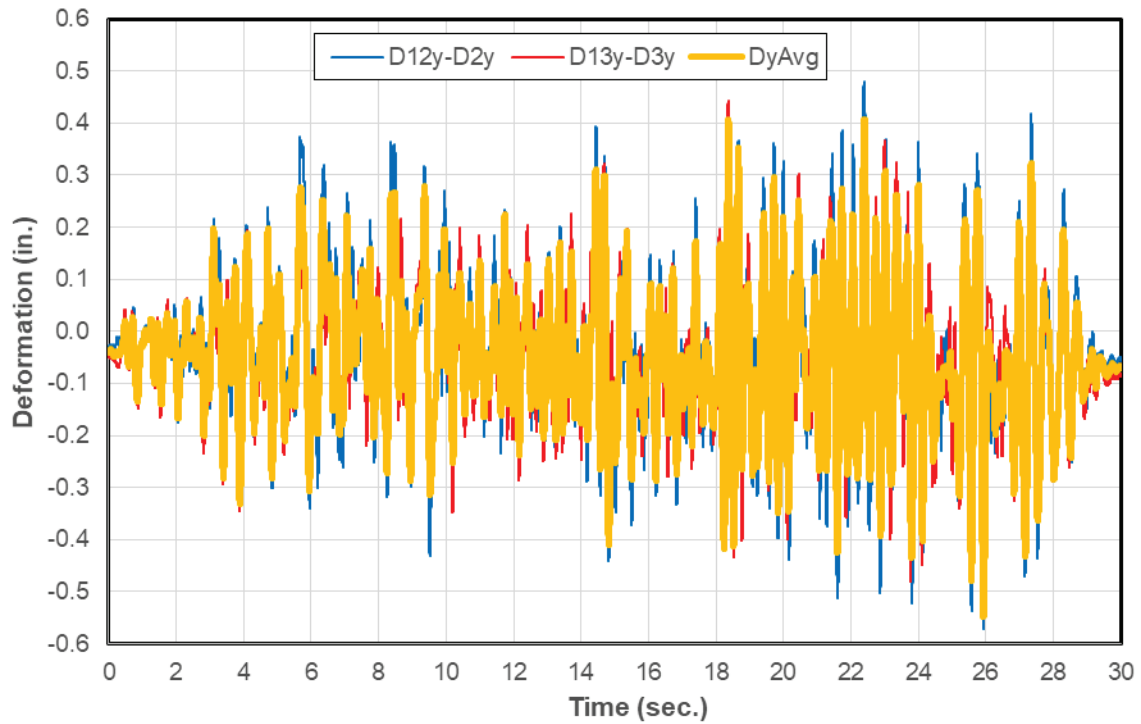
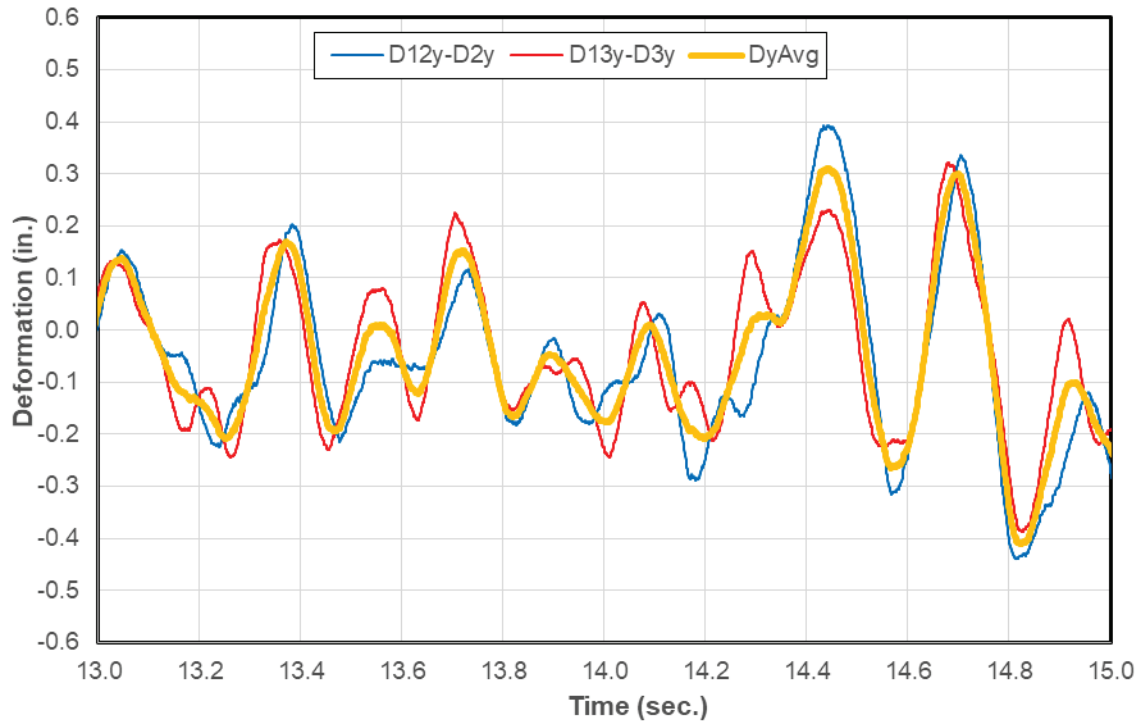
Figure E-12 and E-13 plot the displacements in the X-axis and Y-axis, and Figures E-14 through E-17 plot the calculated deformations in both the X-axis and Y-axis, plus the average deformation in both directions ( $D_{xAvg}$  and  $D_{yAvg}$ ). Figure E-15 shows that the X-axis average deformation oscillates at about 6.3 Hz, while the Y-axis deformation oscillates at about 4.3 Hz. These frequencies have decreased from the values of 7.7 Hz and 5.1 Hz (Table 5). These cycle counts are a crude estimate of frequency content, but they do show that the building natural frequencies have decreased, which indicates softening and increased damage.

Figure E-12. Displacements recorded in the X-axis during the 50% seismic test.

Figure E-13. Displacements recorded in the Y-axis during the 50% seismic test.

Figure E-14. Deformations in the X-axis during the 50% seismic test.

Figure E-15. Deformations in the X-axis during the 50% seismic test, 13 – 15 seconds.

Figure E-16. Deformations in the Y-axis during the 50% seismic test.

Figure E-17. Deformations in the Y-axis during the 50% seismic test, 13 to 15 seconds.

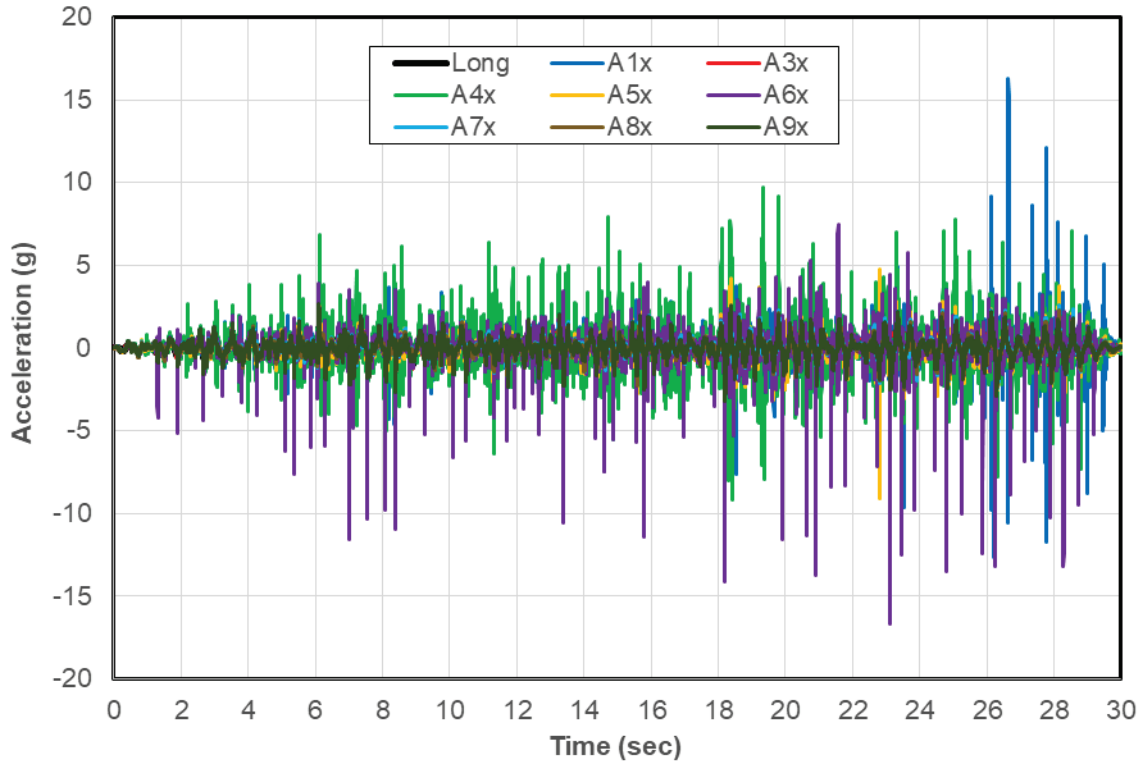
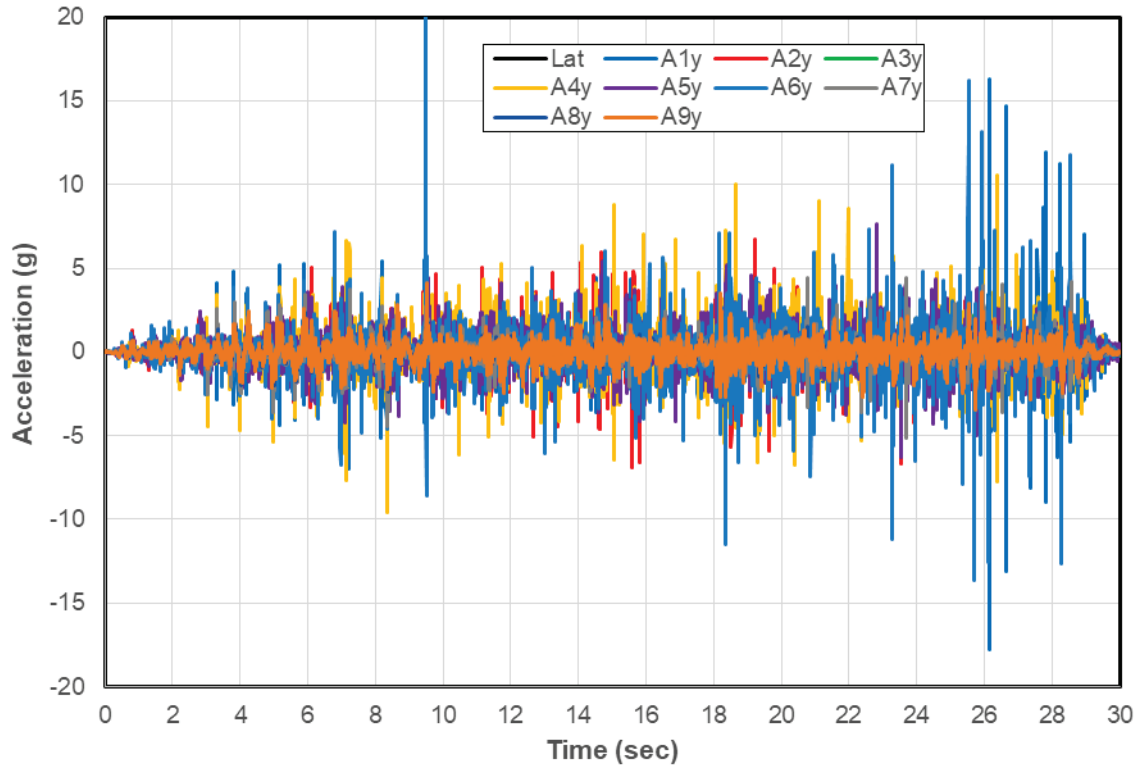
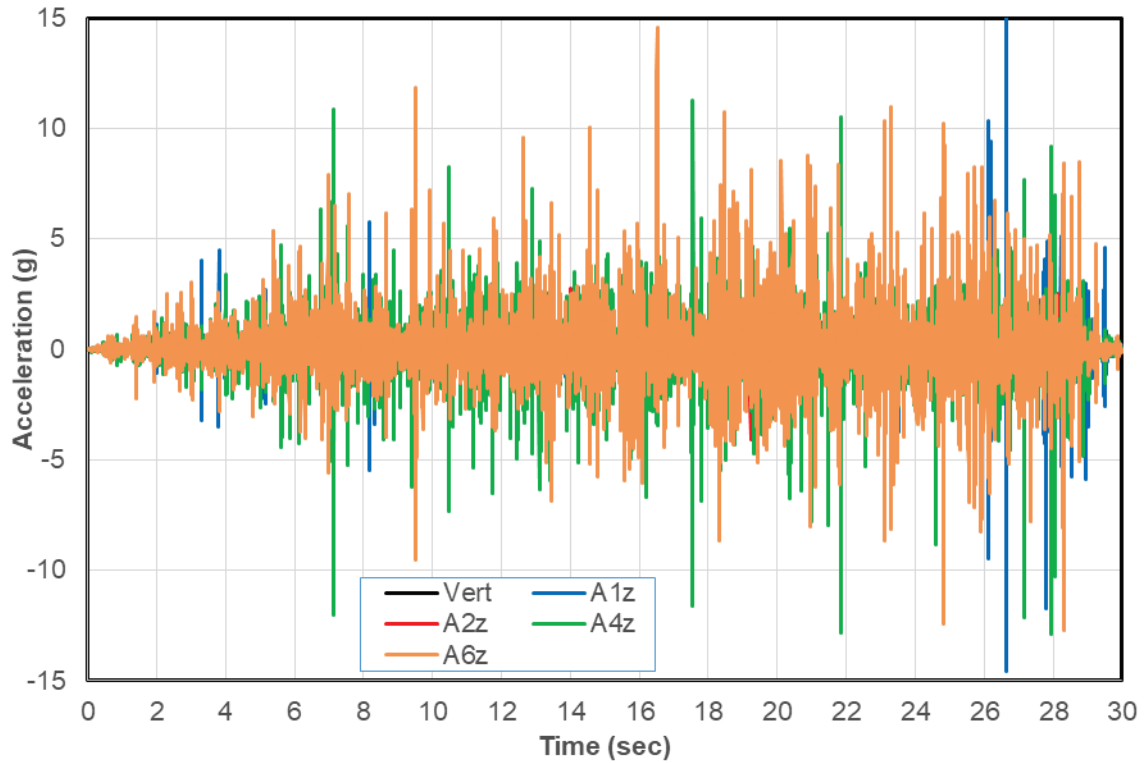
Figures F-1 through F-3 plot all the accelerations measured in the X-axis, Y-axis, and Z-axis of the building for the 100% seismic test. These figures show high frequency spikes. For example, in Figure F-1, the 17 g spike at 23 seconds, measured at accelerometer A6x, has a duration of 0.005 seconds, equivalent to 100 Hz half sine pulse, most likely caused by impact. These spikes reach three times the amplitudes seen in the 50% seismic tests. As presented earlier, these spikes are localized, do not engage large portions of mass; averaging the measured accelerations will preserve some of the real effects of the impact, while reducing the magnitude because the impact take place at different instances in time. The average accelerations plotted in Figures F-4 through F-7 provide a reasonable estimate of the inertial loading when multiplied by the lumped masses at the top and bottom of the building. The inertial loads and base shear plotted in Figures F-8 through F-11, scale up well from the loading seen in the 50% test, where the amplitudes of the high frequency spike portions of these plots are approximately twice the values seen in the 50% test. The number of cycles seen in the average acceleration and inertial loading decreased in the X-axis to 6 Hz. In the short axis of the building (Y-axis), this frequency, which is based on average ceiling cycling (Figure F-7) appears to have decreased to about 3 Hz. However, the acceleration, inertial loading, and building deformation no longer cycles in a clear regular pattern because of significant damage at the bottom of the frame columns.

Figure F-1. Accelerations recorded in the X-axis during the 100% seismic test.

Figure F-2. Accelerations recorded in the Y-axis during the 100% seismic test.

Figure F-3. Accelerations recorded in the Z-axis during the 100% seismic test.
