## **Seismic Testing of an Indigenous Material Troop Constructible Building**

James Wilcoski

September 2019

Final Technical Report (TR)

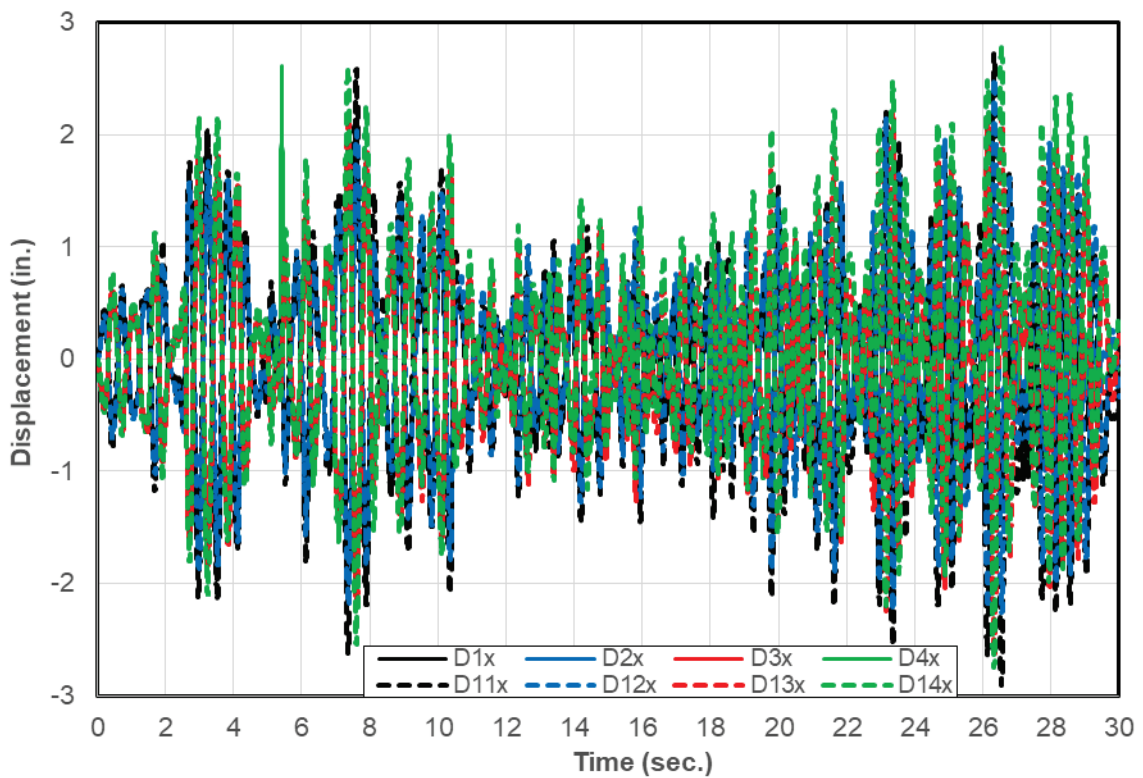
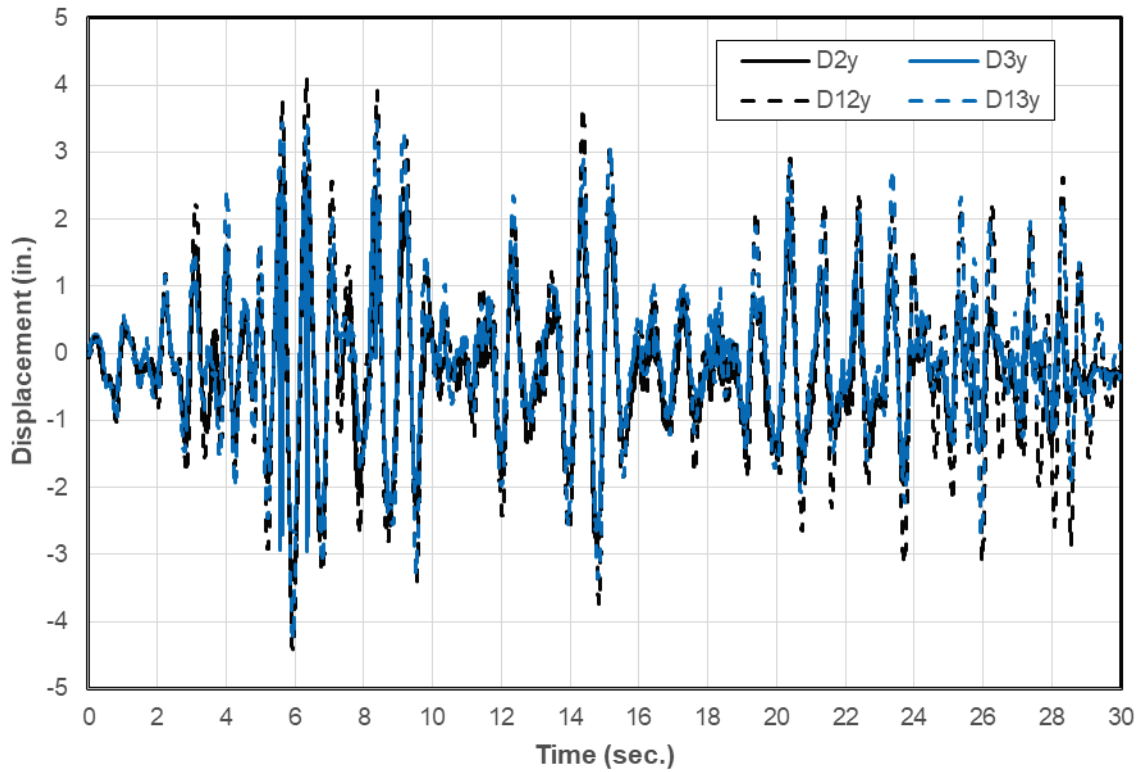
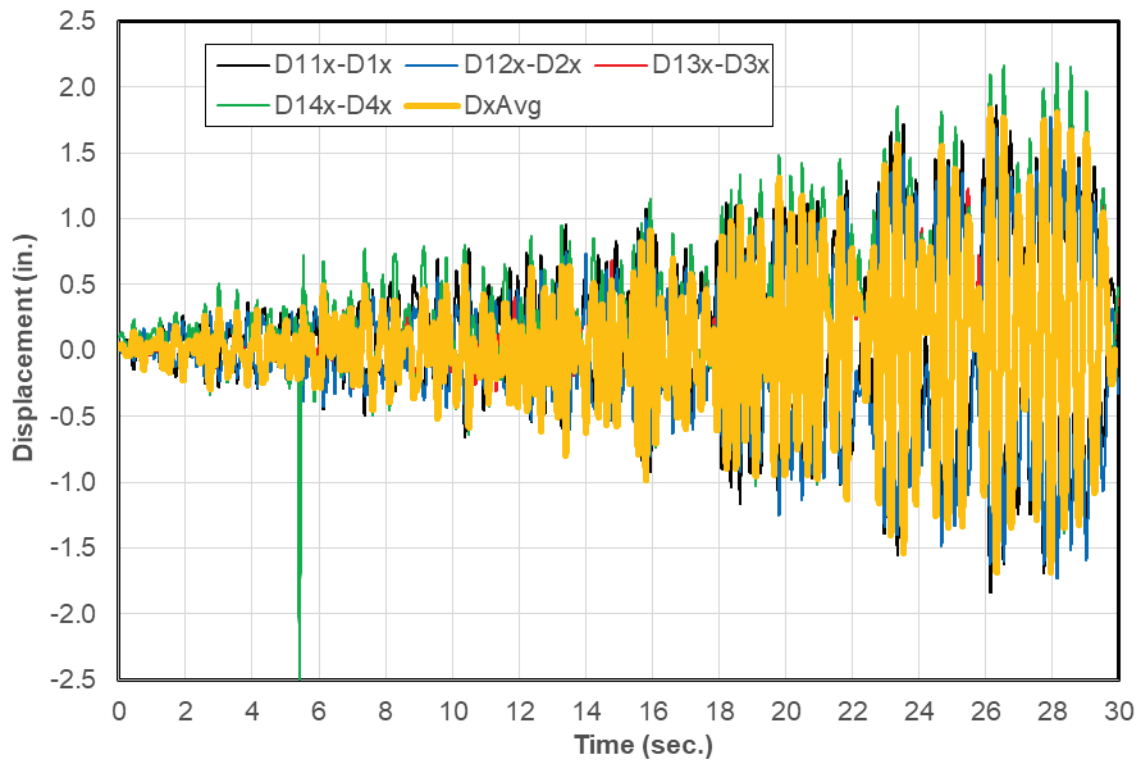
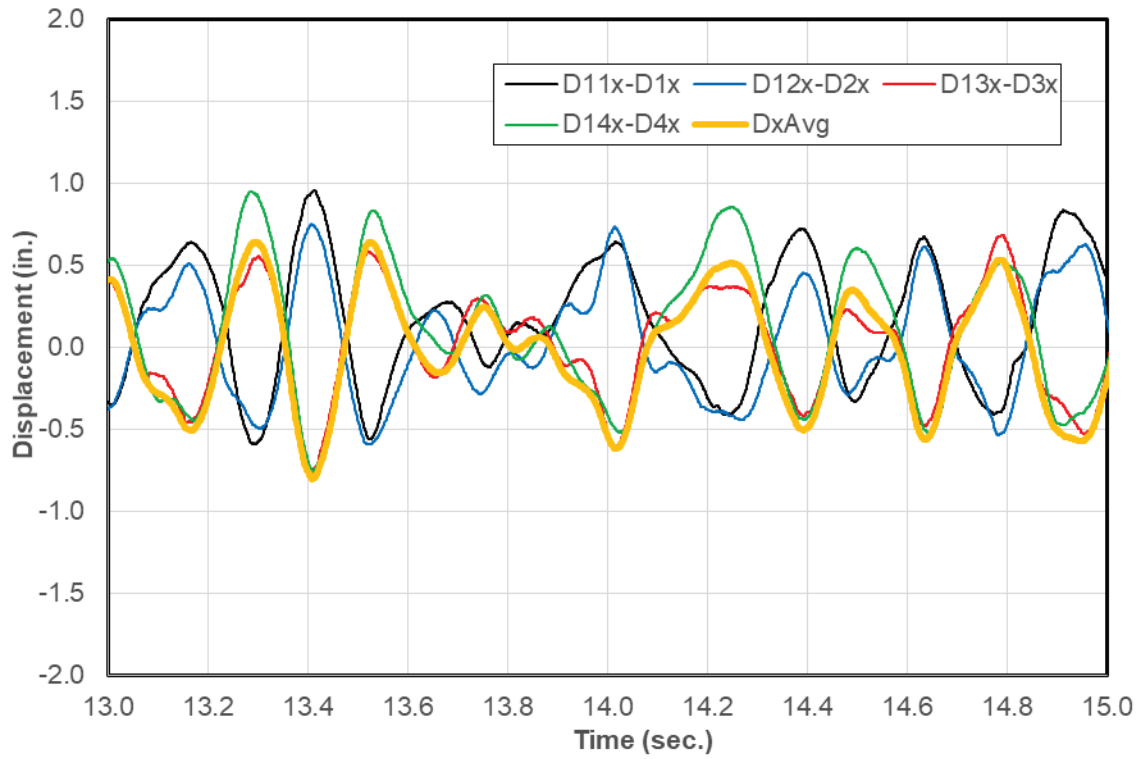
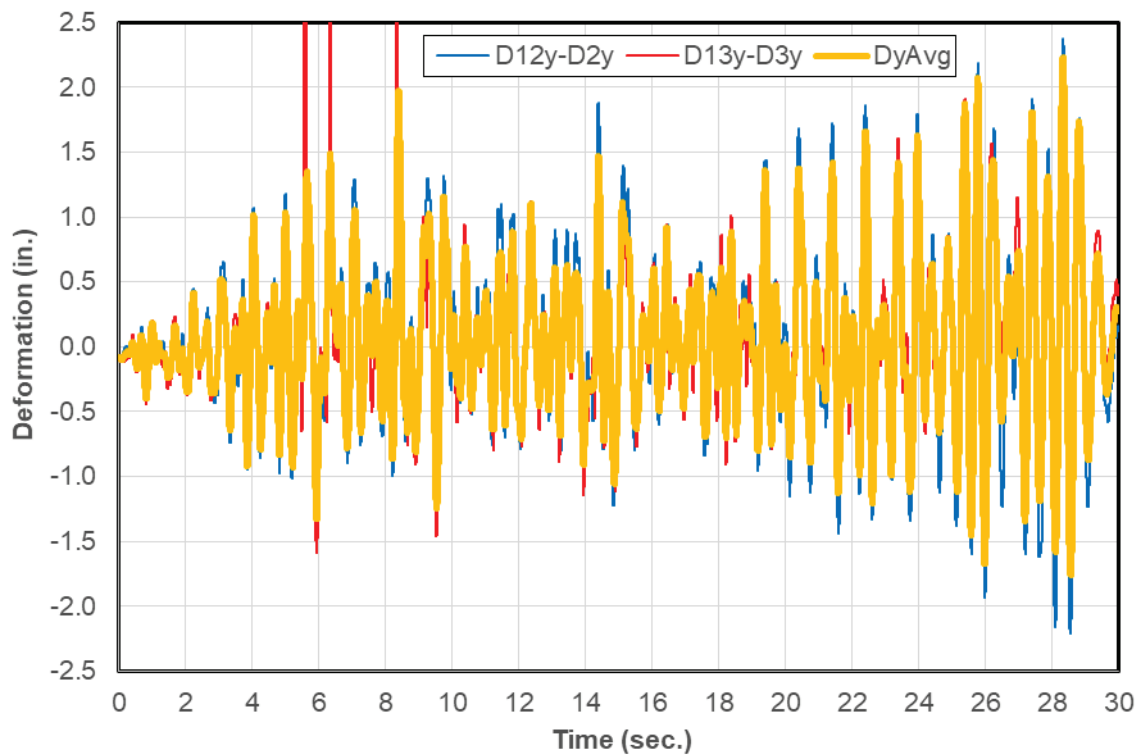
Figures F-12 and F-13 plot the displacements in the X-axis and Y-axis; Figures F-14 through F-17 plot the calculated deformations in both the X-axis and Y-axis, plus the average deformation in both directions ( $D_{X_{Avg}}$  and  $D_{Y_{Avg}}$ ). Figures F-12 and F-14 show that the displacements and deformations in the X-axis grow throughout the 100% test. In contrast, in the Y-axis, the displacements start out large, but actually decrease in this test. The building was considerably damaged at the beginning of the 100% test and displaced and deformed considerably in the Y-axis along the bottom of all the corner columns, but the interior columns held together until later in the tests. Once all the interior columns had also failed in the Y-axis, it appears that the entire building, just above the footings, was free to displace and deform just above the footings.

Figure F-12. Displacements recorded in the X-axis during the 100% seismic test.

Figure F-13. Displacements recorded in the Y-axis during the 100% seismic test.

Figure F-14. Deformations in the X-axis during the 100% seismic test.

Figure F-15. Deformations in the X-axis during the 100% seismic test, 13 - 15 seconds.

Figure F-16. Deformations in the Y-axis during the 100% seismic test.
