STUDIES OF THE NATURE OF WEAR

Vernon C. Westcott, et al

Trans-Sonics, Incorporated

4. DESCRIPTIVE NOTES (Type of report and inclusive dates) Progress Report 1 December 1973 to 30 June 1974		
5. AUTHOR(S) (First name, middle initial, last name) Vernon C. Westcott - Douglas Scott - John L. Middleton - Robert A. White

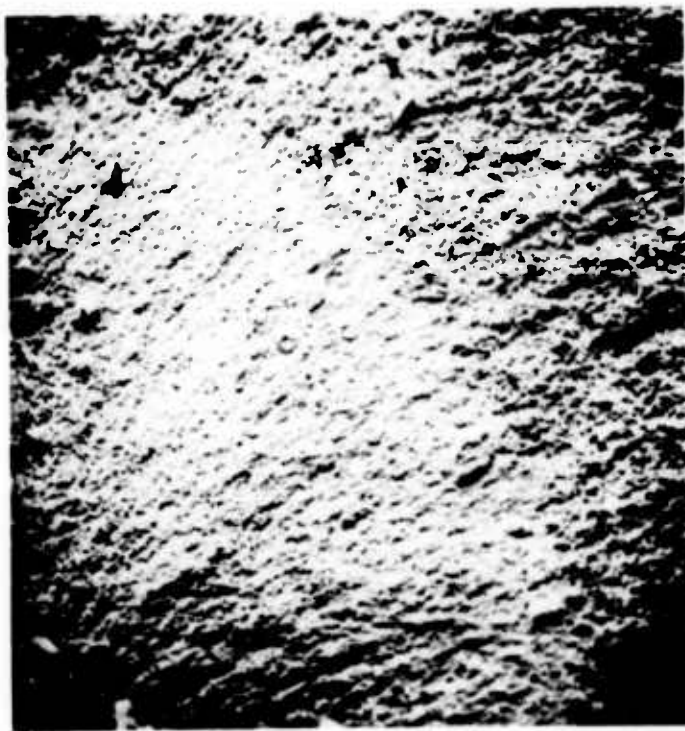
PHOTO NO. 3.1-7      DATE May 74

Enlarge view of fracture initiation  
area.

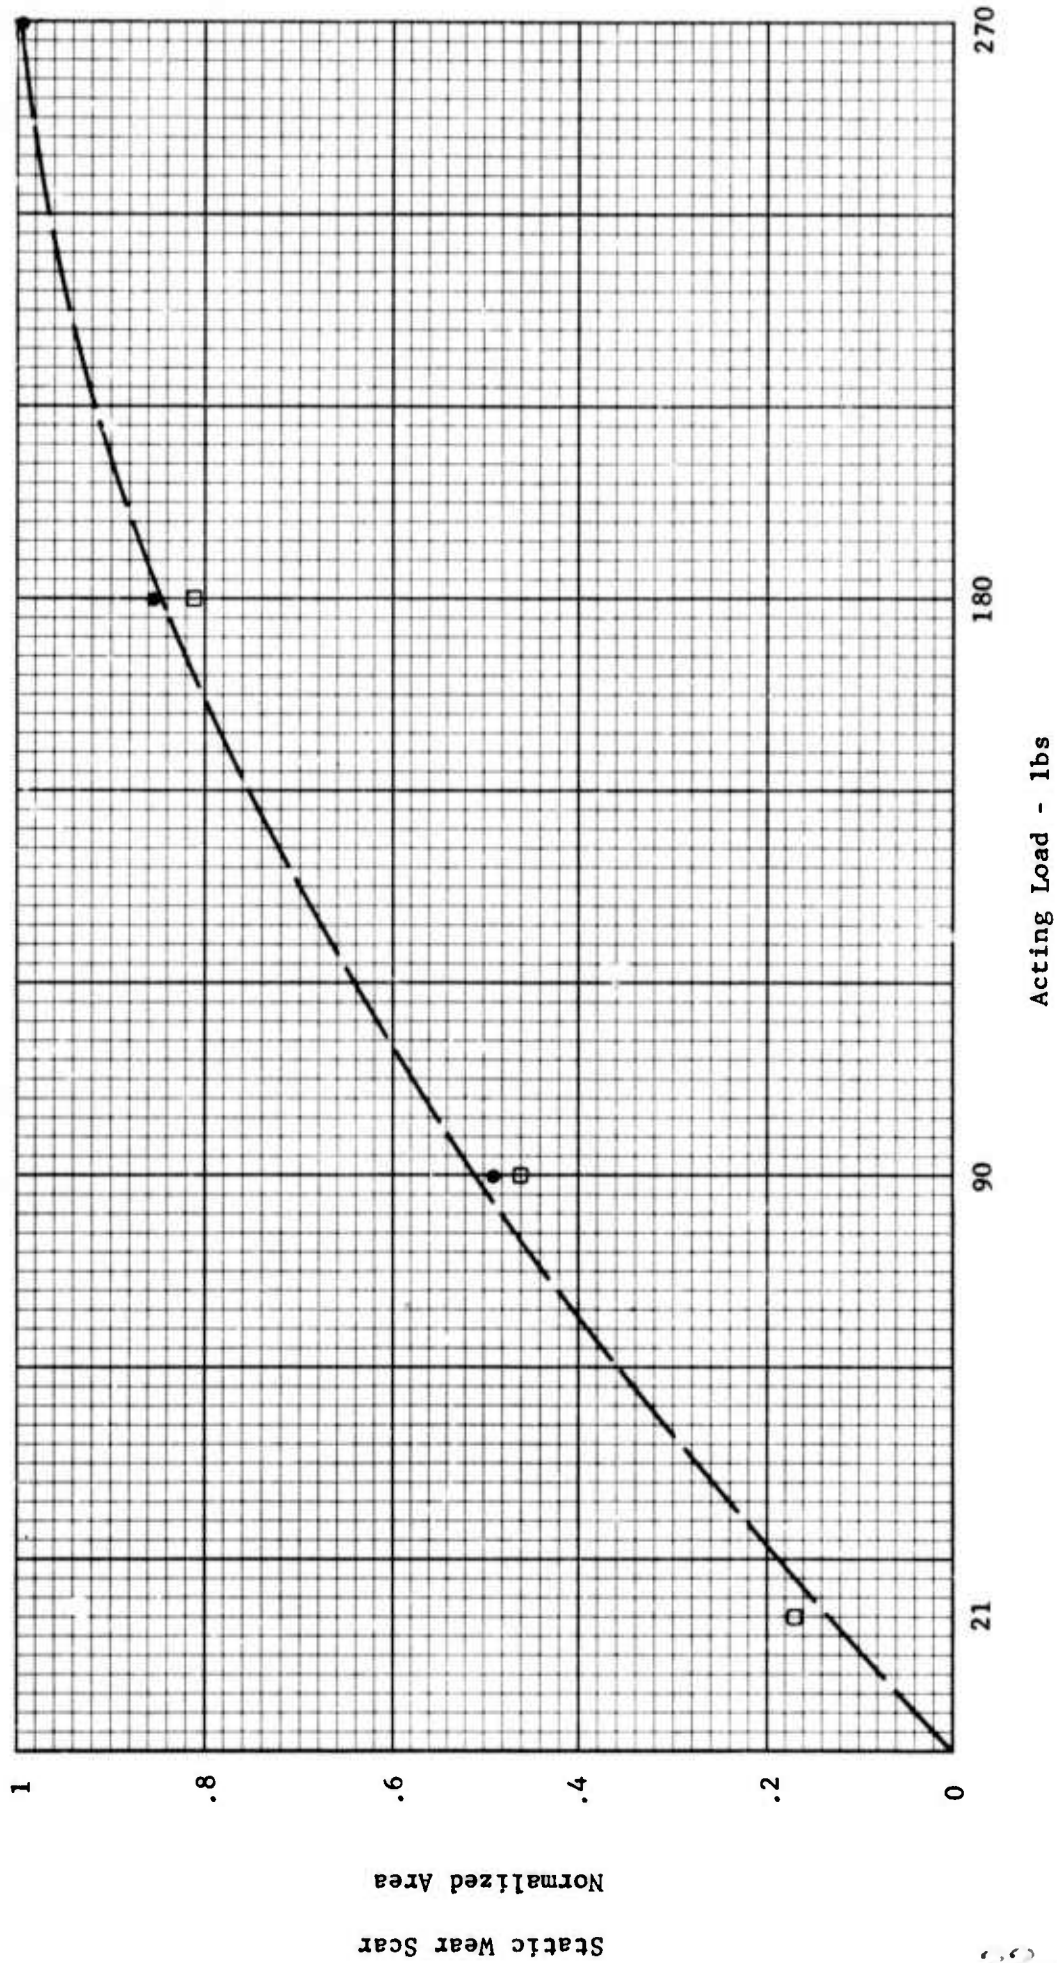
Crossed Race Wear Test Machine  
Load/Area Relationship

A linear relationship was found between this wear scar area of the static specimen and apparent load. Thus, equilibrium contact conditions of elasto-hydrodynamic lubrication are maintained.

● Test 4093 Area = .0193 in<sup>2</sup>  
□ Test 4102 Area = .0064 in<sup>2</sup>

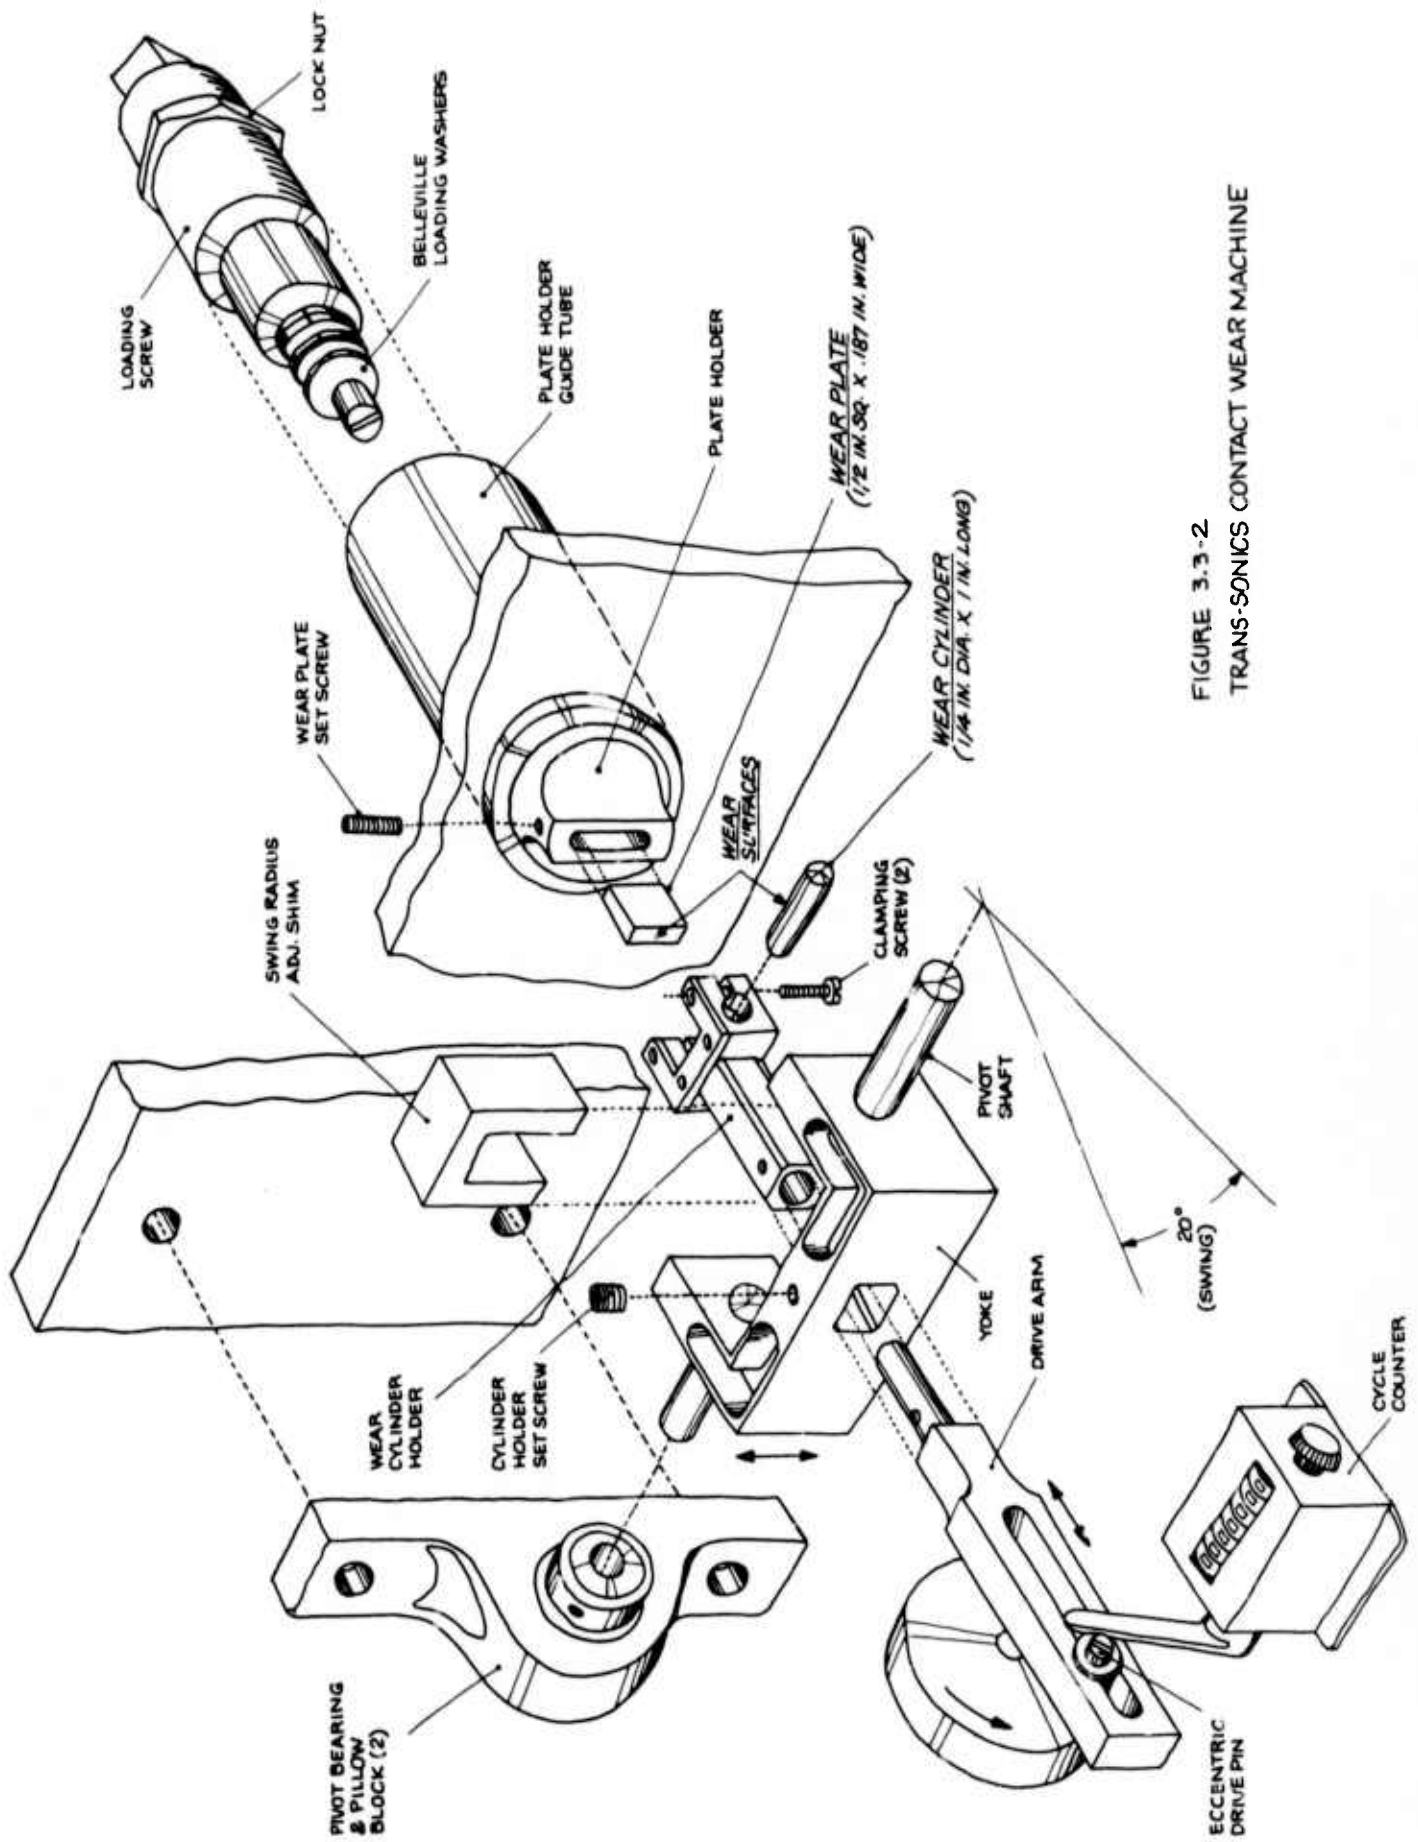
FIGURE 3.3-2  
 TRANS-SONICS CONTACT WEAR MACHINE

This test indicated that the SAE-1040 steel is more prone to fatigue spalling than the Armco 17-4 steel. Also, the contact wear machine produced the same type of pitting associated with heavily loaded gears.

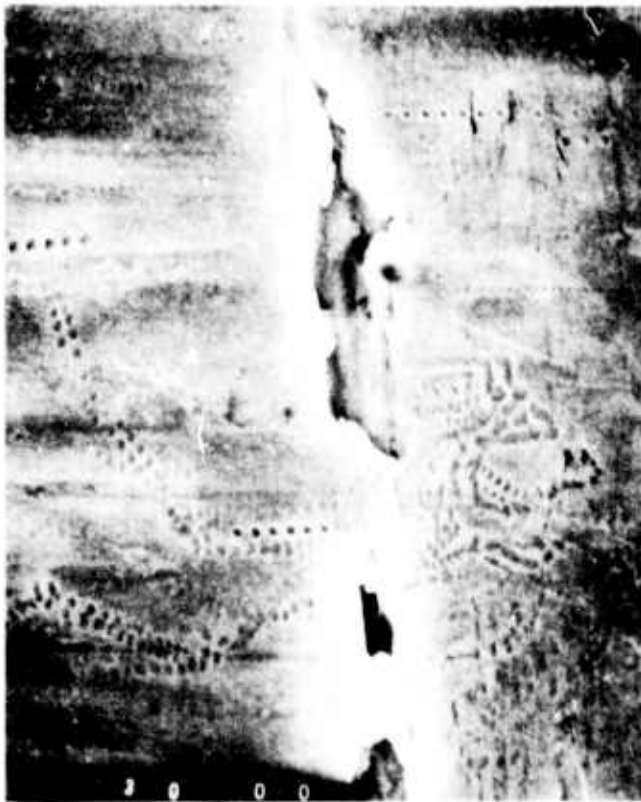
PHOTO NO. 3.3-8      DATE JULY 74

S.E.M. photomicrograph showing network of pits.
