378' WHEC EXPANSION JOINT INSTALLATION
AND PERFORMANCE EVALUATION

Coast Guard Research and Development Center

1. Report No. CG-D-67-75		2. Government Accession No.		3. Recipient's Catalog No. AD-A007876	
4. Title and Subtitle 378' WHEC EXPANSION JOINT INSTALLATION AND PERFORMANCE EVALUATION				5. Report Date July 1974

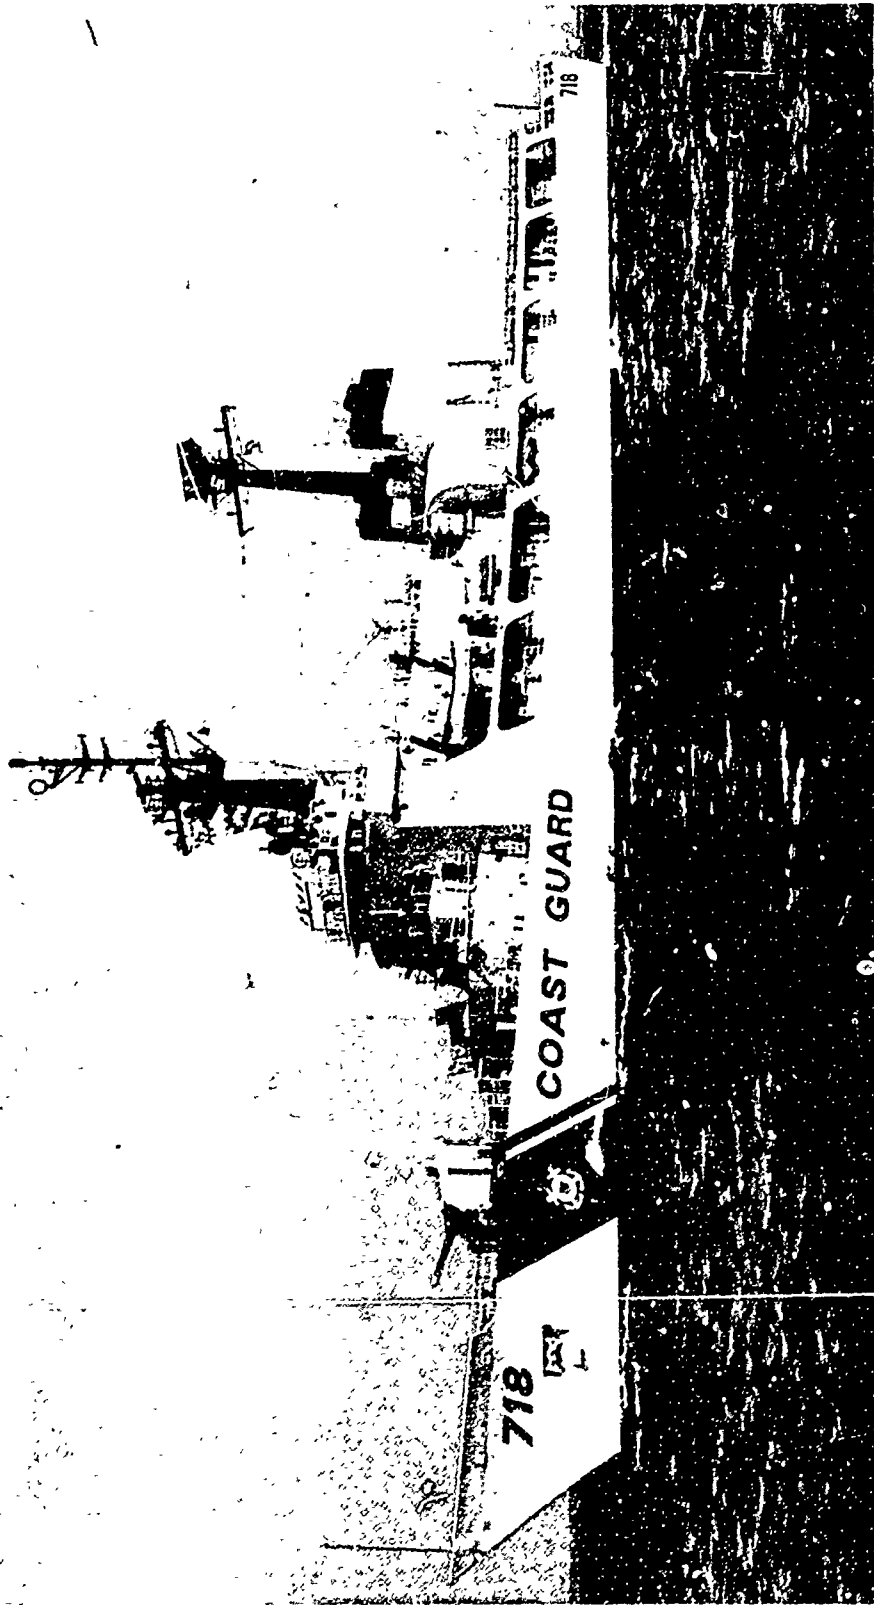
Figure 1. USCGC CHASE (WHEC-718) prior to installation of expansion joint and side curtain.

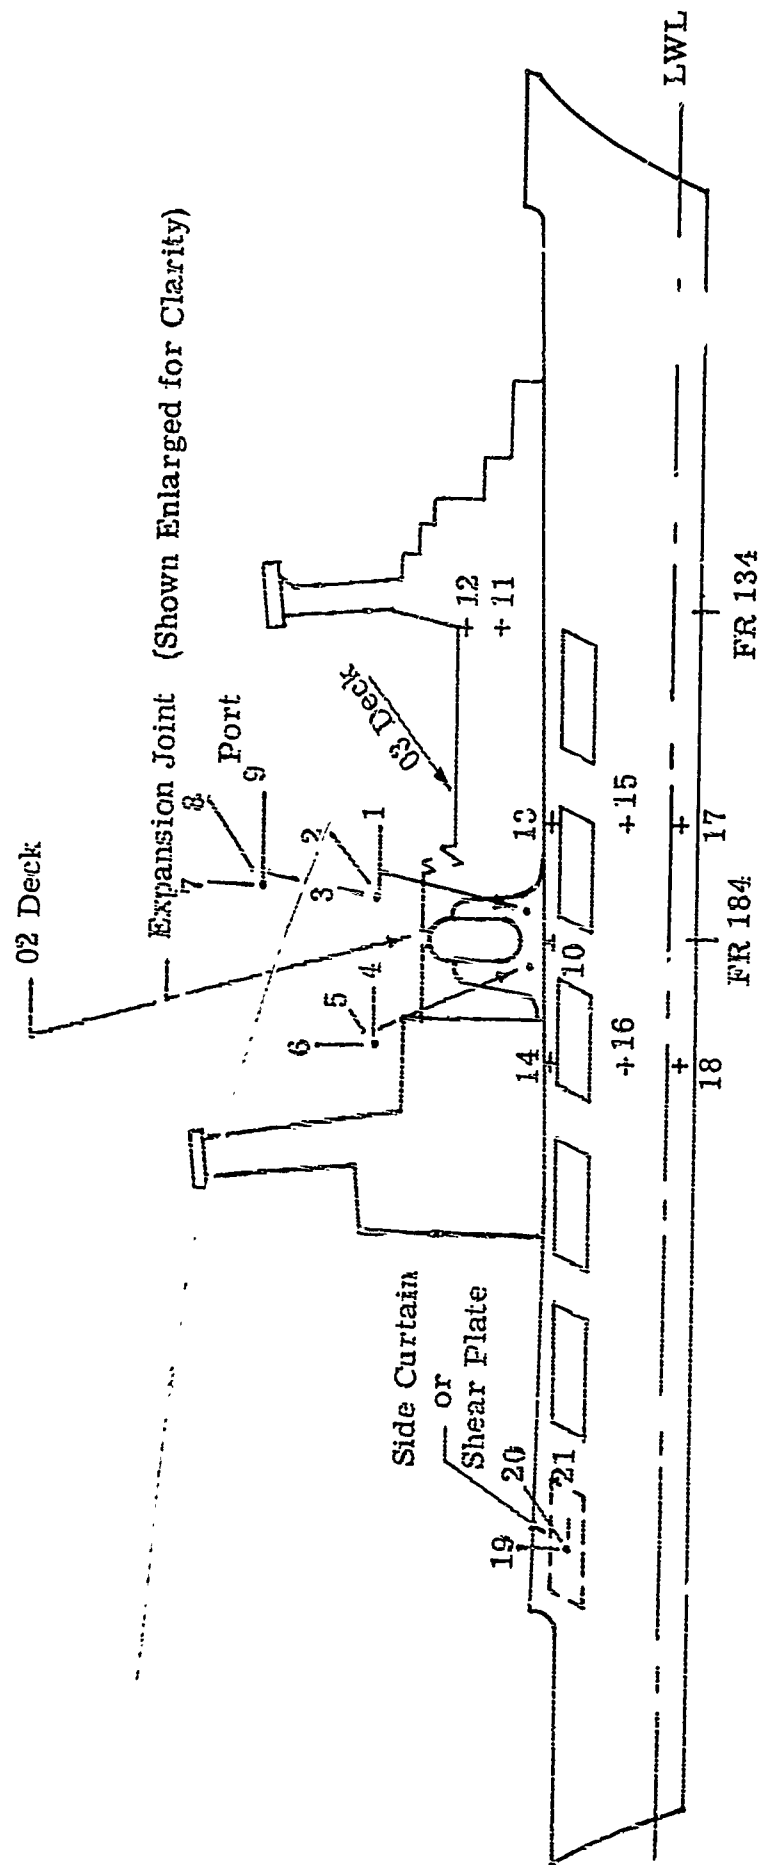
Figure 8

Due to the failure of the O1 deck plate gauges (Figure 8, gauges #13 and #14) installed ten feet fore and aft of the expansion joint hinge, it was not possible to ascertain the O1 deck plating longitudinal stresses simultaneously with the principal stresses at the hinge; however, by correlation of the data obtained in Phase II (Figure 9, gauges #3, #4, #7 and #8), it is seen that the hogging and sagging-induced longitudinal stresses in the bottom portion of the hinge plate are of the same order of magnitude as the O1 deck plating stresses just forward and aft of the expansion joint.

STRAIN GAGE LOCATIONS PHASE I
