SEAFLOOR CONSTRUCTION EXPERIMENT, SEACON I
AN INTEGRATED EVALUATION OF SEAFLOOR CONSTRUCTION
EQUIPMENT AND TECHNIQUES

CIVIL ENGINEERING LABORATORY (NAVY)

FEBRUARY 1975

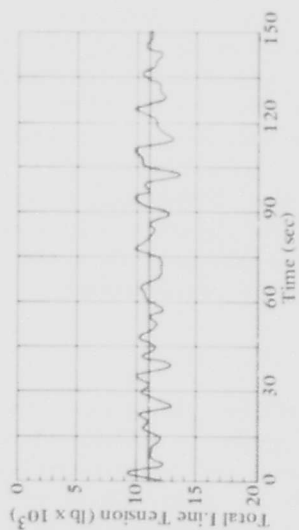
The effectiveness of the soft-spring lift system is clearly demonstrated in Figure 3.3.8. The hull was suspended 50 feet above the seafloor, near where the danger of a hard landing on the concrete foundation was of primary concern. The measured dynamic tension was only 2,000 pounds. The vertical peak-to-peak motion of the hull was estimated to be only 0.6 foot. The spring constant of the lift line was slightly lower than the design value due to the breakage of the outer braid. The nylon rope was effective in reducing tension and motion when the hull was near the foundation.

Figure 3.3.8. Record of line tension obtained when hull was suspended at 550 feet with nylon line (peak dynamic tension less than 2,500 lbs).

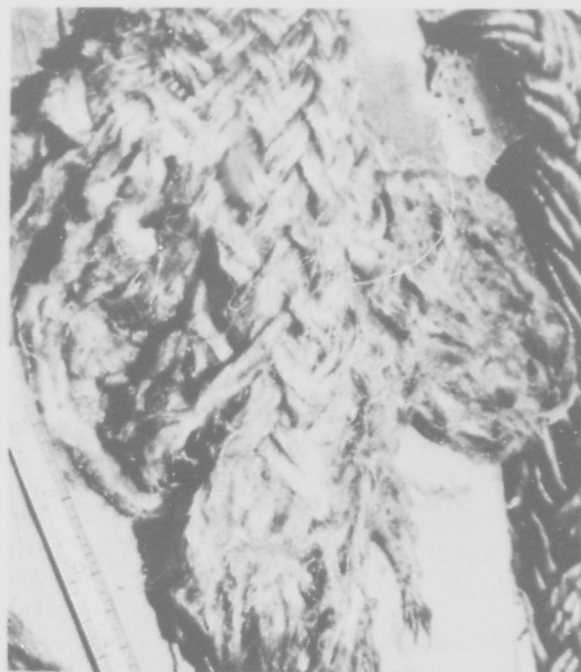
The parting of the outer braided cover (Figures 3.3.9 and 3.3.10) occurred after the SEACON I hull had been suspended under the warping tug at the 50-foot depth for about an hour. The rope was supported by a sheave 24 inches in diameter having a bell shaped groove 1-3/4 inches wide. The sheave had been hard-surfaced with chromium-nickle and this had partially chipped off. Since the lift line was a 2-inch-diameter Samson 2-in-1 braided nylon rope, the sheave groove was slightly undersized. At the time of the selection, it was expected that the rope would deform under tension to conform with the steel groove. The lift line was powered by a double-drum traction winch. Based on consultation with several specialists, the possible sources of failure are wear,

heat generation, and fatigue, but not oversteering. After the line was recovered during the hull retrieval, a visual examination was made to identify the cause of failure. Based on this visual examination, it was concluded that the line failed due to nonuniform distribution of load between the core and the outer braids. Frictional wear against the undersized sheave, and stress creep under long-term loading also contributed to the failure.

Figure 3.3.10. Lower end of parted nylon rope.

6. Specially designed load-handling equipment is recommended for safe payload ingress into the sea.
7. Prolonged suspension of a payload near the surface (50 feet) should be avoided. The handling procedure should be designed to allow the completion of most of the rigging and other mechanical and electrical connections on deck of the support platform or at the surface before the lift line is subjected to the dynamic loading.

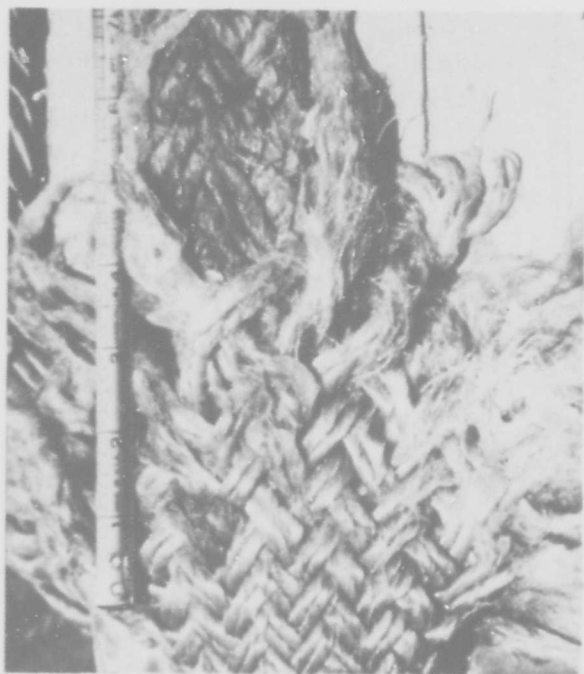
It is hypothesized that the nonuniform stress distribution between the inner and outer braids was caused by slippage between the braids. Slippage results because the lift line is reeled on/off the storage drum by a traction winch which develops line pull by friction between the traction winch drums and the

outer braid of the nylon rope. In this operation, the nylon double-braided rope was wrapped around the 36-inch double-traction drums seven times. As slippage progressed under the continual dynamic loadings, the outer braid continued to take a greater share of the load. The slippage, plus a reduction of fiber strength from mechanical abrasion of the outer braid against the metallic sheave and time-dependent effects, caused the outer braid to part after 1 hour with the hull at 50 feet.

Figure 3.3.9. Upper end of parted nylon rope showing exposed core braid.

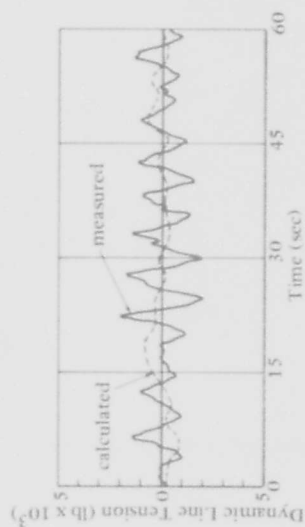
Figure 3.3.11. Comparison of calculated and measured dynamic tension showing lack of agreement due to oversimplification of dynamic model for counterweight system.

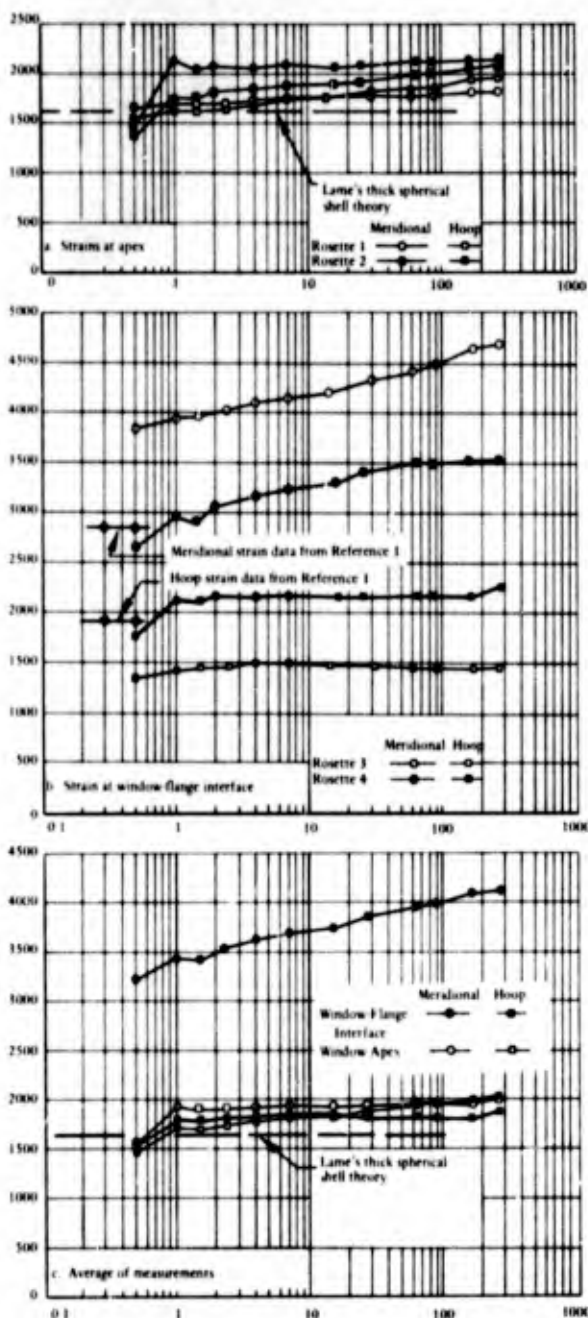
The strain data for the spherical acrylic window are presented in Figure 4.4.6. The meridional and hoop strains near the window apex, Figure 4.4.6a, agree to within 15% of the average value at a given time. The magnitude of strain computed using Lamé's thick spherical shell theory is within 27% of all the measured strains at the apex during the first days of

submergence; however, it is just 12% less than the average value of the measured strains for the same time period. The computed value was obtained using an elastic modulus equal to 450,000 psi, a Poisson's ratio equal to 0.35, and a pressure of 267 psi (depth, 600 feet). The computed strain corresponds to a stress in the acrylic equal to 1,115 psi, which is well within the material's strength capability. As shown in Figure 4.4.6c, the average meridional strain near the window-flange interface is approximately twice as great as the corresponding hoop strain, which is approximately equal to the meridional and hoop strains near the apex. Using the elastic modulus and Poisson's ratio noted previously, the strains at the interface correspond to meridional and hoop stresses equal to 2,060 psi and 1,510 psi, respectively. Similar

Figure 4.4.6. Spherical acrylic window strain data: strain versus time.

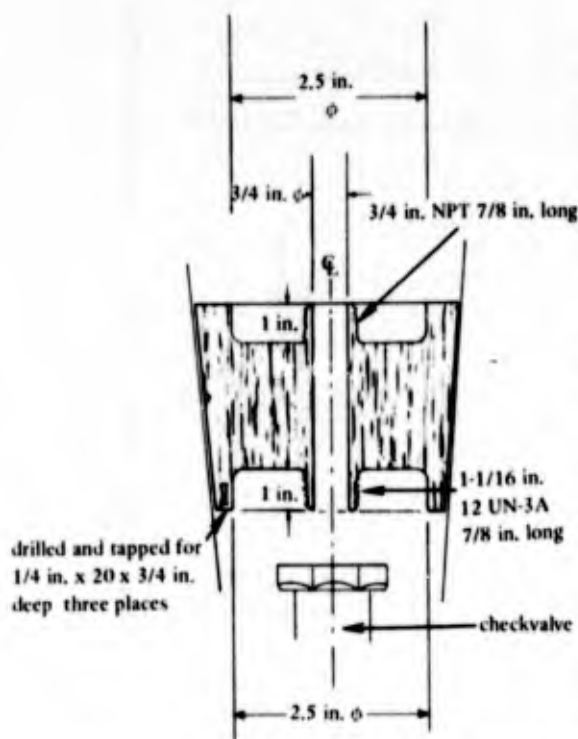
Figure 4.5.5. Modification of nickel-chromium-molybdenum alloy 625 penetrator plug.

The nickel-copper 400 alloy plug was fitted with a nickel-copper 400 alloy electrical connector. The plug-connector interface was sealed, utilizing redundant O-rings. The nickel-chromium-molybdenum alloy 625 plug was fitted with a type 316 stainless steel check valve. The valve-to-plug threads were sealed with a Teflon tape sealant. The connection between this check valve and the sump-pump tubing was made with an insulating nylon-lined fitting in order to eliminate potential galvanic corrosion between the sump-pump plumbing and the check valve/plug assembly.

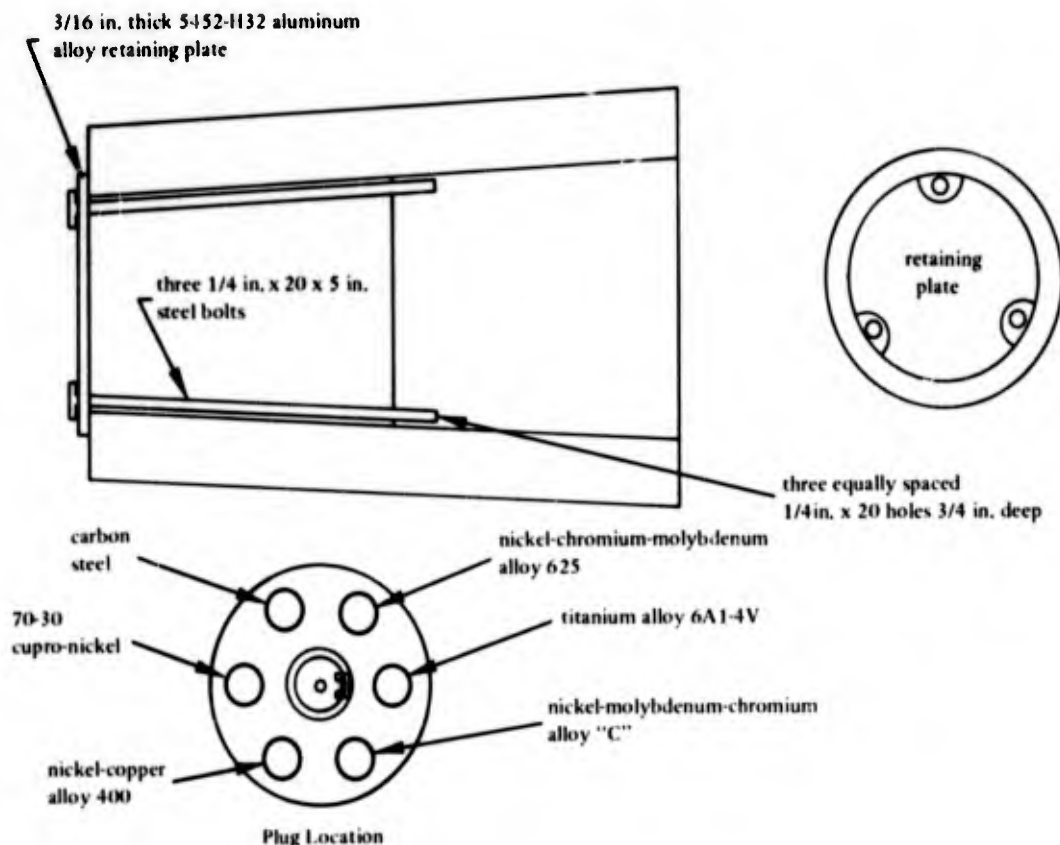
The six sleeves were installed in the concrete hemisphere in the locations shown in Figure 4.5.6, by the following procedure. The tapered holes in the hemisphere were cleaned with ethyl alcohol and dried with infrared heating lamps. The outside surfaces of the metallic sleeves were likewise cleaned and dried. A two-component furane cement was applied to the inside of a tapered hole in the concrete hemisphere in a layer approximately 3/8 inch thick. A metallic sleeve was then pressed into the tapered hole. Considerable force, applied utilizing a threaded rod and end plates, was used to pull the sleeves into the holes. As the final hull-to-sleeve clearance was approximately 1/8 inch, much cement was extruded; however, this procedure insured complete coverage of the sleeve-hull interface with cement and, therefore, a watertight joint. This procedure was repeated for each of the five remaining sleeves.

Figure 4.5.6. Retaining system for modified penetrators and location of penetrators.

5. The plug retaining systems utilized in this experiment should be redesigned utilizing corrosion-resistant materials.

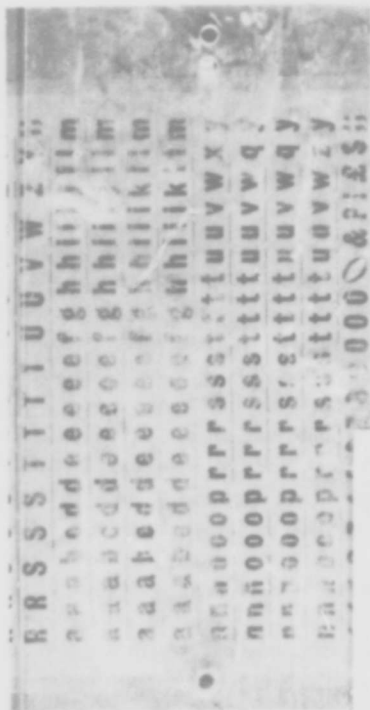
Figure 4.7.3. Acrylic (Plexiglas) panel exposed 4 months at SEACON 1 site (600 feet).

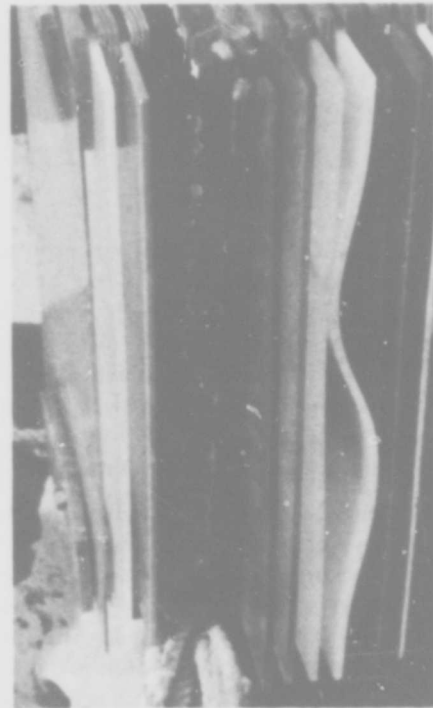
Over 20 different kinds of materials (30 individual specimens) were evaluated for fouling and biodeterioration. The general condition of some of the test specimens soon after being recovered from the sea is shown in Figure 4.7.4.

Figure 4.7.4. Test specimens after 6 months' exposure at SEACON 1 site (600 feet).

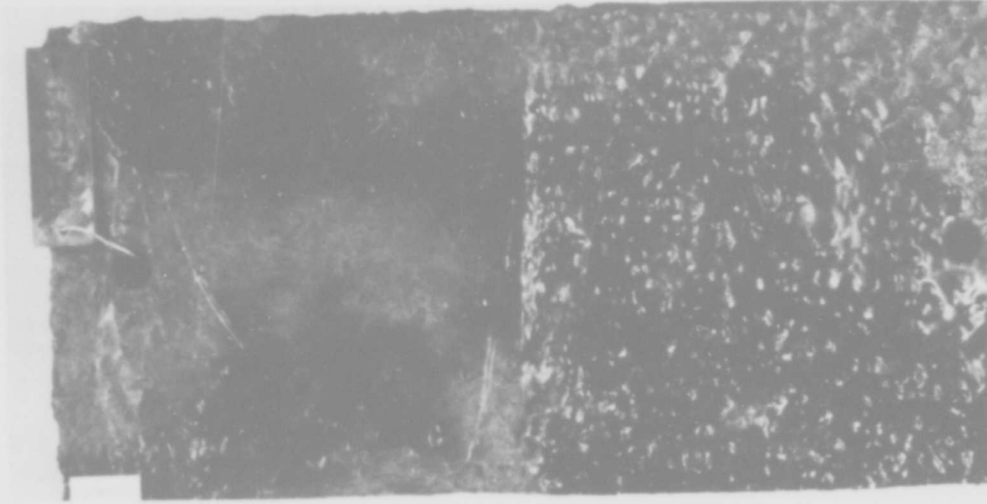
Antifouling Concrete Panels. The antifouling concrete test panels were free of fouling attachment. The surface of the treated panels became heavily coated with creosote oil shortly after recovery (Figure 4.7.5). The oil had expanded and oozed out

Figure 4.7.5. Antifouling concrete test panel after 6 months' exposure at SEACON 1 site (600 feet).

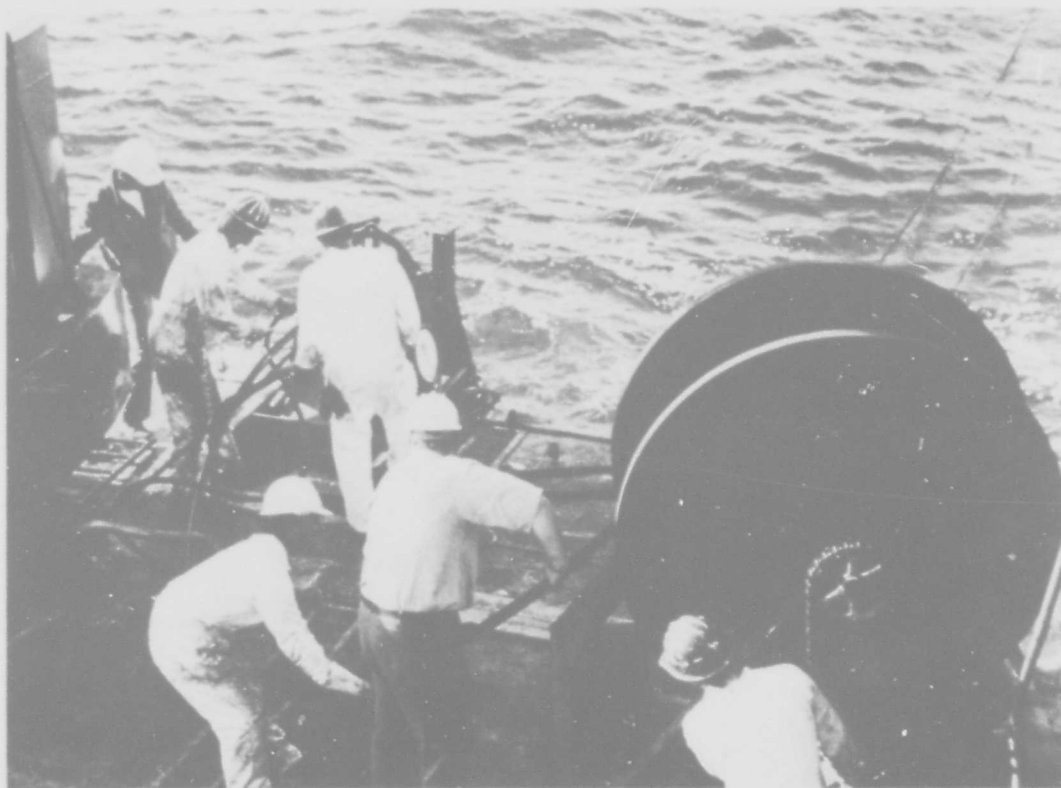
Figure 5.2.10. Cable handling during SEACON I recovery.

The cable was observed to have a light growth of hydroids and barnacles and a thin layer of fine silt over its entire length. The slipperiness of the surface, the stiffness of the cable, and the several observed punctures in the jacket all indicate that an outer cable jacket is a handicap to deck handling and also a very poor waterblock. The difficulty of cable recovery illustrated the need for an underwater disconnectable connector that would separate the cables from the structure prior to recovery.
