BOATING ACCIDENT INVESTIGATIONS 1974, FIRE AND
EXPLOSION

Report No. CG-D-119-75

BOATING ACCIDENT INVESTIGATIONS 1974

FIRE AND EXPLOSION

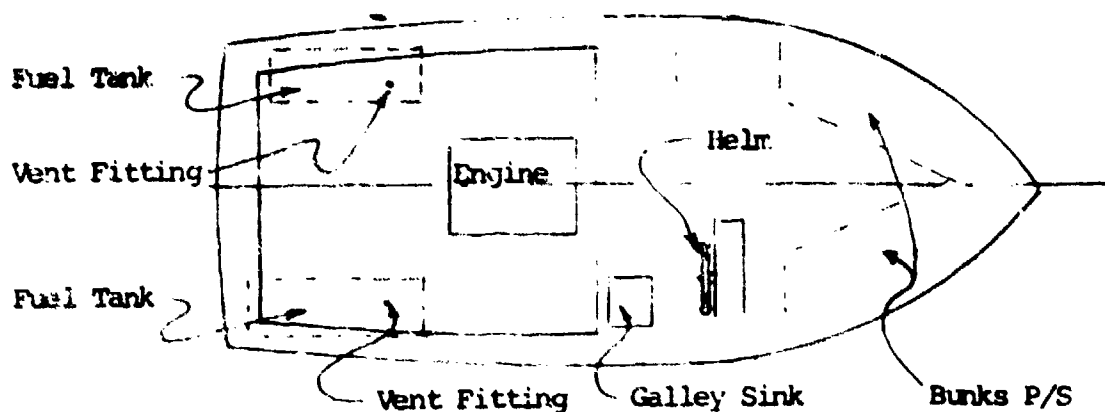
Figure No. 1

All of the facts and findings in this case tend to confirm that the source of fuel for the fire was from the missing vent plug from the port 42 gallon tank. The boat was filled until the sound indicated the fuel had reached the fill pipe. Although the exact amount is not known, the horizontal section of the fuel fill would fill up quickly and the major sound level change would occur when the fuel reached the vertical pipe. At that point the fuel would be pouring out of the missing vent opening to the bilge. The boat did not move for about 20 minutes which would allow additional fuel to be discharged due to the gradual increase in the temperature of the fuel. The fuel was delivered from an underground tank and the temperature of the engine compartment was probably about 50° C (122F) since the fresh water cooled engine would operate at about 82° C (180F).

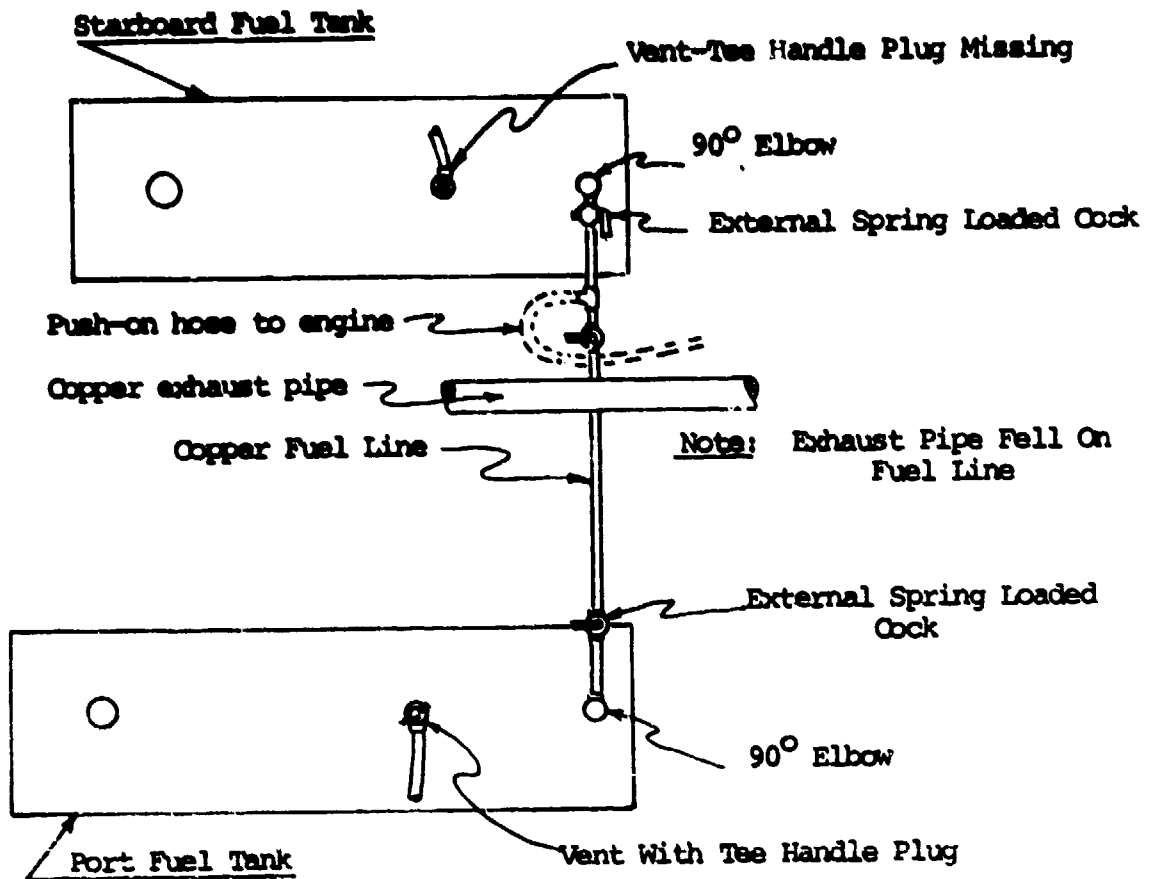
Diagram No. 1

Fuel Feed System Layout

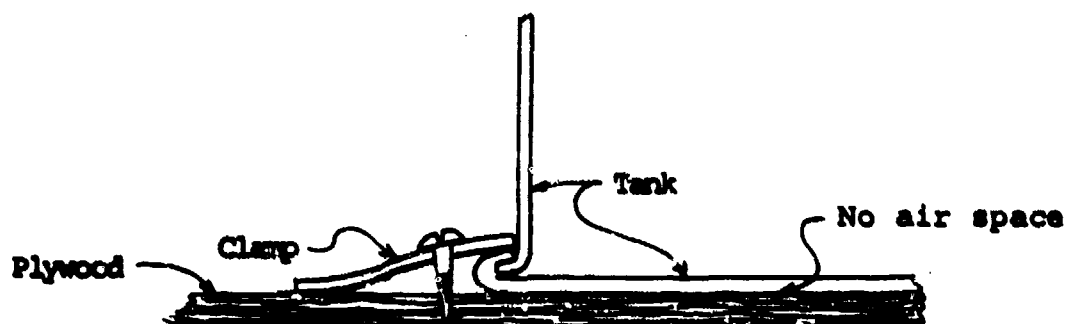
Figure No. 1

The single 18 gallon terneplate fuel tank was located outboard of the engine on the port side below the aft deck. See Photograph No. 3. The tank was set on a flat surface and secured by a metal strip that clamped the tank flange. See Figure No. 1.

- (1) The fuel tank was installed on a flat plywood surface providing no air circulation under the bottom surface. The installation did result in some overall accelerated corrosion of the bottom surface. See Figure No. 1.
- (2) The fixed fuel line was not supported at the point of connection to the flexible fuel line. This condition will result in an increase in the vibration amplitude reaching the fixed fuel line rather than a decrease as intended. See Photograph No. 4.
- (3) The fixed fuel line between the tank and engine was inadequately supported.

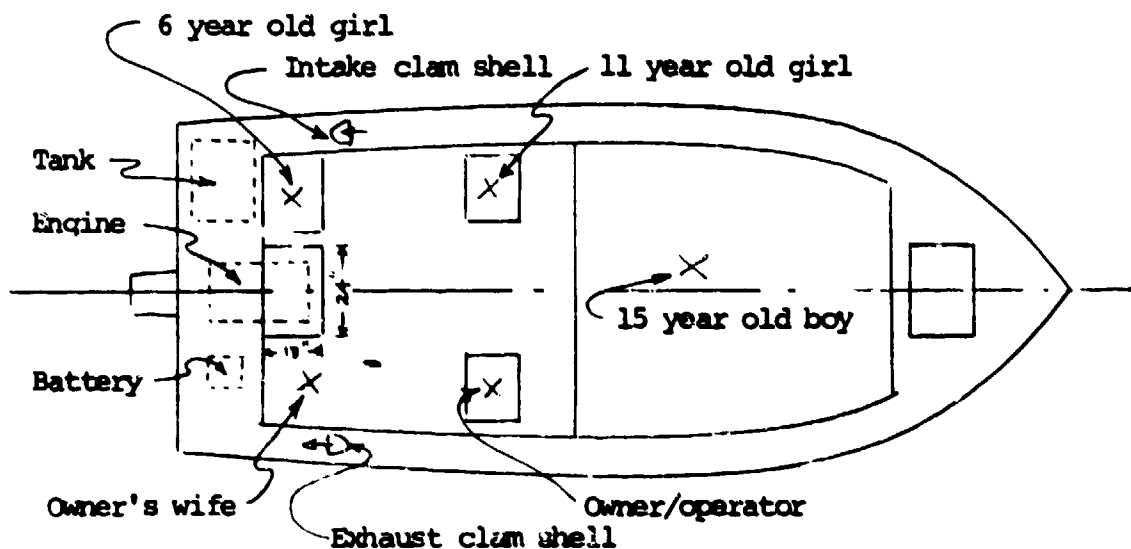
Diagram No. 1

The boat has a 4 cylinder in-line Mercruiser inboard engine with an inboard/outdrive propulsion unit. The engine was located aft at the transom. The aft deck is hinged at the transom and the engine box is hinged at the forward edge. The hinged deck aft is 24 inches deep and the engine box extends into the cockpit approximately 13 inches. The latter is 24 inches wide. See Diagram No. 1.

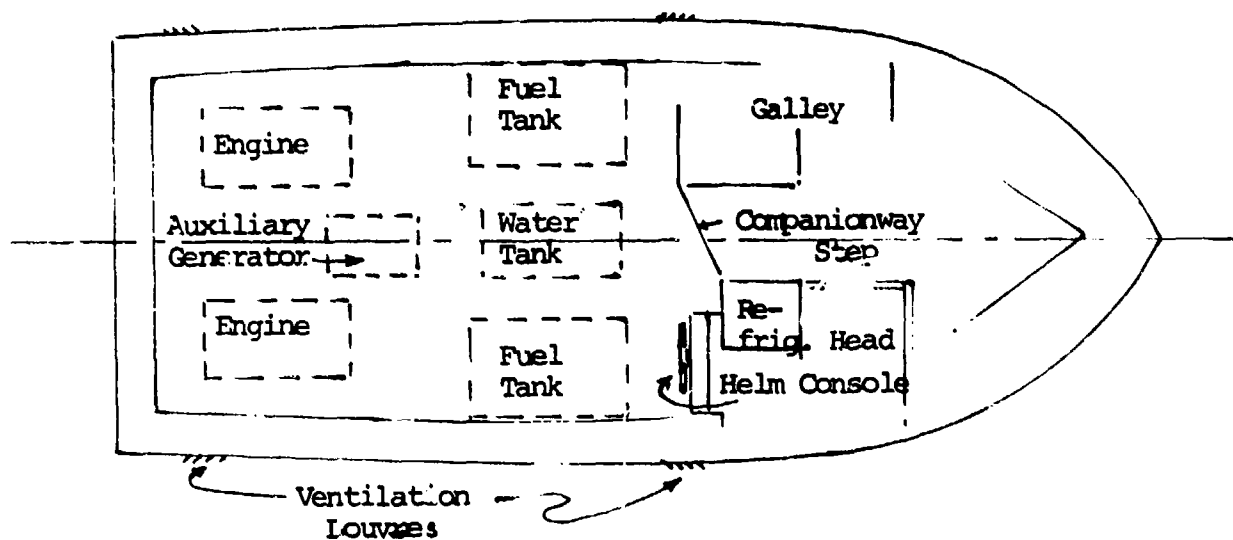
FIGURE NC. 1

The boat layout included an open cockpit aft approximately 8 feet long, a salon cabin and wheelhouse approximately 9 feet long and a forward cabin with a head, galley and sleeping accommodations. The head was on the starboard side and a large refrigerator was located between the head and helm console at the companionway step. See Figure No. 1 and Photograph No. 7.

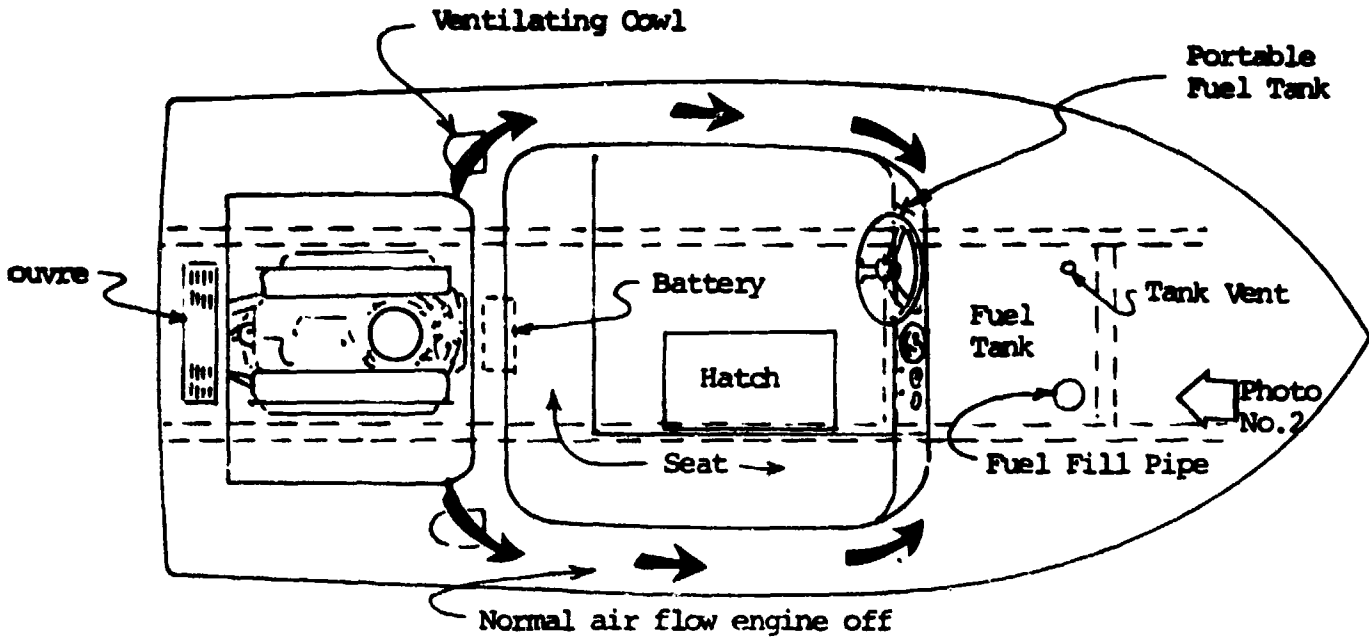
FIGURE 1

The boat had a conventional speedboat layout, with a midship cockpit, bow deck and engine compartment aft. See Photograph No. 1. The 1/0 engine was below the aft deck with a large flush engine hatch. The hatch was hinged at the aft end and latched at the forward edge. The engine space was inter-connected to the fuel tank space by openings between the cockpit ceiling and hull. Limber holes in the engine space bulkhead and the floors would permit the free flow of bilge water between the engine and fuel tank space. See Figure No. 1.

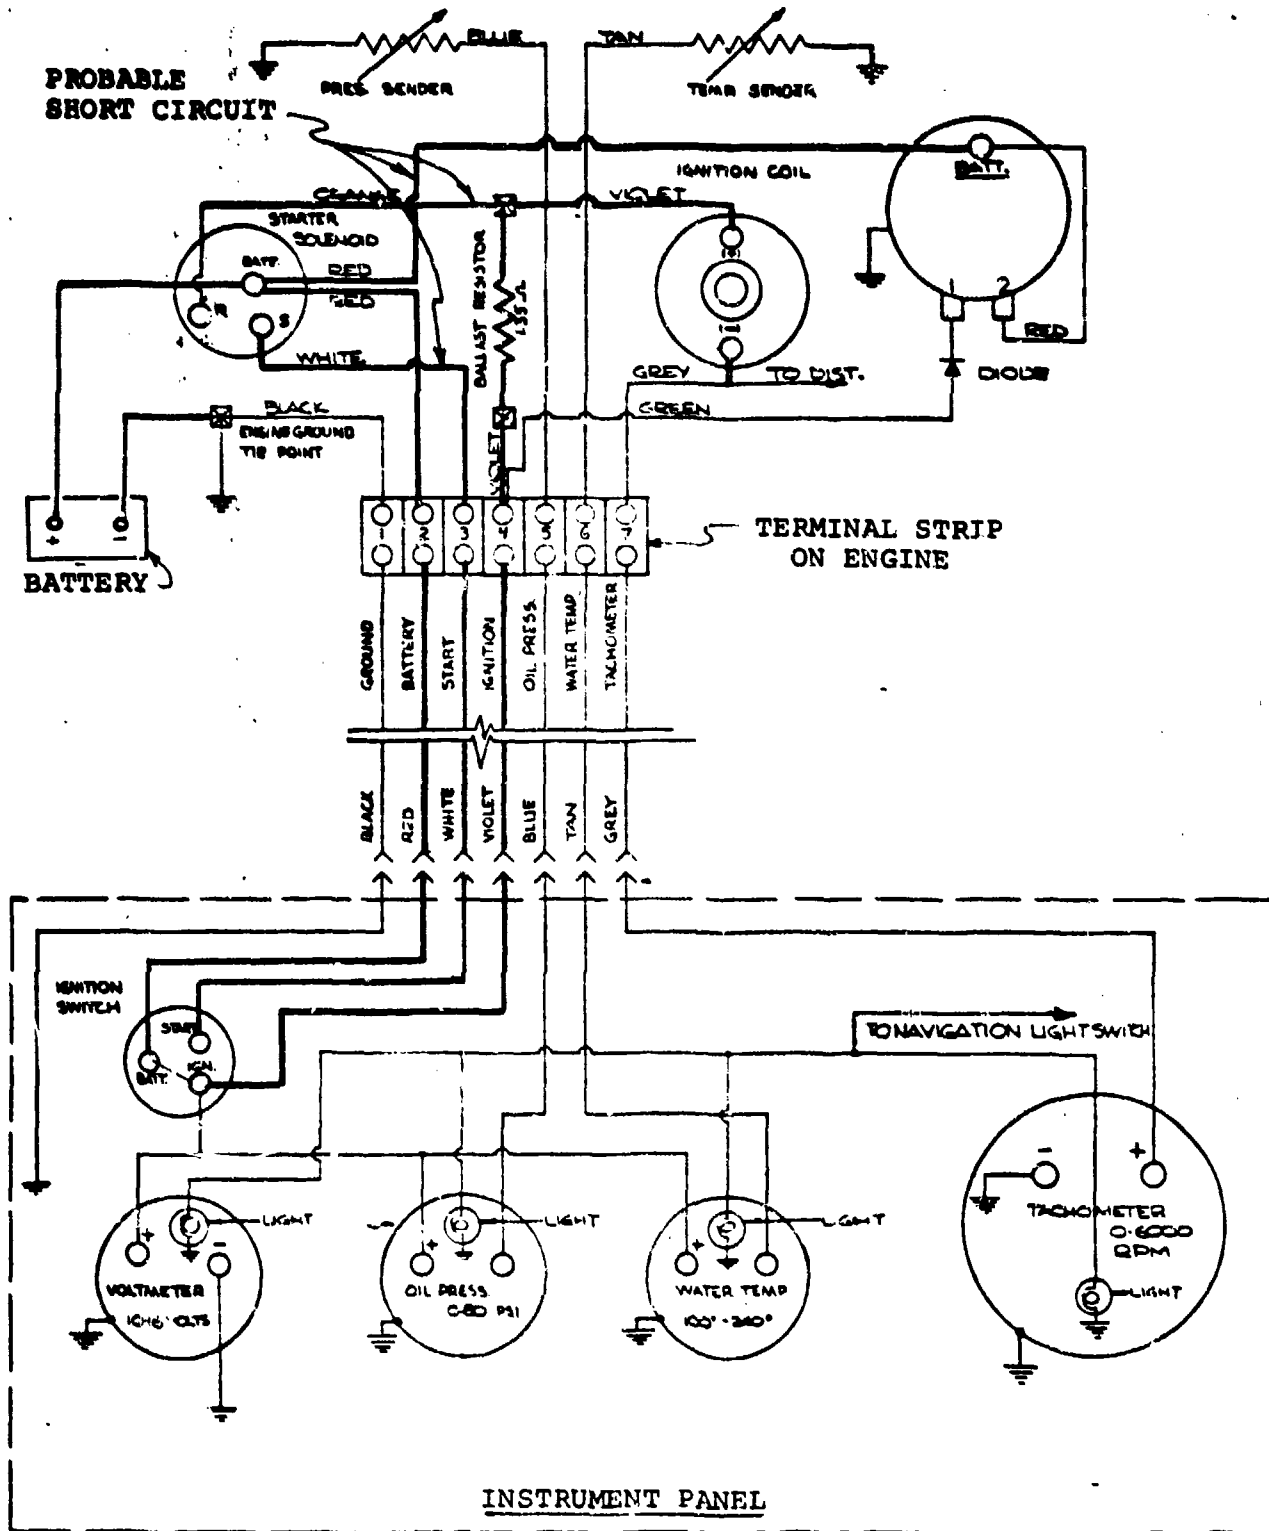
FIGURE 2

- (a) Master Battery Switch - The boat was not equipped with a master battery switch. Since the boat operator shut off the fuel valve almost immediately, it is quite probable that he would also have shut off a master switch if one had been provided. The master switch might have prevented the electrical fire behind the instrument panel.
- (b) Overcurrent Protection - The engine wiring was such that there were several unprotected wires. The power lead from the starter solenoid to the ignition switch and panel was unprotected. A short circuit in the ignition, alternator or the starter solenoid circuit could result in a dead short that could ignite the electrical harness from the engine compartment to the instrument panel. See Figure No. 2.
