EXPLOSIVE TESTS OF BLAST CELL,
NAVAL TORPEDO STATION, BANGOR ANNEX

J. M. Ferritto

Technical Report

R 823

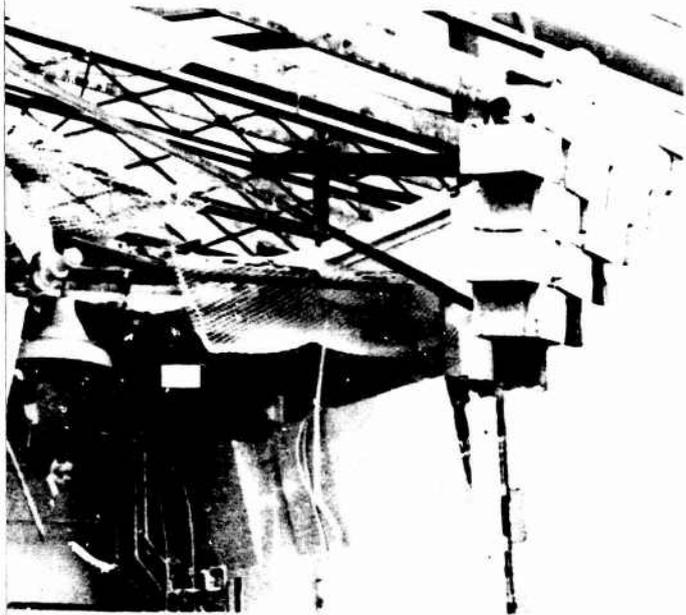
Figure 7 (cont).

View of interior of cell 3.

Exterior of cell 2.

Debris net in cell 3.

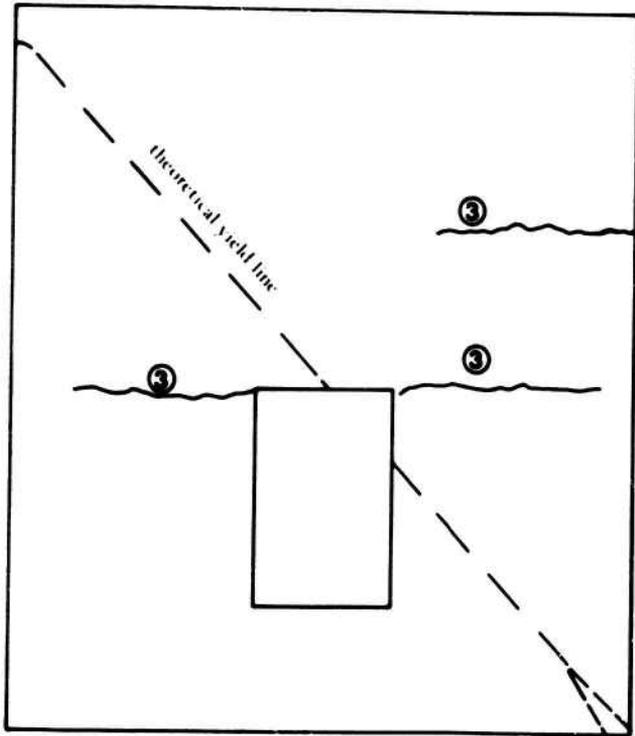
Right Sidewall

Permanent deflections of the sidewalls were measured to be about 3/16 inch outward. No permanent deflection could be measured in the blast door or passthrough door. Window breakage is shown in Figure 9. Figure 10 shows the crack pattern observed in the blast cell walls. The numbers correspond to shot numbers. No evidence was observed of shear failure of the door frame.

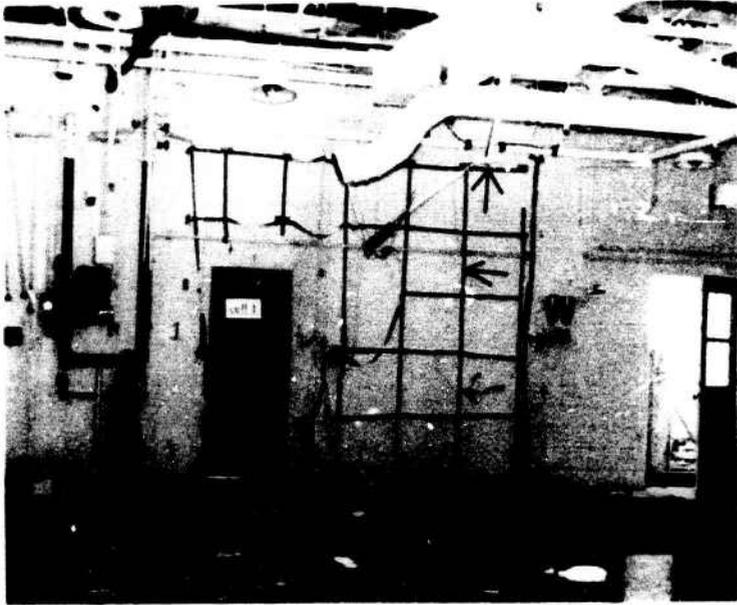
Figure 12. Observed damage after shot 3.

Interior of building.

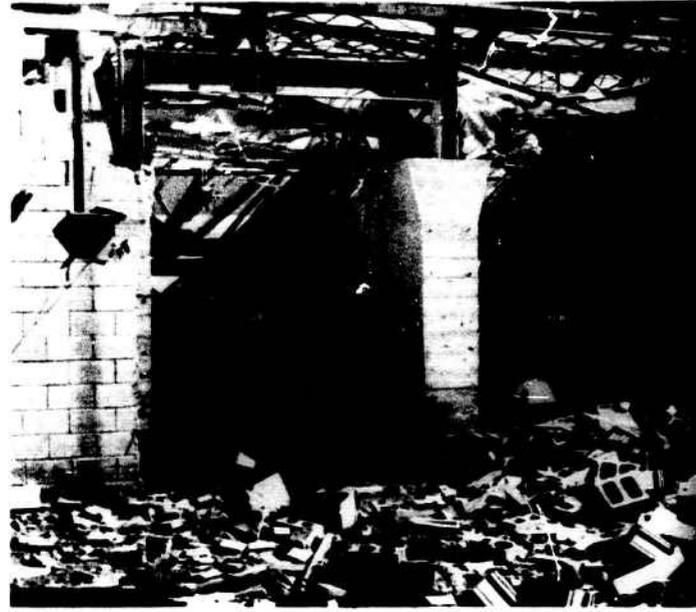
Shot 4 - 10 Pounds, Cell 1. The fourth shot duplicated the position of shot 2. This shot caused additional roof and ceiling damage. Figure 13 shows photographs after the shot. Additional cell-wall cracking is shown in Figure 10.

Figure 13. Observed damage after shot 4.

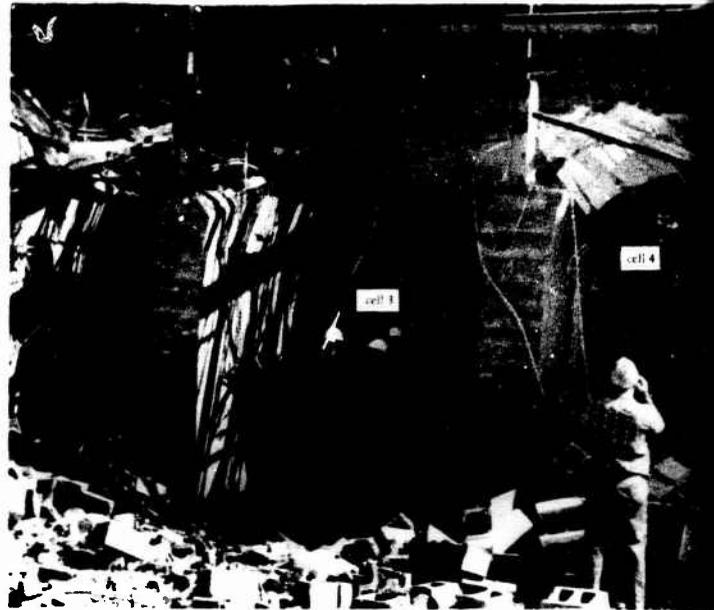
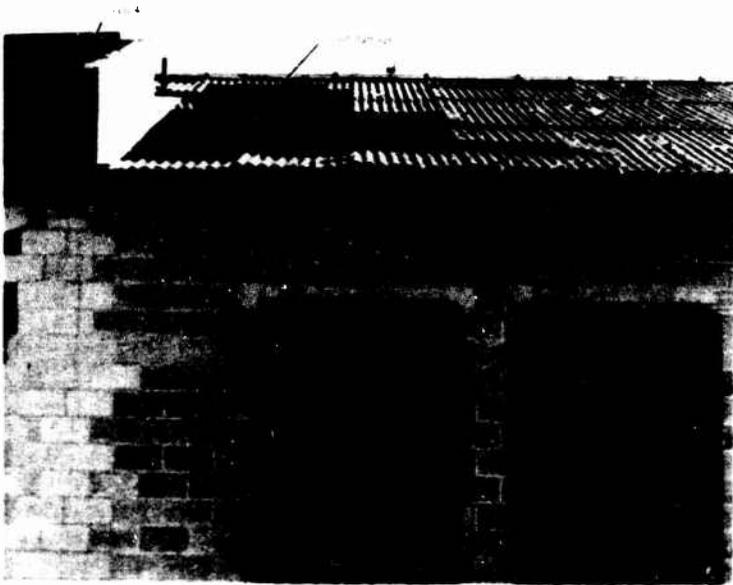
Shot 7—20 Pounds, Cell 3. This was the second shot of 20 pounds in cell 3. The charge was positioned 2 feet from the backwall and 2 feet from the sidewall between cells 3 and 2. Some roofing in the middle bay was blown in. Portions of roofing cracked by earlier shots failed. Additional ceiling was blown down; however, most of the roof on the leeward side of the building (east side) was still in place. The blast cell sidewalls had an additional permanent deflection of about 5/32-inch. The passthrough door in the backwall rebounded off its supports. This 2-by-3-foot, 1-inch-thick steel plate has a permanent deformation of 1 inch at its center. The blast door was still operable with no measurable permanent deflection. The rebound supports failed. Figure 17 shows photographs after the shot.

Debris net cell 4.

Exterior cells 3 and 4.

Exterior structure looking east.

Figure 17. Observed damage after shot 7.

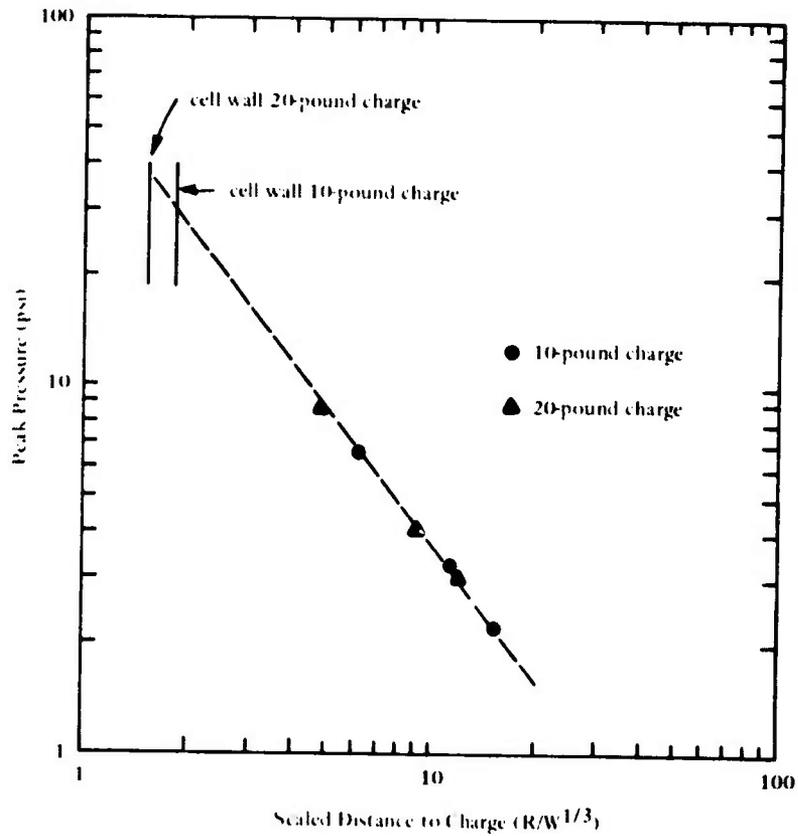
Figure 19. Pressure/distance for leakage pressure around door.

Data was reduced and peak pressures obtained. Figures 18 and 19 give the peak pressure on the floor from an average of the 10- and 20-pound tests. This pressure was caused by leakage around the blast door. It is of a high enough level to cause injury. Figure 20 gives the pressure at the ceiling level. Figure 21 gives the pressure on the roof. As noted in Figures 20 and 21, the pressure immediately behind the back wall of the blast cell is higher when the roof is in place over the cell. This is understandable in that the frangible roof remains intact long enough to deflect the pressure wave downward. This would not occur if the roof were not there. Figure 22 shows this, if a roof over the cell does not exist, the shock wave will travel upward, leaving a low-pressure area immediately behind the cell.
