3000-HP ROLLER GEAR TRANSMISSION DEVELOPMENT PROGRAM.
VOLUME V AIRCRAFT TIEDOWN TESTING

3000-HP ROLLER GEAR TRANSMISSION DEVELOPMENT PROGRAM
Volume V - Aircraft Tiedown Testing

Sikorsky Aircraft
Division of United Technologies Corporation
Stratford, Conn. 06602

Final Report

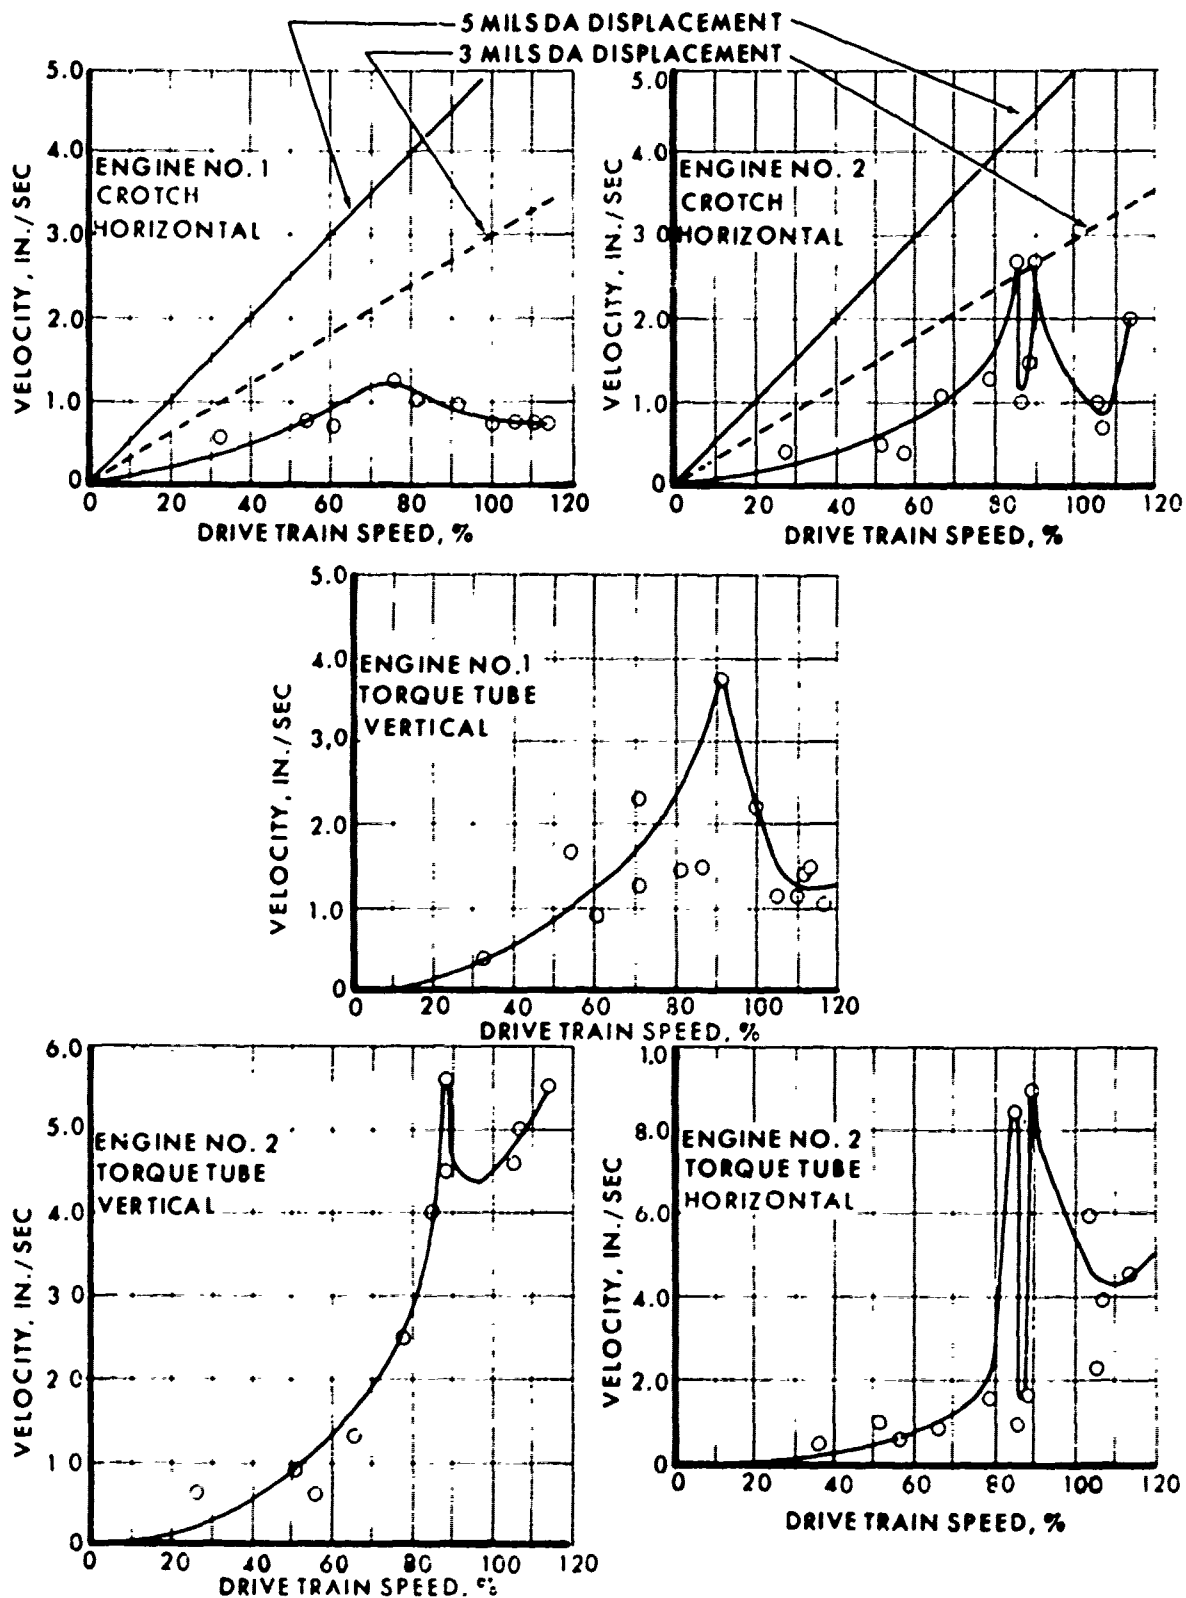
Figure 43. Engine Vibration Graphs

The vibration pickups located on the engine torque tube are not engine pickups and are therefore not subject to the G. E. limits. Plots for these pickups are presented in the graphs of Figure 43, where some evidence of a resonance is seen at 90 percent rotor speed. No limits have been determined for these locations; however, the vibration levels observed there may have contributed to the gimbal mount deterioration. Since these resonances are below normal operating speed and are not divergent, no safety problem is involved.

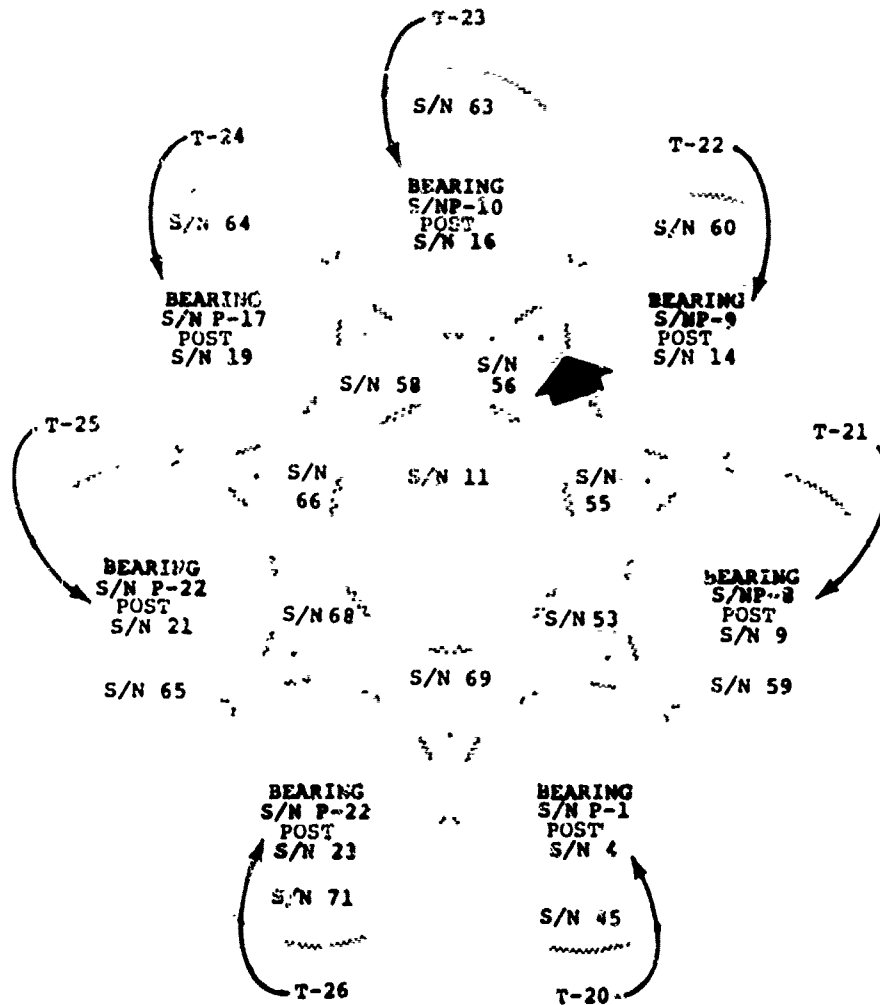
Figure 47. Roller Gear Assembly

Visual inspection of the roller gear components revealed slight surface distress on the lower small-diameter rollers of first-row pinions serial numbers 55 and 56 (Figure 46). As seen from Figure 47, which shows the assembled location of the roller gear components, the identity of the bearings and post within the second-row gear and the appropriate thermocouple (T number), the second-row gear, serial number 60, mated with these pinions. The second-row gear rollers showed only faint markings due to the rolling action with these pinions. Examination of the first-row pinion distressed area revealed a frosted surface approximately 0.12 inch wide around the circumference. This area started on the roller surface where the crown relief of the second-row roller commenced.

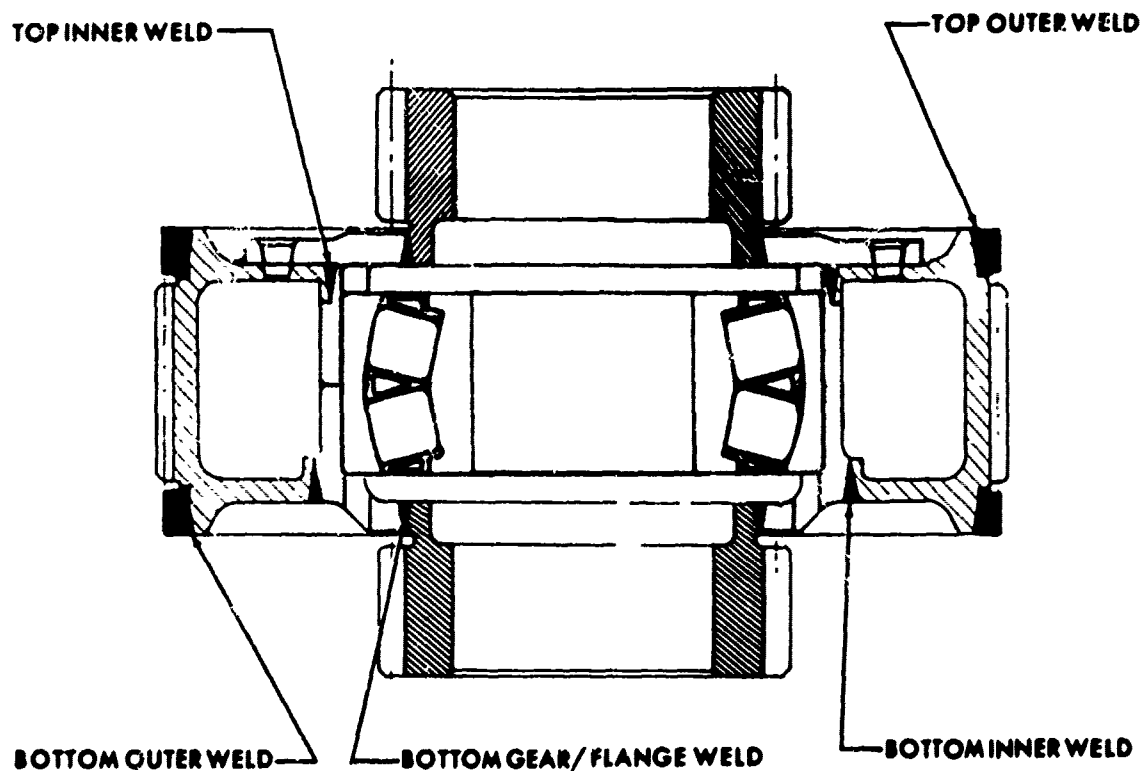
Figure 50. Electron-Beam-Weld Locations, Second-Row Gear

Prior to the start of the 50-hour tiedown test, ultrasonic inspection was performed on the electron beam welds of the roller gear components, and facsimile recordings C-scans were obtained. At the completion of the 50-hour test, this inspection was repeated, and the C-scans were compared to determine if any degradation had accrued in the weld. It was found that none had occurred in the welds in the sun gear and the first-row pinion welds; however, the outer roller welds in the second-row gears, identified in Figure 50, did show indications of crack propagation at the root of the weld. Figures 51 and 52 show the ultrasonic inspection methods whereby the degradation of the welds was discovered.

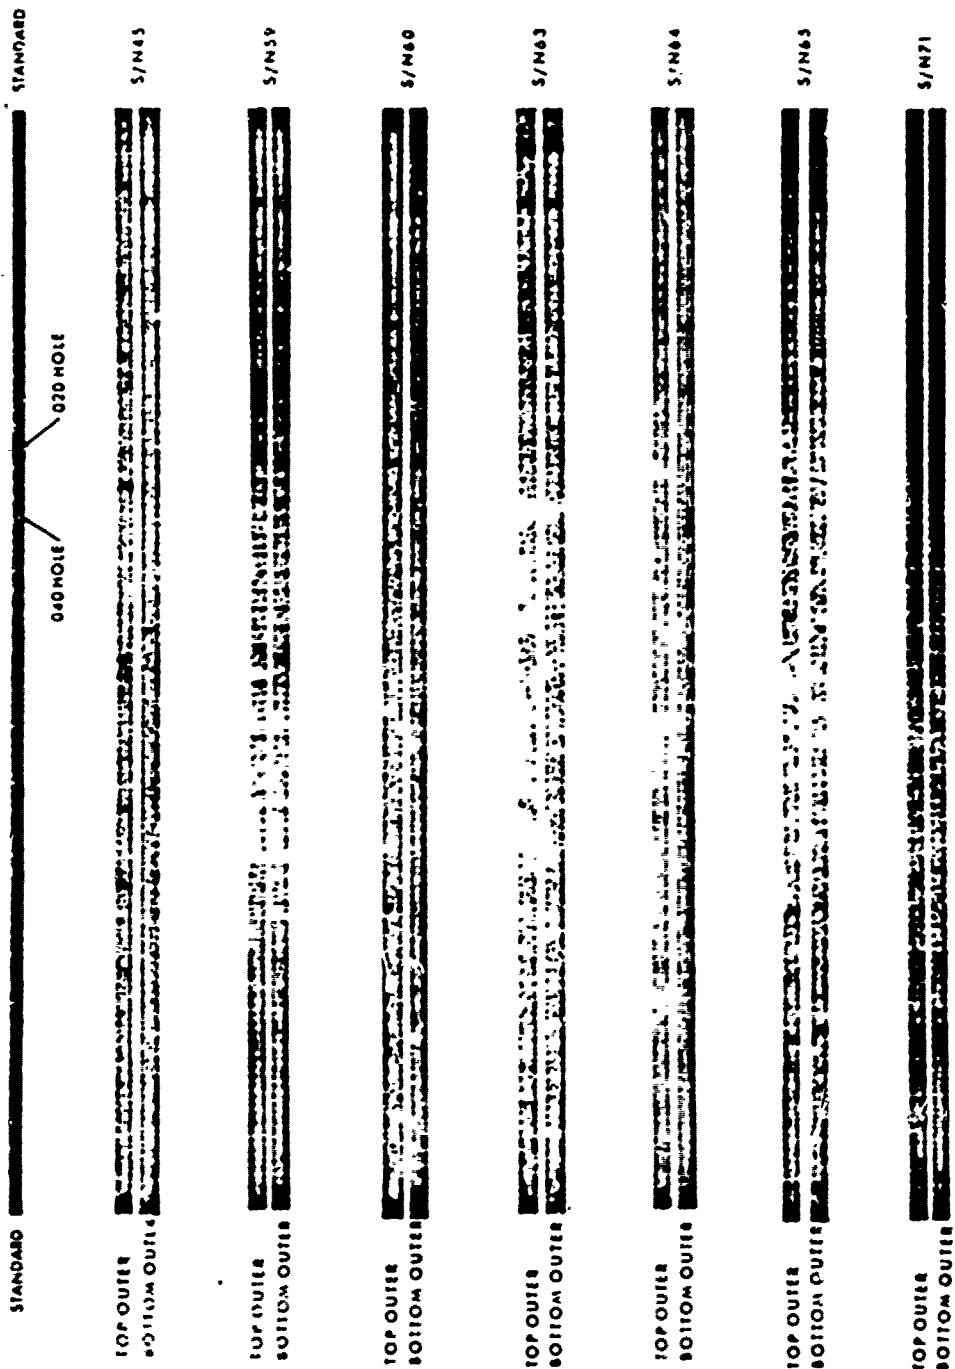
Figure 53. Ultrasonic Inspection C-scans, Second-row Gear Prior to Test

Figures 53 and 54 depict the C-scans of the second-row gear roller welds before and after testing. The degradation can be seen in the lower roller welds of serial numbers 45, 59, 60, 63, 65 and 71. Also, slight degradation is visible in the upper roller welds of serial numbers 59 and 65. The C-scans are recorded on an 8.0-inch-diameter drum; the weld diameter is 9.03 inches. Thus, the indication depicted on the C-scans is slightly smaller than the actual crack in the part. To determine the nature and cause of the indication, the lower roller of second-row gear serial number 63 was partially removed to reveal a fractured zone 1.0 inch long by 0.22 inch wide. Figure 55 shows the fractured zone which was revealed by locating the zone from the C-scan and machining the case-hardened roller with a solid carbide endmill.

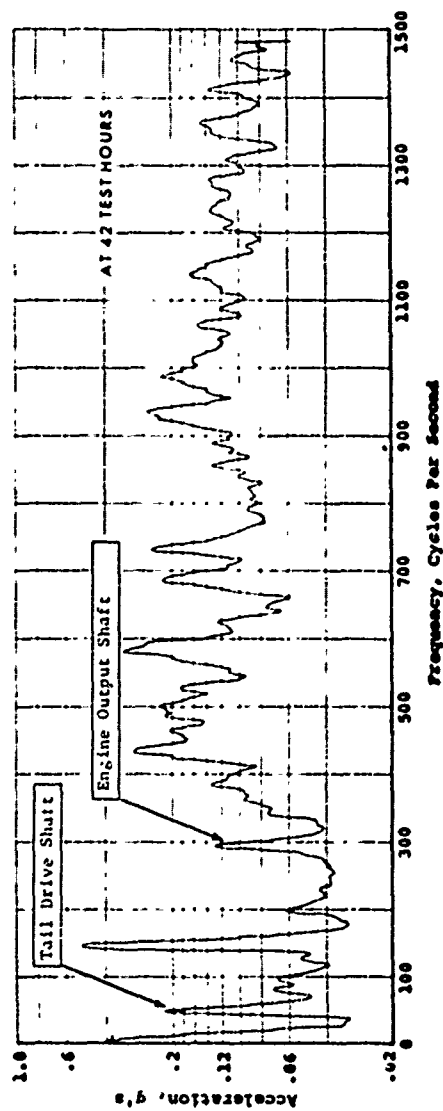
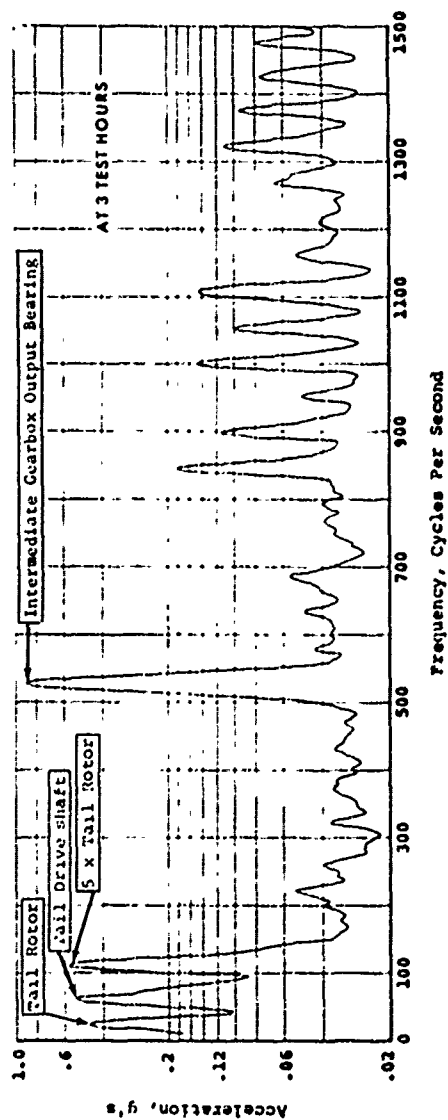
Figure 56. Vibration Spectrum, Intermediate Gearbox

The overall maximum vibration levels for the two vibration pickups on the tail gearbox and the intermediate gearbox (as presented in Table 23) were higher than expected, and since vibration monitoring was being considered as a possible failure detection method, an investigation was conducted into the characteristics of the vibrations. The vibration signals were subjected to a spectrum analysis, and the resulting plots are shown in Figures 56 and 57. The identifiable frequencies of interest are labeled in these figures. Intermediate gearbox spectrums were obtained early in the program and near the end, Figure 56. The plots show that a change occurred in both the character and the amplitude of the vibration as the test progressed. This change was also observed on oscillograph records as a change in waveform. No firm explanation for the change is offered since little experience has been gained in the measurement of gearbox spectrums on an operating helicopter, and none at all on grease-lubricated gearboxes. It is apparent that further work is required before vibration measurement and analysis may be used as a failure detection method. The spectrums presented here could be interpreted as indicating a deterioration of the intermediate gearbox, while in fact the posttest inspection showed no discrepancy or indication of significant deterioration.

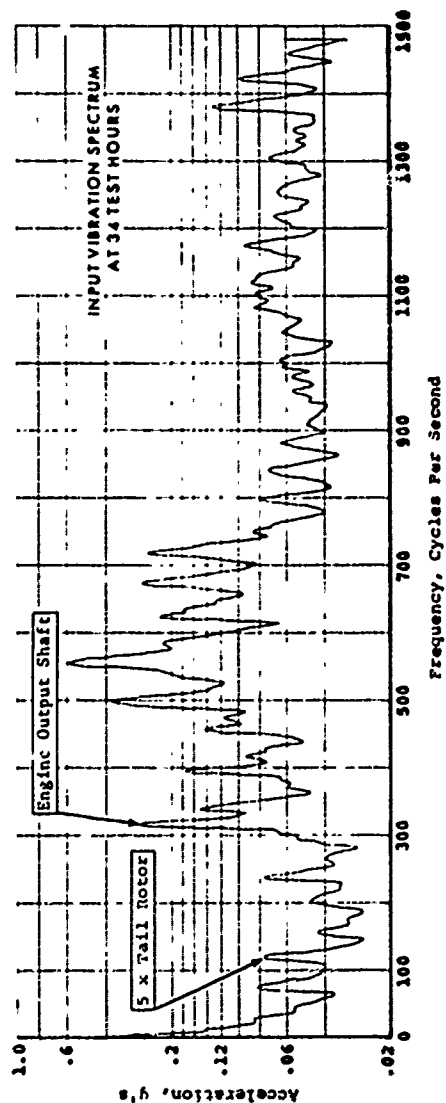
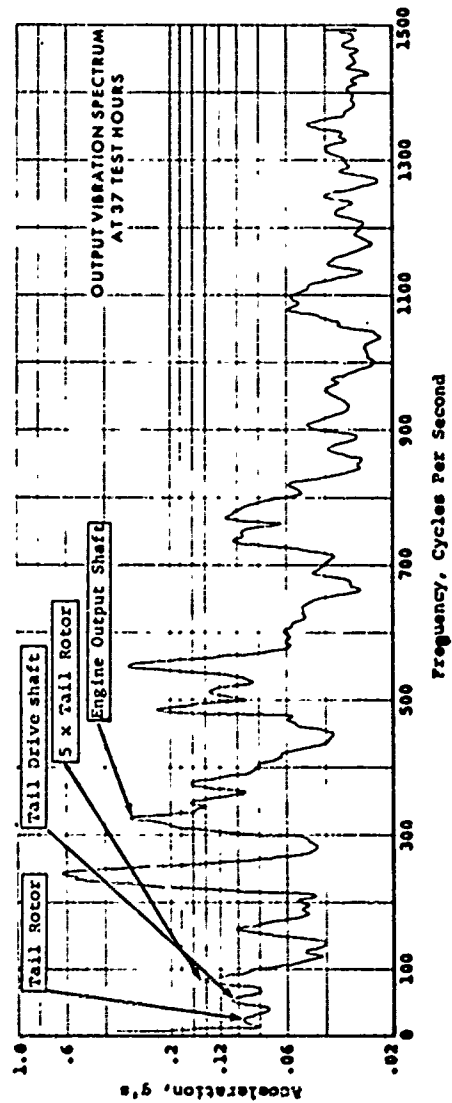
Figure 57. Vibration Spectrum, Tail Rotor Gearbox

Spectrums for the two pickups on the tail gearbox are shown for reference in Figure 57. These spectrums were taken only once during the test. Oscillograph records again showed some variation in the amplitude and character of the waveforms from the tail gearbox pickups which did not appear to be dependent on test time.
