## LOW FRICTION HULL COATINGS FOR ICEBREAKERS

PHASE II, PARTS I AND II

TECHNICAL REPORT

S.J. Calabrese, M.B. Peterson and F.F. Ling

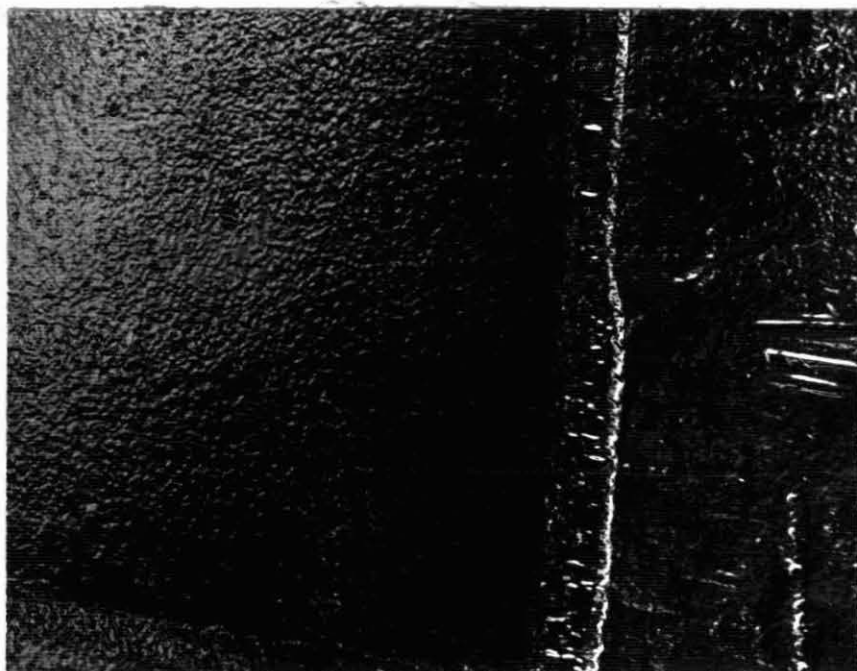
Figure II-7 Photograph Showing the Difference in Surface Roughness of Plate, Weld and Keel Sections of the Bow of the Cutter Sauk

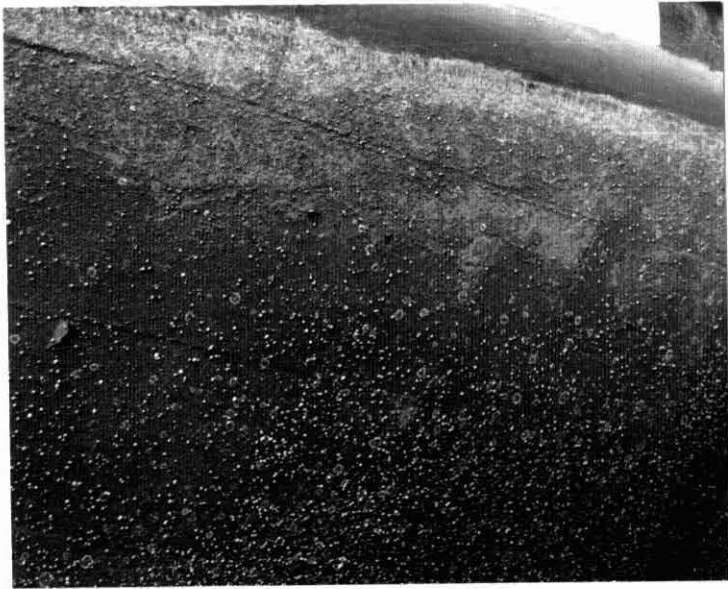
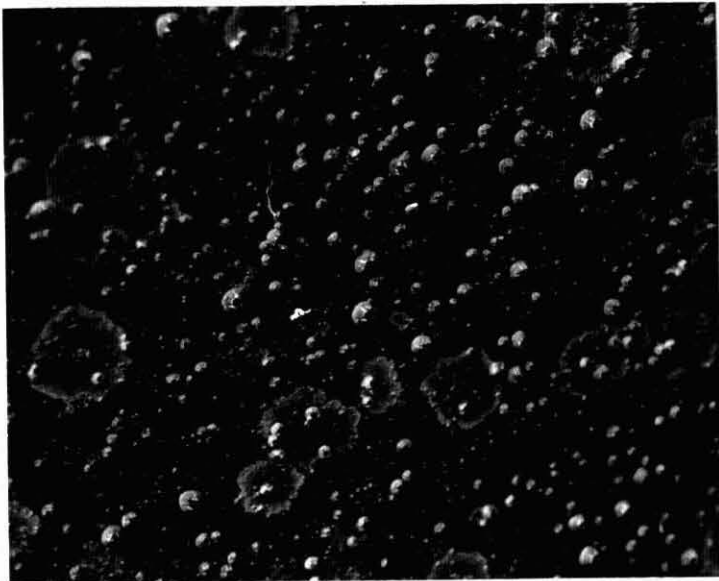
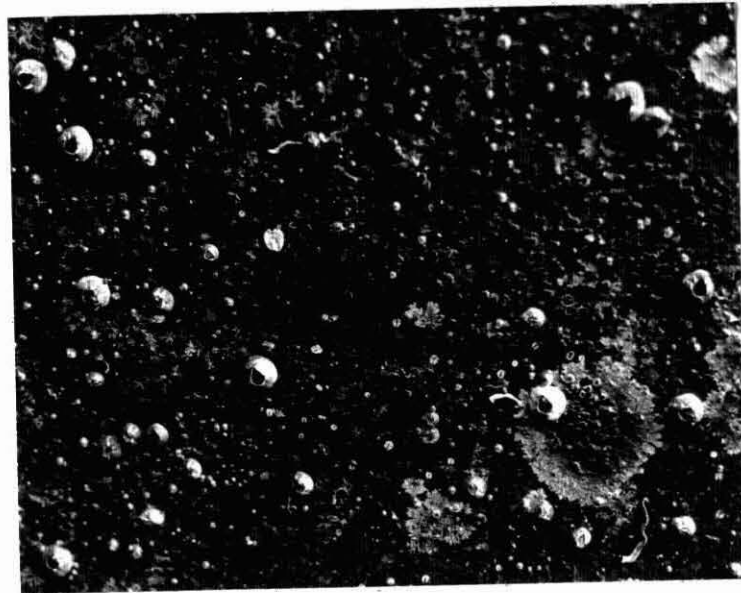
During the season the ship had logged 40.25 hours of icebreaking. It had broken both hard ice and the "pack ice" which is the small granules of ice particles compacted together. According to the information obtained on the ship, the hard solid ice appeared to present little problem with the coating.

Figure II-8 Hull Surface of the USCG Cutter Sauk after One Year of Icebreaking Service.

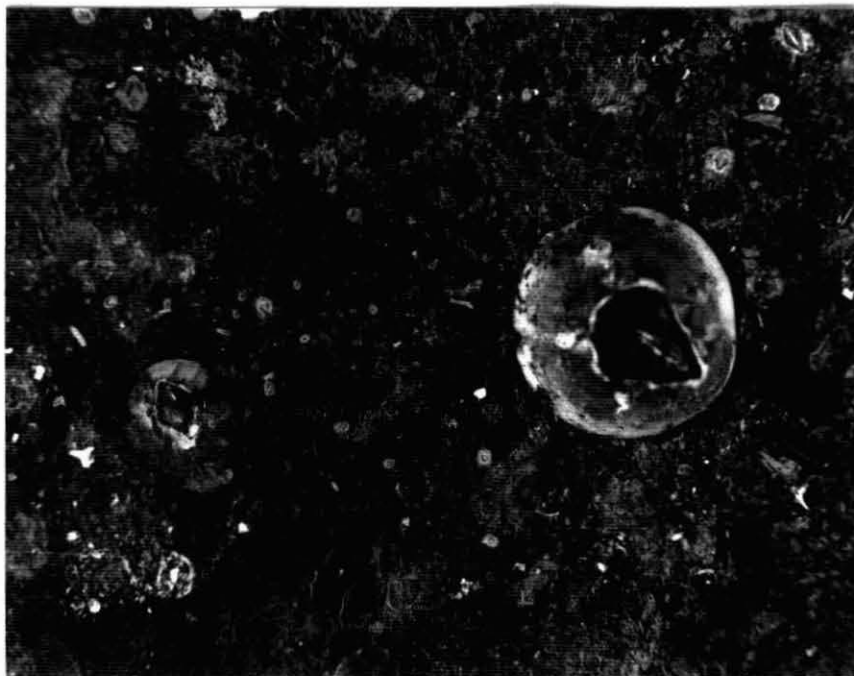
a.

One portion of the coating was removed and returned to RPI for close examination. Photomicrographs of the surface are seen in Figures II-9 and II-10. Figure II-9a shows the typical surface appearance as seen coming out of the water. Figure II-9b shows the same area with the larger barnacles removed. The white material in the center is the adhesive which the barnicle uses to attach itself to the coating. This material can be easily removed with water. Figure II-10a shows a portion of the coating as it appears on the ship (left) and a portion of the coating which was cleaned with water. Note all of the material was easily removed except for the slight discoloration where the growth had been. It should be stressed that the only fluid used for removal was water. Figure II-10b shows the same area with the large barnicle removed. Table II-6 shows a comparison of the coating properties before and after service.

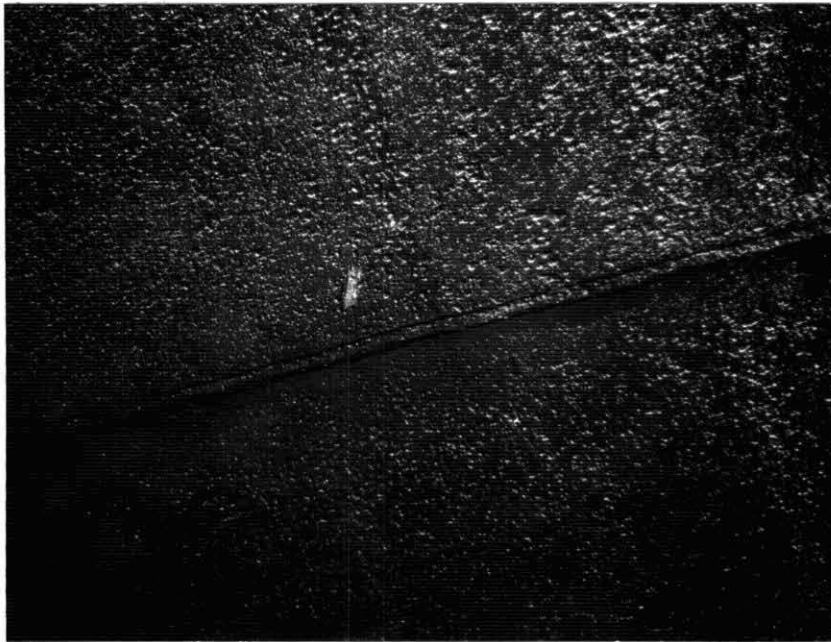
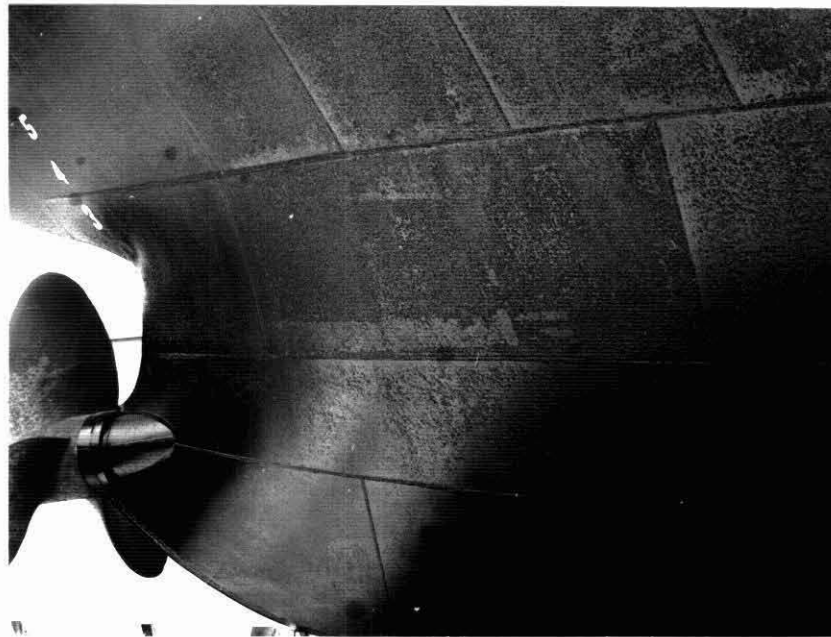
Figure II-14 Surface of Hull of Cutter Mackinaw after Application of the Elastomeric System to the Port Side. Note very heavy pitting on the hull plating.

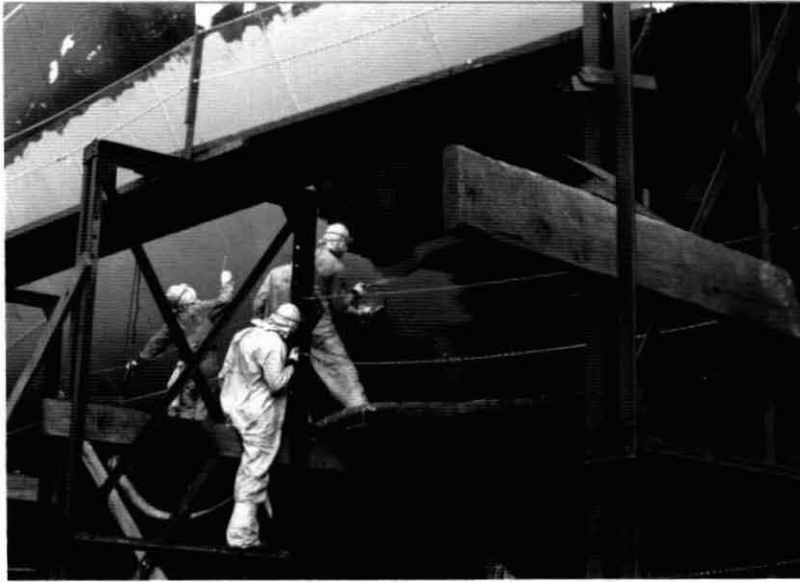
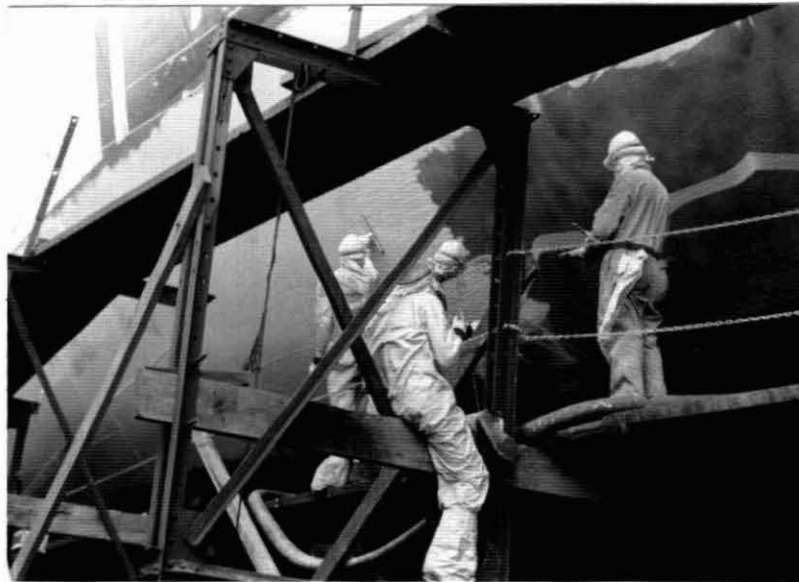
Figure II-16 Photographs Showing the Application of the First Coat of Nonsolvented Polyurethane. This coating was applied and then squeegeed down to fill the pits on the hull of the ship. Subsequent coatings were applied to build up the coating and obtain coverage.

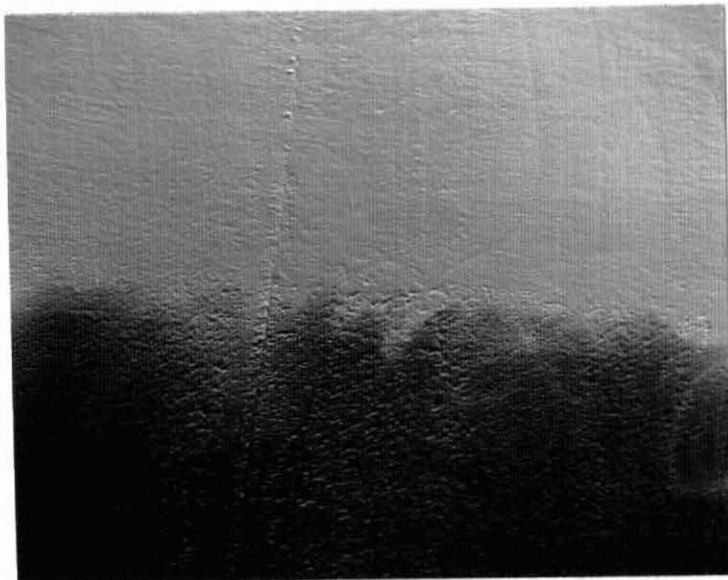
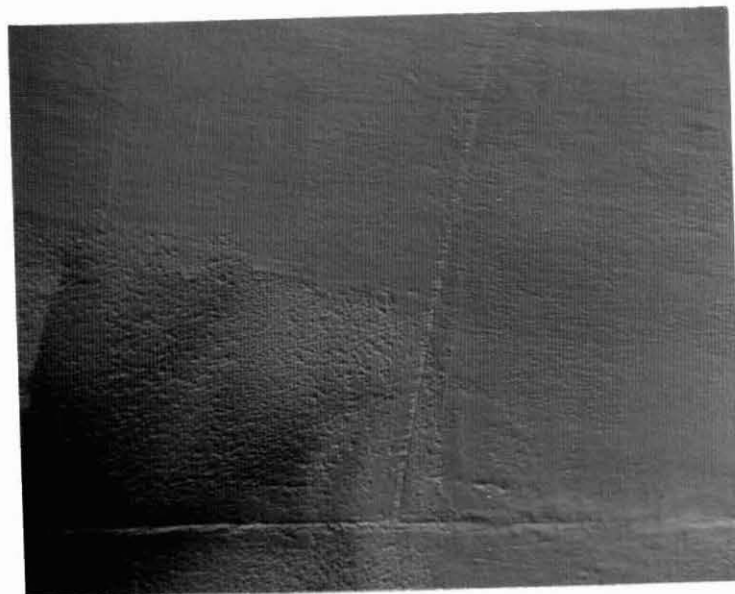
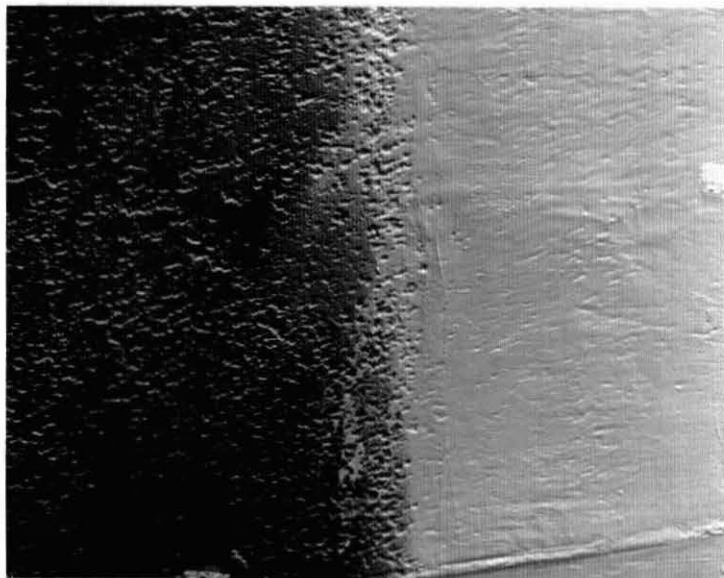
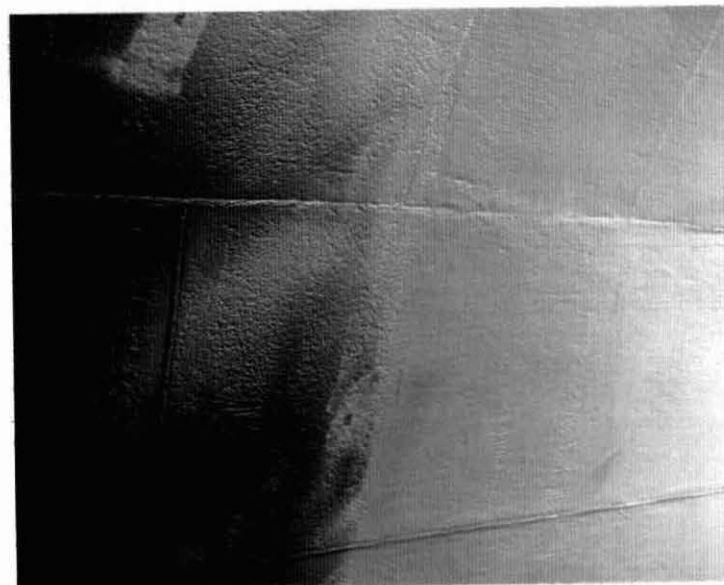
Figure II-17 Typical Hull Appearance of the USCG Cutter Mackinaw after Coating with Nonsolvented Urethane. Note the base metal showing the pits in the metal before application.

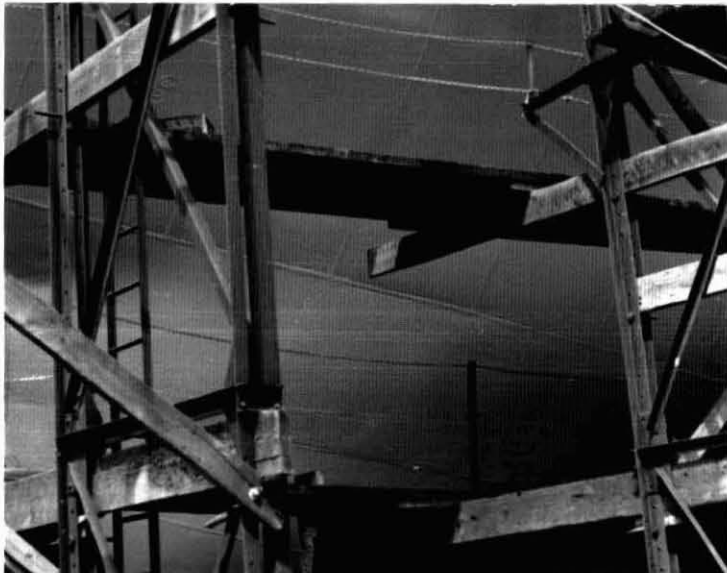
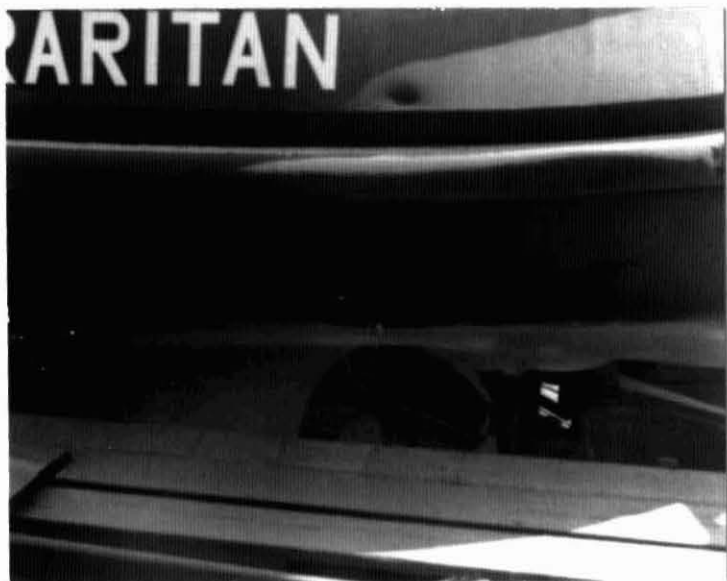
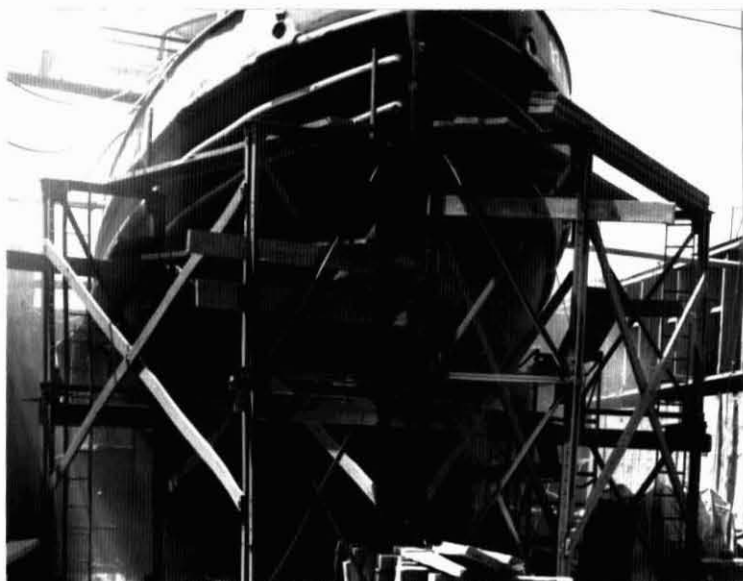
Figure II-19 Photographs of the Hull of the Cutter Raritan after Application of a Nonsolvent Polyurethane

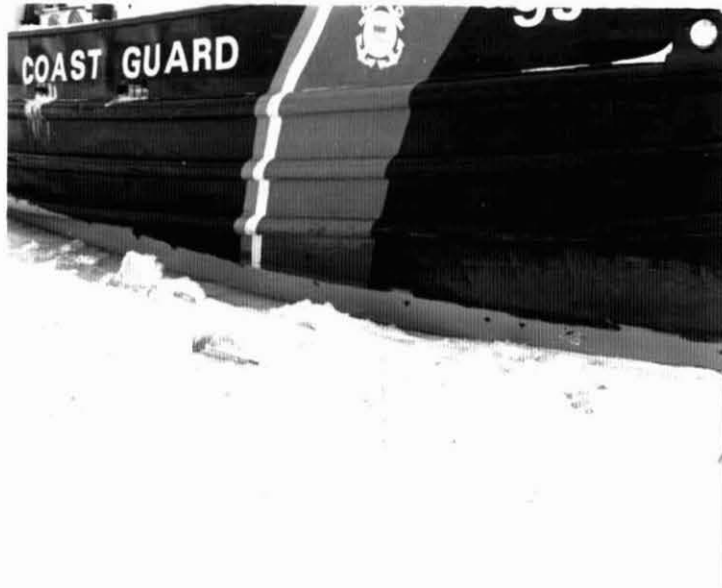
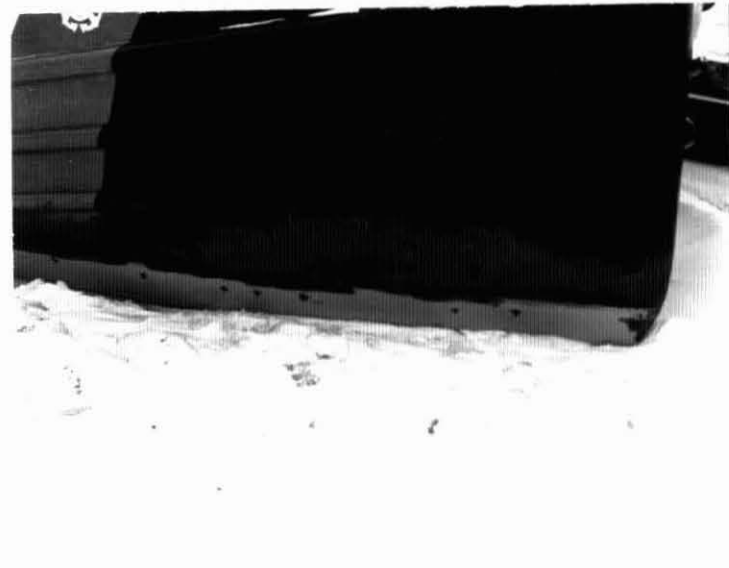
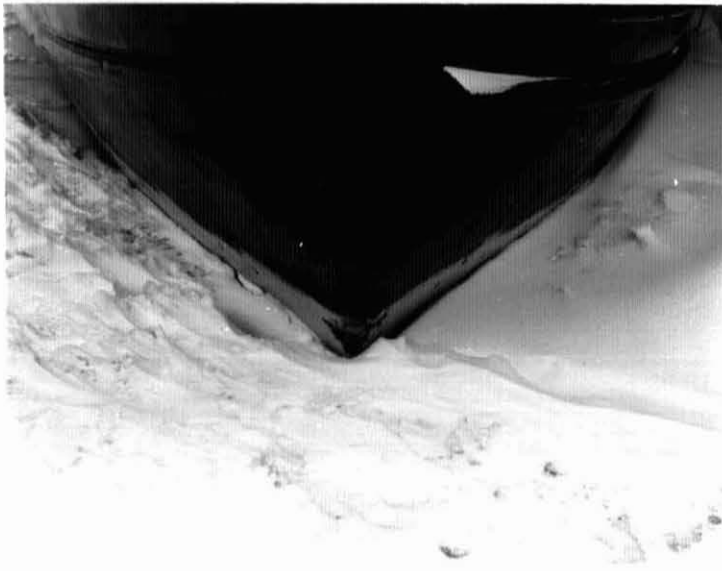
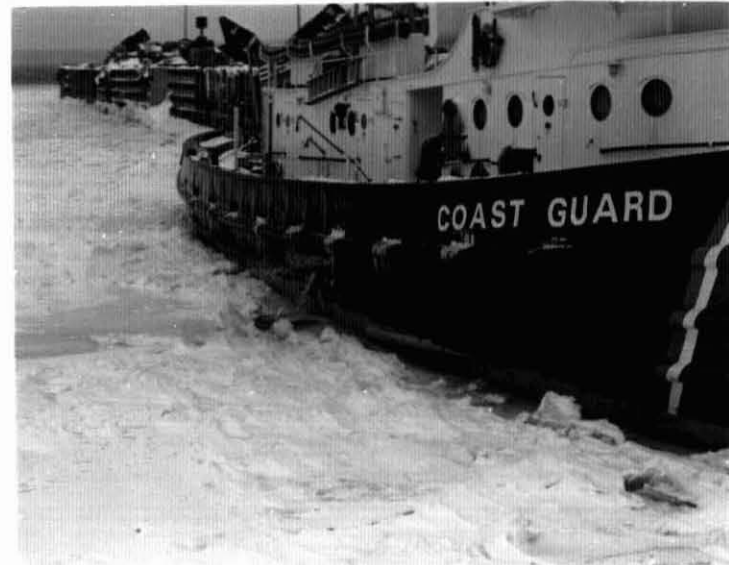
The ship had seen service assisting the Cutter Mackinaw at Sault St. Marie on the Great Lakes. At that time the coating appeared to be completely intact except for a 4" x 6" triangular shaped portion on the stern. Photographs of the ship taken during that inspection are shown in Figure II-20. The standard alkyd paint above the urethane was completely removed at the bow. Areas below the water line could not be seen because of the heavy ice, however during a period when the ship was in clear water, the hull was examined and found to show no damage as far down as could be seen.

134  
Figure II-20 Water Line Area of the Hull of the USCG Cutter Raritan after Icebreaking Service. Photographs taken during March 75 before the end of the icebreaking season.

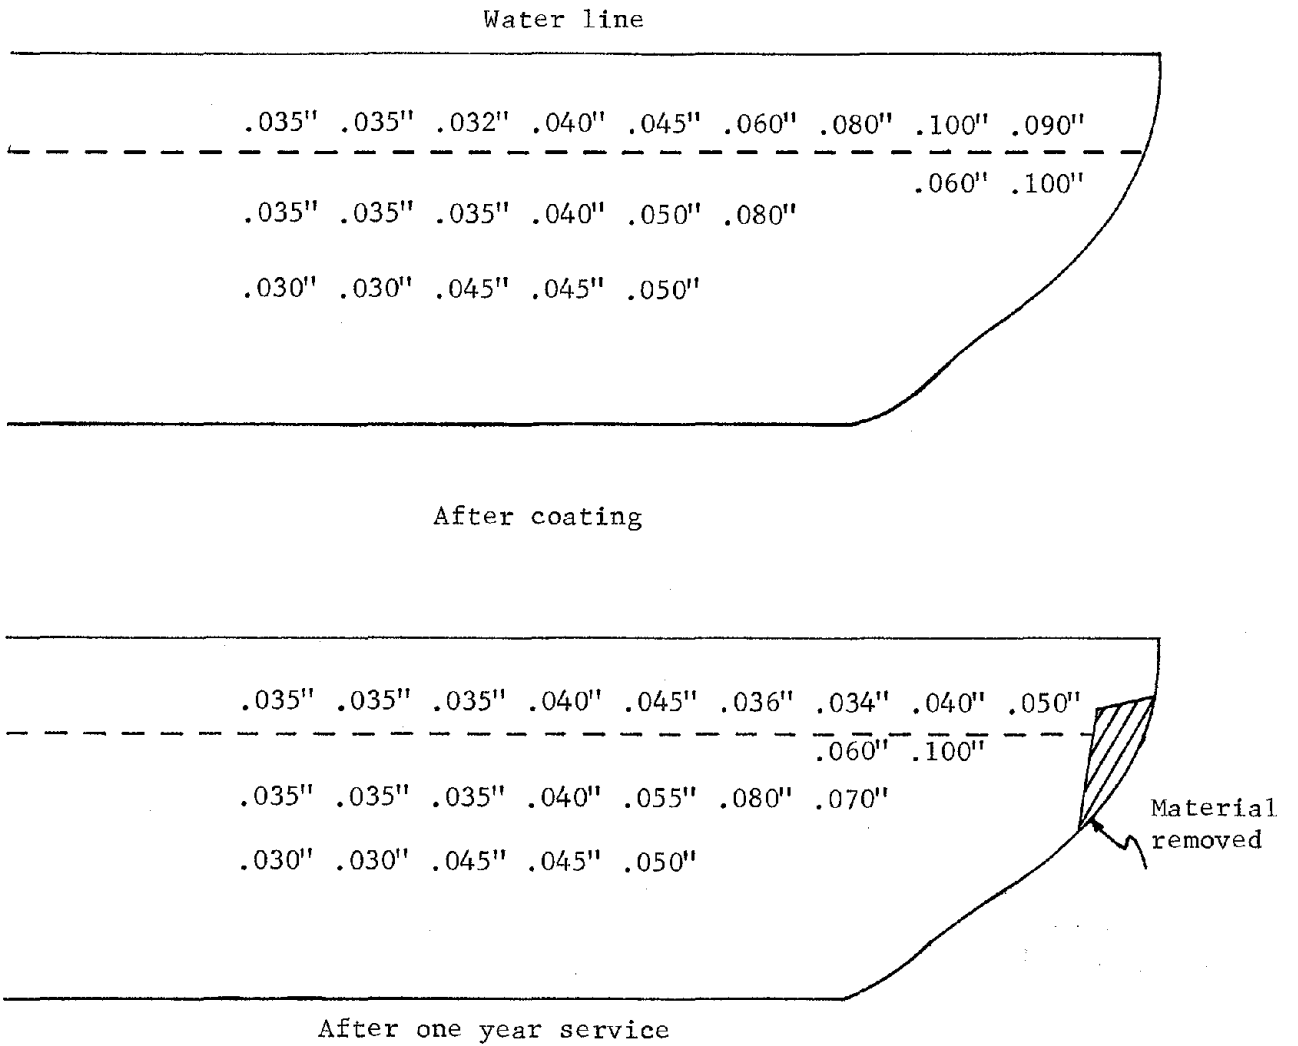
Wear occurred at the water line, near the bow, in a band approximately 8" wide. This could be seen by visual inspection. The worn areas were dull. Areas adjacent and on the underside of the hull were still shiny from the original coating glaze. The distribution of wear on both sides (port and starboard) appeared to be the same.

Schematic of the Coating Thickness of the Nonsolvented Polyurethane on the USCG Cutter Raritan "as applied" and after One Year of Service

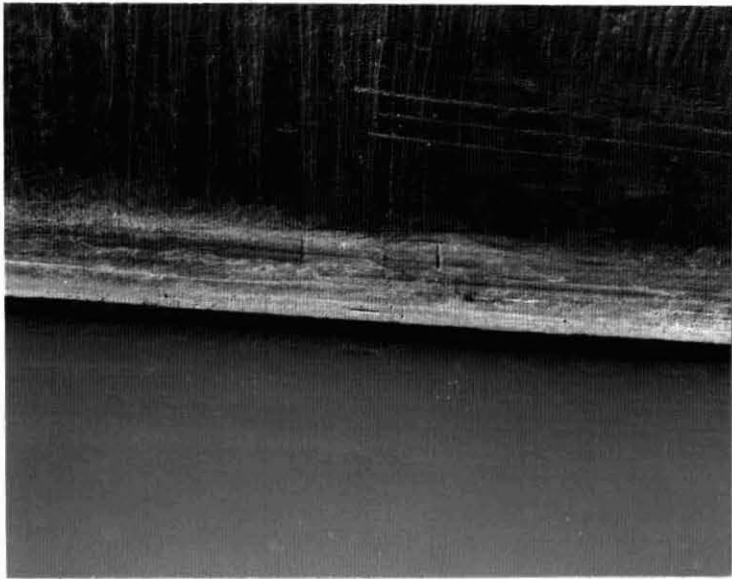
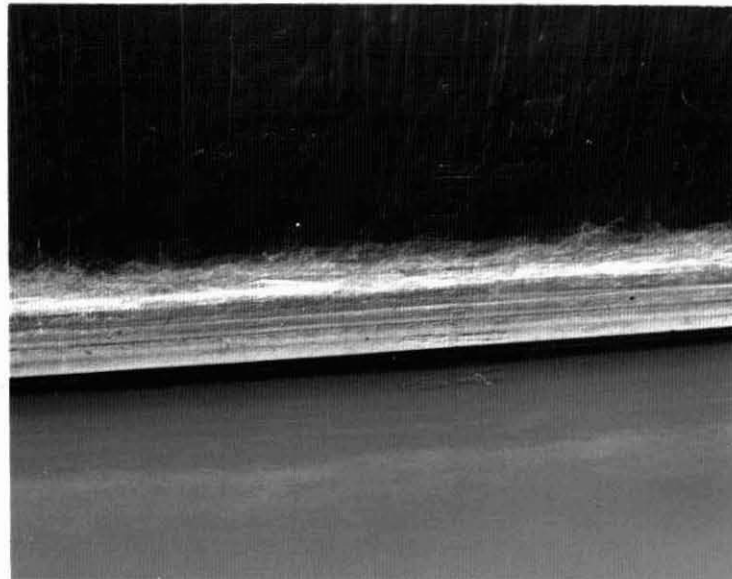
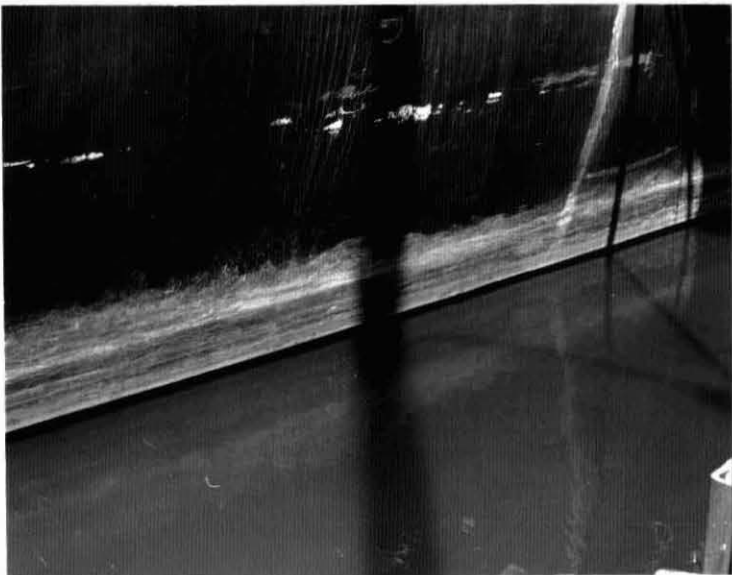
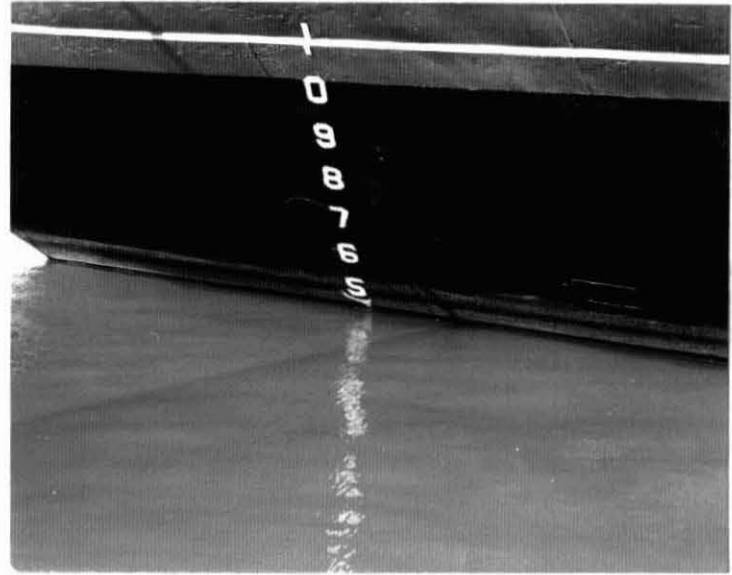
The ship was examined while in the water during August. Little could be determined at that time. Photographs of the hull were taken and are shown in Figures II-24 and II-25.

Figure II-24 Typical Appearance of the Polyester Glass Flake Coating at the Waterline on the Hull of the USCG Cutter Westwind (Midship to Stern)

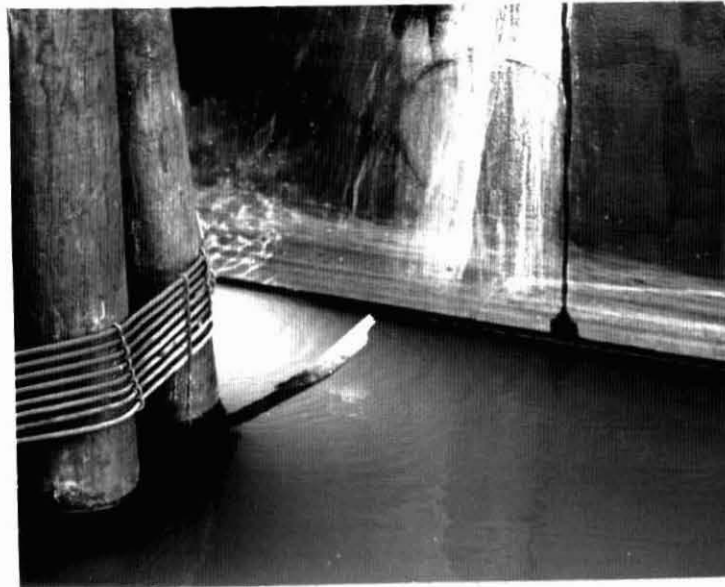
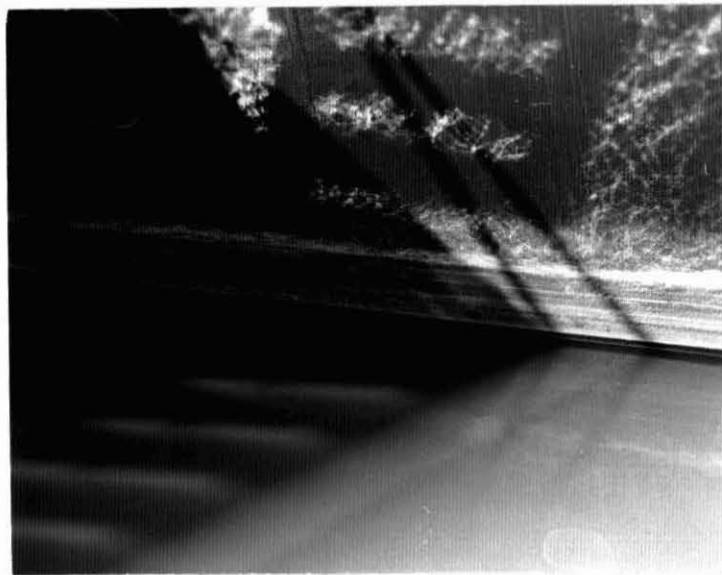
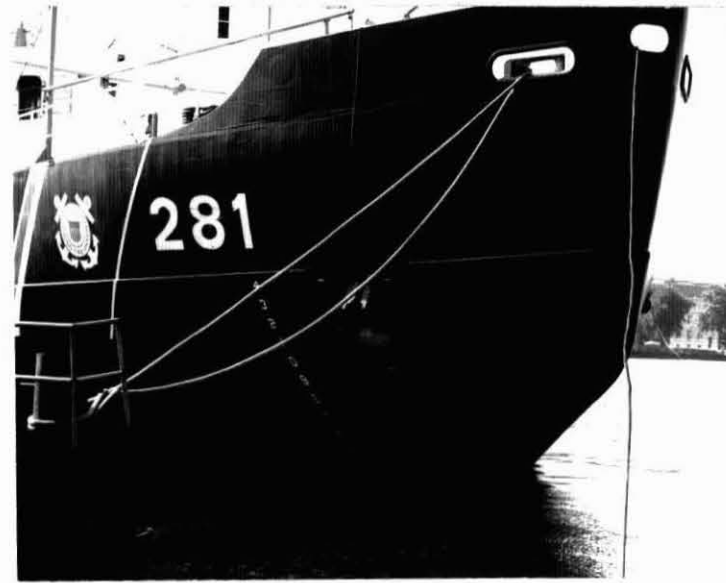
Figure II-25 Typical Appearance of the Polyester Glass Flake Coating at the Water Line on the Hull of the USCG Cutter Westwind (Bow to Midship)
