DIAGNOSTIC SIGNIFICANCE OF MACRO- AND MICROSCOPIC FEATURES OF CATASTROPHIC GUN-TUBE FAILURES

1976

ROBERT L. HUDDLESTON

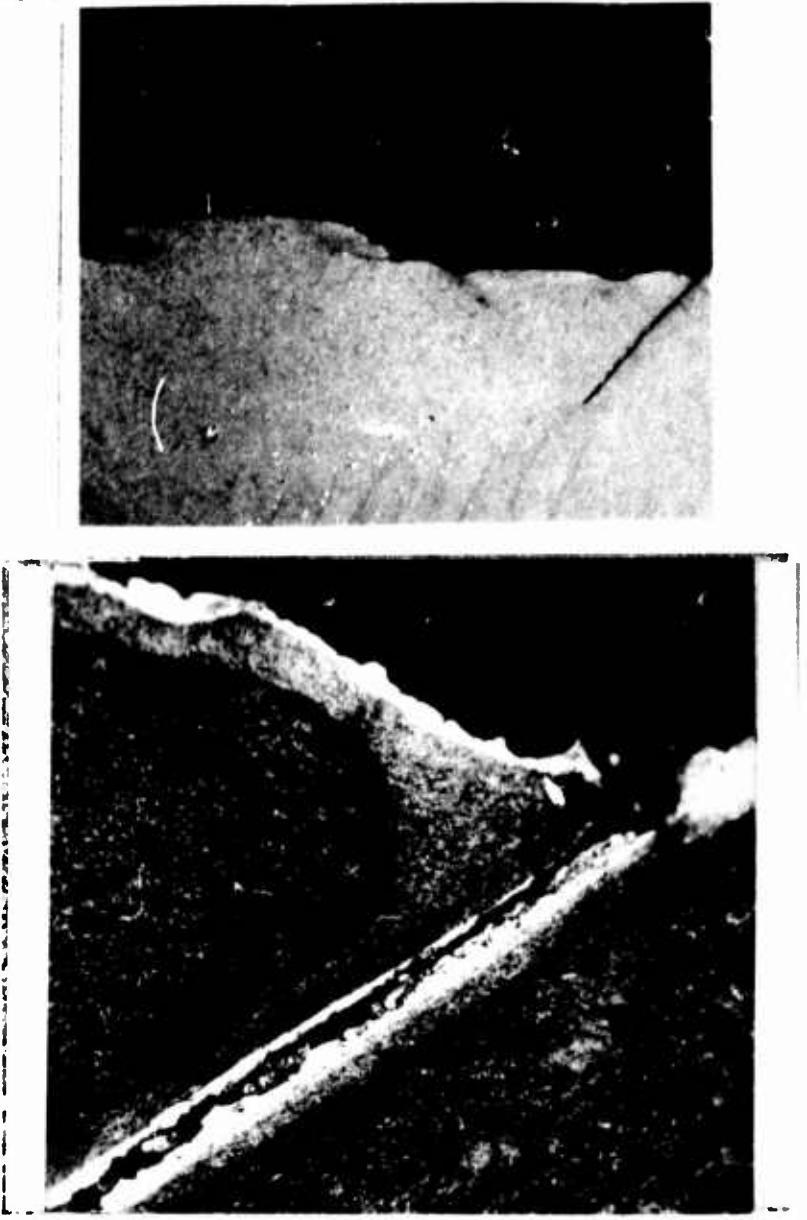
have not been observed on recovered shell that were fired under normal conditions and apparently are caused by the intense heat, possibly in combination with the pressure of the detonation gases. Almost all fracture surfaces of tube and shell fragments exhibit a gas-washed surface layer. This alteration of fracture surfaces, by masking

fracture detail, has seriously impeded efforts to better analyze fracture surfaces with the scanning electron microscope. The diagnostic significance of this observation is that the presence of a "white layer" in surface cracks in tube fragments after detonation is not necessarily evidence of a pre-existing fatigue crack, as has been believed by some investigators.
