TR75-118 AMEL

**SIMULATED SOLAR HEAT TESTS OF
M.U.S.T. AIR-INFLATABLE,
DOUBLE-WALL HOSPITAL WARD SHELTERS**

MAY 1974

**UNITED STATES ARMY
NATICK RESEARCH and DEVELOPMENT COMMAND
NATICK, MASSACHUSETTS 01760**

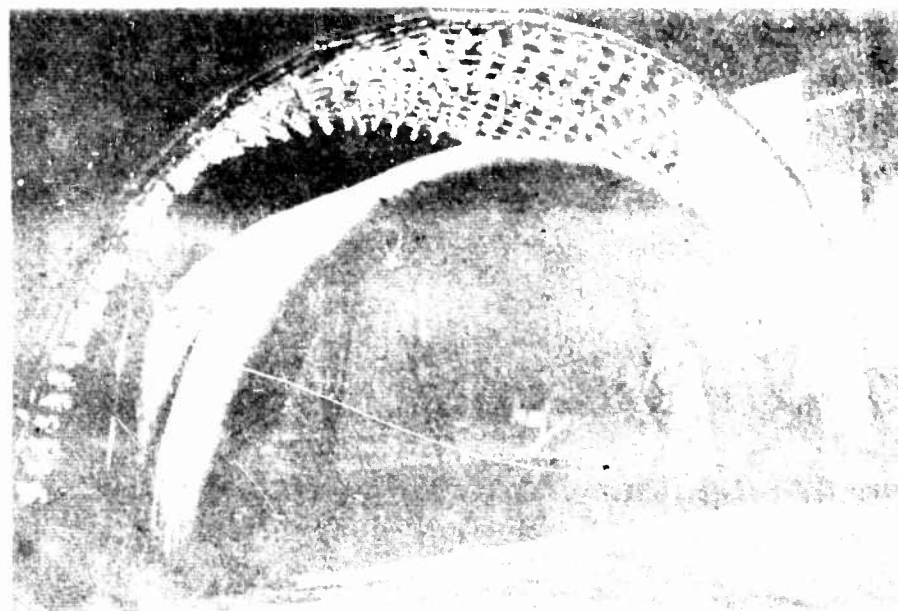
Figure 1. Shelter Section Undergoing Simulated Heat Load Test

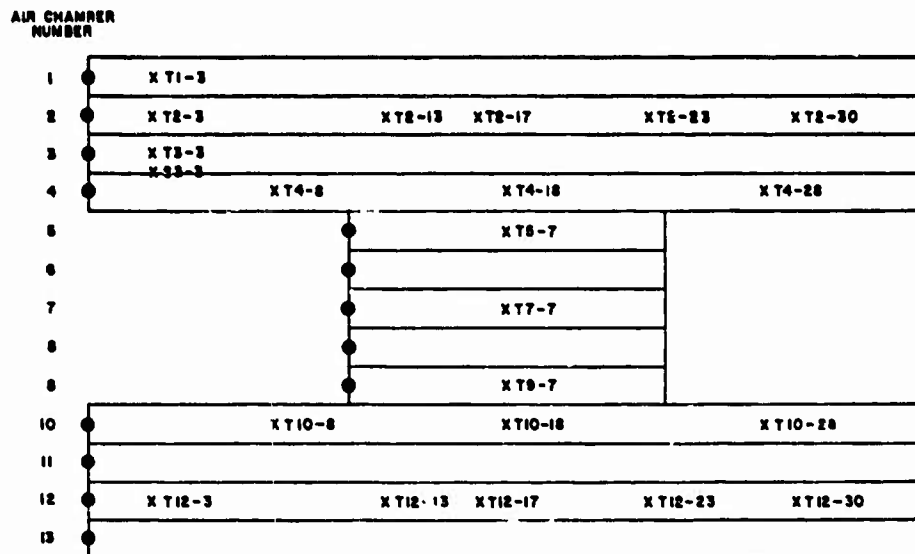
Figure 5. Location of Exterior Surface Thermocouples on Shelter Sections Fabricated by Manufacturer IP

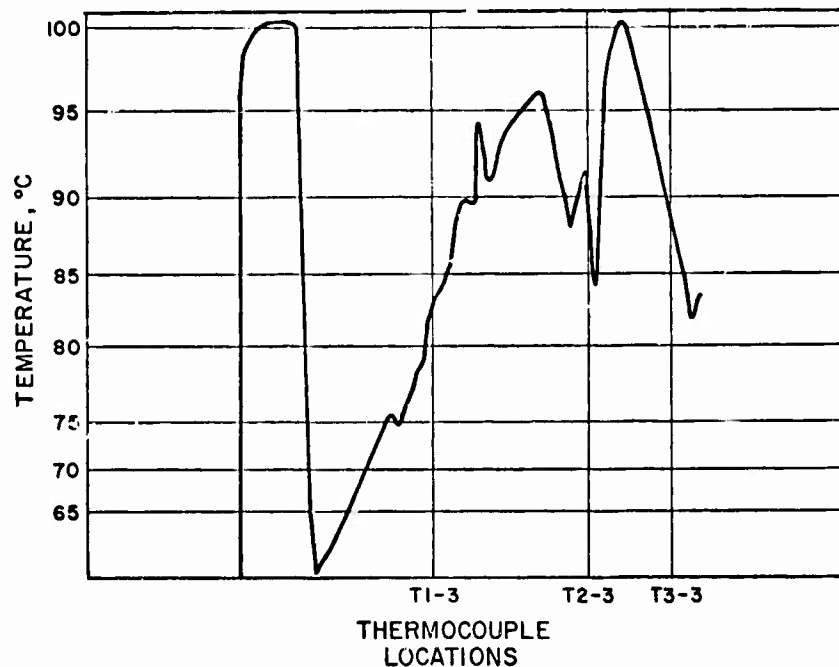
Figure 6. Temperature Graph Obtained by the Thermographics System

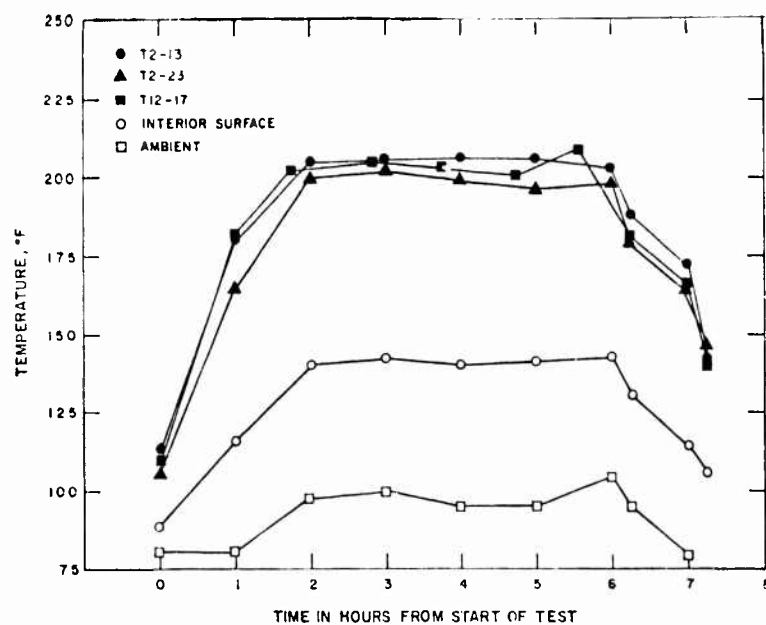
Figure 8 contains a plot of data from three representative exterior surface thermocouples, one interior surface thermocouple, and one ambient air thermocouple during the first cycle of the test. The location of the exterior surface thermocouples can be noted in Figure 4. A plot of the thermocouple readings for the second test cycle is not included because of the similarity of readings obtained in the two cycles.

Figure 8. Temperature Readings of Selected Thermocouples During the First Cycle of Shelter Section F-1

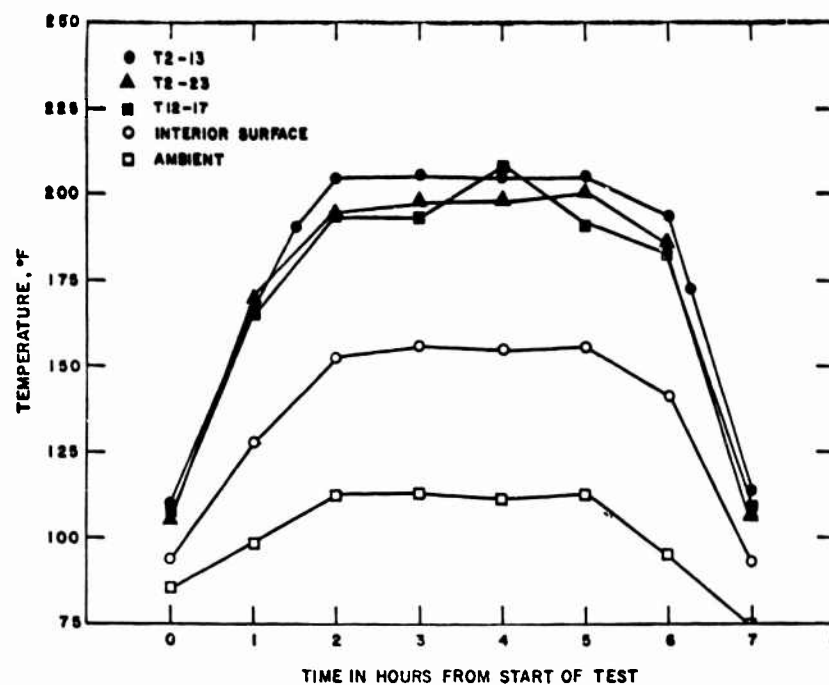
Figure 9 contains a plot of data from three representative exterior surface thermocouples, one interior surface thermocouple, and one ambient air thermocouple during the first cycle of the test. The location of the exterior surface thermocouples can be noted in Figure 4. A plot of the thermocouple readings for the second test cycle is not included because of the similarity of the readings obtained in the two cycles.

Figure 9. Temperature Readings of Selected Thermocouples During the First Cycle of Shelter Section F-2

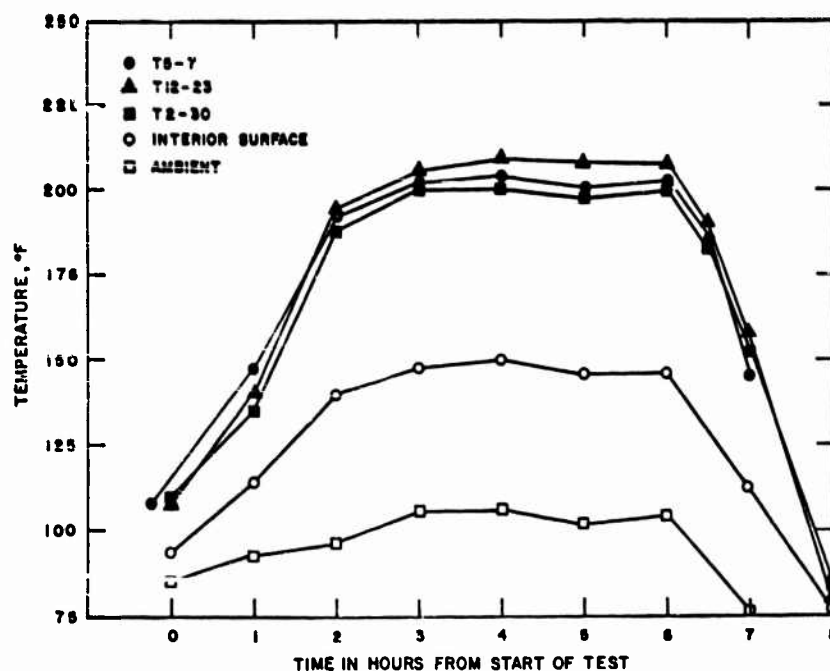
Figure 17 contains a plot of data from three representative exterior surface thermocouples, one interior surface thermocouple, and one ambient air thermocouple during the first cycle of the test. The location of the exterior surface thermocouples can be noted in Figure 5.

Figure 17. Temperature Readings of Selected Thermocouples During the First Cycle of Shelter Section IP-1

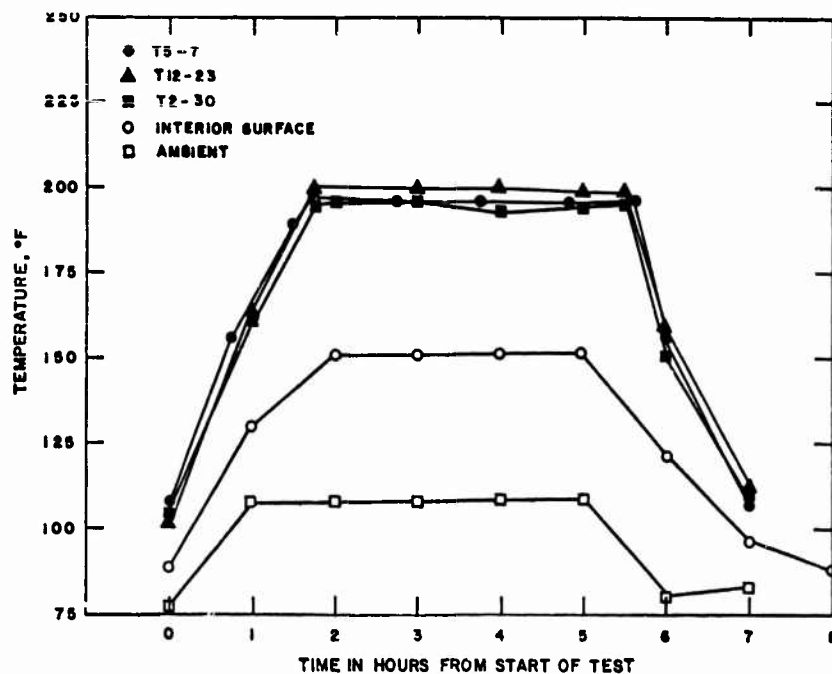
Figure 18 contains a plot of data from three representative exterior surface thermocouples, one interior surface thermocouple, and one ambient air thermocouple during the first cycle of the test. The location of the exterior surface thermocouples can be noted in Figure 5.

Figure 18. Temperature Readings of Selected Thermocouples During the First Cycle of Shelter Section IP-2

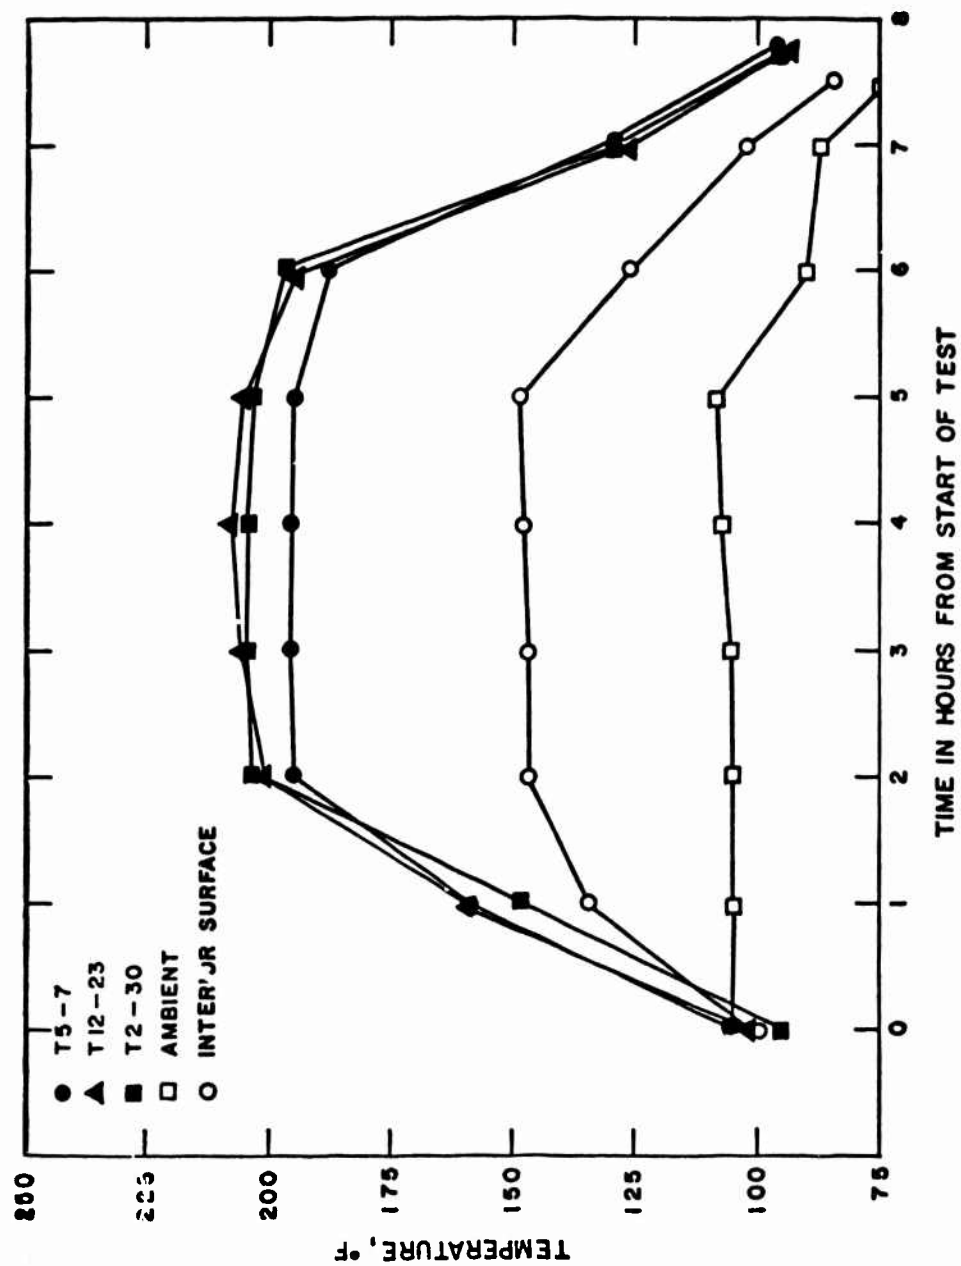
Figure 21 contains a plot of data from three representative exterior surface thermocouples, one interior surface thermocouple, and one ambient air thermocouple during the first cycle of the test. The location of the exterior surface thermocouples can be noted in Figure 5.

Figure 21. Temperature Readings of Selected Thermocouples During the First Cycle of Shelter
Section IP-3
