USAAMRDL-TR-76-9

• **DEVELOPMENT PROGRAM FOR FIELD-REPAIRABLE/EXPENDABLE  
MAIN ROTOR BLADES**

Kaman Aerospace Corporation  
Old Windsor Road  
Bloomfield, Conn. 06002

Final Report

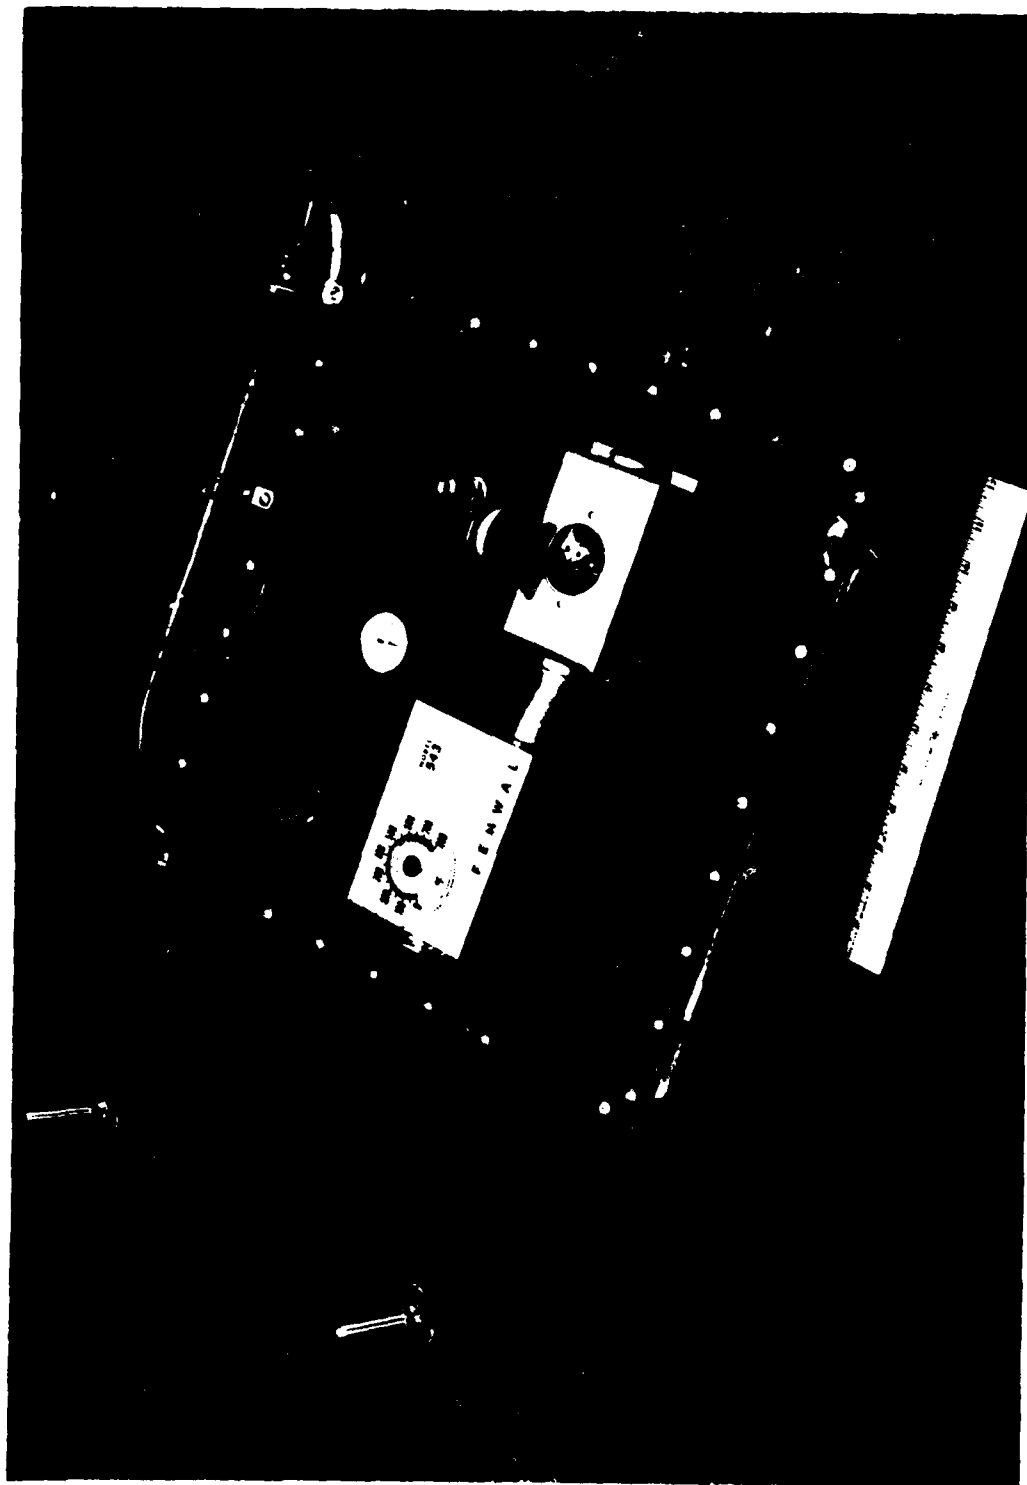
Figure 38. Pressure/Heat Pack.

With these various modifications, the pressure/heat pack worked well and produced consistently good bonds, except for the deep, 1-1/4-inch plugs, whose installation tended to produce slight bulges in the skin on the opposite side of the blade. Upon investigation, it was determined that the expansion of air within the core, due to the application of heat, exerted an outward force on the skins. This force was reacted by the bladder on the side of the repair; but on the opposite side of the blade, where no restraint was present, the skin bulged. Since this occurred before the adhesive was completely cured, the adhesive became redistributed along the floor of the cavity and, after hardening, prevented the skin from returning to its natural shape. This problem was corrected by adding a backing plate to the pressure/heat pack which kept pressure against the opposite skin during the cure cycle.

The problem was not entirely eliminated with this modification, however. Some bulging of the skin persisted with deep plugs after the backing plate was added. It was determined that insufficient cure time was the cause. Removing the pressure/heat pack from the blade before the bond at the bottom of the plug was completely cured allowed the heated air to bulge the skin slightly as before and, when the cure was complete, caused a permanent deformation. This was corrected by increasing the cure cycle from 15 minutes to 30 minutes for the deep plugs.

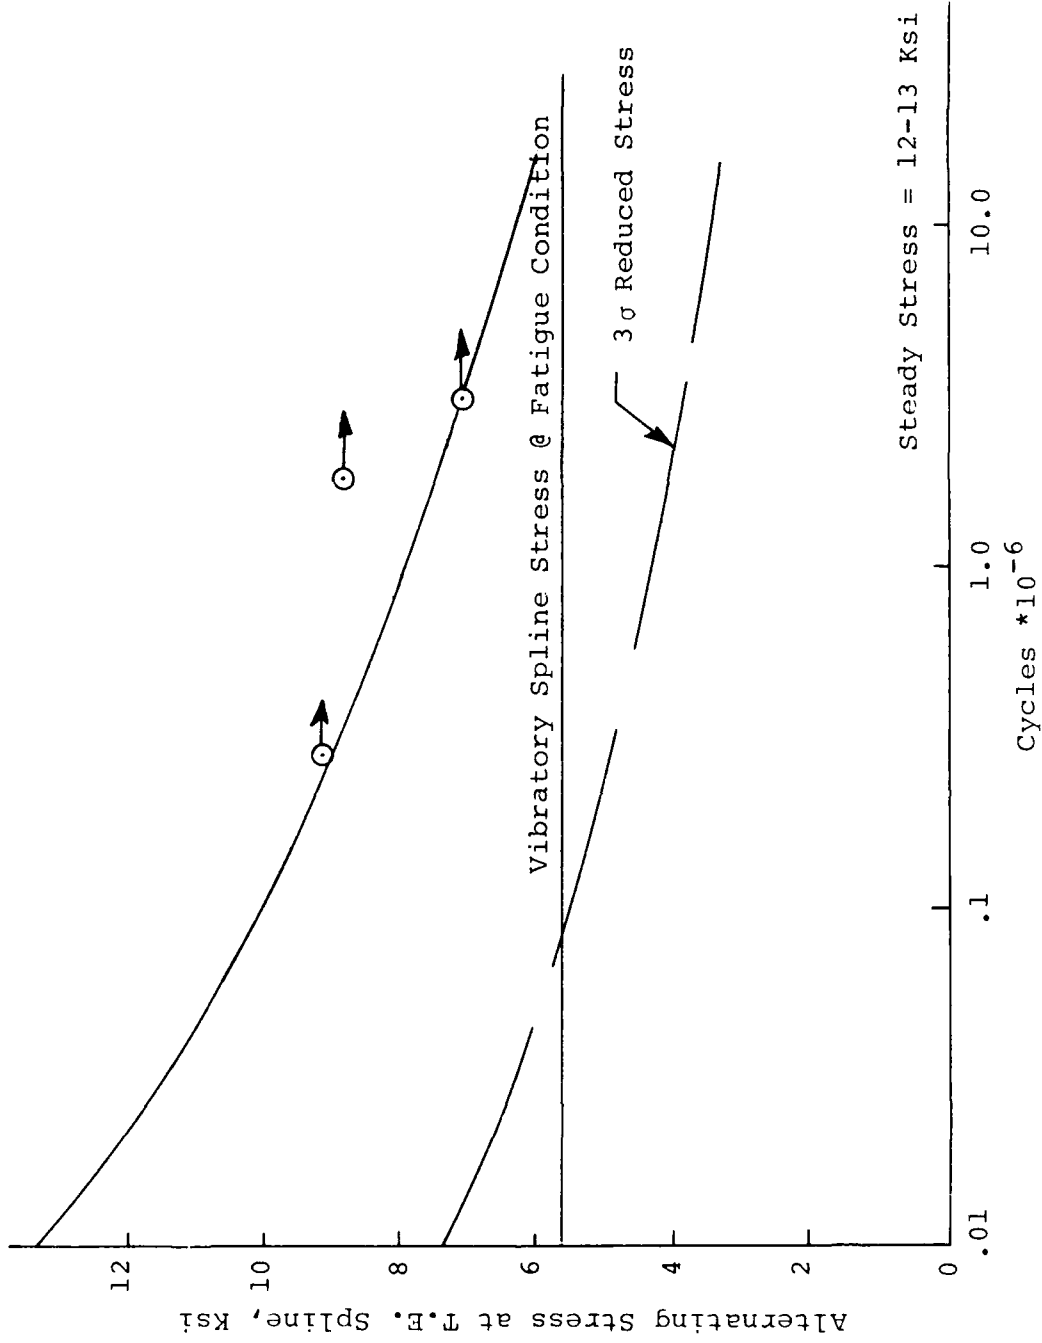
Figure 72. S/N Curve for Root End Fatigue Specimens.

The loads applied during test and the cycles to drag brace failure are given in Table 43. Figure 72 is a projected fatigue curve, based on the data obtained from this testing. In this curve, the runout points are plotted with arrows and the fatigue curve is drawn through these points. This introduces an unknown level of conservatism into the curve with respect to the blade. The curve could be thought of as a drag brace fatigue curve because of the relatively high strength of the blade in comparison to the drag brace.

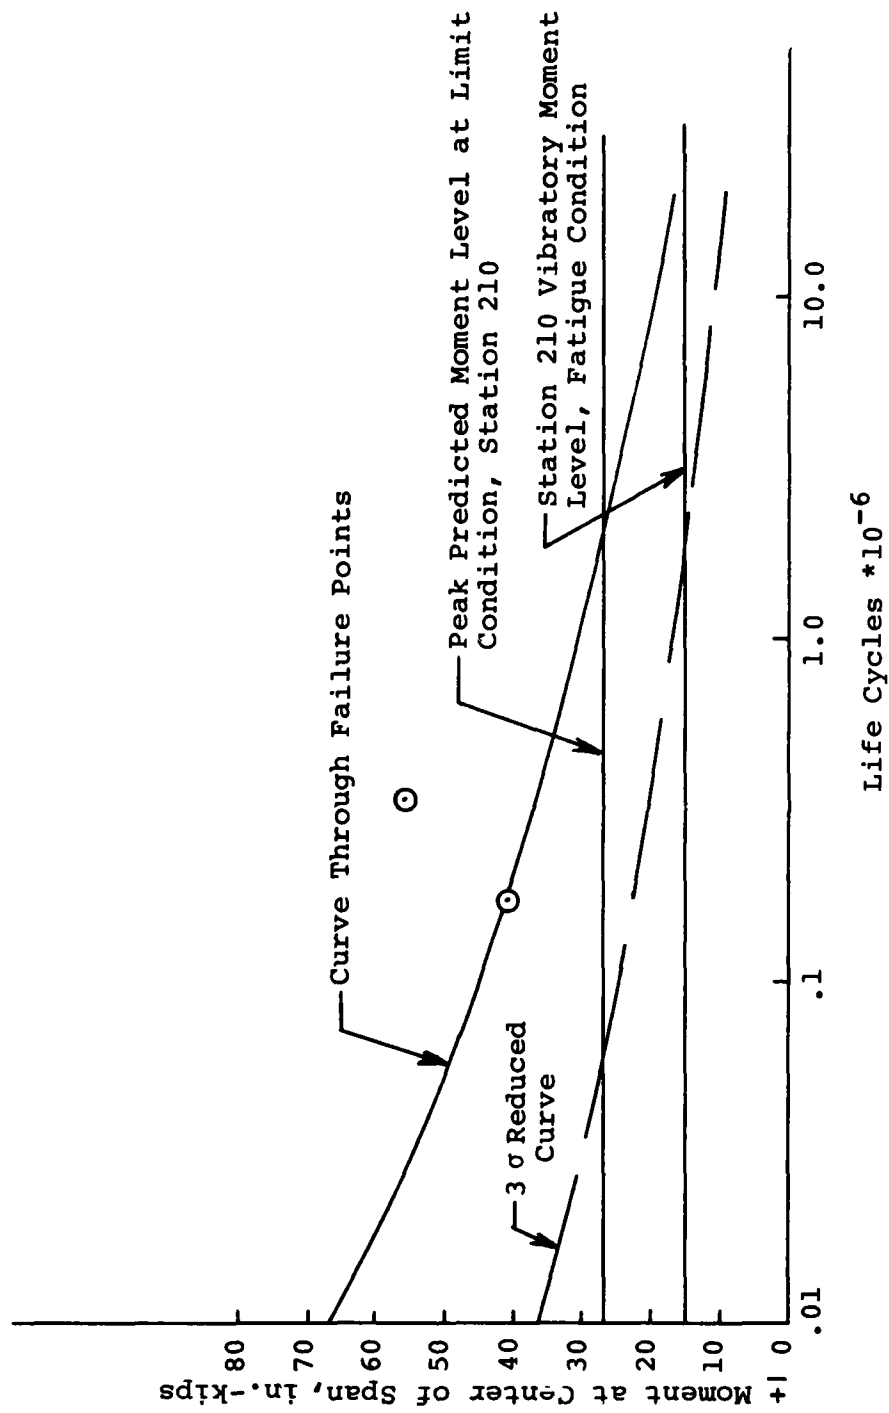
Figure 76. Flatwise Free-Free Beam Fatigue Curve.

repair. Specimen 7F withstood a failing level of flatwise load for 351,000 cycles before a fatigue crack originated at the spar rebate. A fatigue curve generated from these two data points is shown in Figure 76, along with reference load levels of the peak flatwise moment predicted at station 210 and the fatigue moment predicted at station 210.

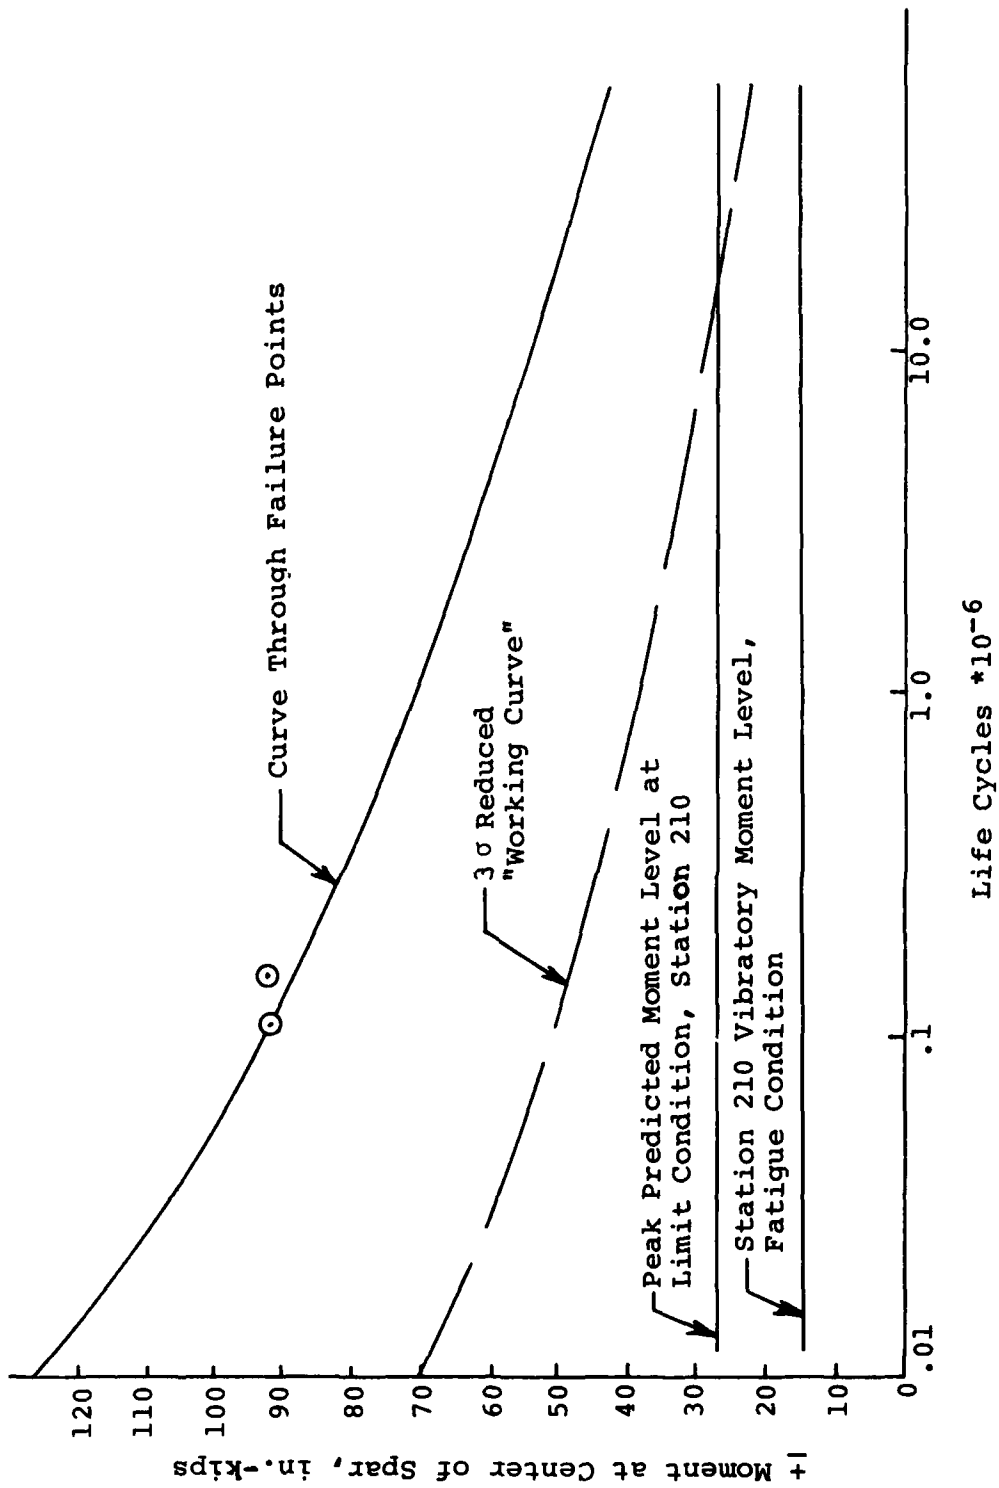
Figure 78. Edgewise Free-Free Beam Fatigue Curve.

The edgewise testing of specimens 11E and 7E was conducted in a similar manner. Specimen 11E was tested at a high load level intended to fail the specimen in a short time. A crack was started on the spline, and failure was noted by a distinct change in driving power required at 152,000 cycles. The spline crack and its effect on the skin are shown in Figure 77. Specimen 7E was first damaged with a through-hole and a chordwise slit. The specimen withstood 10 equivalent flight hours at the fatigue level without deterioration of the holes. One of the holes was then enlarged to 3 inches in diameter, and 1/2 inch deep, and testing continued for an additional 10 hours equivalent, again with no deterioration. After repair, another 10 equivalent flight hours was withstood at the fatigue level, again without specimen deterioration. The load level was then increased to the high-level (early failure) fatigue load, and a failure was finally noted on the spline after an additional 104,000 cycles. These two points were interpreted to give the fatigue curve of Figure 78.

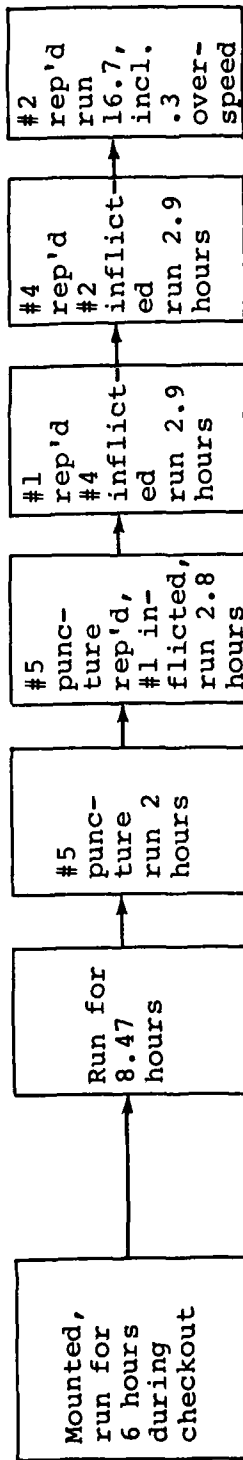
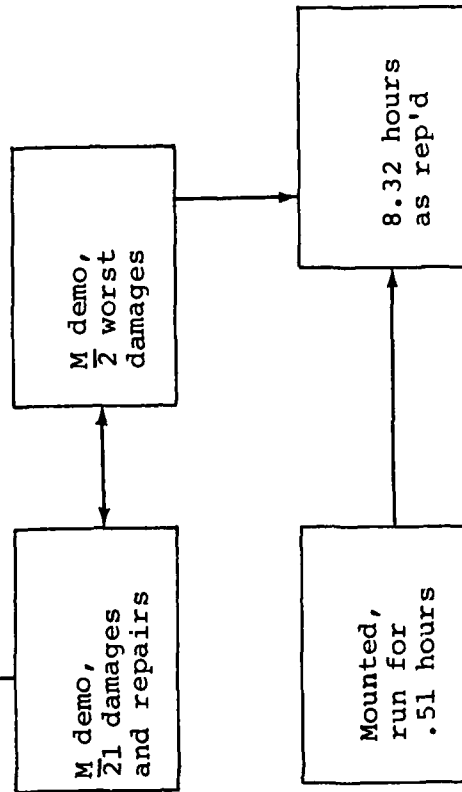
Figure 80. Whirl Test Flow Chart.

Figure 80 shows a flow chart of the whirl test, including where the various damage and repair events occurred in the test sequence. Table 45 goes with Figure 80 and describes the damage and repair events in more detail. The whirl test was designed to demonstrate three aspects of the FREB:

During the entire whirl test sequence, the undamaged blades showed no distress, the damage inflicted to the blades did not progress, and the repairs did not deteriorate. The applied loads included 10% rotor overspeed, as well as full thrust of 9900 lb. Blade balance and track before damage, after damage and after damage repair remained within acceptable limits. Figure 81 compares the thrust versus horsepower requirements of the FREB to that of the present UH-1H blade under similar test conditions.

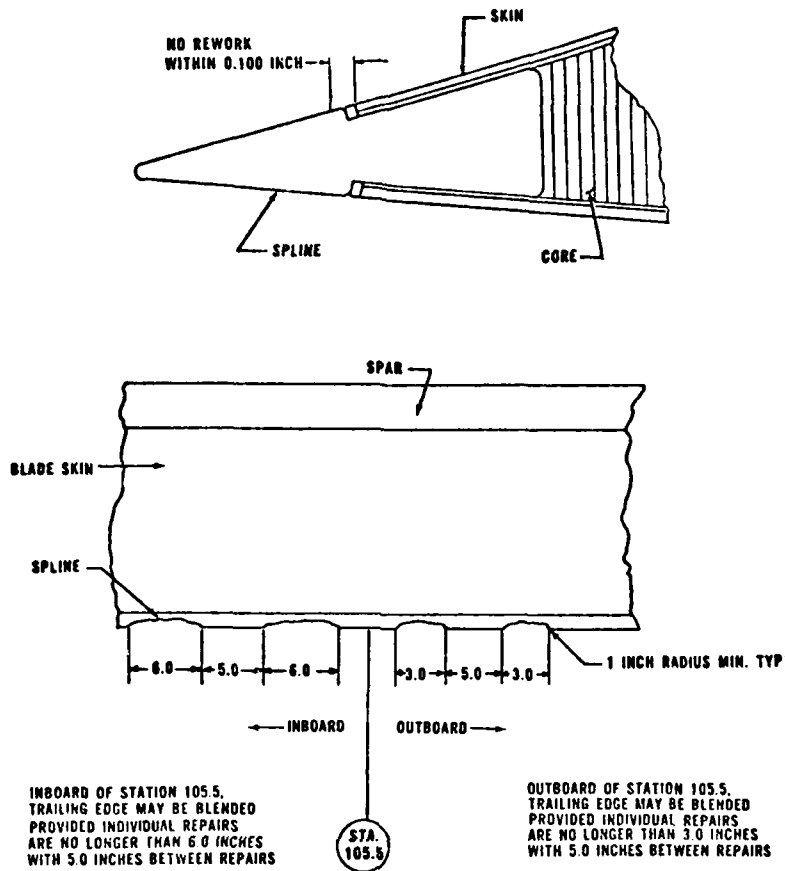
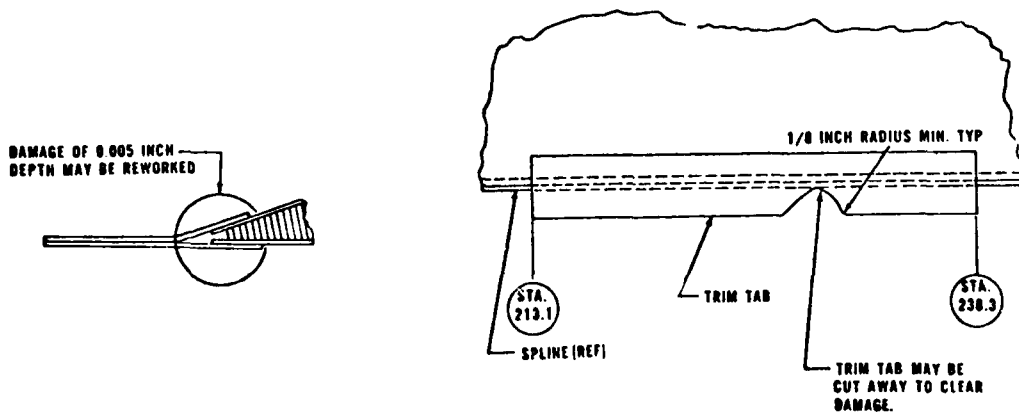
Figure B-2. Blend Limits for Spline and Trim Tab.

a. Cracks, punctures, tears and delaminations in the tab from the spline trailing edge forward requires scrapping blade.

b. Bends, dents and distortion of tab aft of spline may be mechanically straightened providing none of the items in Step a above occur.
